Carnachenwen W/13/2221

Tir Gofal Farm Visit Historic Environment Report

Report No. 2002/108

Carnachenwen
Tir Gofal Farm Visit Historic Environment Report

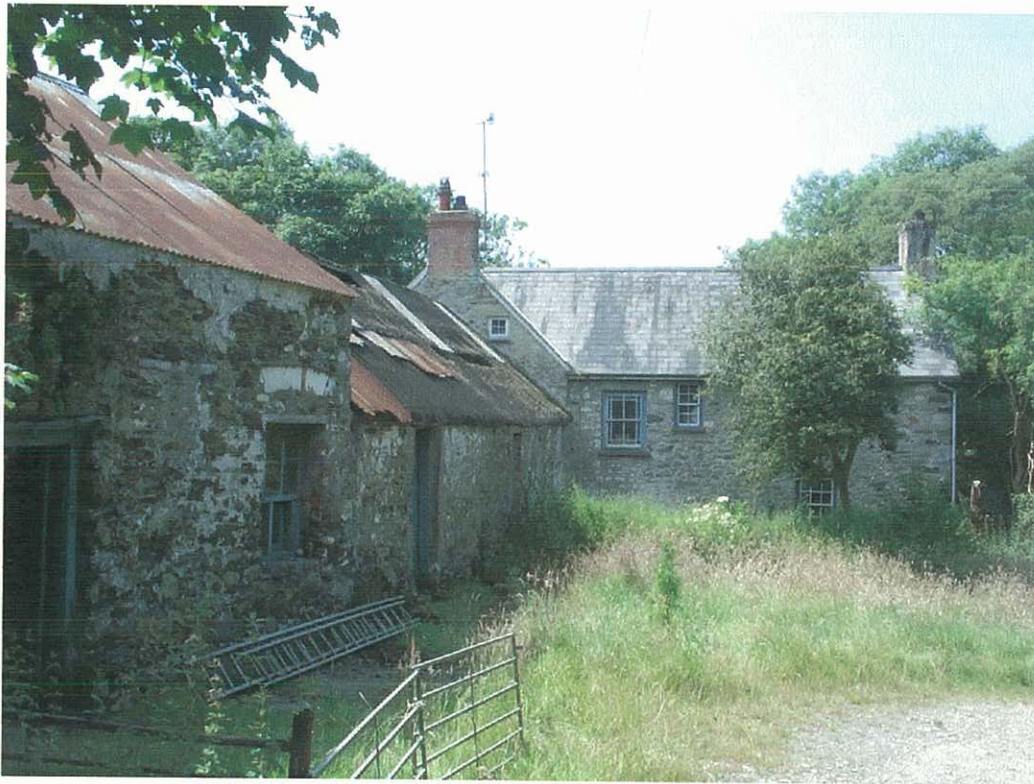
The north wing of farmhouse (Prn 16761) and cow shed (Prn 47747)

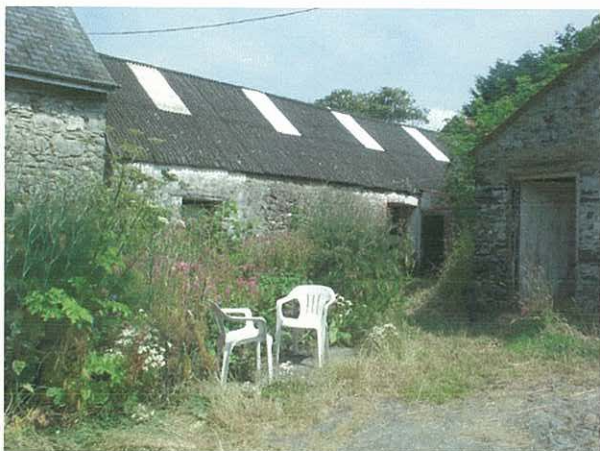
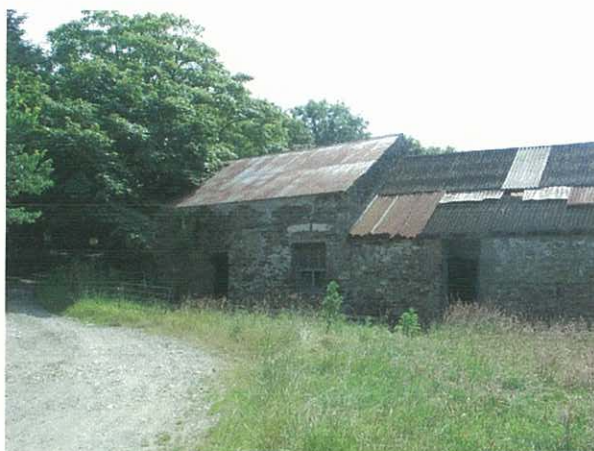
The lower section of the one storey cow shed, adjacent to the farmhouse, is roofed in corrugated asbestos. Although the sheeting on the south side of the roof appears to be in reasonable condition, the roof to the north has some broken sections which are allowing water ingress. The eastern section, which has a higher roof line, is covered in corrugated iron, which appears to be in reasonable condition.

Prn 47747 - the cowshed to the east of the farmhouse, the southern elevation (left) and the northern elevation (right)

It is a priority to restore these buildings to a weatherproof condition. Whilst rain can penetrate the roof the structural timbers will quickly deteriorate and the bonding mortar of the wall tops will also erode. Corrugated zinc is likely to be the most economical material to repair the roof. Please inform the Local Planning Authority in advance of any restorations works.

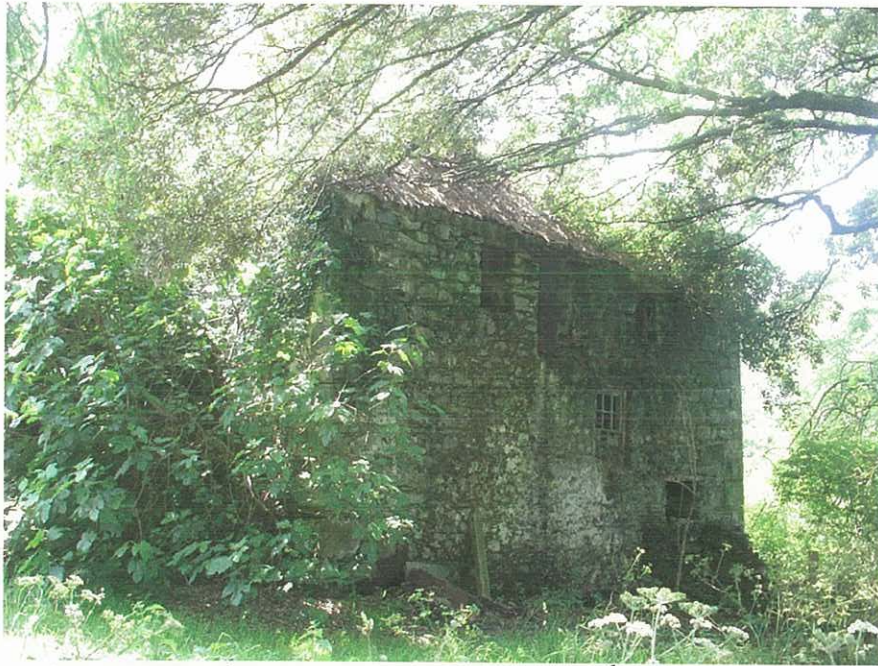
The granary is situated to the northwest of the farmhouse, and is currently disused. A large tree overhangs it to the northeast, and a large sycamore sapling is growing within the outside steps. The corrugated iron roof has corroded in places and has been leaking sufficiently to begin to rot the floorboards (the roof timbers were not seen). Water is evidently percolating through the wall tops and causing further instability. In addition a further problem is caused by overhanging branches which are brushing against the roof and wall tops.

Prn 47748 – the granary or storws, a rare 18th century example

It is a matter of some urgency that this building is repaired and made weatherproof, before significant structural damage is caused. The priority for this building is to repair the roof to prevent further water ingress. Where the bonding mortar matrix has been eroded the walls should be repointed and consolidated. Vegetation which has become established within or in close proximity to the masonry, should be cut back and the roots left in place, these should be spot treated to prevent regrowth. Ideally any overhanging branches should also be cut back to prevent further damage being caused to the roof covering and the wall tops.

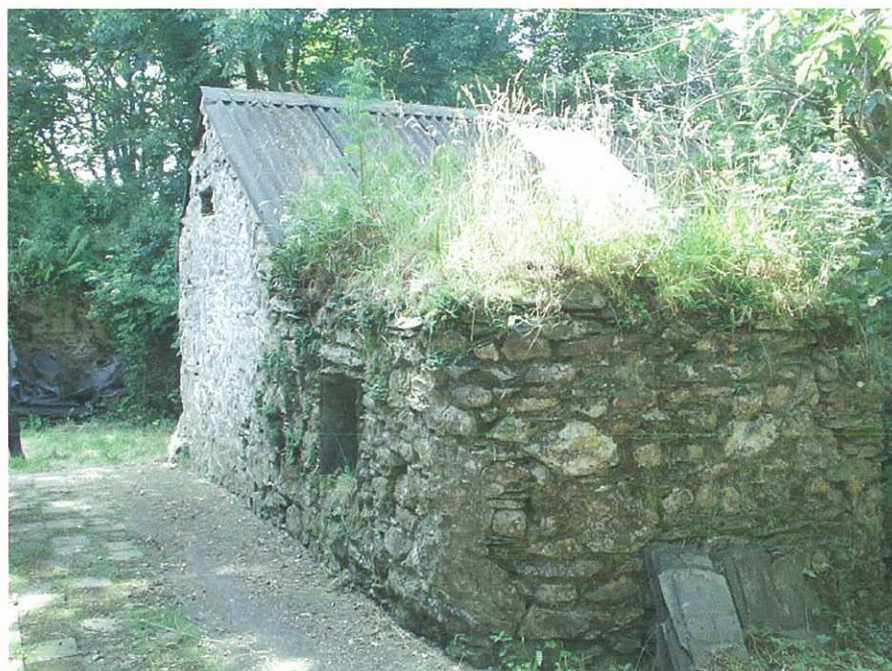
The pigsties are located immediately to the west of the farmhouse. Now disused the pigsties are becoming rather overgrown, particularly along the tops of the yard wall, with a large sapling established in the north wall. The west gable end has become overgrown with ivy.

Prn 47749 – the pigsty, with a slate lined feed chute in the yard wall.

In order to maintain the pigsties in a stable condition it is recommended to remove the vegetation, which is currently growing in the wall tops. If possible the walls should also be consolidated, however if this is not possible then the saplings should be cut back and the roots left in place and treated to prevent regrowth.

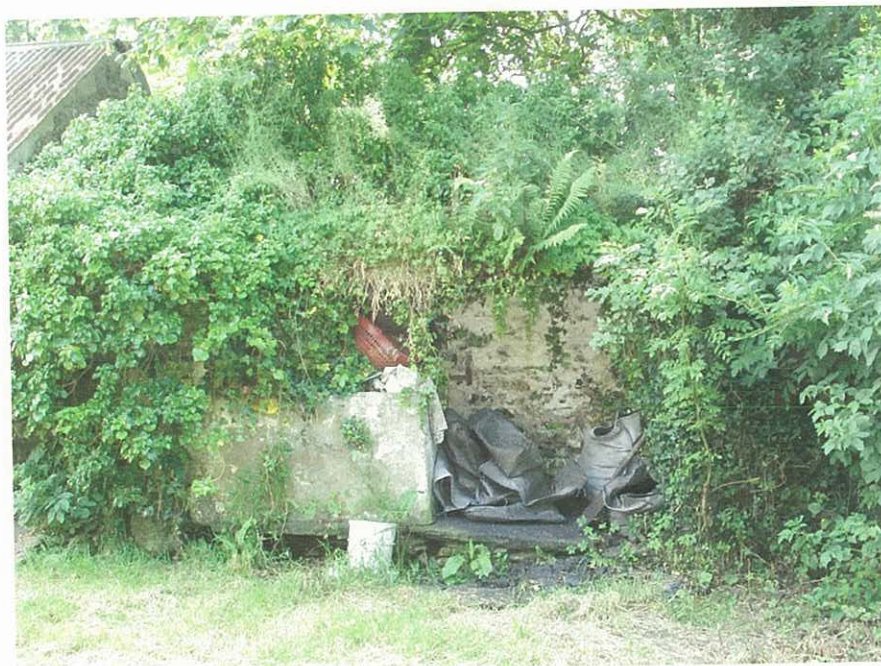
This building is currently very overgrown with ivy which is effectively obscuring much of the building fabric.

Prn 47750 – the stond agolch or outbuilding for making pigswill

In order to prevent serious damage to the masonry, the vegetation, which is engulfing the building, should be carefully removed. The ivy stems should be cut and the roots treated to prevent regrowth. Ideally the walls should also be consolidated.

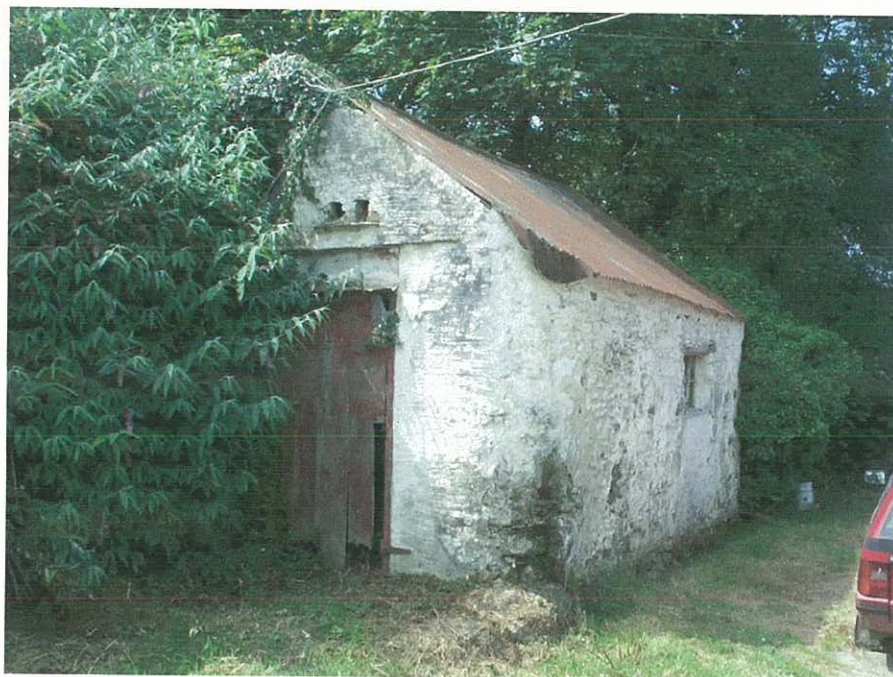
Although overgrown this building appears to be in a reasonably stable condition.

Prn 47752 – an outbuilding known as Ty'r Odyn

The vegetation which is beginning to engulf the building should be cut back and the roots treated to prevent regrowth. Once the vegetation has been removed the roof should be checked for leaks and repaired and any loose masonry or eroded pointing should be consolidated.

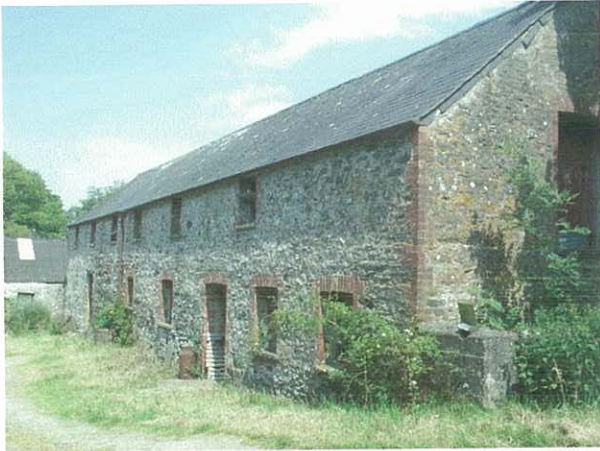
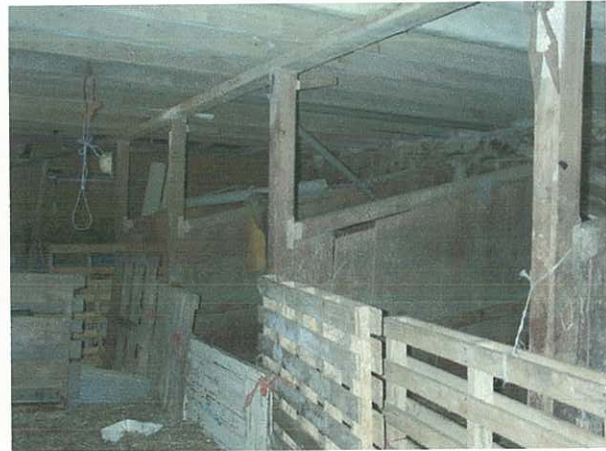
The barn appears to be in a reasonably stable condition.

Prn 47753 – the west elevation of the long and some of the interior stalls which survive within it

This barn should be maintained in a weatherproof condition.

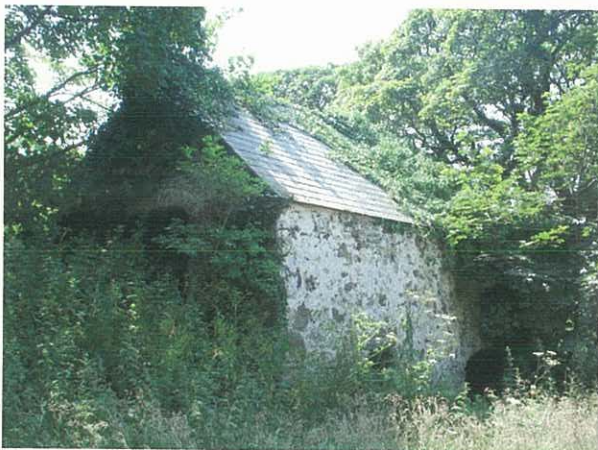
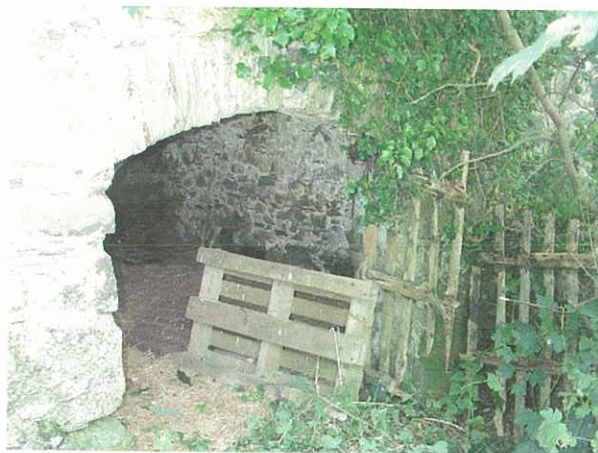
Prn 47754 - the cart house exterior and the stone arched cart entrance

The major problem with this building is encroaching vegetation which, if left unchecked, will undoubtedly cause serious structural problems, particularly since ivy is well established on the roof. Therefore it is essential that the vegetation is cut back and kept in check by spot treating the roots to prevent regrowth. Ideally the roof should be repaired and the walls also consolidated where necessary.

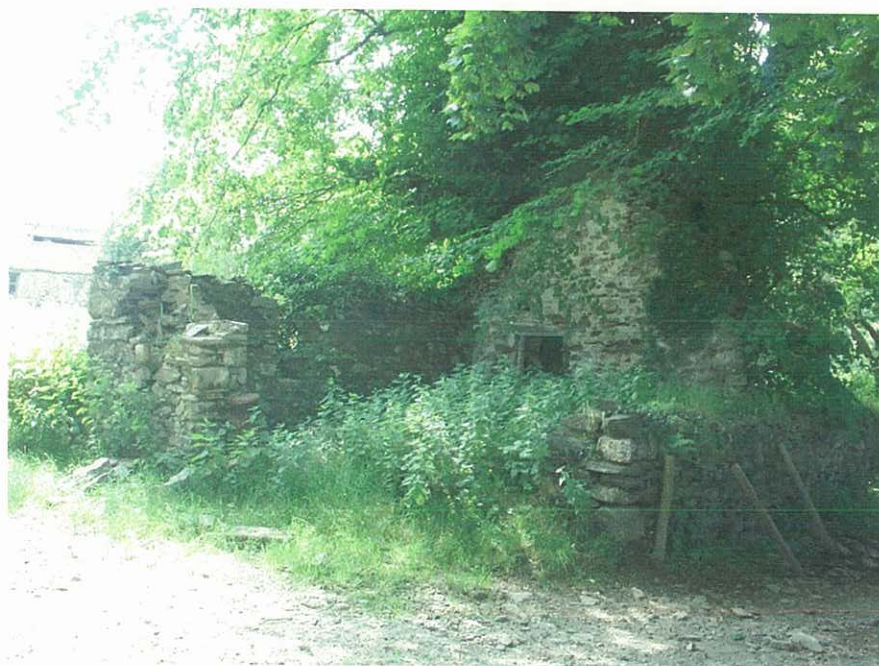
The ruined walls are covered with ivy and the wall tops are loose. In addition branches from an adjacent trees also overhang the wall tops and, by coming into contact with the stonework are loosening the masonry along the exposed wall tops.

Prn 47755 – the remains of a second cart shed, to the north of the farmhouse

The vegetation should be cut off just above the roots and allowed to die in place. Ideally a programme of consolidation could be carried out to stabilise the wall tops, then the ivy should also be removed. Overhanging branches brushing against and dislodging stonework should be removed.

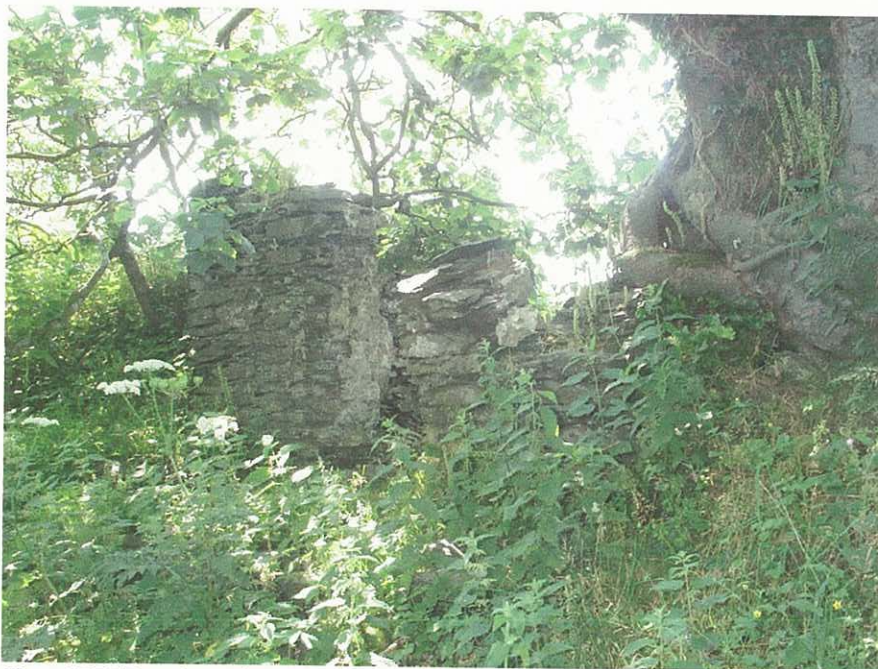
The stonework on the walls tops is clearly loose and unstable, probably partially caused by overhanging branches coming into contact with the masonry.

Prn 47757 – the ruined remains of a gazebo, built into the garden wall

Ideally the wall tops should be consolidated and the overhanging branches cut back.

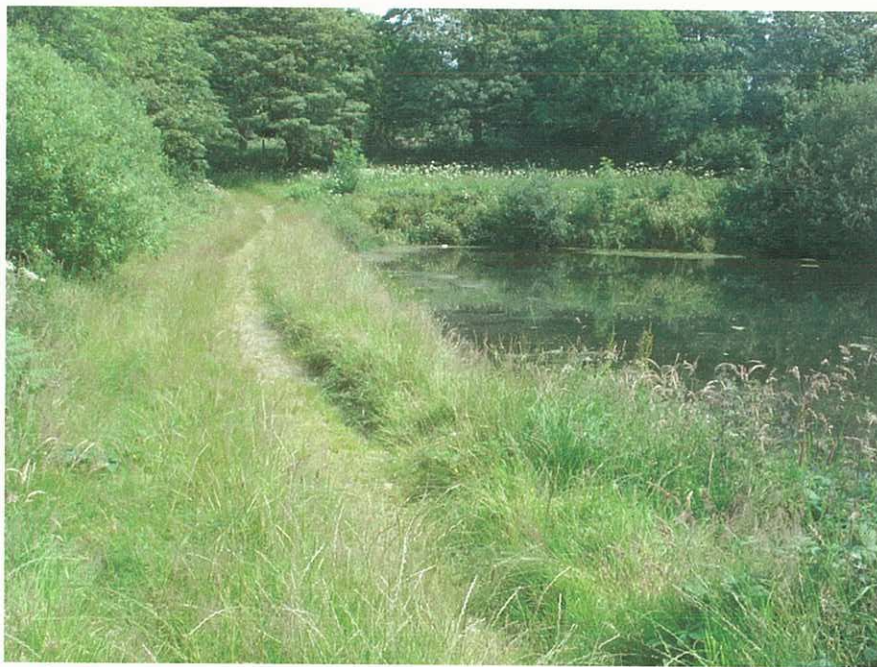
The pond and its' revetment bank survive in good condition.

Prn 47761 – the lower of the two ponds, appears to have been created some time in the 20th century

If any works to modify the pond are being considered, please consult with Cambria Archaeology in advance.

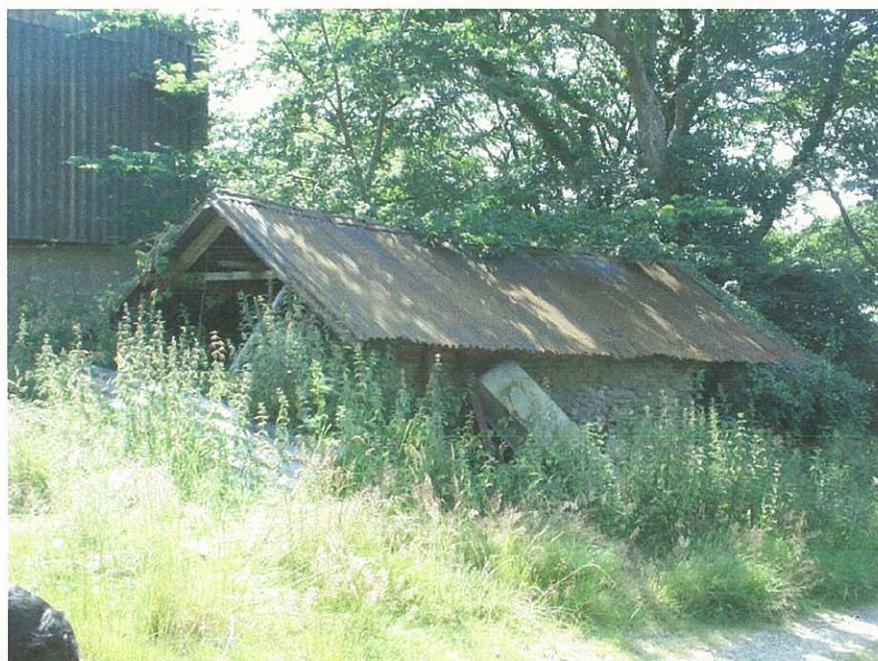
The roof and walls appear to be in a reasonably stable condition although the corrugated iron sheeting, without preventative treatment, is nearing the end of its effective lifespan and will need to be repaired or replaced in the near future. A sapling is also maturing on the south of the building and the branches are also brushing against the roof, which will undoubtedly cause further problems.

Prn 47764 – an outbuilding situated to the south of the trackway to the farm

The sapling growing immediately to the south of the building should be removed before it causes serious damage to the structure and further vegetation around the building should be kept under control. If the roof is beginning to leak then repairs should be carried out to prevent further damage to the structure of the building.
