Tir Gofal Farm Visit Historic Environment Report

Report No. 2002/59

Report Prepared for:
Countryside Council for Wales

Capeston
W/13/1561
Tir Gofal Farm Visit Historic Environment Report

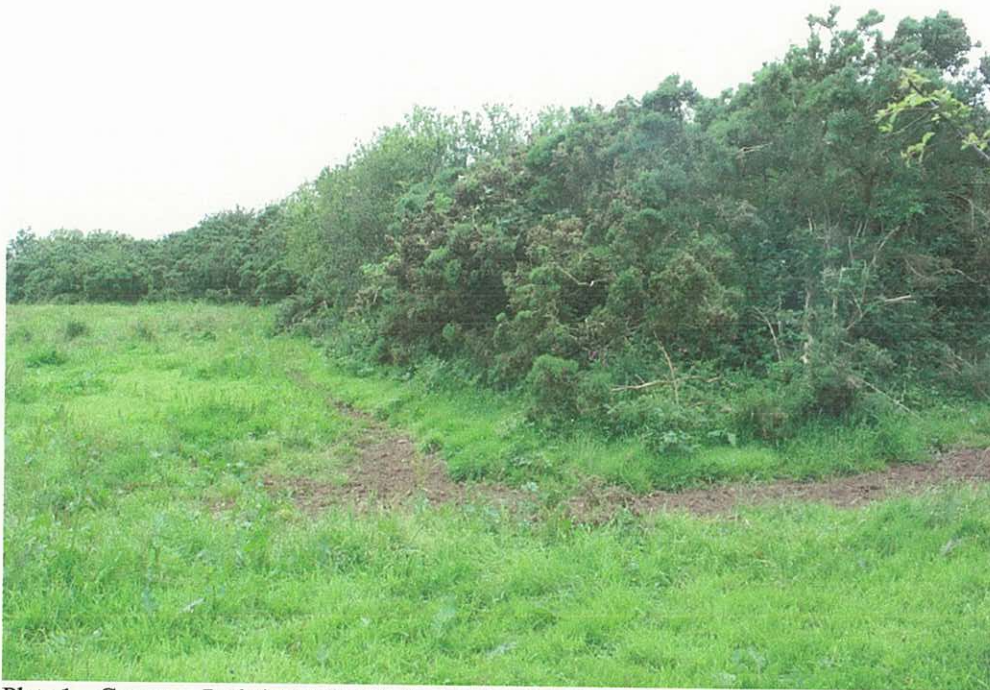
Plate 1 – Capeston Rath (PRN 3015), the interior from the southeast

These recommendations include recommendations made by Louise Mees (Cadw Monument Warden). Scrub clearance from the banks is recommended, although this is complicated by the presence of the badger sett. The clearance should be careful and comprise the removal of soft vegetation, followed by cutting back the hard vegetation to just above ground level and then the stumps should be treated. This treatment should also apply to the mound in the SW corner in order to ascertain its nature. Badger activity should be monitored. No more breaches should be made through the banks and using the new breach for vehicular activity should stop. Clearance of the ditch between the banks should be maintained, re-seeding bare areas if necessary. Maintenance of the interior should comprise routine topping of brambles and invasive scrub. Grazing should be continued in the interior, but livestock levels need to be managed ie. low-intensity grazing. This must apply to the adjoining field as fencing the monument off is not considered to be an ideal solution. Livestock erosion through the gateway in the adjoining field boundary should be monitored, and the gateway might be moved further west – out of the scheduled area – if erosion continues. A 12m margin should be left between the ploughed area of the adjoining fields and the site.

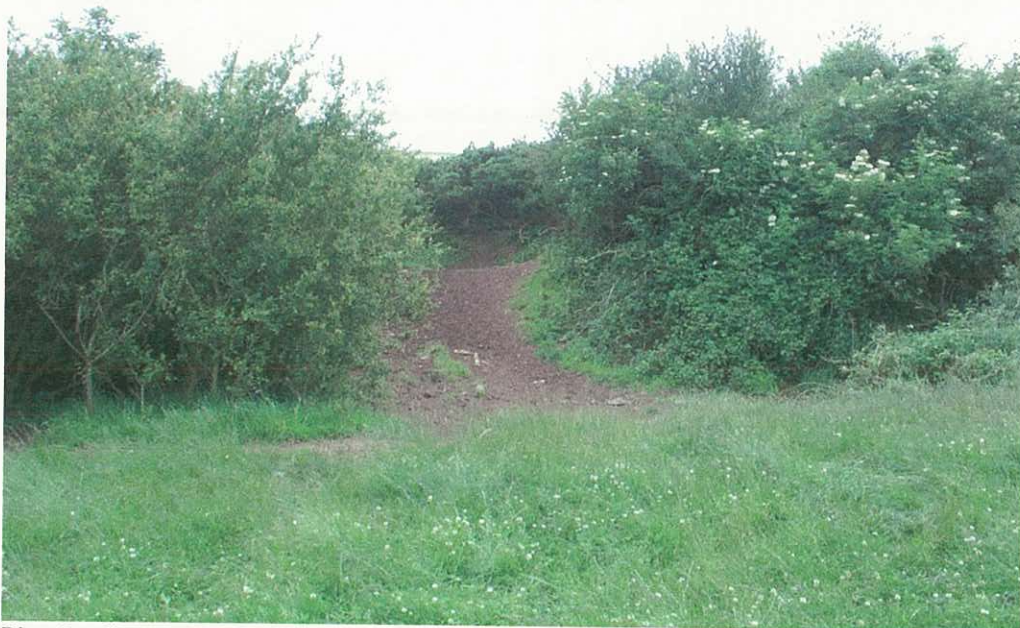
Plate 2 – Capeston Rath (PRN 3015), the external banks from the north showing vehicular erosion

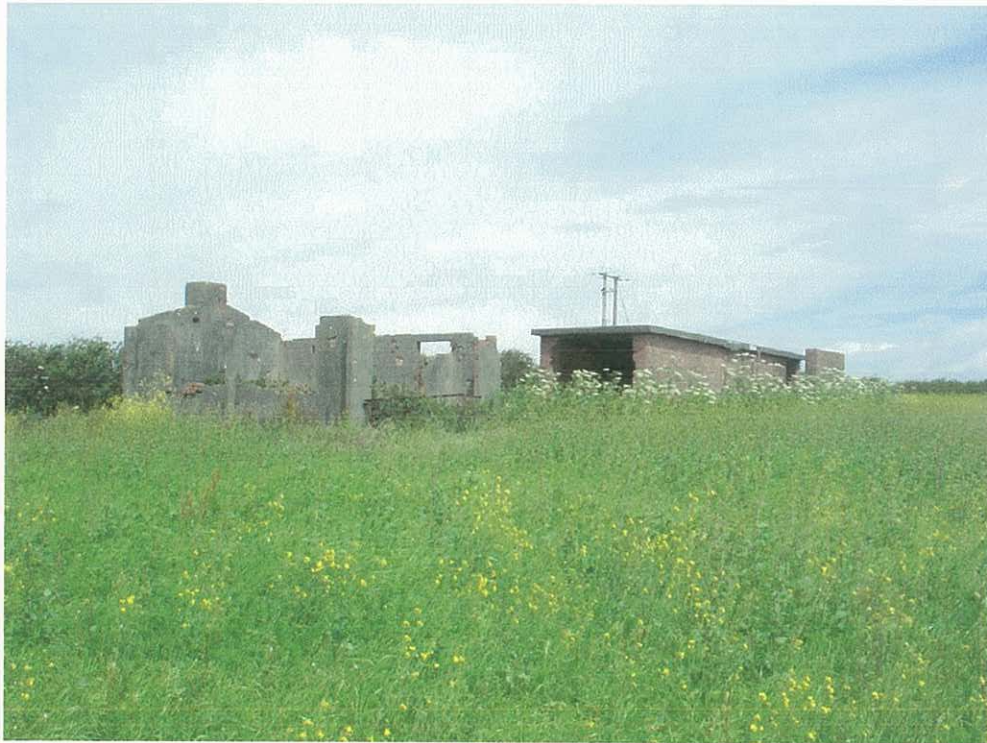
Generator House associated with RAF Ripperston Radio Station, operational between 1943 and 1945. Described in 1993/4 as 'Stand-by Set House, Generator Set, present use low-grade agricultural. Single storey, brick, corrugated asbestos pitched gable roof removed. Double doorway in east wall' (Thomas, 1993/4). There is a chimney in the west end gable wall, and the two side walls are each pierced by large window openings. The head, and indeed much of the upper part of the wall, is missing from the southern opening. The building is rendered externally. All fittings have gone from the building but the interior exhibits physical evidence for their presence in the form of scars. Poor condition; the building is in active decay.

Plate 3 – The Generator House (PRN 28694) from the SE

The building should be maintained as existing, as a visible feature.

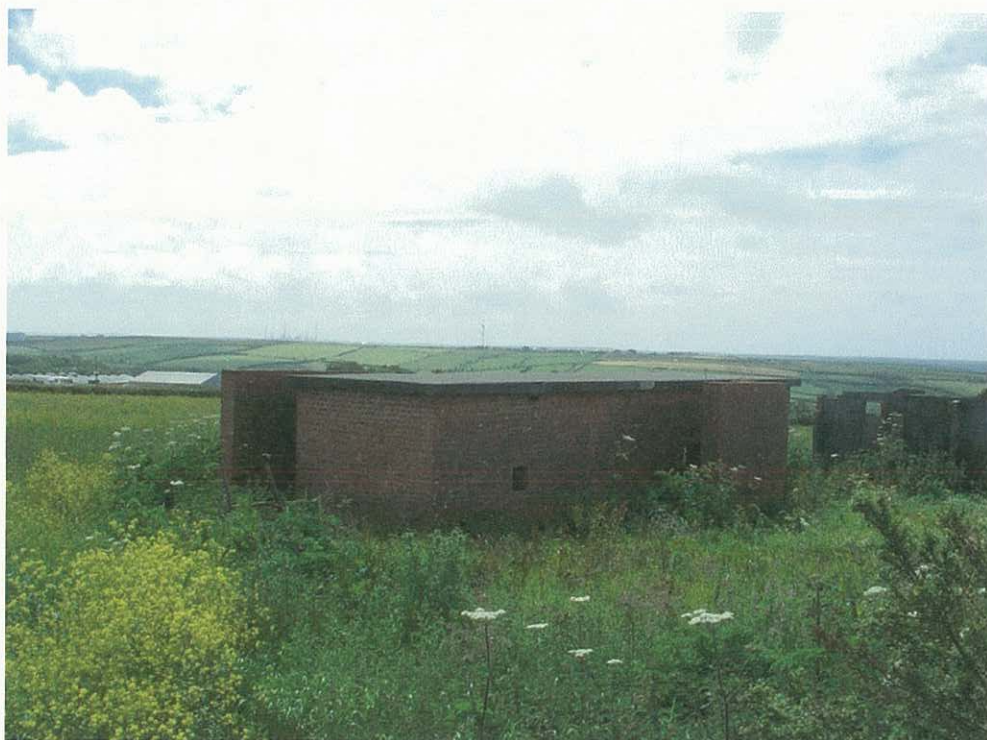
Plate 4 – The Transmitter Block (PRN 28695) from the NW

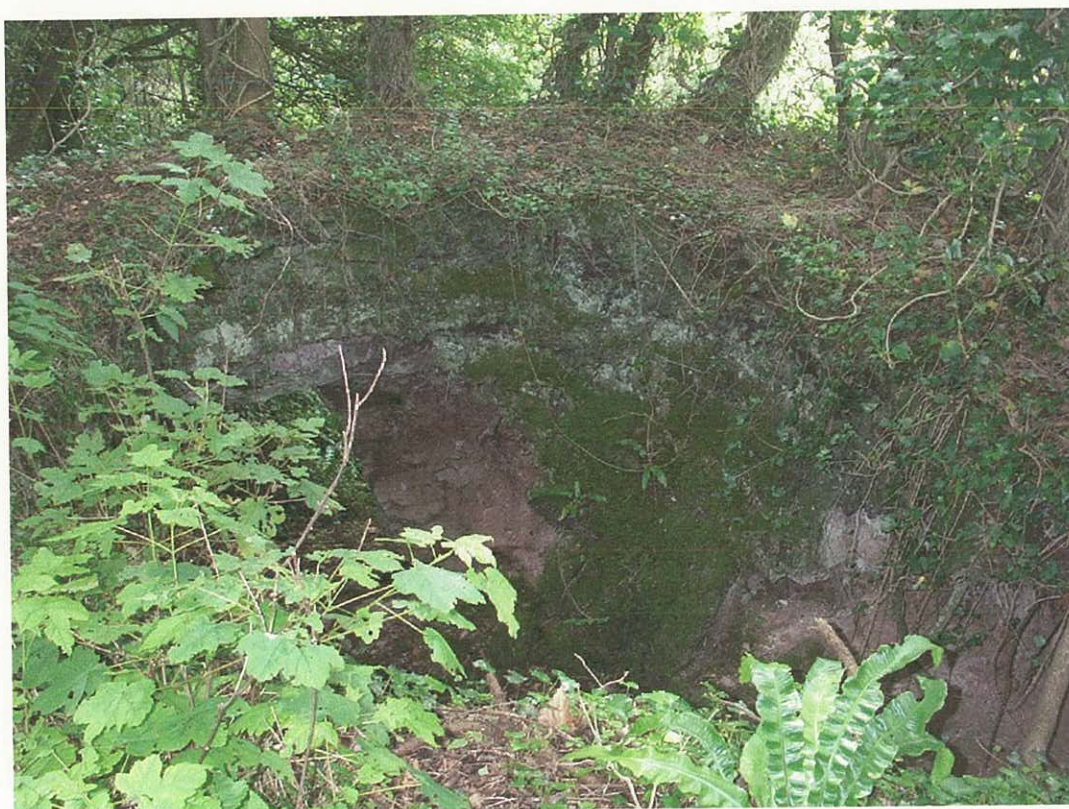
Limestone rubble limekiln, subcircular in plan with an external diameter of 6.5m and approximately 4m high. The circular pot, which is 2.2m in diameter, is open, with opposing draw-holes. The northern draw-hole is now collapsed, while the southern hole is beginning to collapse. The kiln lies on the shallow, west-facing scarp down to Spreadeagle Pill into which a charging-ramp has been terraced, with 'herringbone' revetment. This has been partly remodelled as a footpath. The kiln is depicted on the Ordnance Survey map of 1887, but not on the 1908 map. It is in a state of decay and overgrown with soft and hard vegetation including saplings, while the charging-ramp has been variously damaged/alterd/obscured.

Plate 5 – The limekiln (PRN 34478) from the NW

The vegetation should be cleared from the ruins, the masonry remains consolidated and maintained as a visible feature.

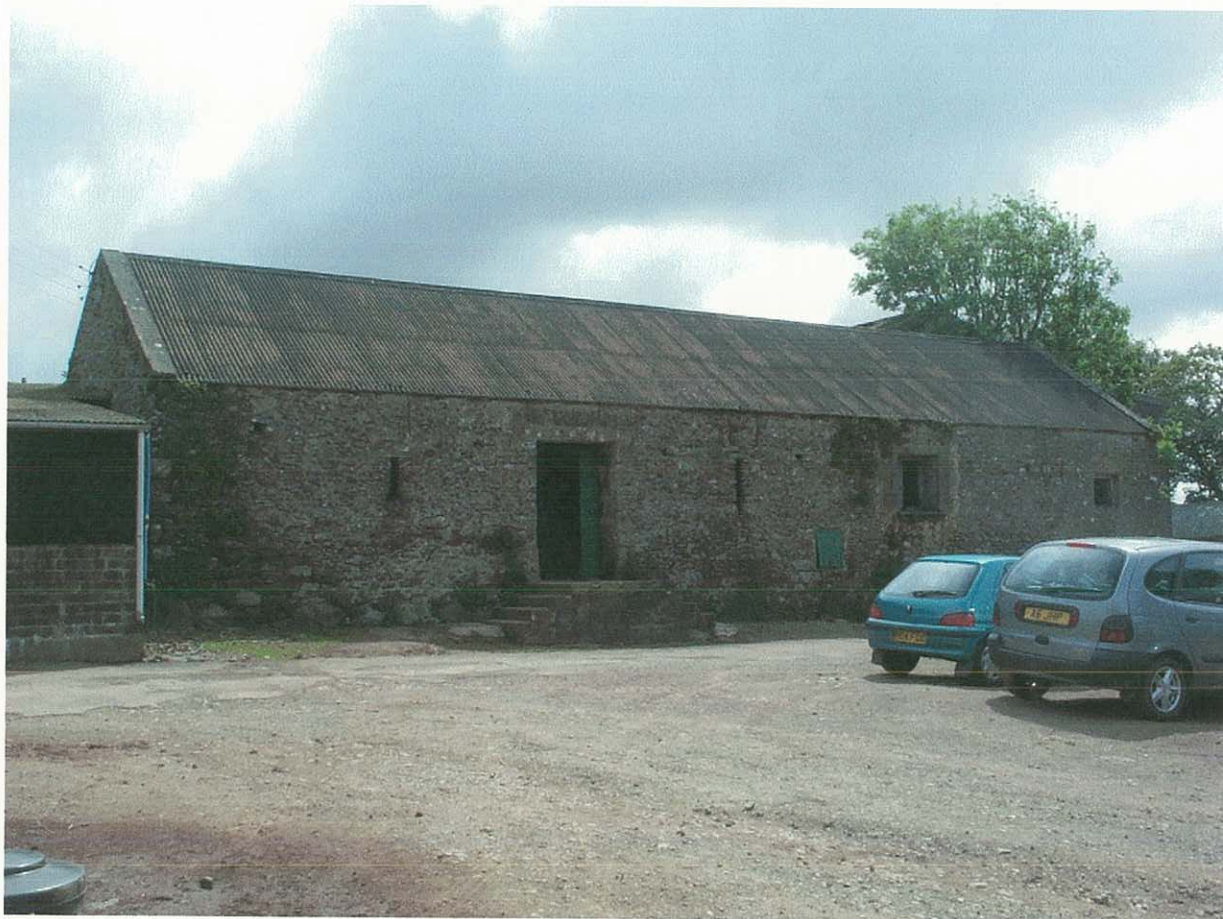
Plate 6 – the barn (PRN 45216) from the NW

The barn should be maintained as existing using traditional materials.

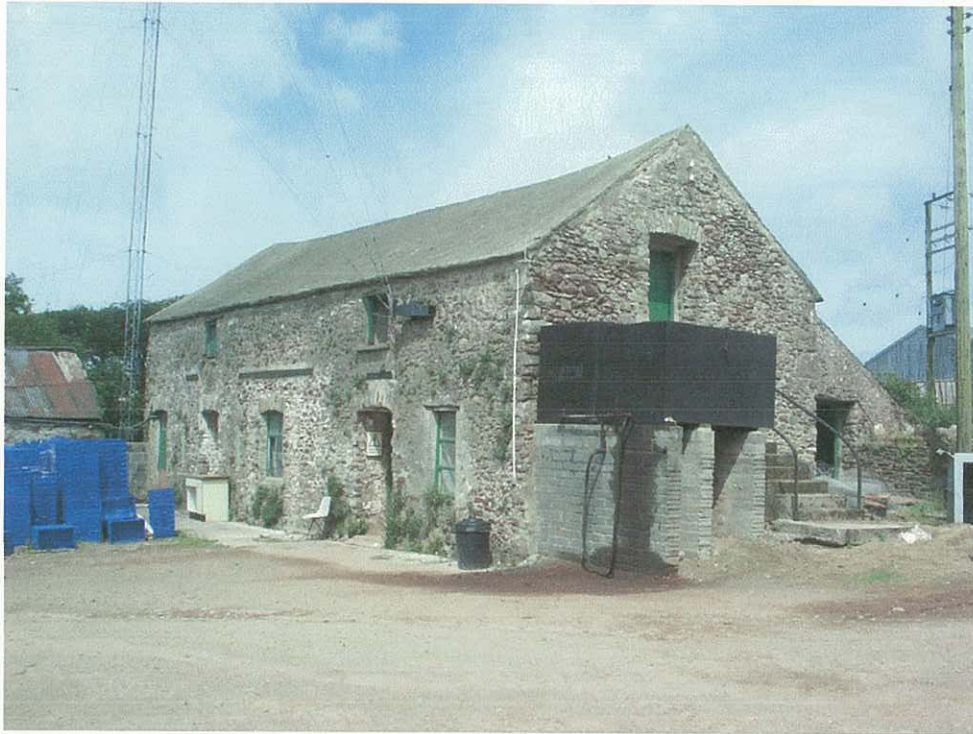
Plate 7 – Building (PRN 45217) from the SE

The barn should be maintained as existing using traditional materials.

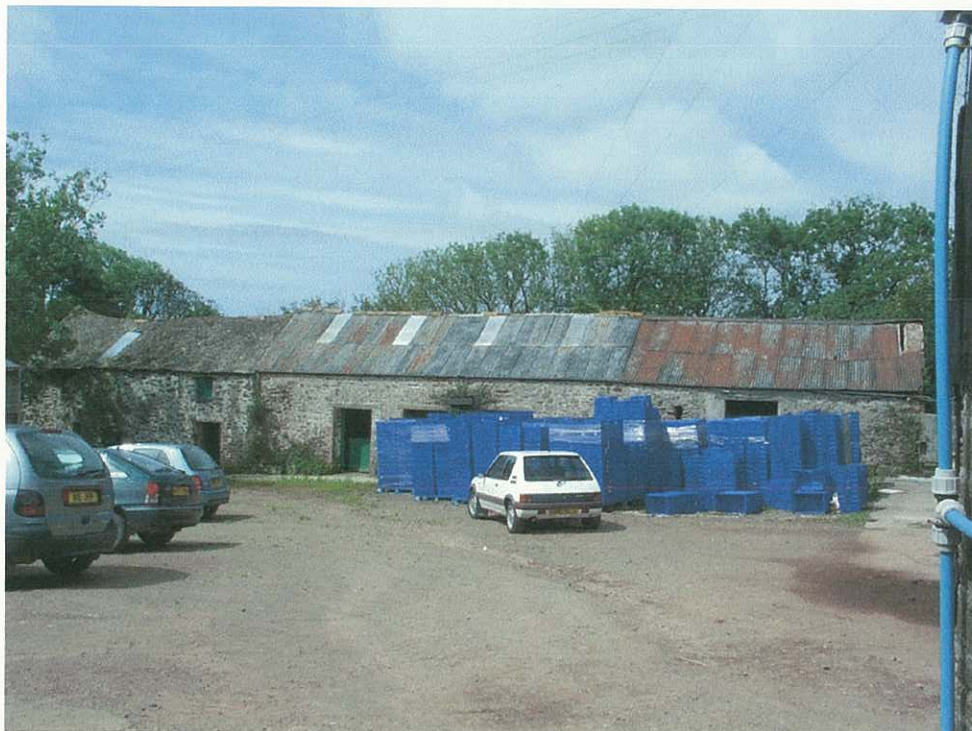
Plate 8 – the ?cow sheds (PRN 45218) from the E

The buildings require sensitive consolidation using traditional materials. Primarily, they need to be made weatherproof. This may involve replacement of some of the roof timbers, and the replacement of the sheet-metal roofing with more sympathetic materials.

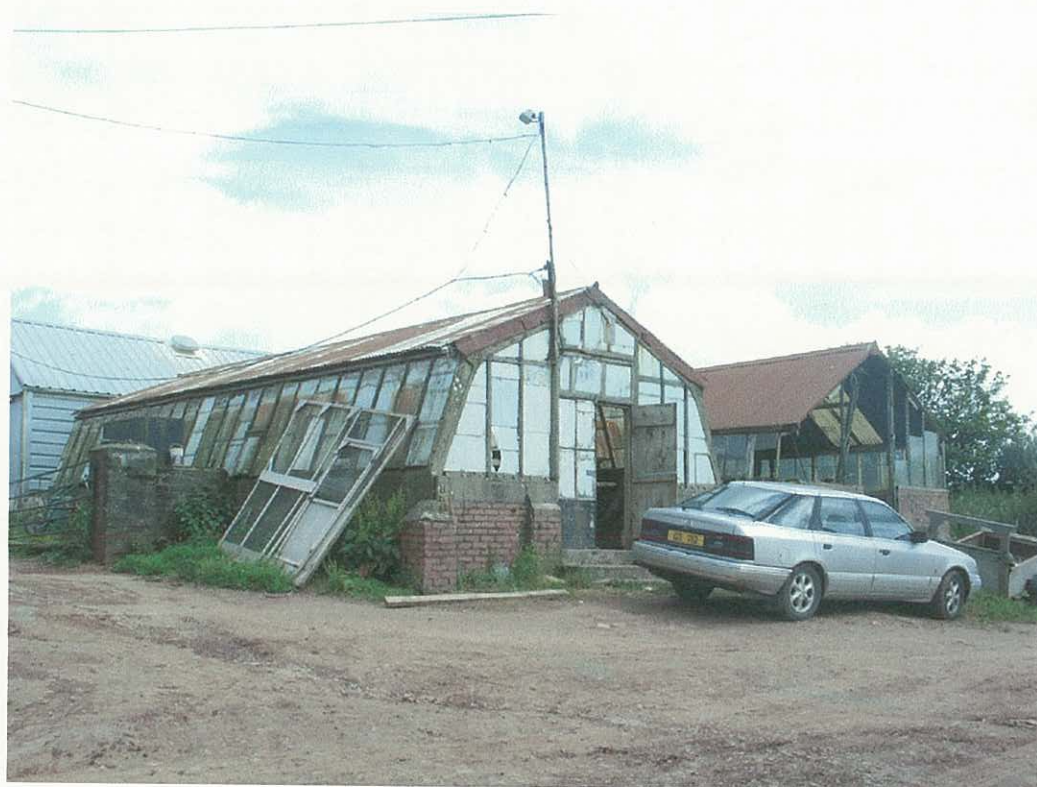
Two long, rectangular greenhouses, lying N-S and side-by-side, to the east of the farmyard. They have red-brick sill walls, above which the timber superstructures have a 'mansard-roof' line. The western greenhouse is substantially intact, but both now have sheet-metal roofs. Neither is now used for horticultural purposes. They are not marked on Ordnance Survey maps of 1887 and 1906, but appear to be marked on the 1964 map. Nevertheless, they are probably from the first decade of the 20th century. Poor condition, especially the eastern greenhouse which has lost most of its glass. The timbers are decayed in both, and both now have sheet-metal roofs. They are fine examples of large, Edwardian agricultural greenhouses and should be carefully restored in timber and glass.

Plate 9 – the greenhouses (PRN 45221) from the SW

The greenhouses are fine examples of large, Edwardian agricultural greenhouses and require sensitive consolidation in traditional brick, timber and glass, including the replacement of the sheet-metal roofing.

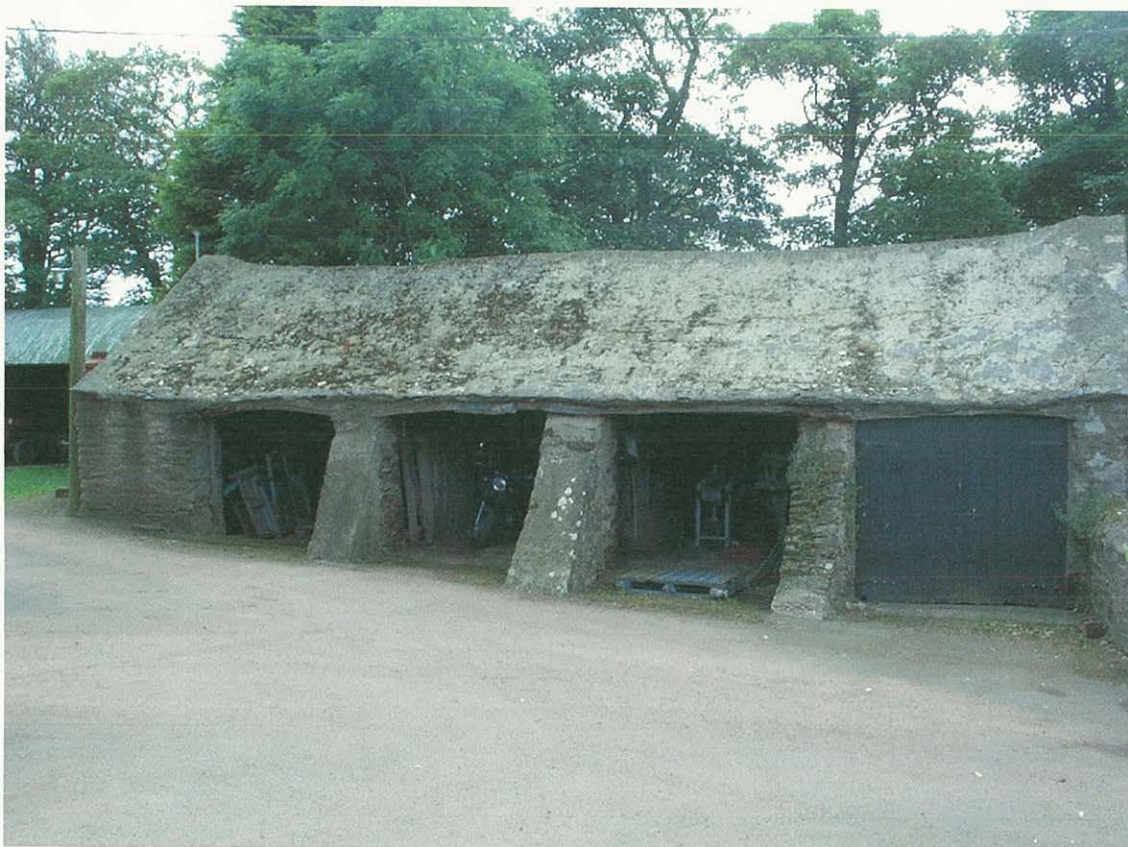
Plate 10 – the cart shed (PRN 45224) from the NW

The building should be maintained as existing using traditional materials.

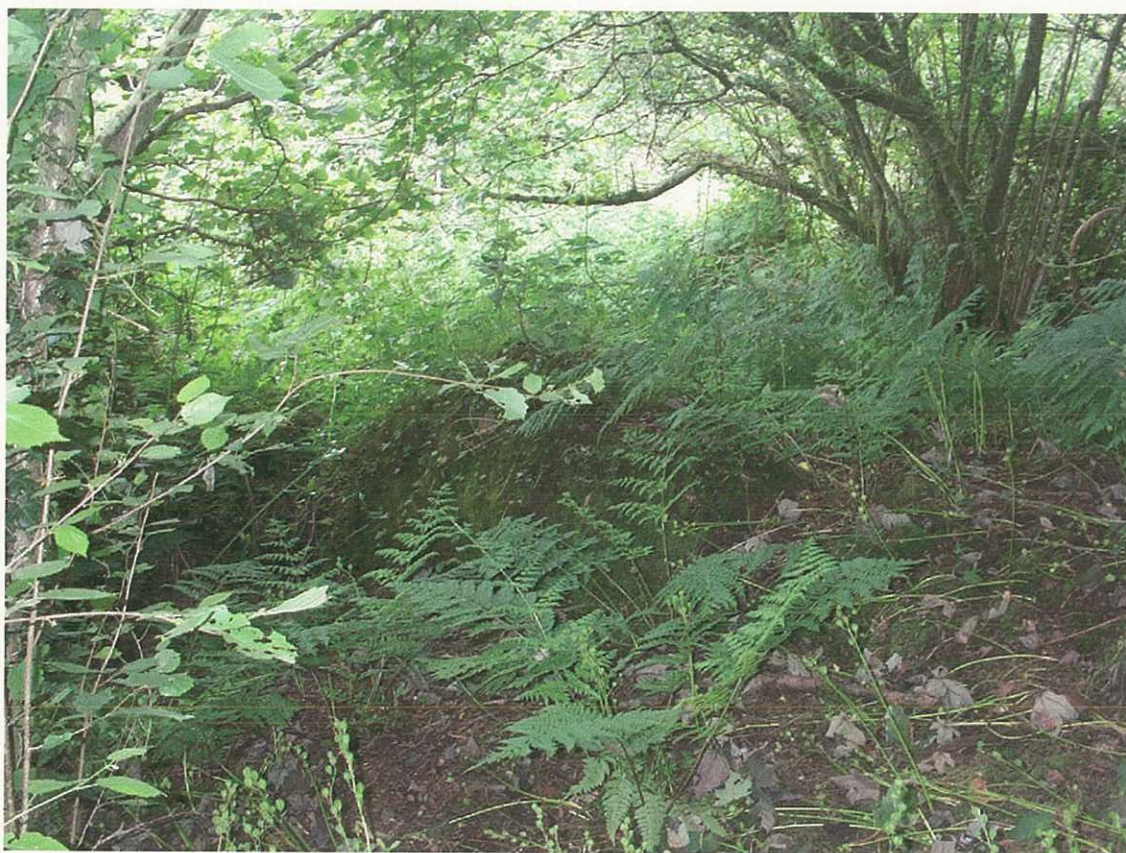
Plate 11 – The Rock settlement site (PRN 45235), surviving wall from the N

No detailed management recommendations can be made at this stage, although the clearance of vegetation from the site may allow recommendations to be made. The site lies on a footpath which is still marked by a fingerpost in the neighbouring field. The footpath was entirely overgrown and indiscernible in July 2002, and furthermore lies on the edge of a steep scarp slope making it very dangerous. The footpath therefore also requires clearance and definition. The soft vegetation should be carefully removed. The hard vegetation should be carefully cut back to just above ground level and then the stumps should be treated. A call-out visit should then be made by the Tir Gofal archaeologist to allow recommendations to be made.
