# **TREPRIOR FARM**

## **W/11/1516**

### **Tir Gofal Farm Visit Historic Environment Report**

REPORT NO. 2003/24  
PROJECT RECORD NO. 41702

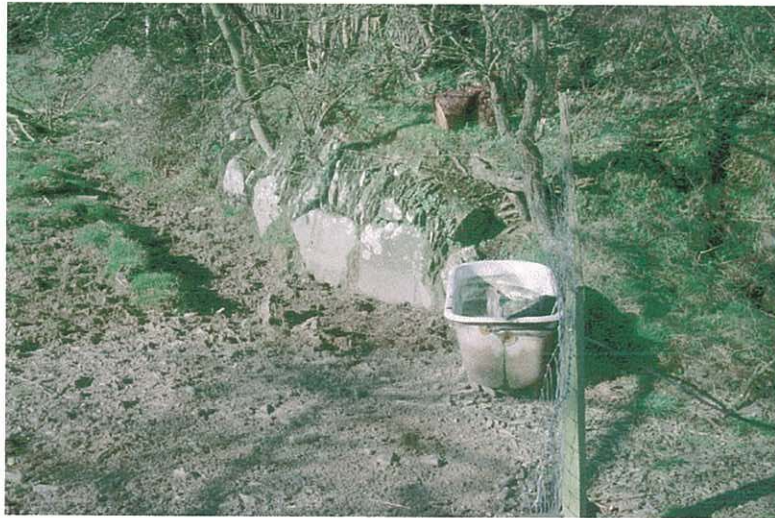
**Plate 1:** The base of the retaining bank is constructed from impressive stonework, suggesting that this aspect of the feature was intended to be visible. Material that has fallen from the bank could be removed to expose more stonework and to supply stones for making repairs to the structure.

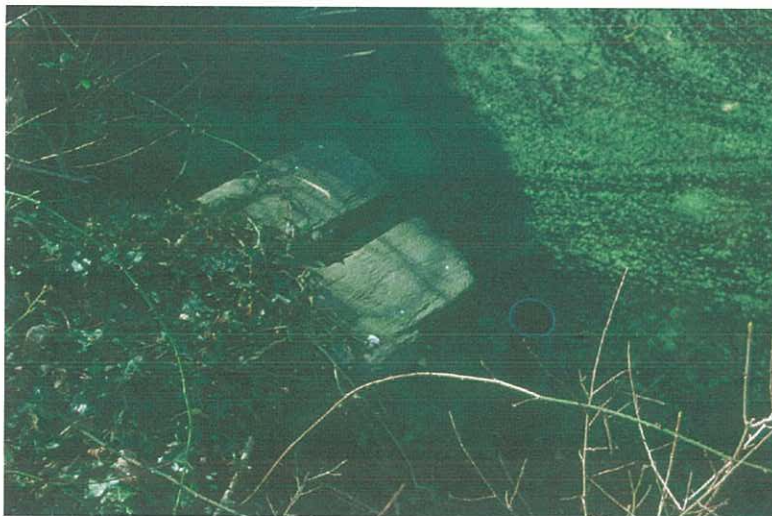
**Plate 2:** This stone slab may indicate that there was an earlier mechanism for draining the pond than that which exists at present. It is suggested that vegetation be removed in this area to ascertain whether this is so and if it could be restored to its original function.

The retaining wall in the vicinity of the drain/sluice should be cleaned back to investigate any previous drainage arrangements that might be reinstated or more effectively blocked to prevent further leakage from around the existing drainage pipe.

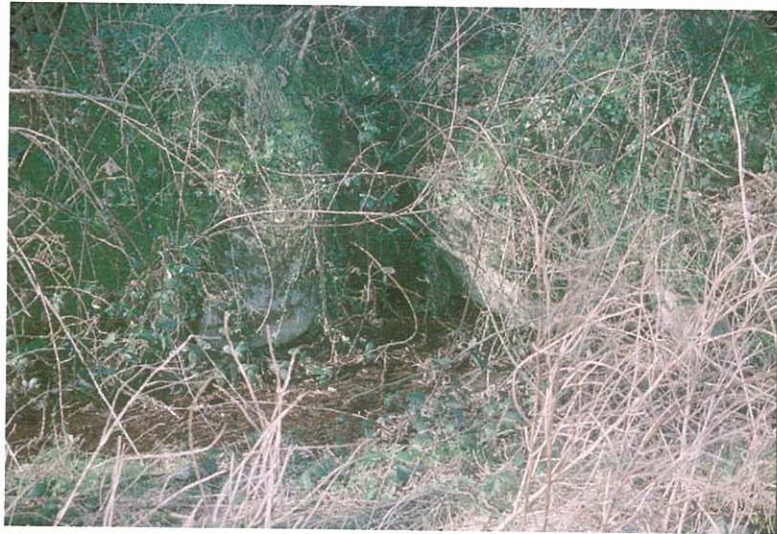
**Plate 3:** The outflow pipe for draining the pond. Water was observed leaking from around this pipe suggesting that it is an area of weakness in the retaining bank. Vegetation and loose material could be removed to ascertain how this could be repaired.

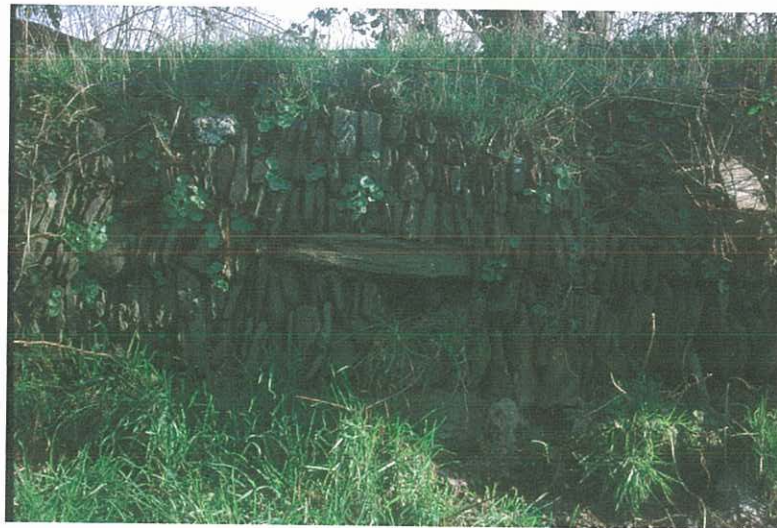
**Plate 4:** The overflow pipe for the pond, indicating the level to which the water could rise. Larger vegetation that is causing the stonework to loosen should be removed to prevent further weakening of the retaining bank. Stonework should be repaired with the same materials, techniques and pattern as was used in the original construction.

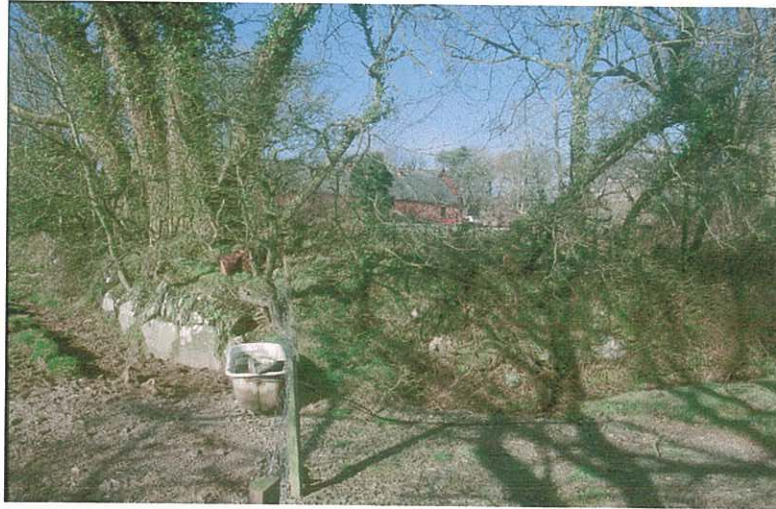
**Plate 5:** If the long term future of this feature is to be secured, it will be necessary to cut down the trees growing on the retaining bank to prevent further damage to the structure. Depending on the extent to which the bank has been weakened by this tree growth, it may be necessary to remove the stumps and roots and reconstruct the stonework.

Although possibly an extremely specialist and extensive job, it is felt that the repair and restoration of the bank would be the best solution for the long term survival of this feature. This would, however, require the removal of the trees that are growing on the bank to prevent further root damage and extensive repair and rebuilding of the retaining wall.
