**Gwernant Home Farm  
W/11/1595**

**Tir Gofal Farm Visit Historic Environment Report**

Report No. 2002/33

Gwernant Home Farm  
Tir Gofal Farm Visit Historic Environment Report

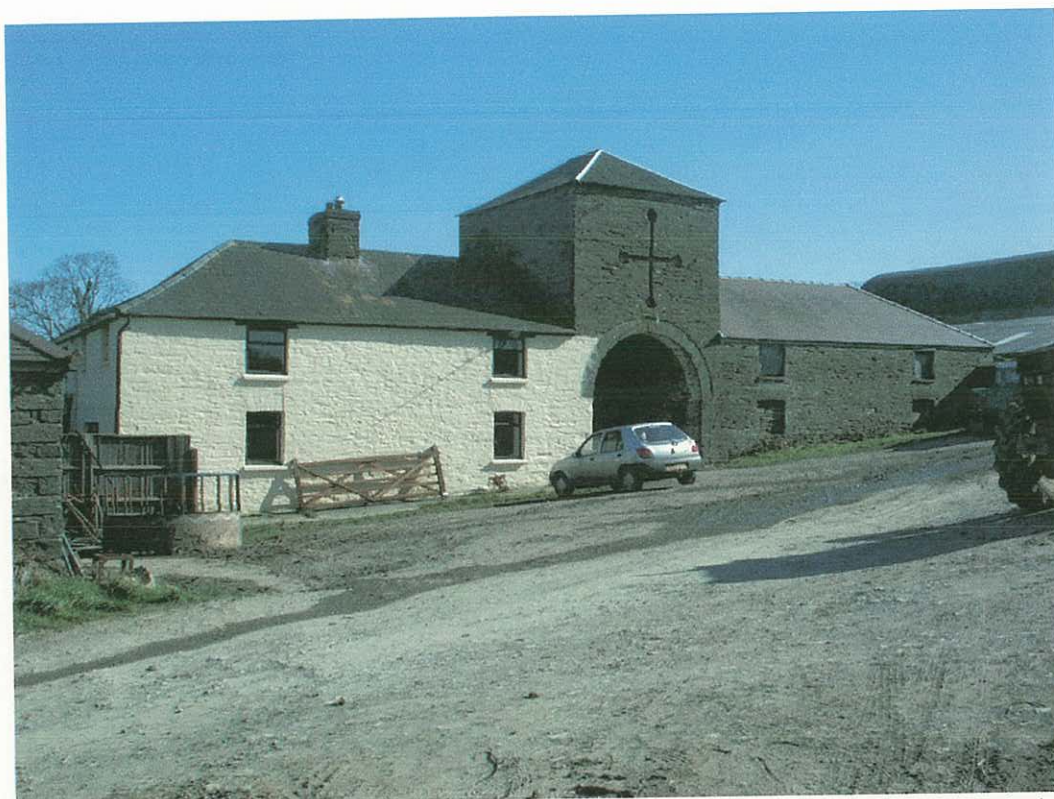
This range of buildings survives largely intact, with only some modifications. The structure is largely in good condition although the south range appears to be suffering some structural failings and has been supported with props. The owners have obviously taken trouble to maintain the buildings which is a substantial undertaking.

Plate 1 – the farmhouse and farm buildings (PRN 6619) arranged in a courtyard plan.

These buildings should continue to be maintained in a stable and watertight condition. The south range requires structural repairs which should be undertaken at the earliest possible opportunity.

Care should be taken to retain the historic internal fittings including the feed racks, and any machinery associated with the waterwheel.

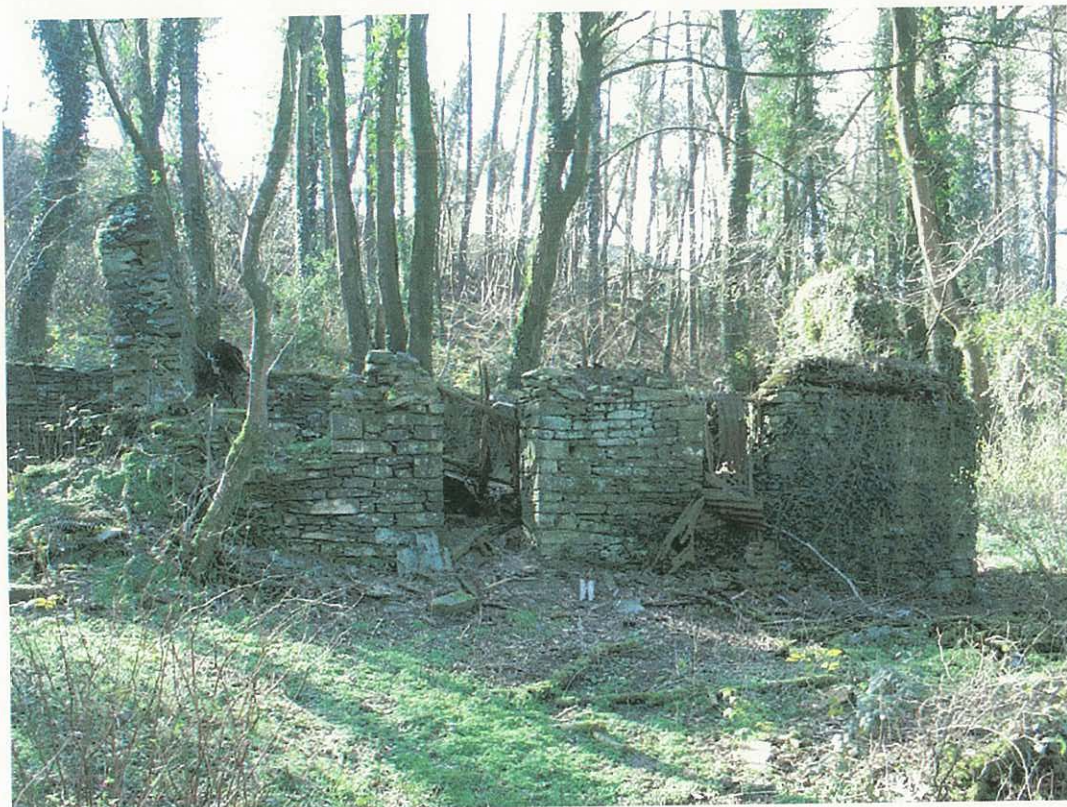
The cottage has deteriorated considerably since this record was taken (plate 2). The tin roof described has fallen in completely and the clay wall heads have since eroded away. The masonry is also now beginning to collapse. A photograph (of unknown date) in the possession of the owners shows this hamlet when all the cottages were inhabited and well kept (see frontispiece). This particular cottage, like the rest, did indeed have a thatched chimney and the roof may also have been thatch with a corrugated tin roof overlaid. To the south the cottage was also attached to another building, also possibly a cottage.

Plate 2 – the last remaining cottage at Nant y Gwernant (PRN 9883).

This little ruin is the last surviving remains of the settlement of Nant y Gwernant and a type of cottage that, although once abundant, are fast disappearing. It is important that the ruin is stabilized as far as possible, therefore intrusive vegetation should be controlled and the wall tops consolidated in sympathetic materials.

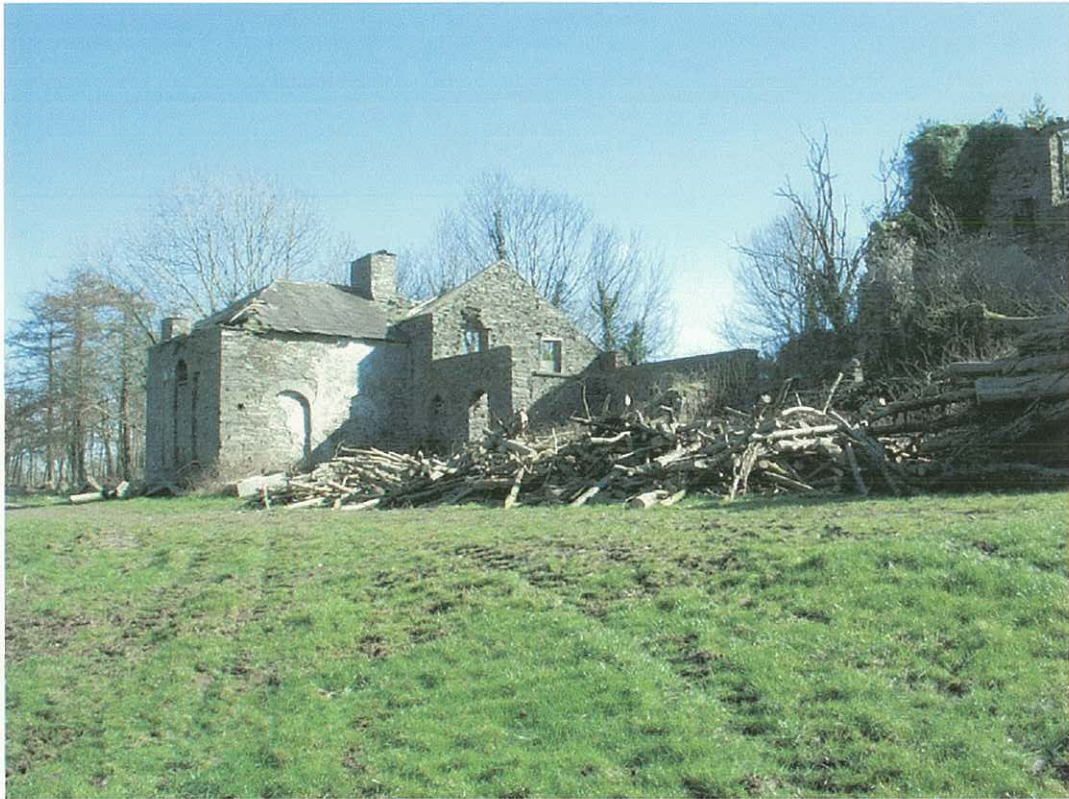
A photograph of the mansion shows that the north west facing elevation also had a projecting pedimented front which was demolished in the mid 20<sup>th</sup> century for safety reasons. The wings to either side of the mansion survive to full height in most places and some roof structure survives on the east and west wings, exhibiting a pegged slate roof covering. In many areas the ruins are becoming overgrown with ivy and brambles although the owners have been carrying some consolidation works and capping of wall tops in places. To the north of the mansion is a terraced area which has been used to store wood and other materials (plate 3).

Plate 3 – the ruined Plas Gwernant (PRN 17398) showing the surviving north east wing.

The substantial ruin of the Plas Gwernant mansion is an impressive feature of the landscape, which unfortunately has fallen into a perilous condition. In order to stop the rapid decay of the fabric, essential consolidation works should be carried out. The most important aspect of this is to control the vegetation which has become established amongst the ruins, and this should ideally be combined with consolidation of the masonry wall tops. Preferably the existing roof structure should be repaired and retained where possible.

The terraced area to the north of the mansion should be cleared of the existing wood pile to enhance the visibility of the ruins.

In the event that further historic fabric is lost through decay or the process of consolidation, it is essential that an archaeological survey is undertaken to record the structure.

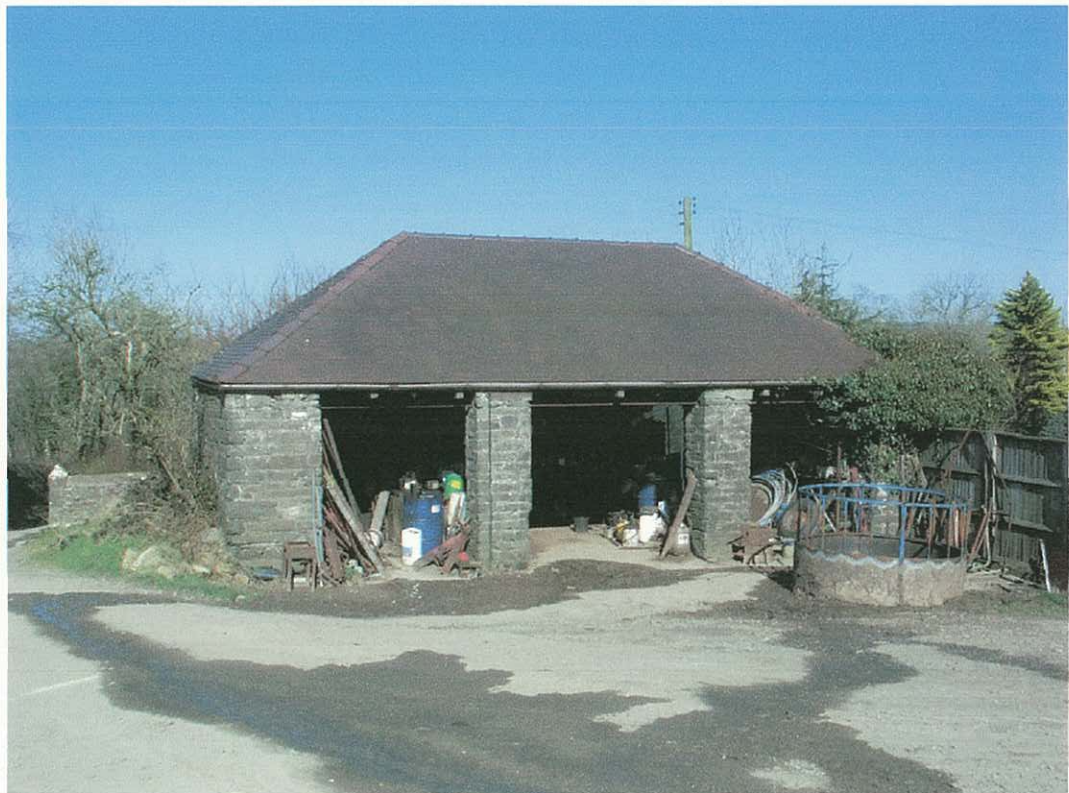
The cart shed does not appear on the Tithe map of 1837 suggesting that it may have been a later addition to the farmyard. Nevertheless it contributes to the historic farmyard complex, which is recognised by its status as a listed building. The cart shed is currently in use as a store and workshop. It is in good structural condition although some ivy is beginning to encroach up the east corner (plate 4). The roof has recently been renewed in clay tile.

Plate 4 – the cart shed (PRN 44581) located to the west of the main farm buildings.

The cart shed should continue to be maintained in a stable and watertight condition using traditional materials. The ivy, which is beginning to grow over the east corner, should be cut and allowed to die before removal.

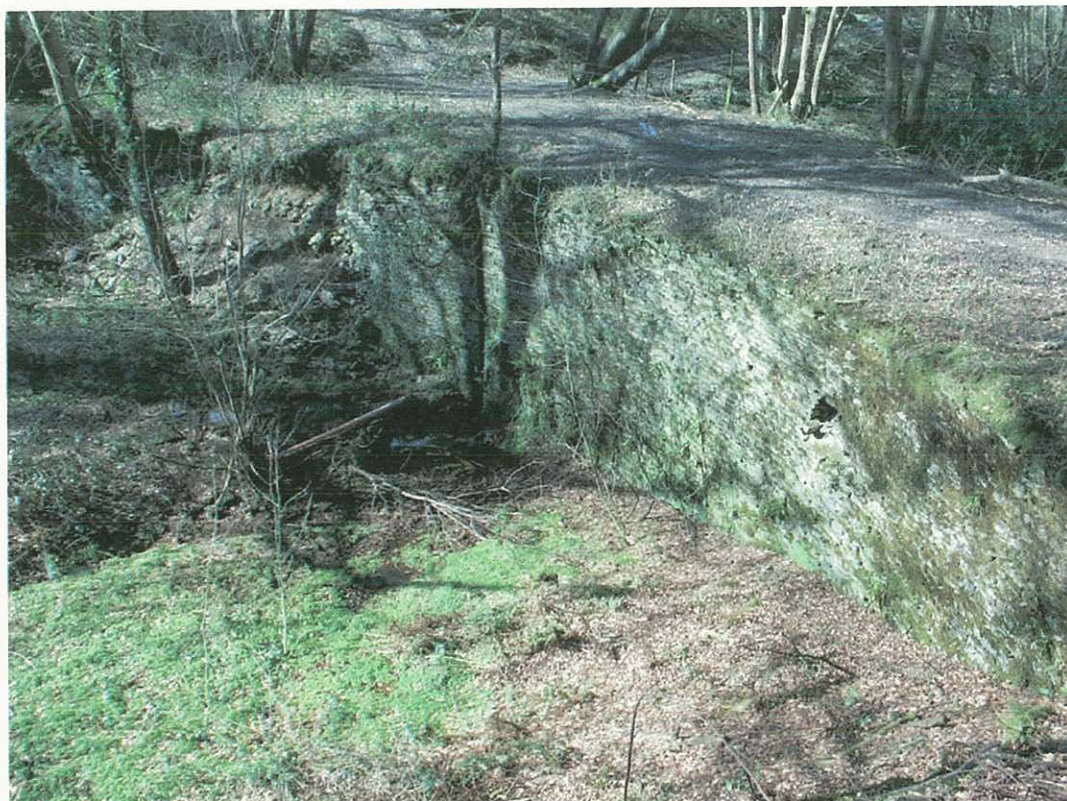
Plate 5 – the south east face of the dam (PRN 44583), showing collapse at the west side.

water supply for the Gwernant Estate. The condition of the structure is beginning to deteriorate and urgent works are required to remove the intrusive vegetation, this should be cut back and allowed to die. The masonry should then be repaired and consolidated. Care should be taken to control the vegetation, and where it has become embedded in the masonry it may better to treat the roots to prevent any grow back.

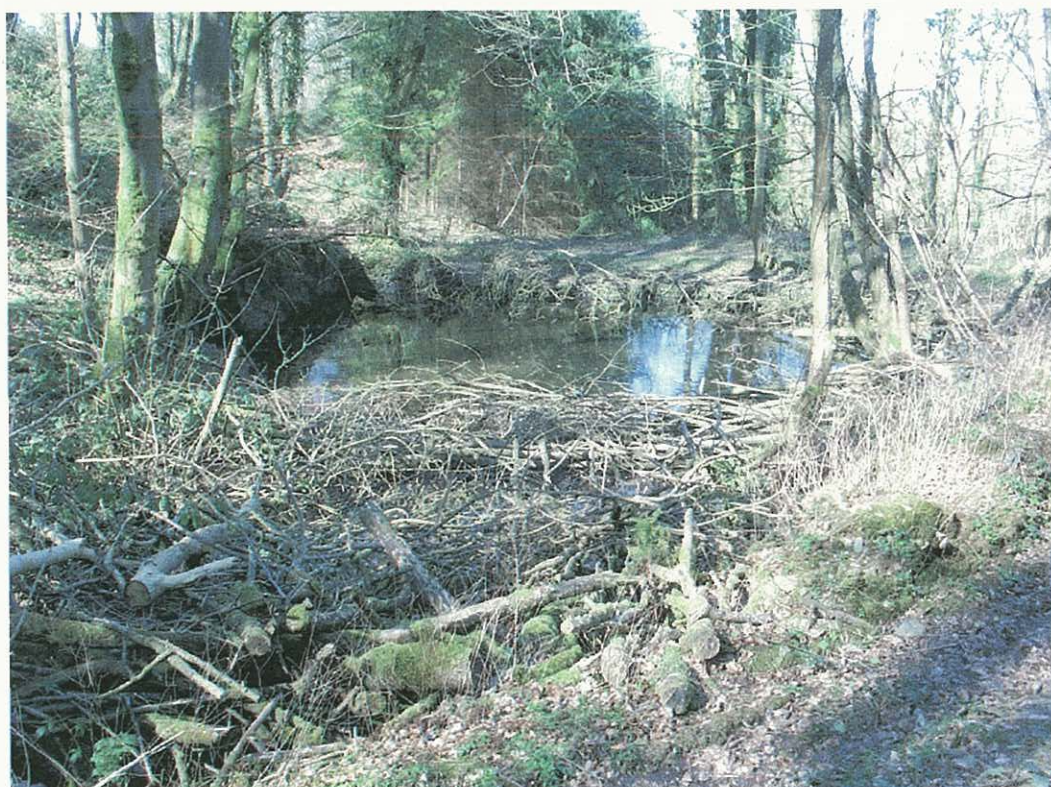
Plate 6 – showing the holding pond and dam (PRN 44584) above Gwernant Home Farm.

The condition of the structure is beginning to deteriorate and works are required to remove the intrusive vegetation, this should be cut back and allowed to die. The masonry should then be repaired and consolidated. Care should be taken to control the vegetation, and where it has become embedded in the masonry it may better to treat the roots to prevent any grow back.

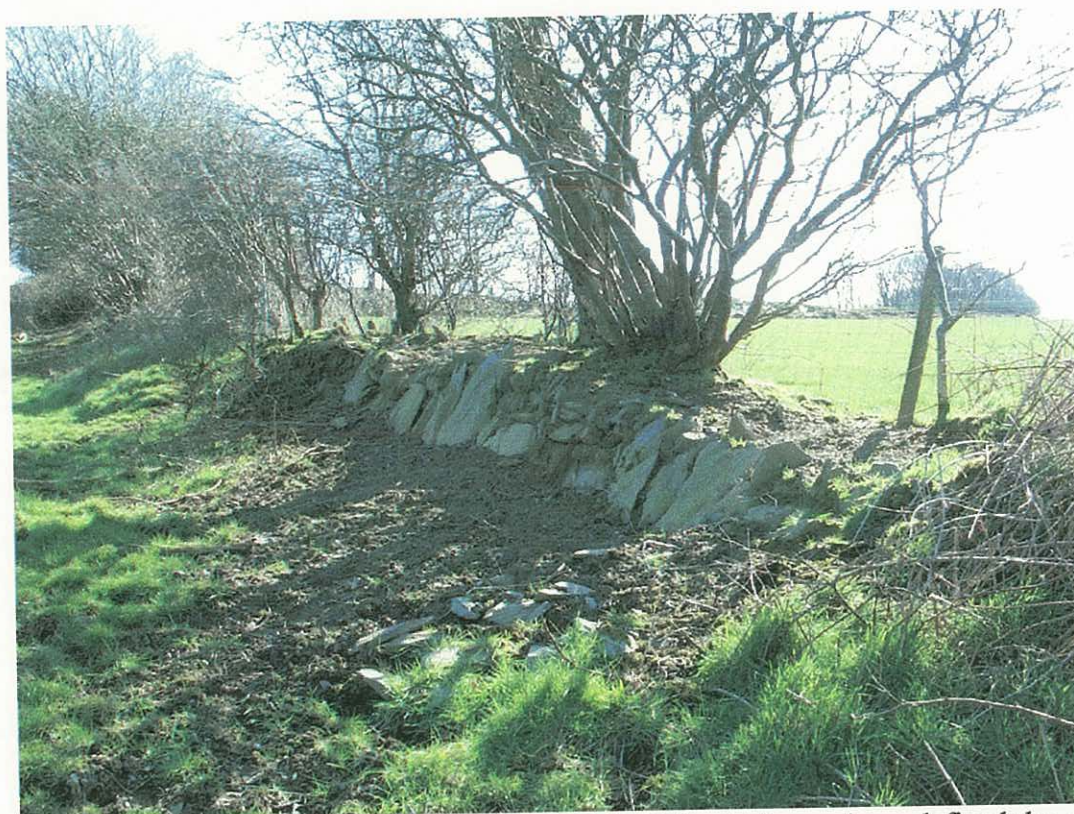
Plate 7 – the remains of a slate boundary bank (PRN 44586) which may have defined the extent of the parkland.

It would appear that this finely constructed stone bank is a relic of the earlier parkland and should be retained and maintained in a stable condition as far as possible. Encroaching brambles should be cleared to expose this feature. The re-instatement of the hedge may prevent animals from climbing on the bank and contributing to the erosion.

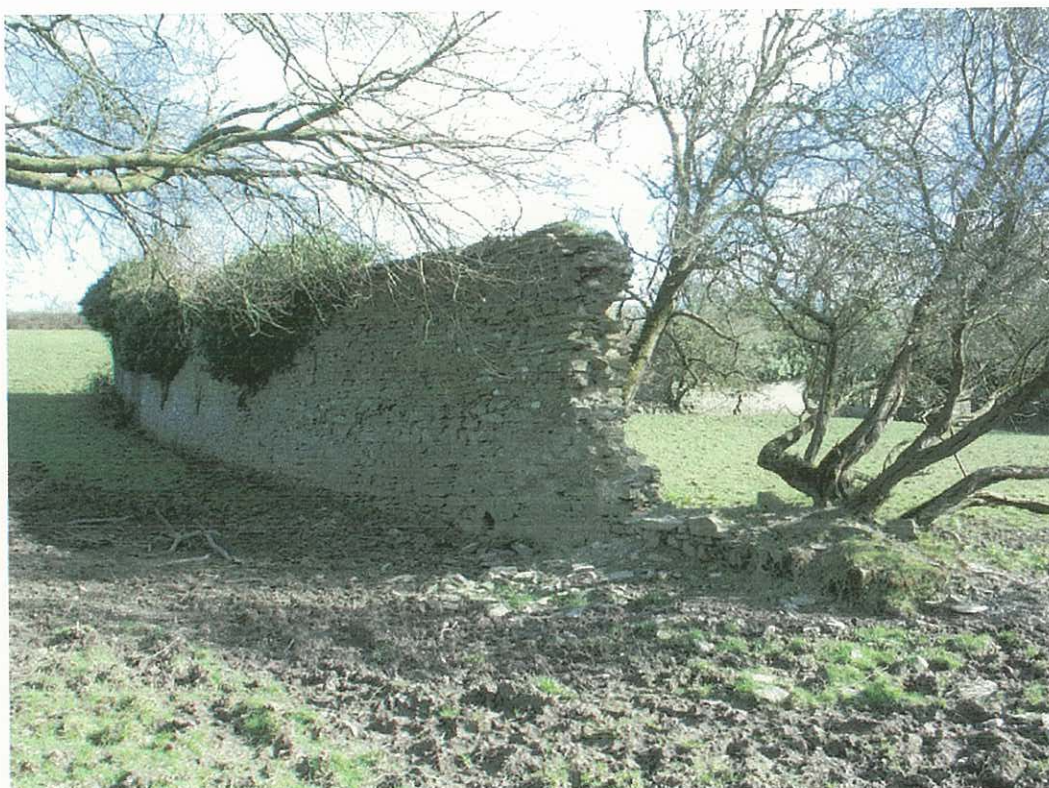
Plate 8 – the north wall of the walled garden (PRN 44590), which survives to its full height at the east end.

In order to prevent the further decay of this significant structure, it is important that the vegetation is brought under control. This will involve cutting vegetation and allowing it to die, and the roots may need to be treated to prevent regrowth. Any removal of the vegetation should be undertaken with care and in conjunction with the consolidation of the masonry.

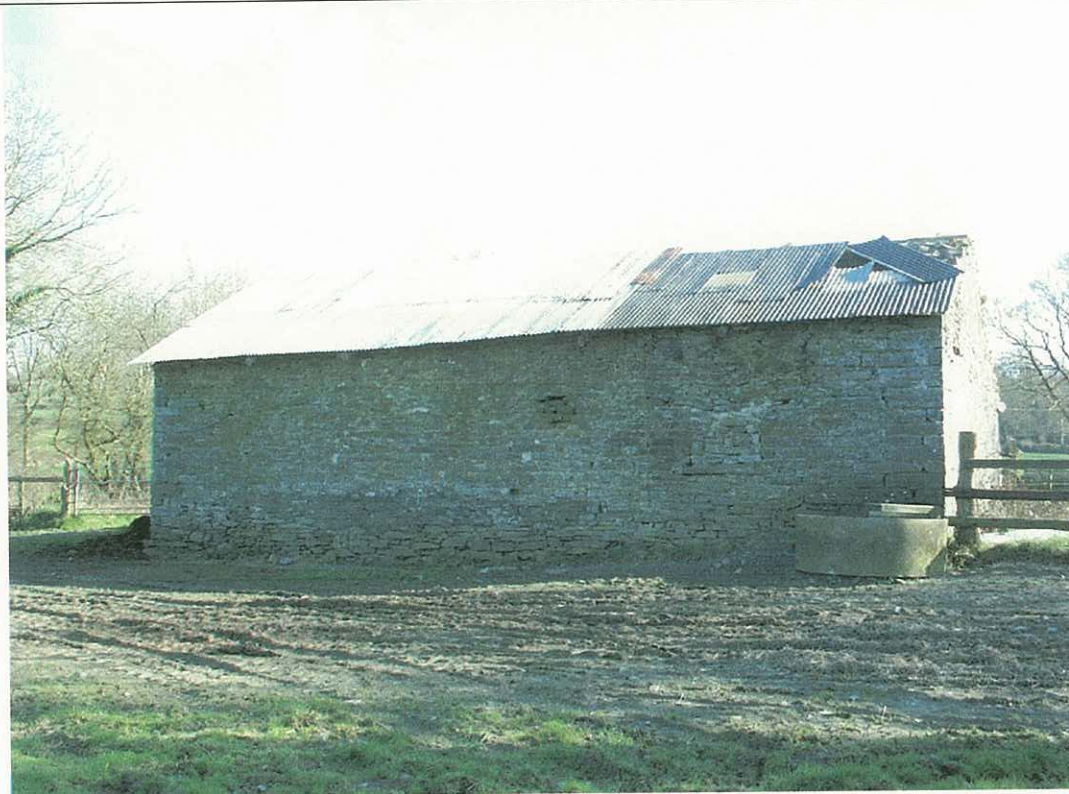
Plate 9 – the remains of the former farmhouse (PRN 44592) at Gwernant-isaf

This structure, although heavily modified for agricultural use, retains some interesting features relating to its earlier use as a dwelling. It should therefore be retained and maintained to prevent any further loss of the historic fabric. This will involve the repair of the roof, the control of intrusive vegetation and some consolidation of the masonry. In the event that further fabric of the building will be lost through decay, archaeological advice should be sought.

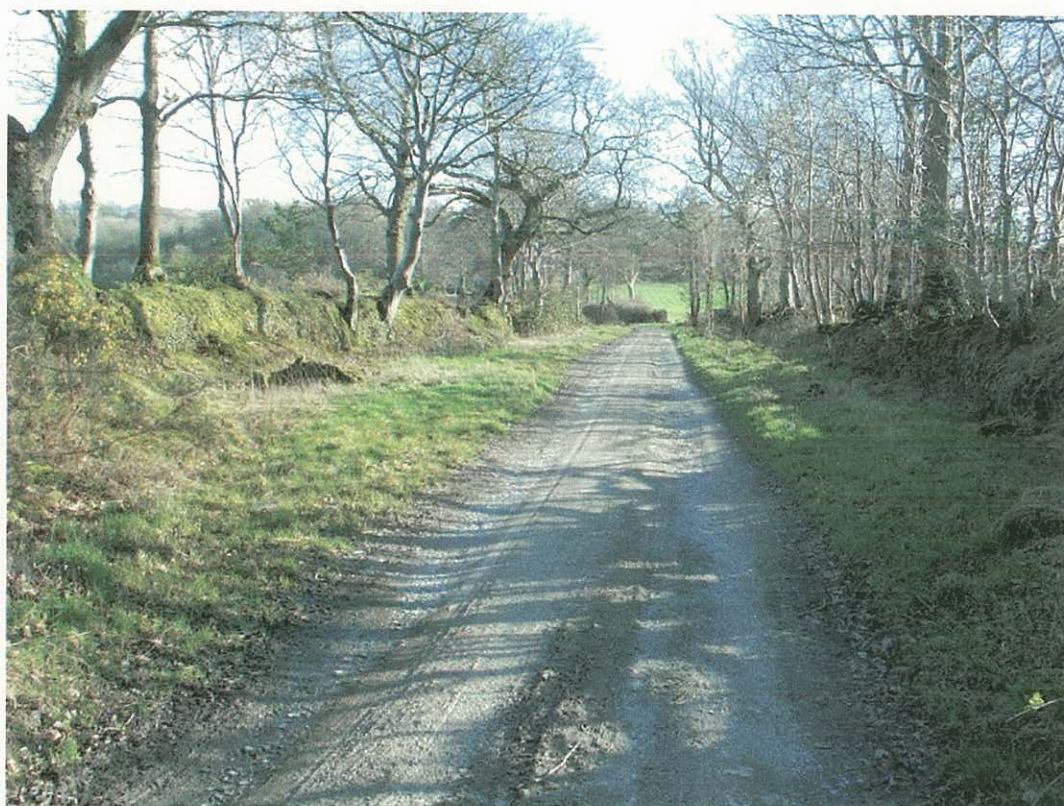
Plate 10 – the track way (PRN 44596) leading from the road to Gwernant-isaf

This track should be maintained. Care should be taken to prevent damage through tree fall as the mature trees may be blown over.
