Tir Gofal Farm Visit Report

Castle Hill

W/11/1842

CASTLE HILL
TIR GOFAL FARM VISIT REPORT

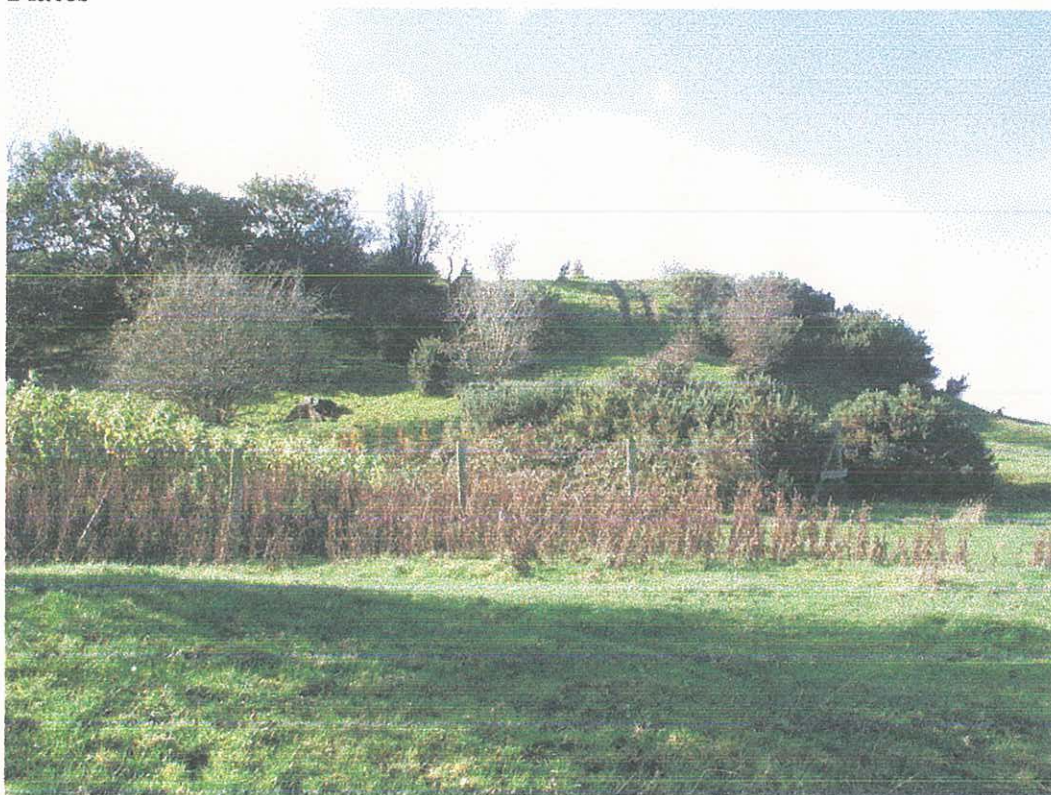
The site is currently under pasture for grazing cattle and sheep, however there are significant areas of gorse encroaching over the earthworks. To the south and east of the monument are fenced enclosures for pheasants. A couple of ring feeders are situated on the south east side of the site at the break of slope which is causing some disturbance to the ground surface. Gorse and blackthorn are encroaching quite intensively over the southern flanks of the hillfort and also within the central ditch/quarry, however the top of the monument is still relatively clear and open. Quad bike tracks run up the north east slope forming ruts up to 200mm deep towards the top (plate 1).

Plate 1 –Pen-y-castell Hillfort (PRN 1995) showing erosion on the east slope

This monument is recognised to be of national importance as denoted by its' statutory protection as a Scheduled Ancient Monument. It is clearly a very impressive site. However in some areas it is obscured by the encroachment of gorse and scrub and it would undoubtedly benefit from some degree of scrub control. Some erosion is caused by tracks formed by the use of quad bikes up the slope on the north east side, where they are cutting into the turf. It would be preferable if the use of these vehicles could be reduced on the monument, so that the turf is allowed to regenerate. The ring feeders are also causing some erosion at the base of the slope on the south east side. The impact on the monument could be diminished if the feeders were moved further away from the site.

There is no formal public access to the monument at present, although the land owner allows visitor access with consent under normal circumstances. The Tir Gofal scheme provides a good opportunity to establish a more official public access route to the monument. Regular monitoring should be undertaken to assess if this creates a further problem of erosion.

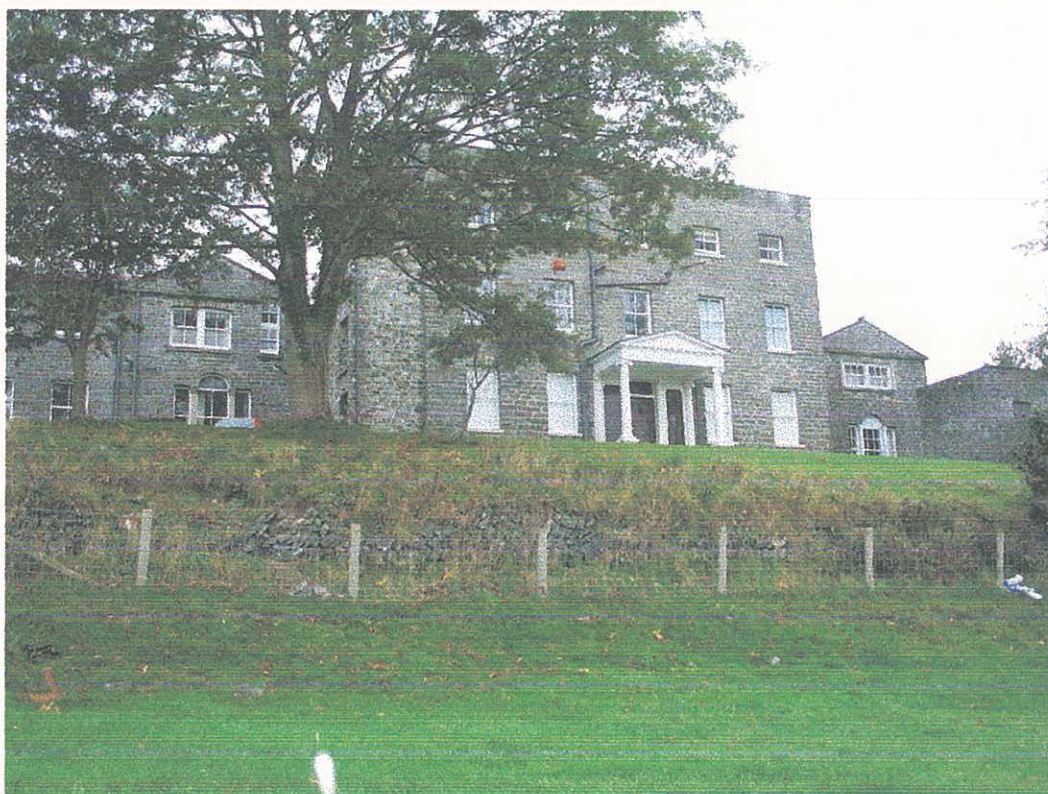
Also to the front facade is a pedimented portico, a four panelled front door and two round windows lighting the basement (plate 2). To either side are two irregular wings with gable ends to front. On the south west facade is a cast iron veranda, facing onto a lawned garden.

To the north of the house a ha-ha extends along the base of the bank on which the house is situated (plate 2). It is constructed out of diagonally set stone which in places has partially collapsed.

Plate 2 – Castle Hill Mansion (PRN 7181) with ha-ha (PRN 43838) to front

The stonework of the ha-ha has collapsed in places. This structure should be stabilized and repaired using traditional materials.

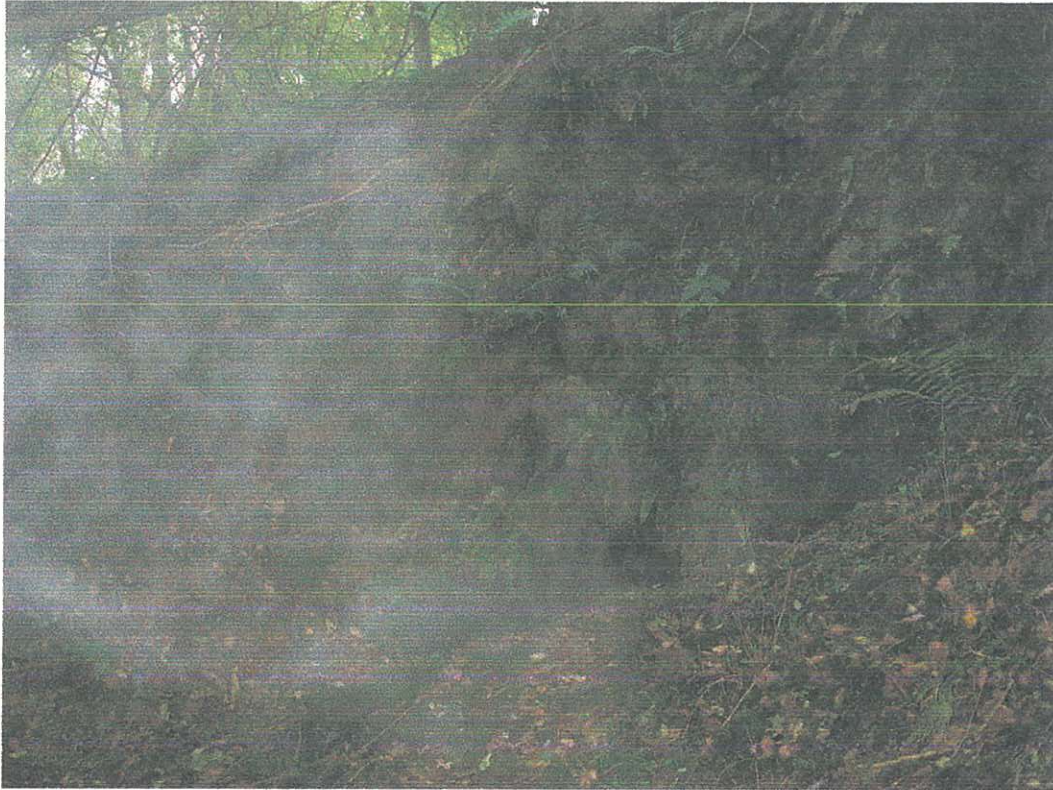
The entrance to the old level is situated to the west of the very steeply sided wooded valley of the Cwm Moch watercourse. The entrance is an irregular opening in the rock, facing north east, at the base of the valley (plate 3). The opening is about 1.5m in diameter leading down into the rock, and Mr. Peter Loxdale, the current owner of the farm, relates that some years ago he and a friend managed to penetrate the level by about 6-7 metres. The valley sides around the entrance have been cut back to some extent, there is little evidence of other associated features in the immediate area. Although recorded in the Upland Ceredigion Archaeology Mines Survey of 1992 there is little information available on this feature.

Plate 3 – the old lead mine entrance (PRN 25893)

This feature should be retained in its current condition and should be kept clear of debris.

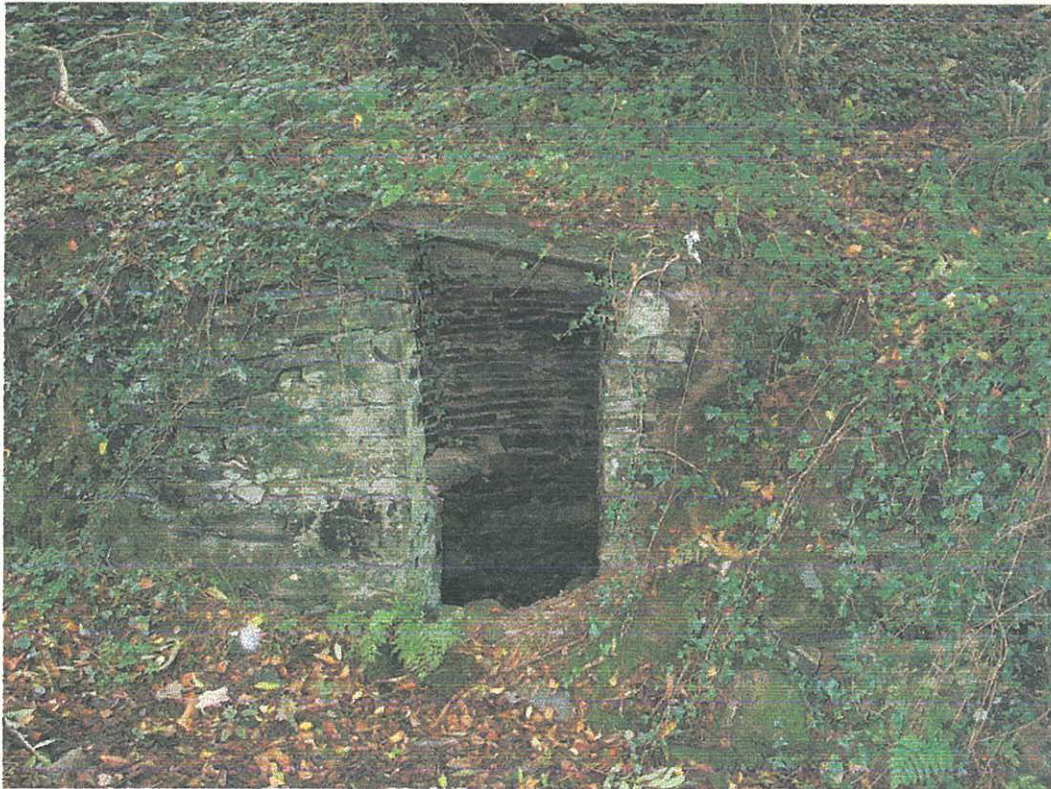
A stone built well is situated on the south west side of the road to the south of the house (plate 4). The well is stone built with an internal circular cistern and a large slate capstone. The north west side of the structure is beginning to collapse.

Plate 4 – stone built well (PRN 43839)

The well should be repaired and maintained using traditional materials.

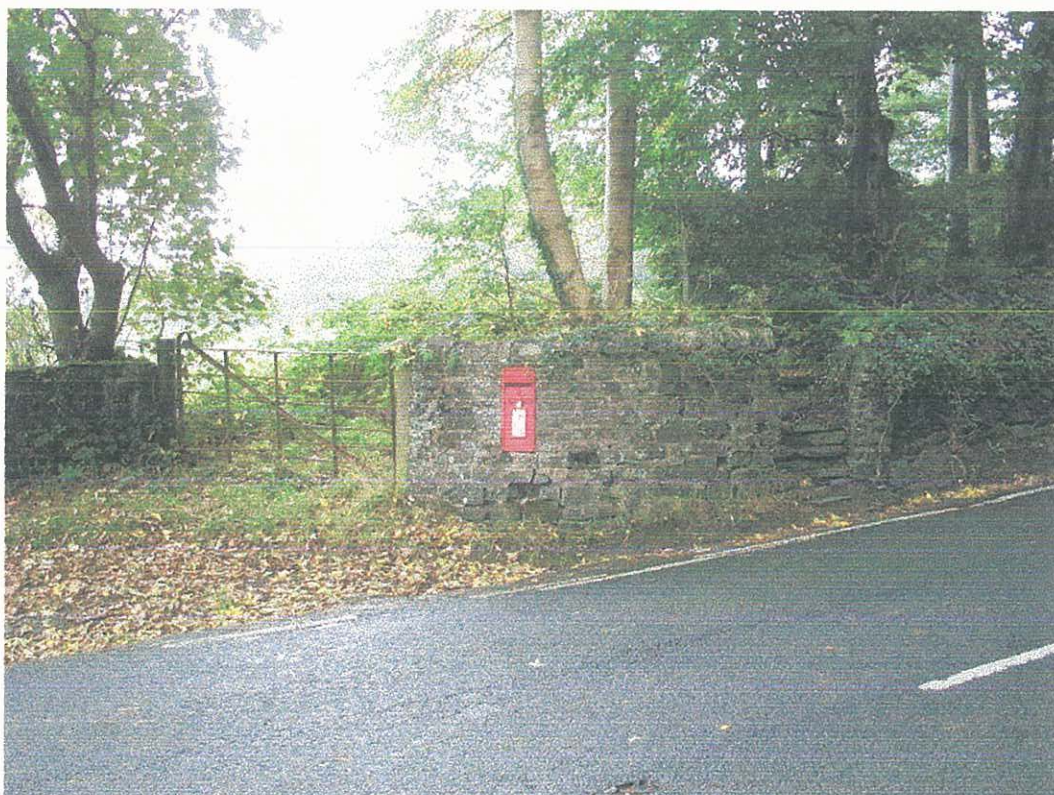
At the end of the path leading from the house to the Llanilar road, is a gateway and a pedestrian stone stile (plate 5). The gate is constructed in cast iron with a diagonal cross piece. The stone stile consists of stone steps on either side set into the wall.

Plate 5 – the gateway and stone stile providing entrance to Castle Hill house from the north west (PRN 43842)

The pedestrian stone stile is becoming overgrown and some steps are loose. The vegetation should be carefully removed and the masonry steps consolidated. The gateway should continue to be maintained in a stable condition.

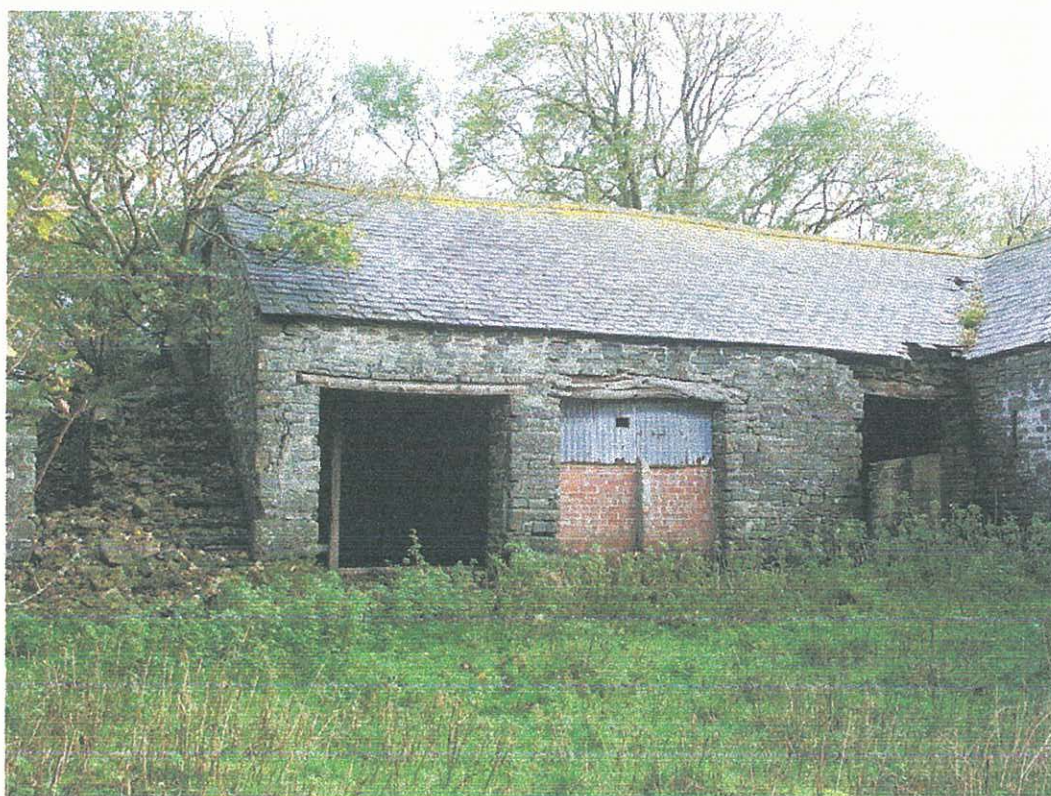
To the south west of the farmhouse is a cart shed with a granary above, accessed by steps at the north east end. The cart shed has two entrances on the north west side, with stone jambs and timber lintels. Peg holes in the lintel of the southern doorway suggest it is reused, this doorway is now blocked by brick and corrugated iron (plate 6). Inside the cart shed are fittings for a feed rack along the north east cross wall, indicating its later reuse as an animal shed. A further large doorway in this elevation is situated in the southern corner of this range with an opposing doorway on the south east side. Outside the south east side of the building is the remains of a roughly circular level platform (plate 7), which indicates the position of a horse gin (horse powered engine). Further evidence for this engine remains within the building; a drive shaft is still in situ on the north cross wall of the barn, with a wheel, at head height, still evident on the external side of the wall.

Plate 6 – the north west elevation of the cart sheds at Meillionen (PRN 43846)

The farmhouse, although collapsed and beyond repair, should be maintained as a visible feature and carefully cleared of intrusive vegetation. The farm buildings however, are in reasonable condition and should be maintained using sympathetic materials. In some areas the roof slates have slipped, these need to be repaired and replaced. The walls, likewise, need consolidation in certain areas. These repairs should be carried out as soon as possible, before water ingress causes further damage. Some of the buildings contain historic fittings, in particular wooden stall partitions, and some machinery from a horse gin. These are historically significant and should be retained.

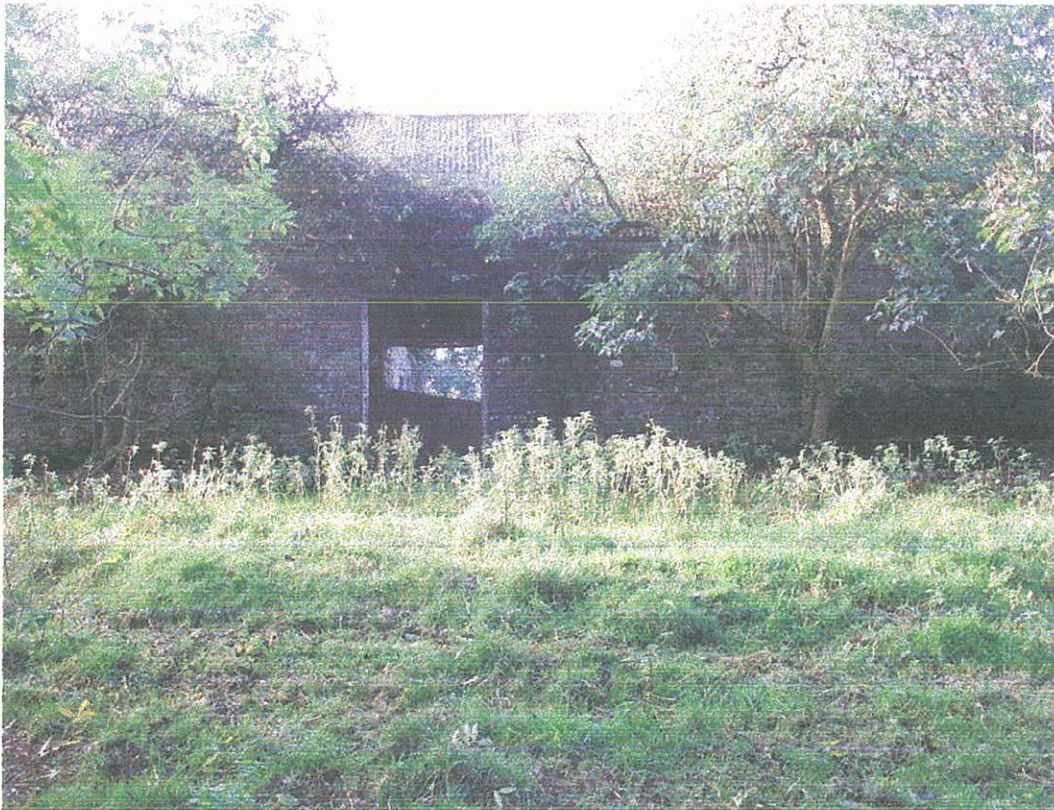
Plate 7 – the position of a horse gin on the south east side of the farm buildings at Meillionen (PRN 43846)

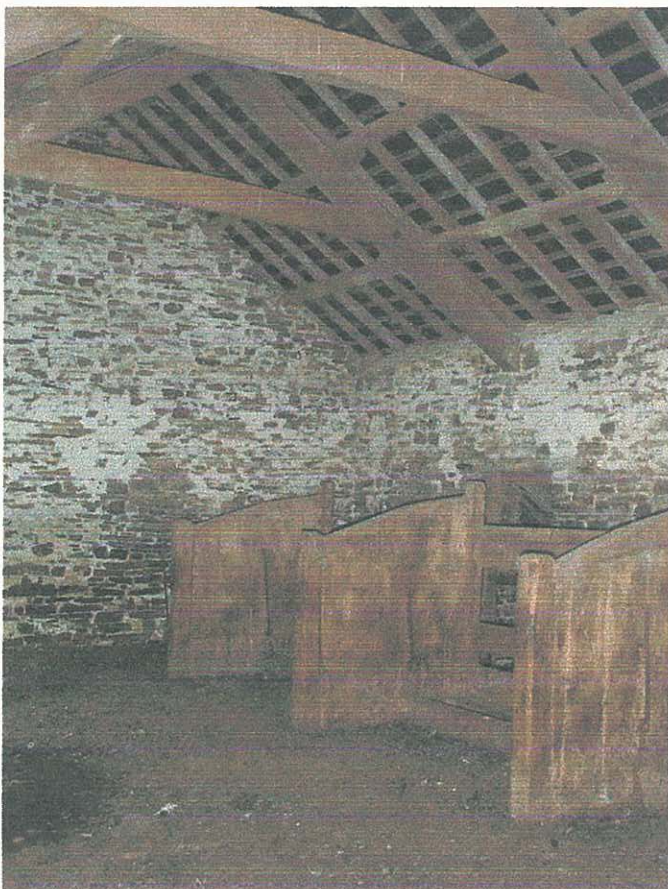
At the south end of the west range of buildings is a cow house. On the north east facing wall are two doorways at either end, with two windows in between, of which the southern window has been inserted into an earlier doorway. This has four substantial timber stall partitions in situ with a longitudinal feed passage along the south west wall (plate 8). A doorway in this wall leads into a small calf house positioned on the exterior of this range. The calf house is also accessed externally by a doorway in the north east wall and has a small ventilation slit on the south east wall.

Plate 8 – the interior of the cow house (PRN 43846) at Meillionen

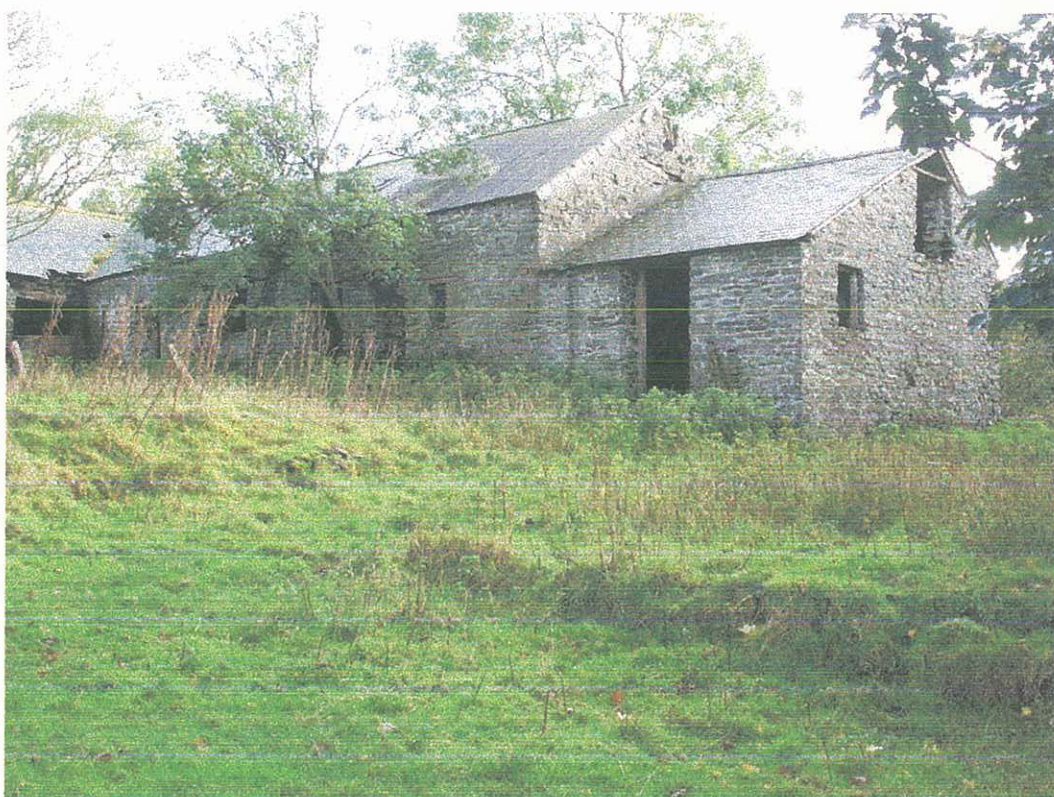
The farmstead itself survives as an L-shaped complex of buildings with an enclosed area to the north. The buildings are constructed out of roughly coursed rubble, with a pitched slate roof. The farmhouse, situated at the north east end of the range, has completely collapsed, the chimney remains the highest surviving fragment of masonry at about 2.5m. Although largely obscured by fallen rubble the copper can still be seen in the south corner of the building.

Plate 9 – the west range of the farm building complex (PRN 43846) at Meillionen
