**TIR GOFAL MANAGEMENT PLAN:
HERITAGE MANAGEMENT INFORMATION**

**Prepared for:
Llwyncolfa Coed**

**Tir Gofal Reference No:
W/11/1945**

**Report Number: 2008/33
Project Record Number:
41710**

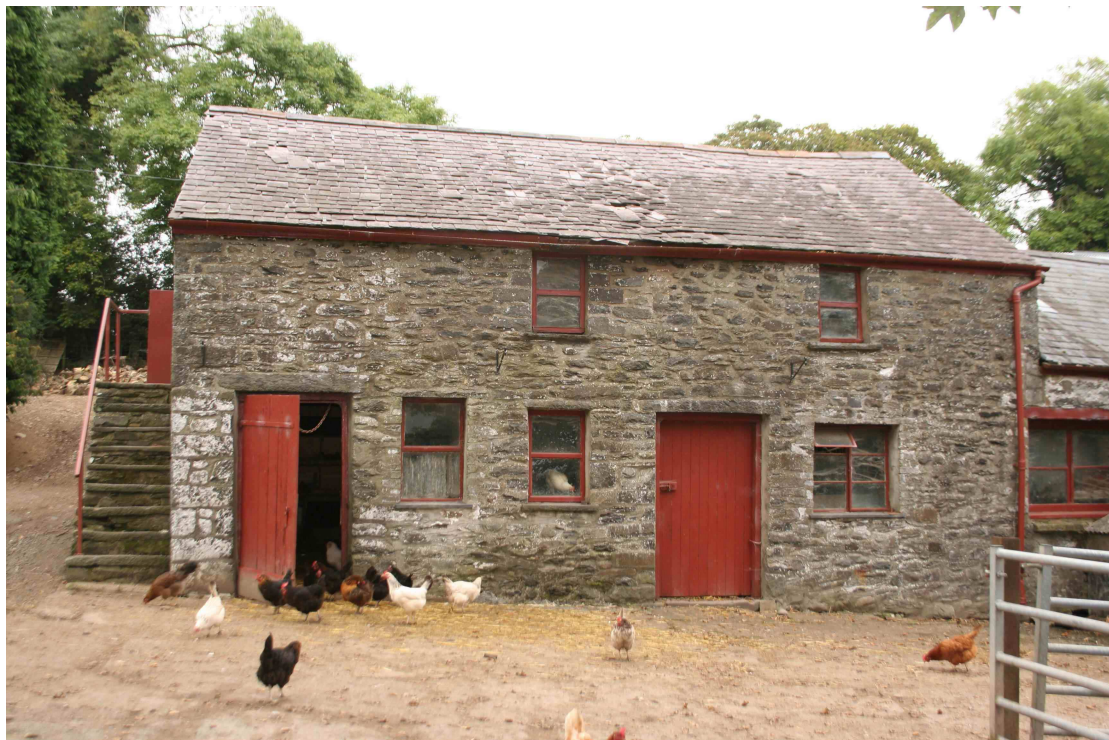
The stable with granary above.

Opportunities for restoration of the buildings within the farmstead should be welcomed. In particular the stable and granary roof would benefit from repairs in order to maintain the building in a sound and weatherproof condition. The following guidelines should be observed in any restoration works:

- Any repairs should retain as much of the original material as possible.
- Where replacement is unavoidable materials should be used which match the original as closely as possible.
- Particular attention should be given to replicate the original slates in size and colour and the coursing technique.

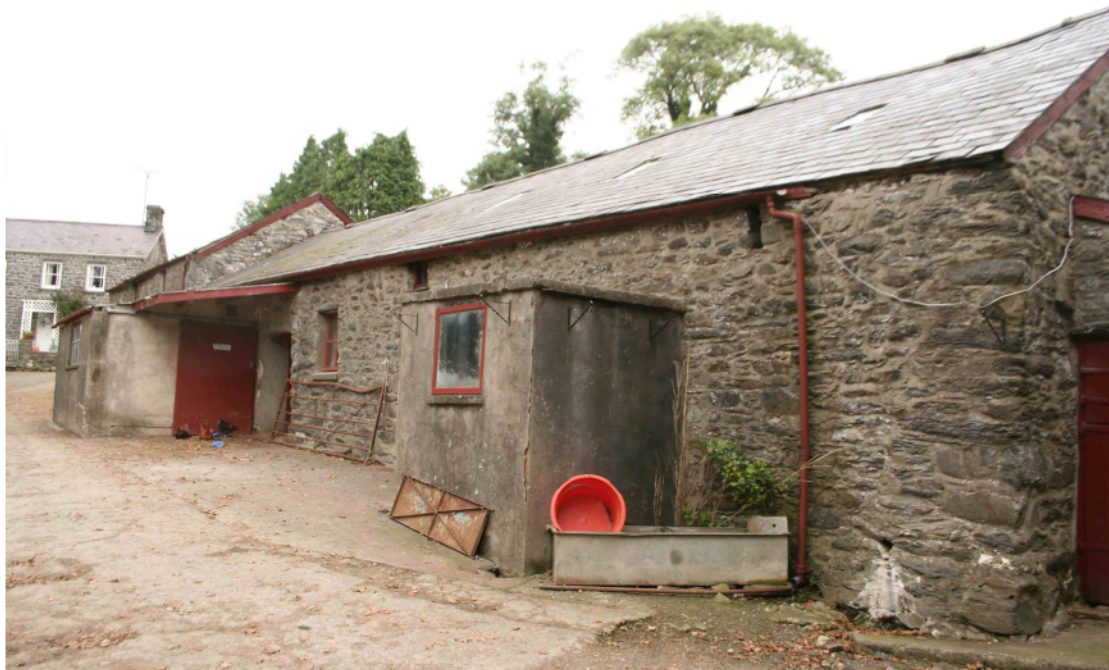
The cow shed is a simple single storey long range with two modern lean-tos on the front wall incorporating a dairy unit. Although somewhat modified in the 20th century, with the internal stalls reordered to incorporate a long feed passage against the rear wall, the cow shed retains much of its historic character.

The cow shed has been added to in the 20th century to accommodate milking equipment

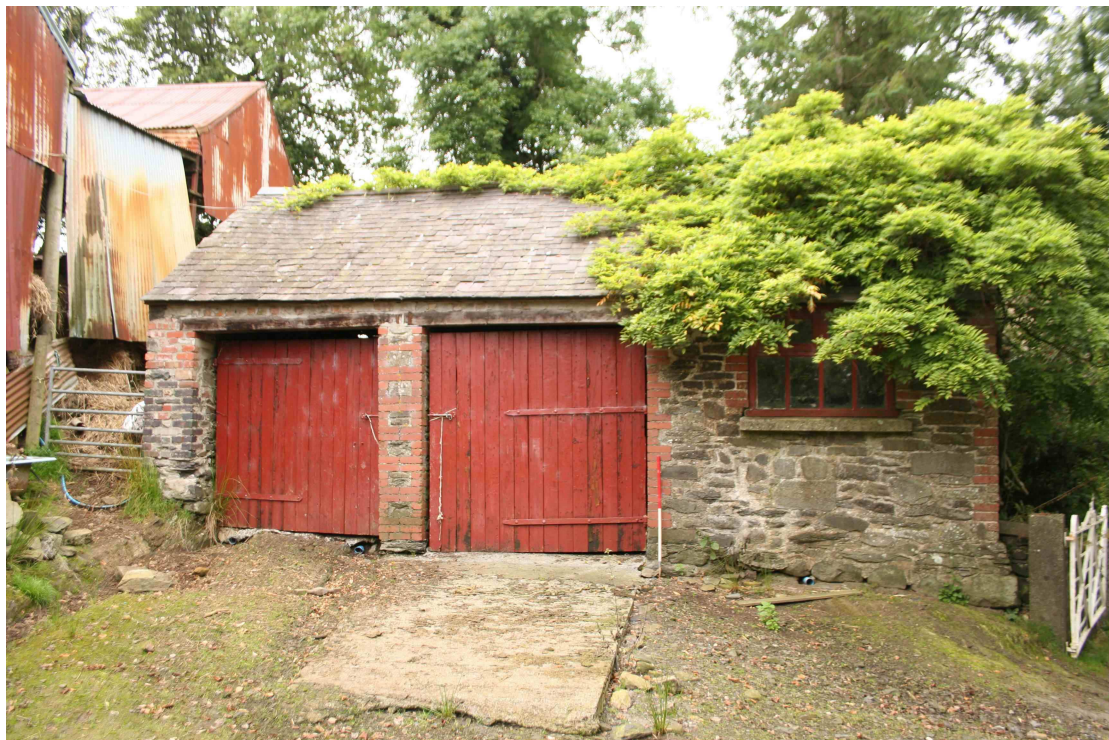
A detached building, at the foot of the farmstead and adjacent to the public road, is a small cart shed. This building is constructed of a mixture of building materials, largely stone and slate, with brick used for dressings and most significantly clom or earth makes up the pine end of the building. This would appear to be a relic survival of a building material which was more widely used on the farmstead. The landowner, whose family have been living on the farm since the 19th century recalls how buildings of clom in previous generations have been replaced gradually by stone. Unfortunately when the clom wall was observed in September 2007, it was so significantly eroded at its base it was deemed to be potentially dangerous and irreparable. It was therefore considered that a record should be made prior to its removal.

The cart shed lies at the bottom of the farmstead

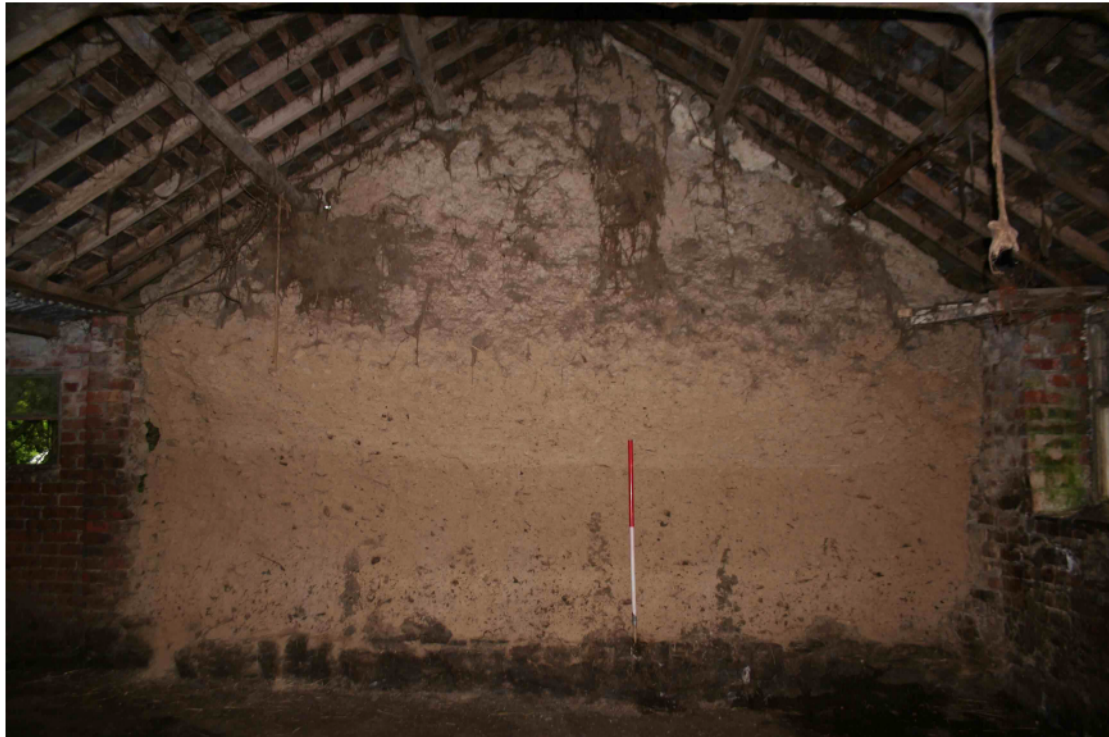
The clom wall is built upon a stone plinth c0.4m high. The wall has a section of 0.5m at its widest, but the lower section has been severely eroded away by stock rubbing against the building. Within the clom walling there are significant horizontal building lifts visible, with sections of mud laid down between 0.4 - 0.5m high indicating the

construction sequence. These lifts are clearly visible as differential colours of mud, suggesting different mixes of material for each construction episode.

The clom walling demonstrates the constructional sequence, with horizontal building 'lifts' clearly visible
