Tir Gofal Farm Visit Report
Fron Farm
W/12/1751

Report Number 2001/68

FRON FARM
TIR GOFAL FARM VISIT REPORT

Tir Gofal Application Number W/12/1751
Address Fron Farm
Fron Eglwys Fair, Llanboidy, Whitland

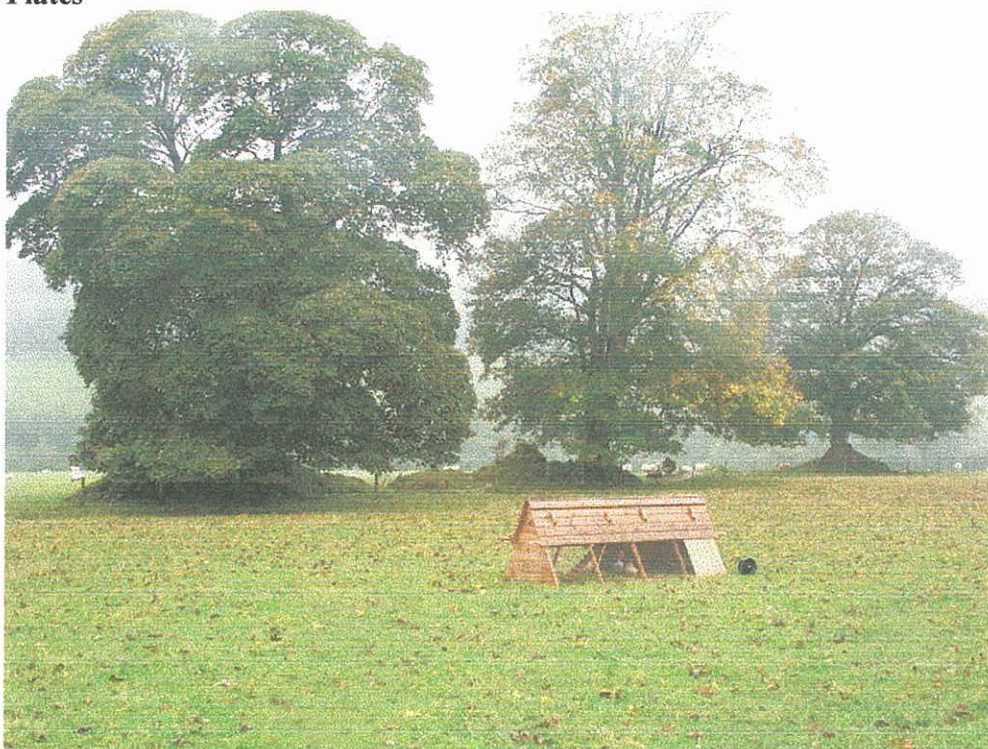
The field boundaries are mostly hedge lined earth banks which in places are no longer stock proof and have grown out into lines of mature trees (plate 1). However the layout of the boundaries still corresponds to those recorded on the tithe map of 1843.

Plate 1 – An old field boundary to the south west of the farmstead

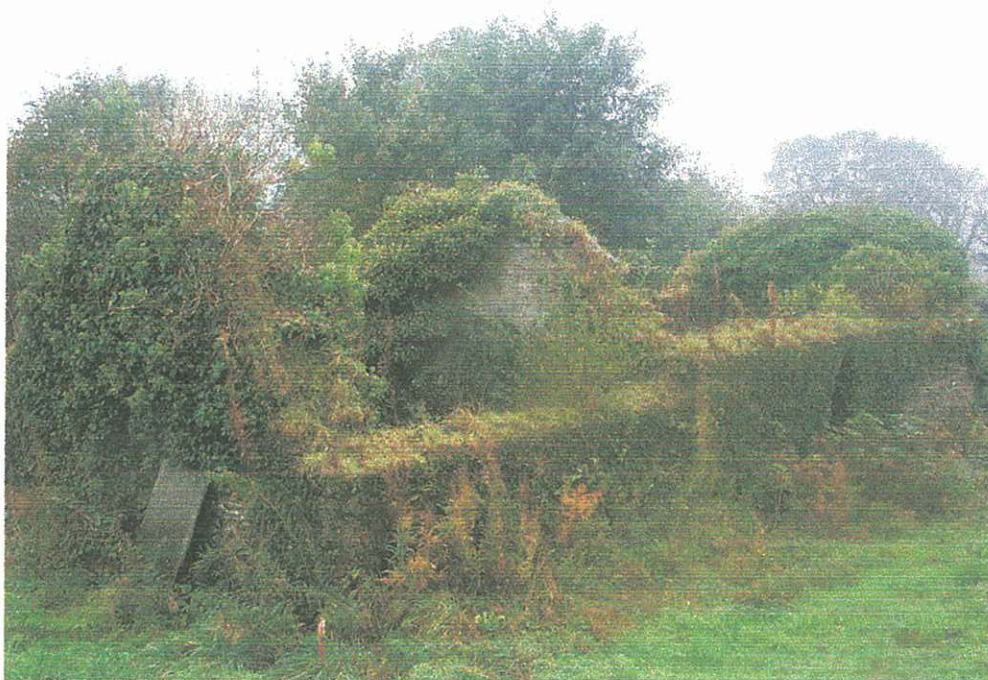
The roof is now missing completely, and although overgrown with ivy the walls remain standing to roof height (plate 2). Internally the nave has a central aisle flanked to either side by raised pew platforms (plate 3) and an octagonal pulpit plinth to the south of the chancel arch. The chancel has a raised slate dais at the east end and sockets within the side walls indicate the position of an altar rail. Internally the walls still retain some render finishes with a scar visible behind the pulpit at dado level. The remains of some decorated woodwork remain scattered about within the chancel.

Plate 2 – St. Mary's Church (PRN 5076) from the north east

The owner is keen to consolidate the ruins of the church and clear the churchyard of intrusive vegetation with a view to opening it up to the public. This would be a very worthwhile undertaking. Priority must be given to consolidating the masonry which is substantially overgrown and in a vulnerable condition. Great care must be given to the removal of intrusive vegetation which may have penetrated the fabric. It may be necessary to undertake consolidation works simultaneously with the removal of vegetation which may be providing support to the structure. Archaeological advice must be sought if works are to be undertaken on the church, and provision should be made for an archaeological record of the fabric before and after consolidation works. Any clearance within or around the structure must be carried out with care, and attention given to the recovery of architectural fragments or fixtures and fittings which may be amongst the debris. Prior to any work being carried out it would be beneficial to seek specialist conservation advice, for contacts see list appended.

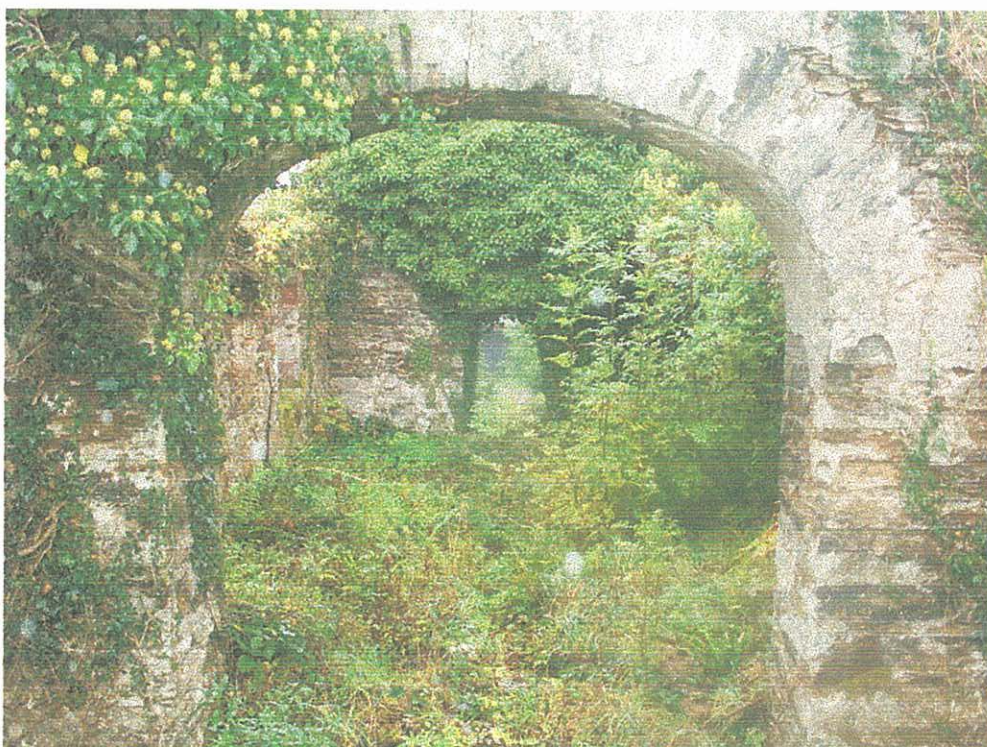
Plate 3 – the interior of St. Mary's Church (PRN 5076) looking west

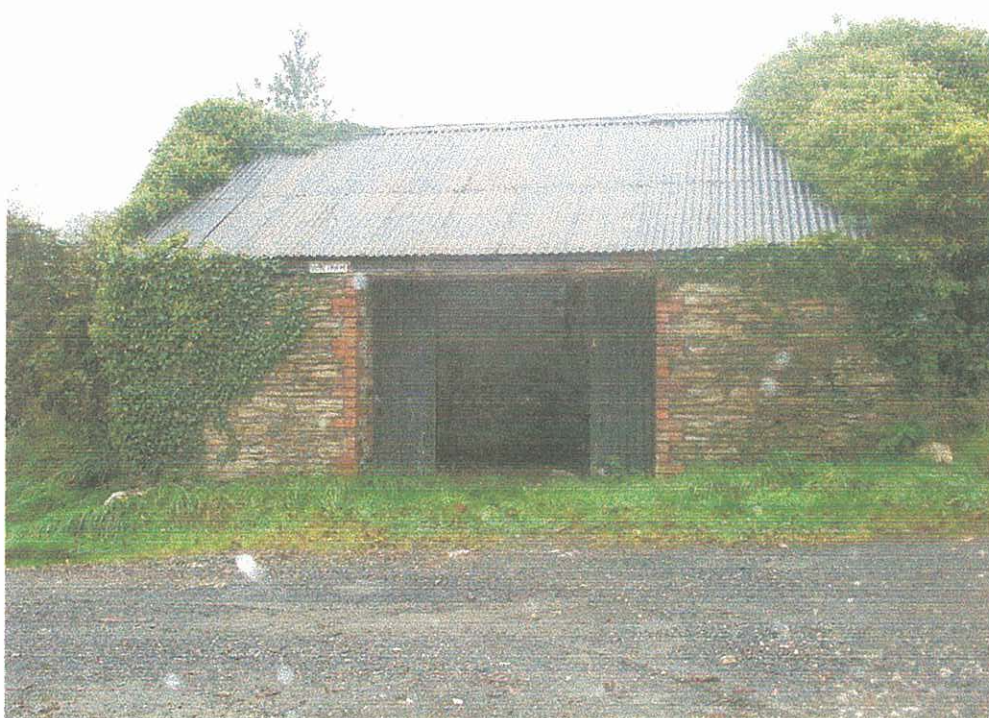
The smithy is a single cell coursed slate construction with a 4 bay pitched corrugated iron roof (plate 4). A large double doorway in its east elevation is dressed with brick jambs and a timber lintel. At its north end is the remains of a large external chimney which has been reduced in height to below roof level and capped over with a single pitch corrugated iron roof. Internally the hearth has a reused timber lintel, scorched at its western end, probably indicating the position of the bellows to the east of the hearth. To the east of the hearth is a vertical depression chased out of the masonry. In the west elevation is a small ventilation window. The floor is rammed earth and lime. It has become very overgrown at both gable ends and the roof over the hearth is no longer watertight.

Plate 4 – the smithy (PRN 22829)

The vegetation which is engulfing the smithy should be carefully cut back and allowed to die before removal, and the masonry consolidated using traditional materials. It is vital that the roof is repaired and made watertight to prevent damage to the masonry.

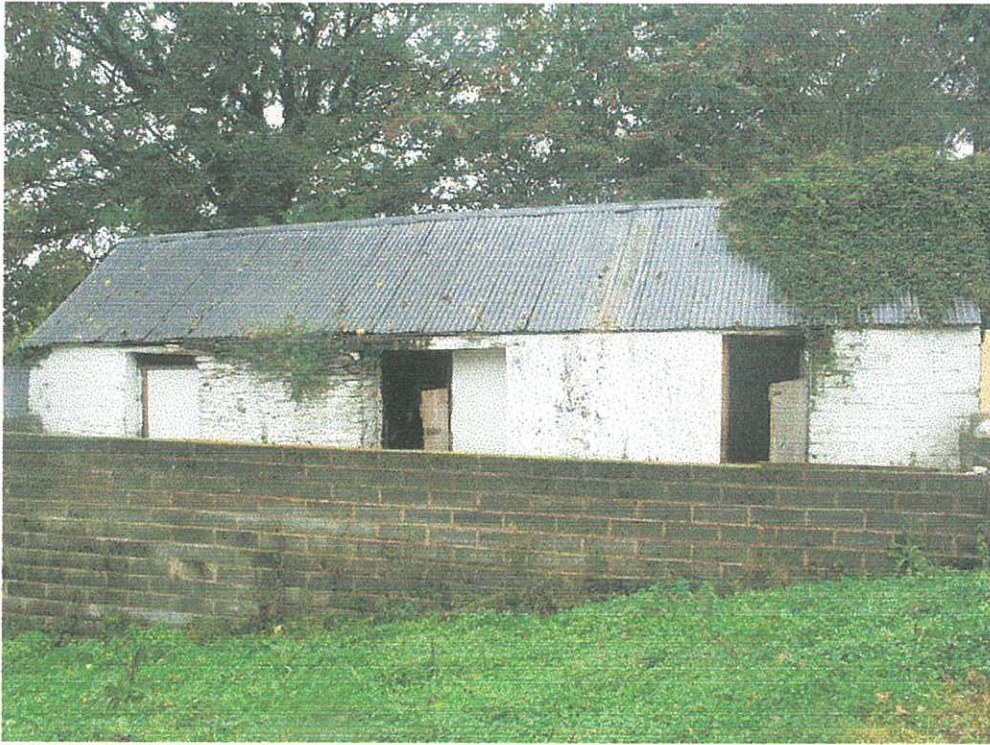
This is a single storey cow shed to the west of the farm yard, constructed in coursed slate with a white wash finish and a pitched corrugated iron roof (plate 5). The east elevation has low doorways at either end and a central double doorway which has been partially blocked in with breeze block; no original fittings appear to survive internally. Internally it has a concrete floor and breeze block partitions. The roof is constructed with timber pegged, collared trusses and strengthening braces have been added longitudinally to prevent the roof racking. At its south end is a lean-to, slate walled on the east and west side and a breeze block south wall with a pent roof. There is a rough cobbled floor, and a slate feed trough along the cross wall.

The cow shed is becoming quite severely overgrown on its gable walls and in some of the wall tops. The vegetation should be carefully removed from the masonry and in particular the wall tops, which should then be consolidated using traditional materials. The slate feed trough in the lean-to at the end should be retained.

Plate 5 – cow shed (PRN 43657) to the west of the farmyard

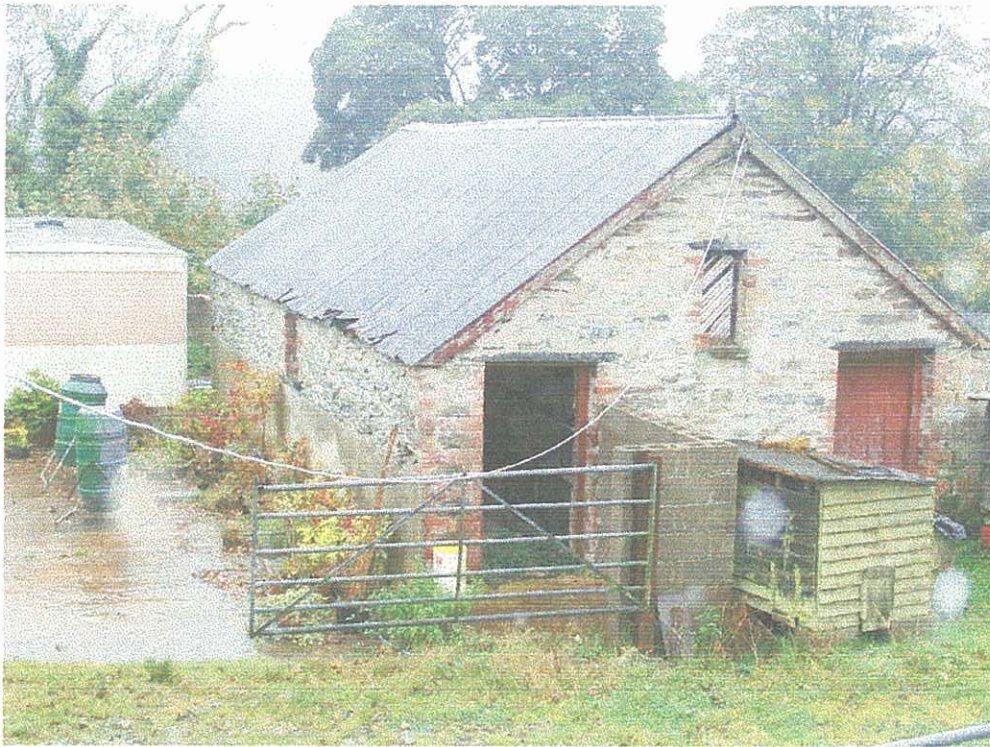
This single storey cow shed is constructed in coursed slate with slate lintels and brick dressings and a pitched, corrugated iron roof (plate 6). The tithe map of 1843 shows a footprint of a building which corresponds with the position of the current building, although the current building appears to have undergone modernisation and remodelling. Internally the roof is a modern (20th century?) collar truss roof of 7 bays. The cow house has a longitudinal feed passage against the east wall, and the feed trough is partly constructed out of large slate slabs, the stall partitions and floor are concrete. Two low doorways at either side of the north gable end provide entry to the feed passage and to the rear of the stalls, above is a small ventilation window to the centre of the gable. Two low doorways in the west wall provide entry into breeze block lean-tos. A vertical building break in the southern gable end indicates an earlier phase to the building. Internally there are two small recesses set into either side of the southern gable wall.

Plate 6 – cow shed (PRN 43658) to the south of the farmyard

The cow shed is currently in reasonable order, and should continue to be maintained in this condition. Any repairs should be carried out using traditional materials. It would be desirable to retain the slate lined feed trough if possible.

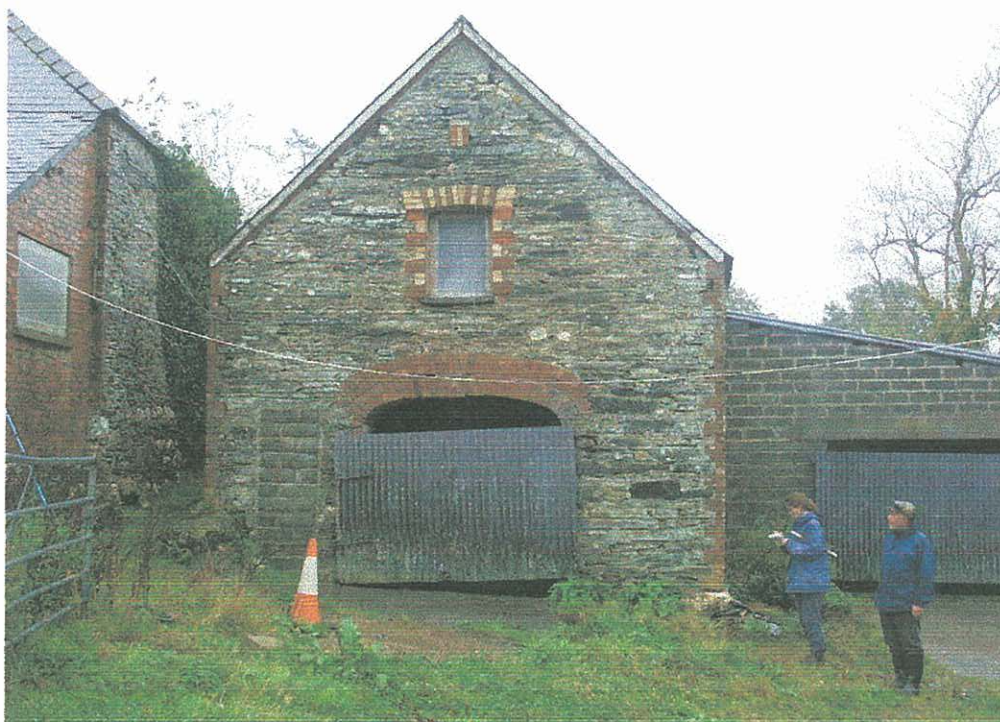
To the east of the farm yard is a two-storey cart house orientated on a northwest-southeast axis, with a low brick arched cart entrance in the west gable wall (plate 7). The building is constructed with coursed slate and quartz with brick dressings and a pitched slate roof. The first floor openings have a polychromatic brick scheme including a small dovecote built into the south wall. The south elevation has a symmetrical arrangement of openings; a central doorway, flanked by windows and with doorways at either end, all with low brick arches and chamfered jambs. Internally the ground floor has iron hayracks against the north wall with a modern breeze block feed trough beneath and the floor is concrete. The first floor loft is accessed by a low ramp to a side door in the north elevation. A collar truss roof has the roofing batons laid directly on the back of the trusses with no rafters in between.

Plate 7 – cart house (PRN 43658) to the south of the farmyard

The cart house is currently in reasonable order, and should continue to be maintained in this condition. Any repairs should be carried out using traditional materials.

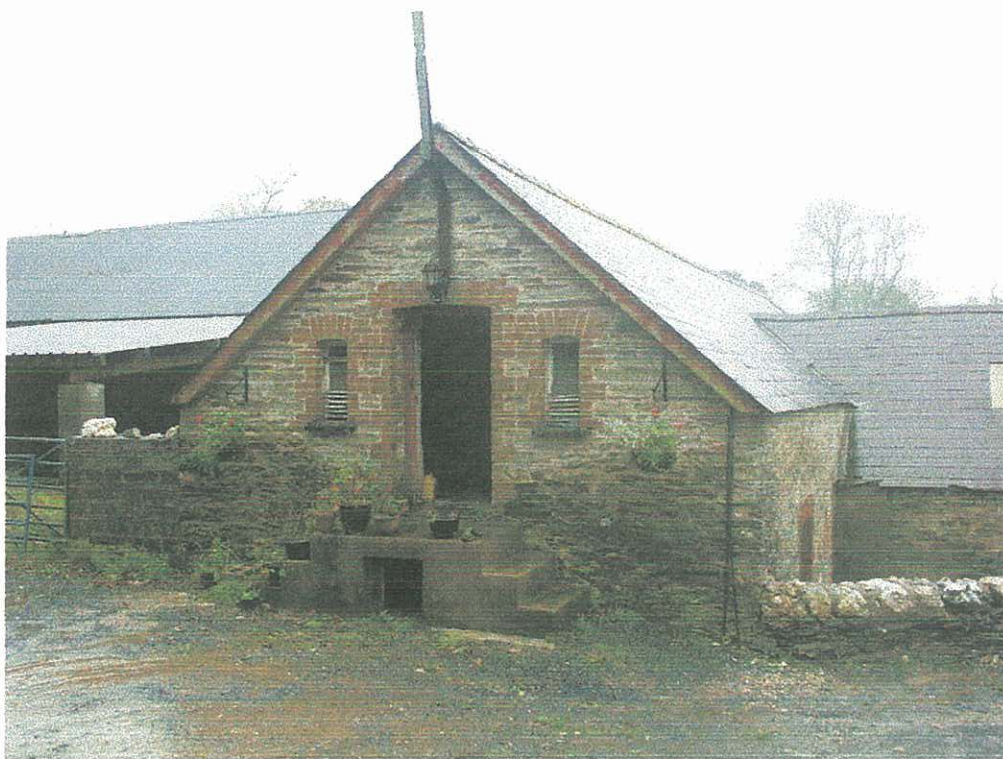
The north end of the barn is two storey with a granary entered by external stone steps and a central doorway in the north gable end (plate 8). Within the north end of the granary a small room has been partitioned off with beaded tongue and groove and the roof lined with lathe and plaster presumably to provide workers accommodation. A doorway through the partition wall leads into a loft space where a chaff cutter has been mounted above a shoot to the floor below. The chaff cutter would appear to be an early 20th century apparatus, although it is not obvious how it was powered. The ground floor of the barn is split level with the upper end containing some slate stall partitions and slate flooring. A water course runs beneath the western extension which the owner believes may have driven a water wheel at one time. This extension has two doorways in the south elevation with a window in between. The north elevation has just two small ventilation windows. Internally a slate lined feed passage runs along the north wall, and the floor is concrete with some slate.

Plate 8 – the granary at the north end of the barn (PRN 43660)

The barn is currently in good order, and should continue to be maintained in this condition. Accommodation in the granary is an uncommon feature and the internal fixtures should be repaired and retained, using sympathetic materials. Other historical internal fittings such as the chaff cutter, the slate slab feed troughs and the stall partitions should also be retained.

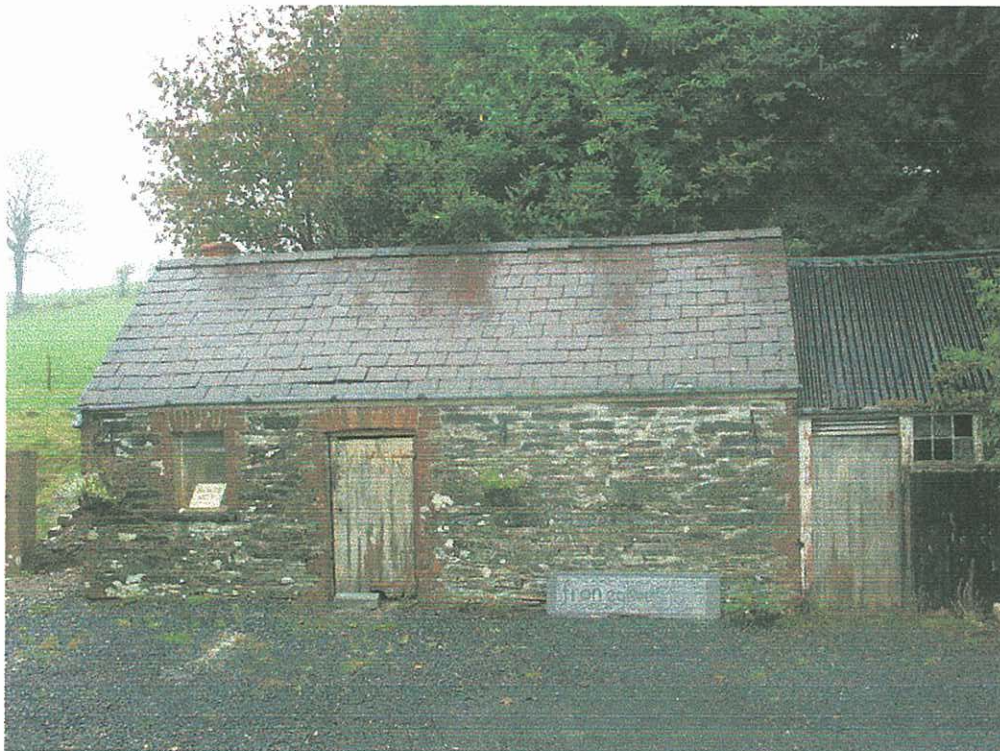
A small building to the east of the farmhouse which is constructed out of coursed slate with brick dressings and a pitched slate roof (plate 9). It has single doorway in the south elevation and a small window to the west of the doorway. A boiler is situated to in the north west corner of the building with a chimney rising at the back of the building. To the east of the gable end is a small timber extension with a slightly lower pitched corrugated iron roof. A large rectangular sump is positioned in the floor of this extension. The function of this building is unclear, and may have had different functions at different times, it may have been a wash house or mash house and the owner suggests that the rectangular vat or sump in the east extension may be a scalding tank for processing carcasses.

The outbuilding has loose and missing slates around the chimney which are allowing water ingress, these need to be repaired and made watertight. Some pointing is showing signs of erosion, these areas need to be repointed. The internal fixtures are an integral part of the building which should be retained.

Plate 9 – the small outbuilding (PRN 43661) to the east of the farmhouse

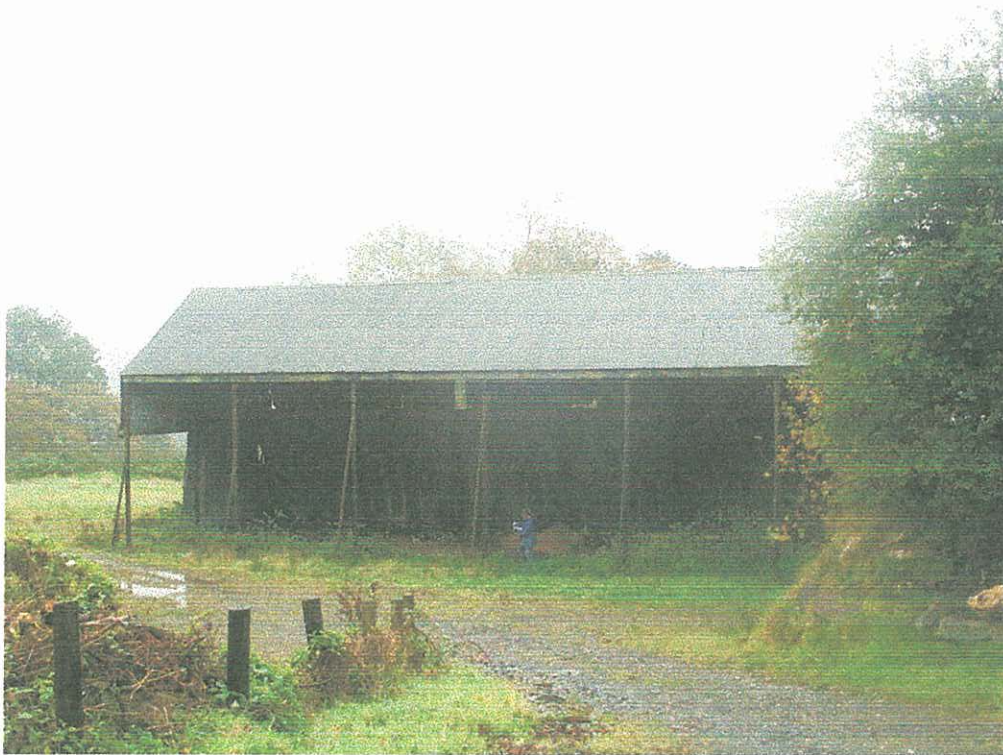
To the east of the farmstead set below the farm track is a large hay barn, enclosed on the south and west sides (plate 10). It has a corrugated iron pitched roof supported on H-sectioned iron supports. A building is shown in this position on the 2nd edition OS map (1907), which must have been a precursor to the current building.

Plate 10 – the hay barn (PRN 43662) to the south of the farm track

The hay barn is currently in good order, and should continue to be maintained in this condition.

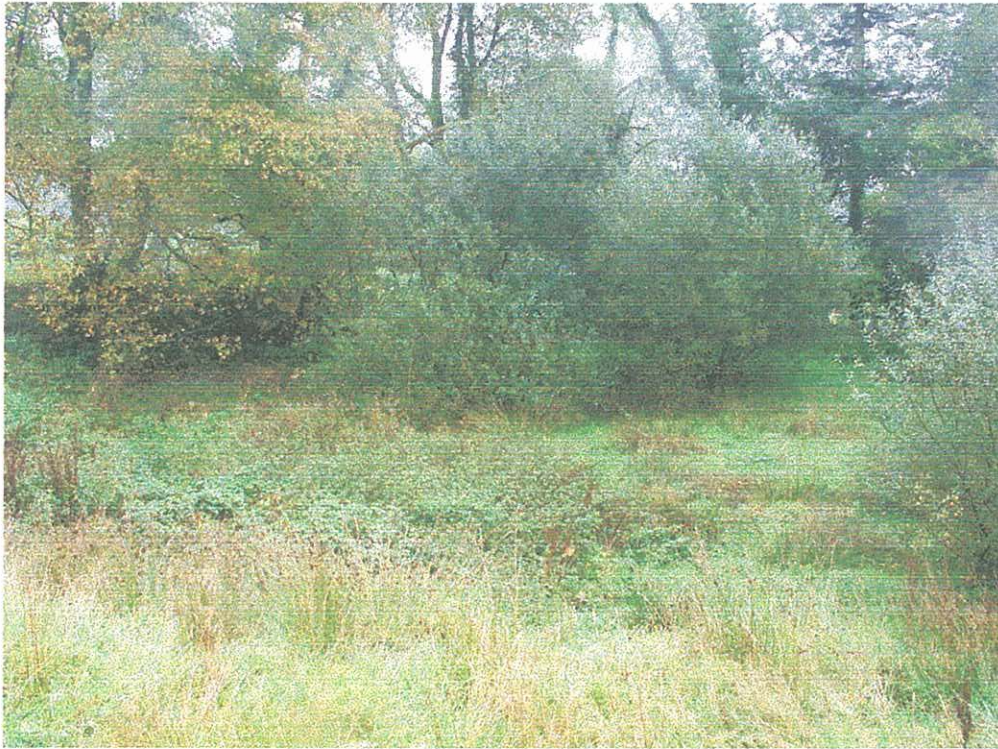
A large artificial pond is positioned to the south of the farmstead which appears on the tithe map of 1843. It is now largely drained and overgrown in places (plate 11).

Plate 11 – the pond (PRN 43835) situated to the south of the farmyard

If the intention is to restore the pond it is advised that any ground breaking works are undertaken with archaeological supervision.

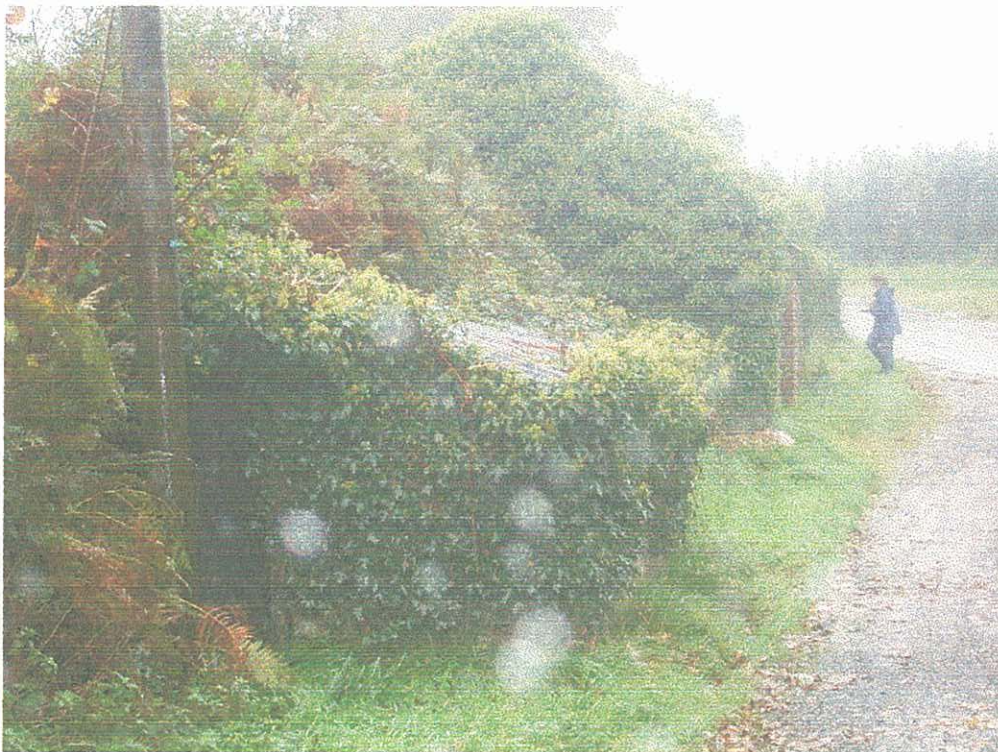
To the south west of the smithy is a small coal shed constructed out of coursed slate and a corrugated iron pent roof (plate 12). It has two small windows in the east and south wall and a low doorway in the south wall.

The coal shed is currently very overgrown with ivy. The vegetation should be removed with care and the masonry consolidated.

Plate 12 – the coal shed (PRN 43836) to the south west of the smithy
