# Waun Fawr W/12/2475

## Tir Gofal Farm Visit Historic Environment Report

Report No. 2002/36

REPORT NO. 2002/36  
PROJECT RECORD NO. 41812

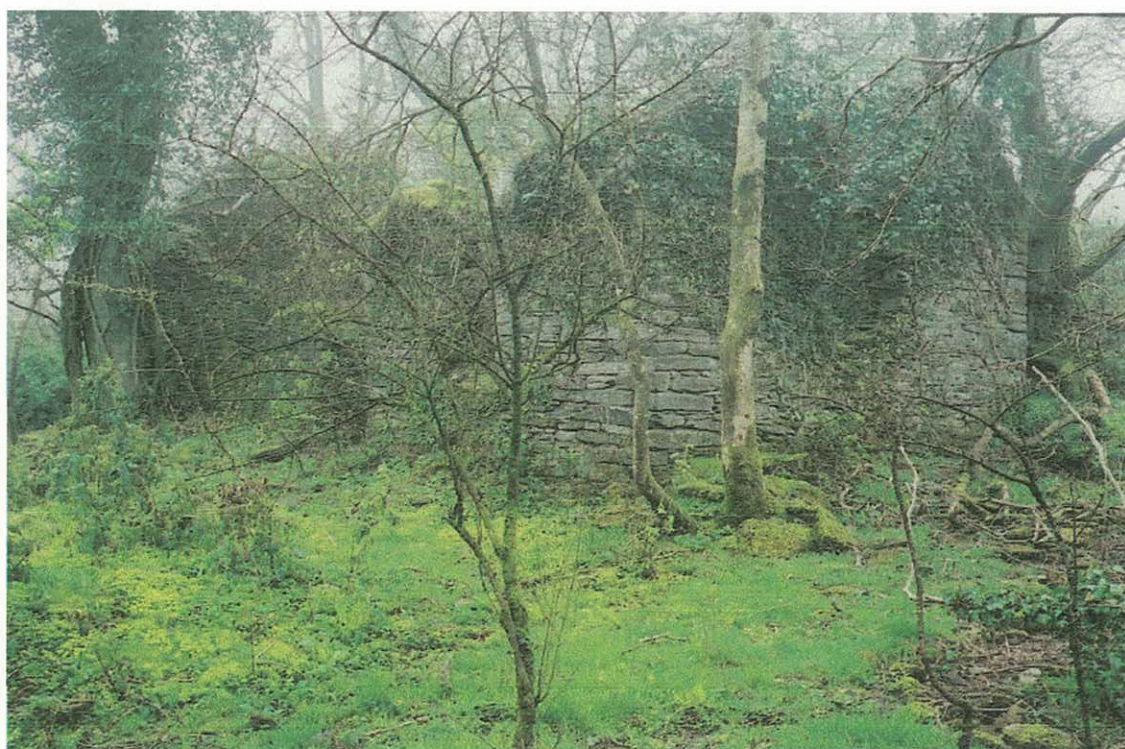
Ruined dwelling fronting onto the trackway (PRN 44812), now a public right-of-way, through the wooded area on the north side of the holding. This area represents a distinctive landscape of early 19<sup>th</sup> century tenant settlement. The dwelling is not depicted on the tithe map of 1848, but is probably late 18<sup>th</sup>-early 19<sup>th</sup> century in date. It is marked on the Ordnance Survey 6" map of 1891. Slate rubble construction, measuring approx. 8m east-west by 4m north-south. It apparently had two storeys – joist-holes can be seen in the south wall – but the upper floor, which may have been a sleeping-loft, and gables have gone. There is now an opening in the west wall, apparently with a slate lintel, but it may be a fireplace and flue that had broken through. There are two square windows and a central entry in the north wall. The south wall is blind. There are the remains of an east-west dividing wall in the east half of the building, the area to the south – which partly occupies an outshot in the south wall – possibly representing a pantry with a small square window in the east wall. The entire building is in a very ruinous condition, surviving to an average height of 2.5m, and overgrown with soft vegetation, ivy and saplings. A single celled extension to the east is in a more ruinous condition, surviving to an average height of only 0.5m and no features can be properly identified. A rectangular, raised/terraced area to the north of the dwelling may represent a yard or garden plot; it too is very overgrown.

Plate 1 – Clyn Helyg dwelling (PRN 22852), from the northwest

An overall management strategy for the wooded area, which should be based around the reinstatement of the public rights-of-way and include selective tree and vegetation clearance, and consolidation, could be extended to take in the site of Clyn Helyg dwelling. The vegetation could be cleared from the ruins, the masonry remains consolidated and maintained as a visible feature.

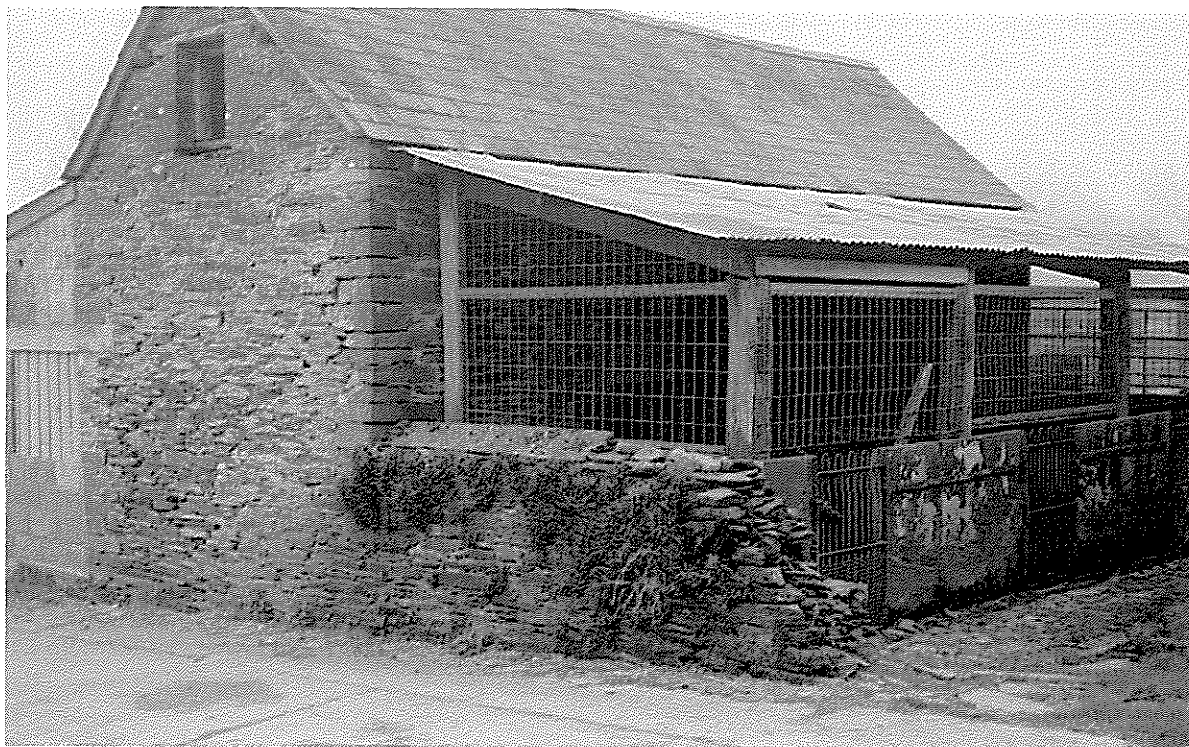
Pigsty in slate rubble, with good quality quoins, on an east-west alignment. It is from the mid-late 19<sup>th</sup> century, not being marked on the tithe map of 1848 but depicted on the Ordnance Survey 6" map of 1891. It has a loft over, possibly for poultry, beneath a slate gabled roof. There are three bays, for three pigs, with yards to the south defined by vertical slate slab 'walling'. The west end wall of the yard area originally ran further south to butt against a former, parallel east-west building which has been demolished, and supplanted by a late 20<sup>th</sup> century farm building on a different alignment. Between the yards and the former building is a path, which is 1m wide and, unusually for southwest Wales, is flagged with Pennant sandstone. A late 20<sup>th</sup> century lean-to, in breeze-block, lies against the north wall of the pigsty, and the yards are now roofed with corrugated sheet-metal, on timber uprights, for the confinement of dogs.

The pigsty is in fair to good condition and should be maintained as existing using traditional materials.

Plate 2 – The pigsty (PRN 44775), from the southwest

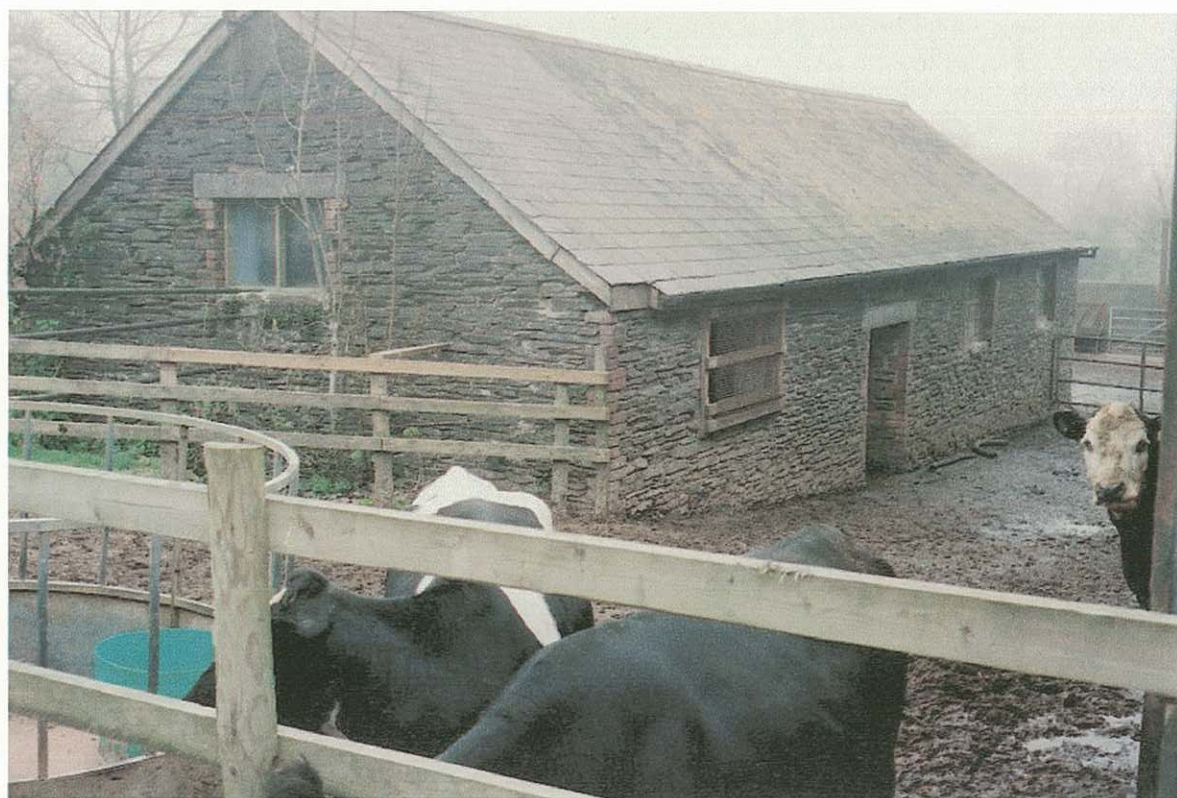
The cow house is generally in fair-good condition but some of the roof slates are loose or missing at the eaves. In addition the brick surrounds, and facework, are ‘hungry’ in areas. Any remedial work should be undertaken using traditional materials.

The cow house is generally in fair to good condition but some of the roof slates are loose or missing at the eaves. In addition the brick surrounds, and facework, are 'hungry' in areas. Any remedial work should be undertaken using traditional materials.

Plate 3 – The cowhouse (PRN 44776), from the southeast

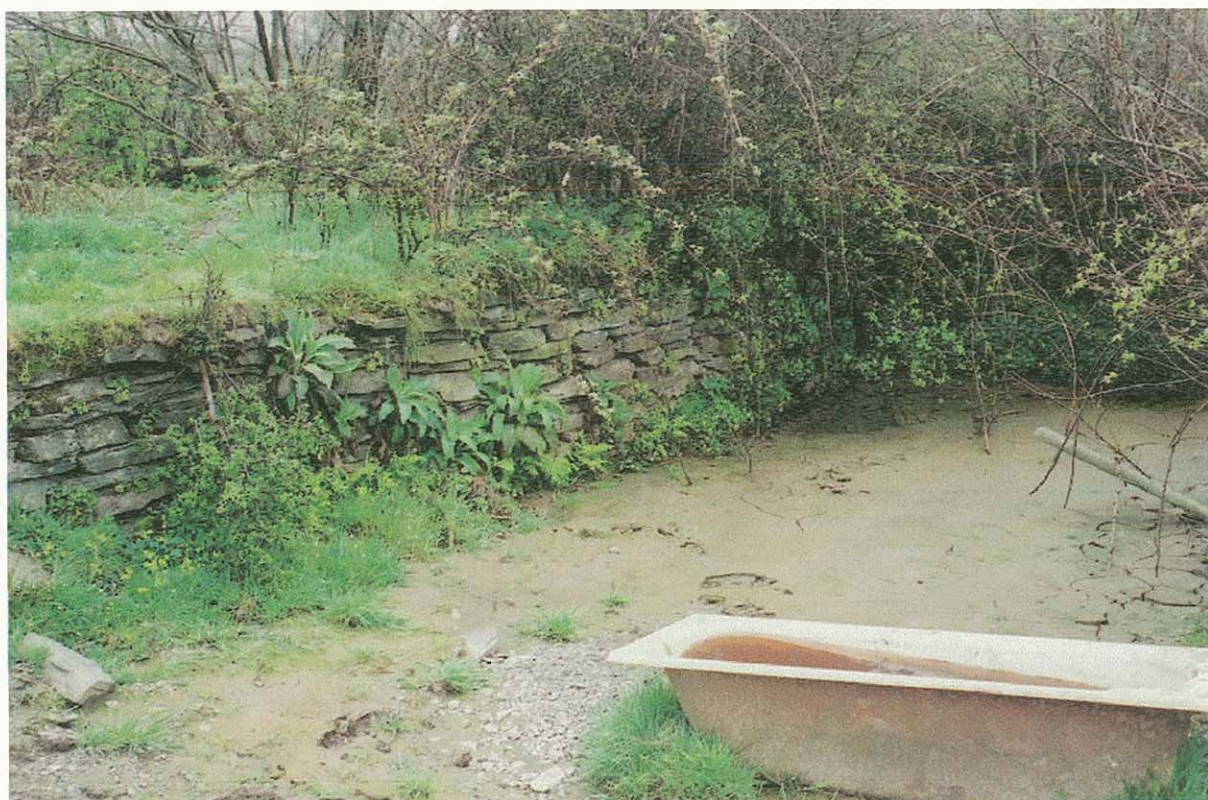
Dam, retaining a leat (PRN 44778) that flowed in from the west. The dam runs north-south for approx. 8 metres, but its north end is obscured by vegetation. It is approximately 1.5m wide, and is now 1m high with slate rubble facework on both sides. It may survive to its original full height, but the base of the dam, and the sluice, appear to lie beneath an unknown depth of silt and build-up. This is particularly apparent on the east, downstream side where the channel turned through 90° to run northwards, apparently to form the headrace of a former mill immediately west of the farmhouse (PRN 44804). This area is now very wet and muddy.

Plate 4 – The dam (PRN 44777), from the southeast

The dam should be cleared of superficial vegetation and restored as a visible feature. The superficial silt and build-up should also be cleared way from the base to expose the sluice and define the form of the leat and headrace in this area.

The dam should be cleared of superficial vegetation and restored as a visible feature. The superficial silt and build-up should also be cleared way from the base of the dam to expose the sluice and define the form of the leat and headrace in his area.

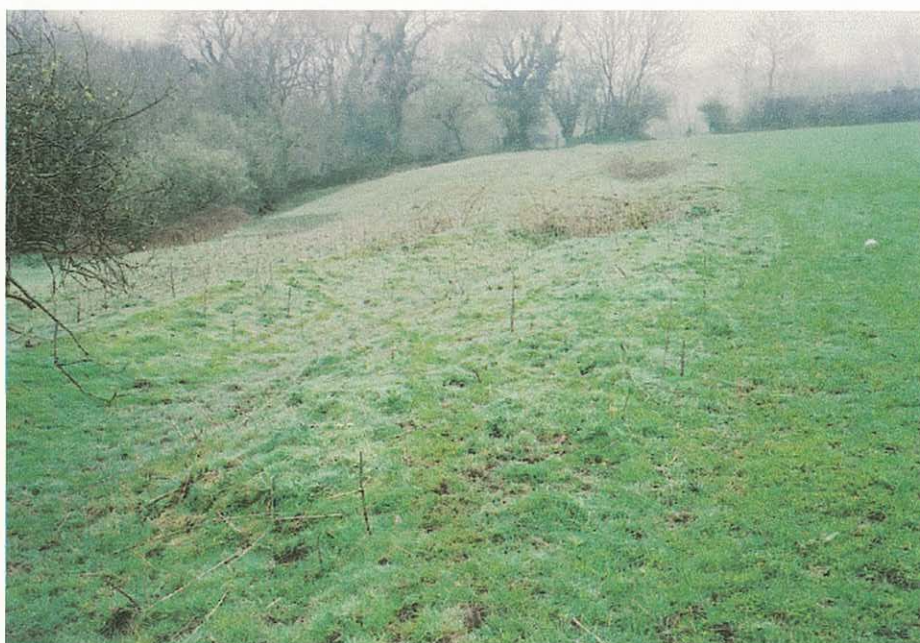
The leat should be preserved as a visible feature. It is currently suffering from some livestock erosion. Livestock level management will prevent further erosion of the banks.

Leat, running for 360m across three fields in the west half of the holding, to dam (PRN 44777). It is now dry. The leat was taken off of the unnamed stream at the west end of the holding but there is now no evidence for a weir or sluice. It is defined by a low bank on both upslope and downslope sides, through the westernmost field. The banks, and the channel, are each 1m wide. There are three areas of livestock erosion in this field. The leat is obscured in the field to the east, apparently having been largely ploughed out. However, two depressions occupy its course, at the junctions with dry stream beds flowing in from the south, and may represent further areas of erosion; the western of these two areas may also have been excavated in order to provide a soakaway. In the eastern of the three fields, the leat is still partly defined by a drain leading towards the dam (PRN 44777). Dam and leat apparently supplied a mill immediately west of the farmhouse (PRN 44804). Their location towards the foot of the gentle downslope rules out any alternative function such as an irrigation leat. The leat is marked in full on the Ordnance Survey 6" map of 1891.

Plate 5 – The west end of the leat (PRN 44778), from the west

The leat should be preserved as a visible feature. It is currently suffering from some livestock erosion. Livestock level management will prevent further erosion of the banks.

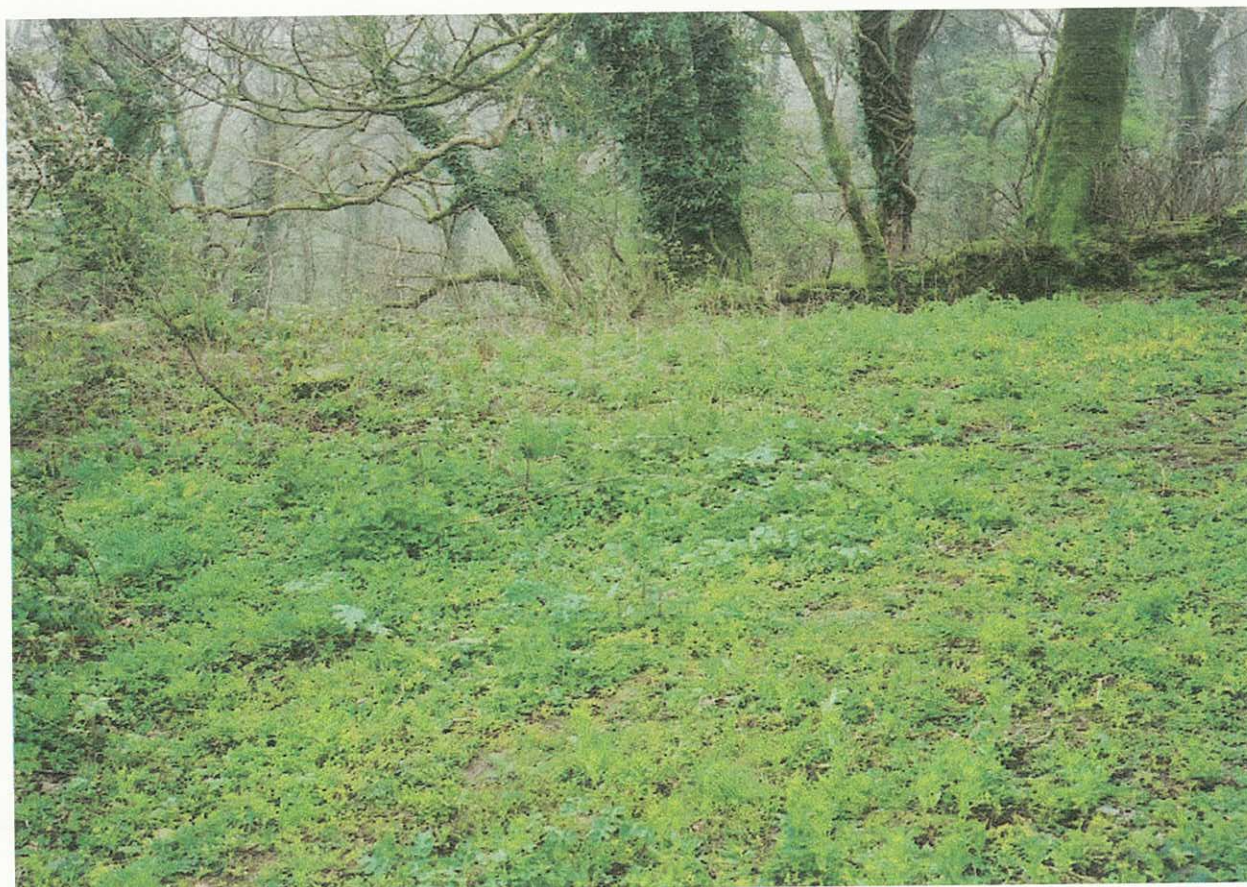
Ruinous building, probably dwelling, associated with an enclosure in the wooded area on the north side of the holding, northwest of Waun Fawr farmstead (PRN 44773). This area represents a distinctive landscape of early 19<sup>th</sup> century tenant settlement. The building is represented by a very low slate rubble wall, barely discernible, defining the north side of a terraced platform measuring approx. 7m east-west by 4m north-south. The entire area is overgrown with soft vegetation and some saplings. Detached from the building, and 3m to the east, is a rectangular enclosure. Only the southwest corner of the enclosure can be properly discerned, where it is defined by a mortared slate rubble wall, up to 1.3m high. Both the wall and the enclosure are in very poor condition and similarly overgrown with soft vegetation, saplings and some mature trees. The enclosure may represent a kitchen garden associated with the possible dwelling. Neither is suggested on the tithe map of 1848, and are not marked on the Ordnance Survey 6" map of 1891, but appear to belong to the late 18<sup>th</sup>-early 19<sup>th</sup> century and probably represent a tenant homestead which had been abandoned by the late 19<sup>th</sup> century. Both building and enclosure lie on the north side of the trackway (PRN 44801). The south side of the trackway is cut into the north-facing downslope which, immediately opposite the building, is retained by a mortared slate rubble wall of good quality, approx. 1.8m high and 5m from east-west.

Plate 6 – The ?settlement, including the enclosure wall (PRN 44802), from the northwest

An overall management strategy for the wooded area, which should be based around the reinstatement of the public rights-of-way and include selective tree and vegetation clearance, and consolidation, could be extended to take in the site of the homestead. The vegetation could be cleared, the enclosure wall made good and maintained as a visible feature.

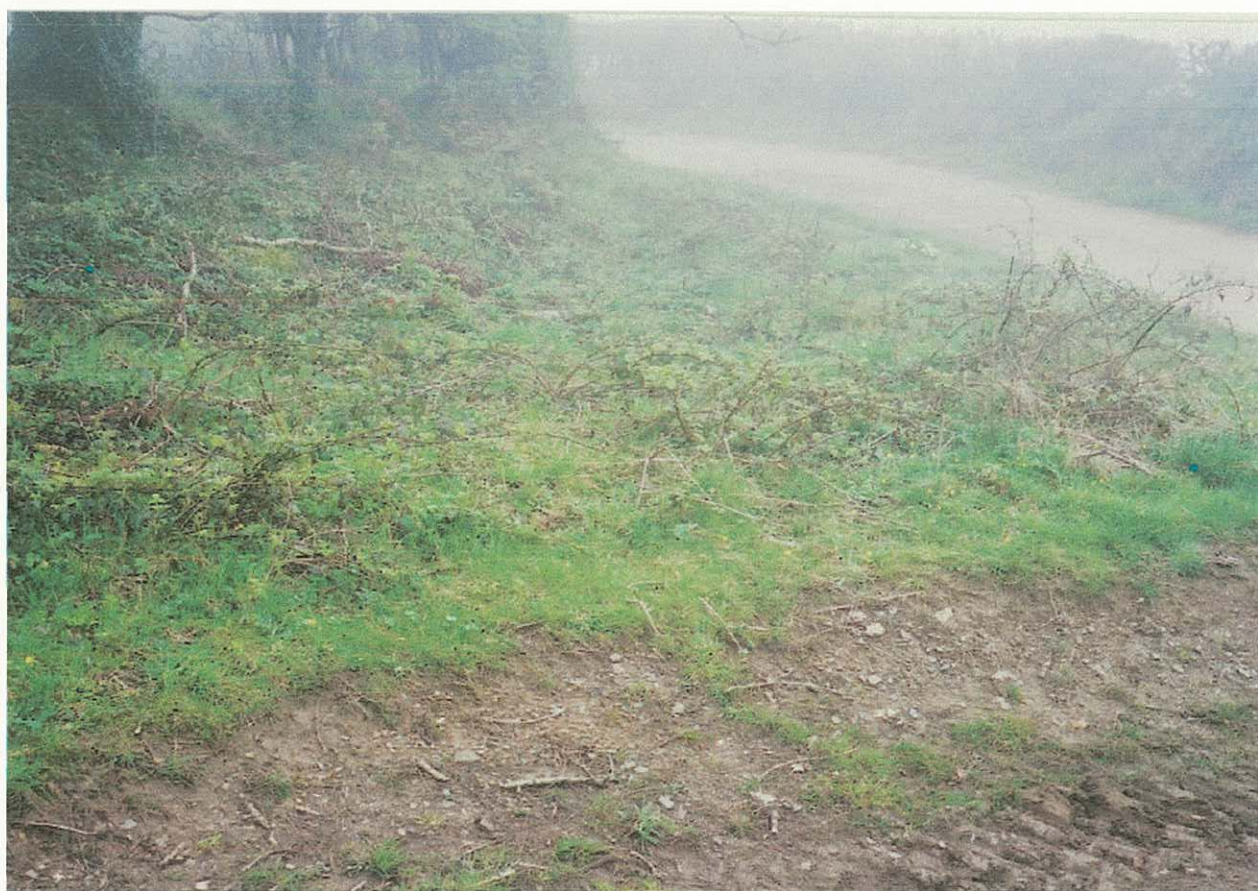
Site of building, occupying a dog-leg along the main farm trackway. It is now represented by a very low, barely discernible length of east-west rubble walling/footings, approx. 8m long, overgrown with brambles. Approx. 3m to the north is a parallel length of similar walling, only 2m long. The building is not suggested on the tithe map of 1848, and is not marked on the Ordnance Survey 6" map of 1891, but it may belong to the late 18<sup>th</sup>-early 19<sup>th</sup> century and probably represents a tenant dwelling which had been abandoned by the late 19<sup>th</sup> century.

Plate 7 – Probable dwelling (PRN 44806), from the east

Clear the superficial vegetation to expose the remains as a visible feature.

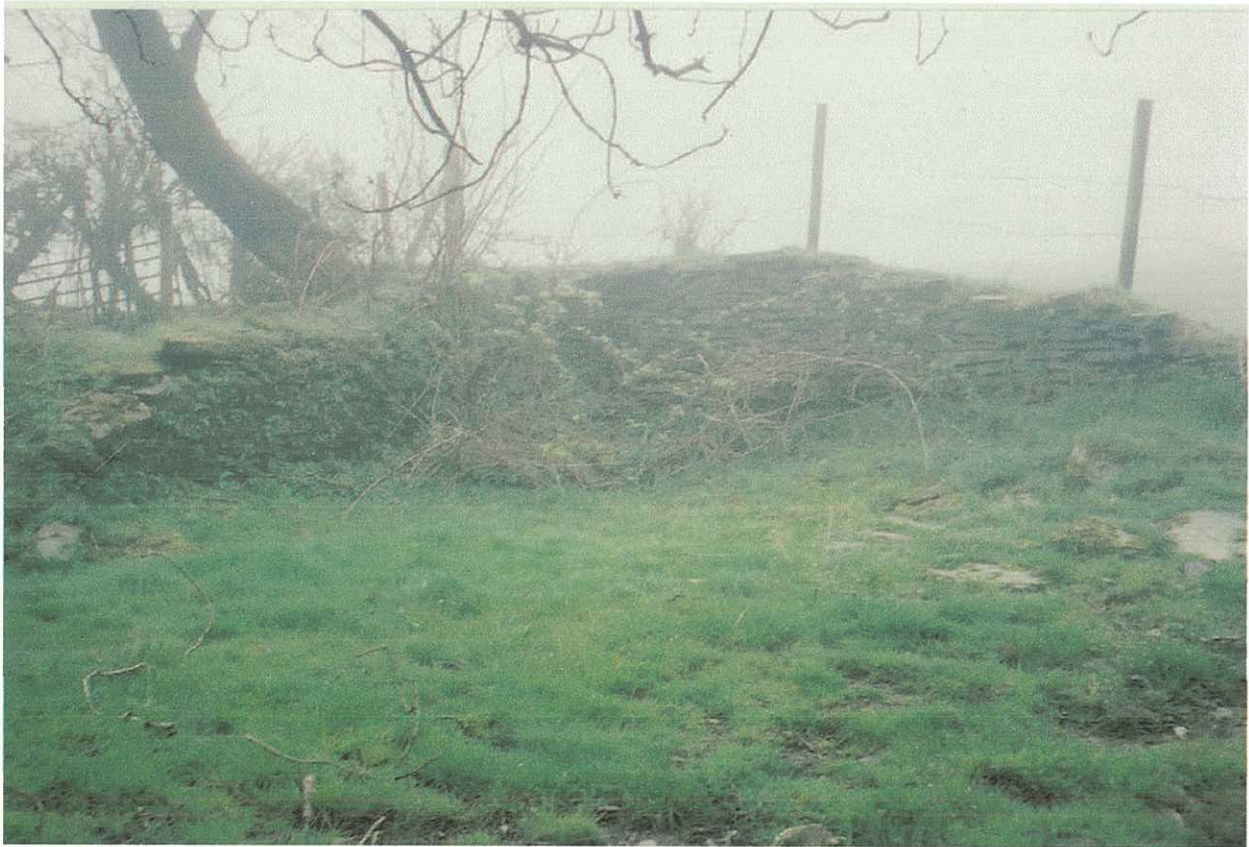
Remains of building, occupying the southeast corner of a small enclosure at the head of farm trackway. The remains comprise the south and east walls of a slate rubble dwelling. The walling survives to a height of 1.2m high but no openings, nor the suggestion of a gable end, survive. Each limb is approx. 3m long. To the north, the line of the east wall is continued as a low wall, 0.75m high, of pitched stone, which curves to the east to join the trackway. The enclosure is now occupied by a slight platform or mound of build-up and debris. The building is not suggested on the tithe map of 1848, and is not marked on the Ordnance Survey 6" map of 1891, but it may belong to the late 18<sup>th</sup>-early 19<sup>th</sup> century and probably represents a tenant dwelling which had been abandoned by the late 19<sup>th</sup> century. It may have been called 'Pen-feidr' (adjacent field name).

Plate 8 – Pen-feidr dwelling (PRN 44808), from the east

Clear the superficial vegetation and consolidate the remains as a visible feature. Any clearance of the material from within the yard should be subject to an archaeological condition.

Clear the superficial vegetation and consolidate the remains as a visible feature. Any proposed clearance of the material from within the yard will require further archaeological consultation.

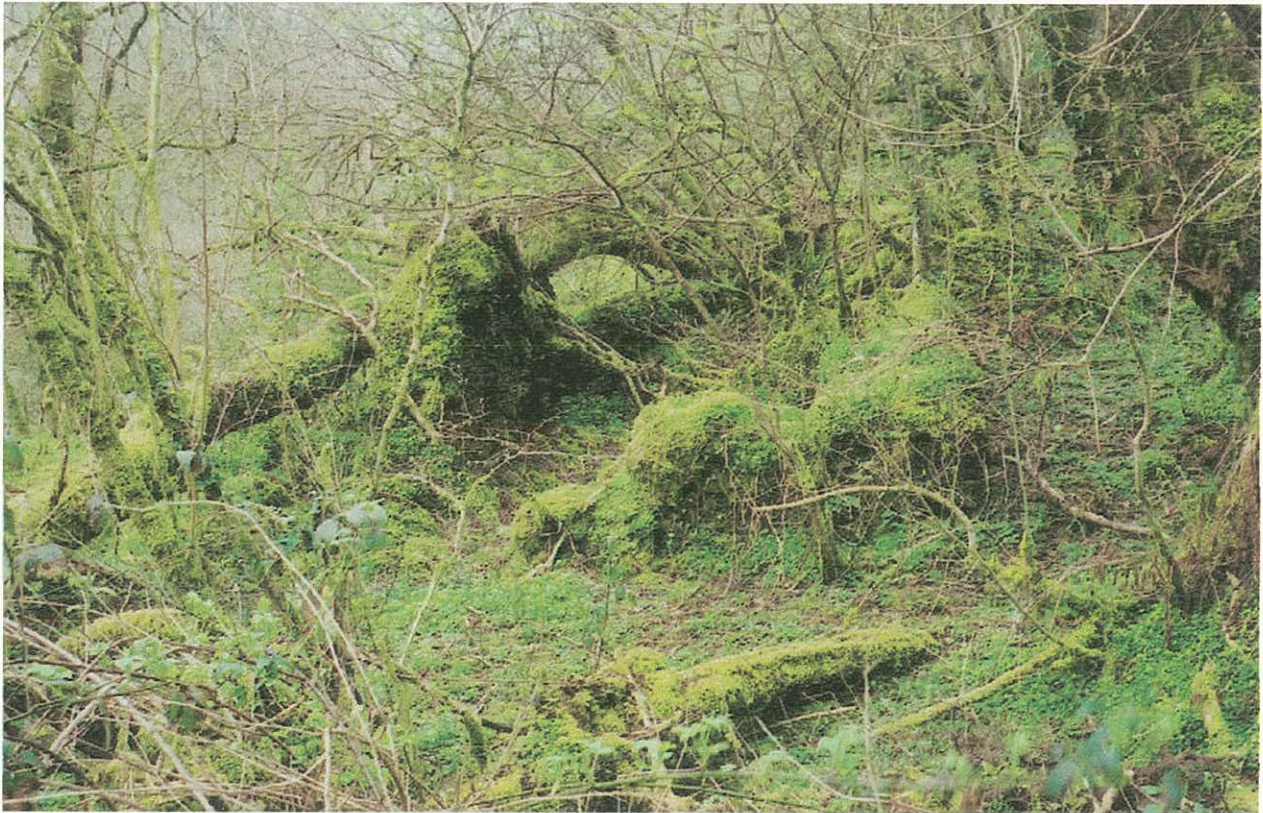
Two ruinous buildings probably representing a homestead, in the wooded area on the north side of the holding. This area represents a distinctive landscape of early 19<sup>th</sup> century tenant settlement. The buildings lie within approx. 5m of each other. The western of the two is represented by the southwest corner and part of a north-south internal wall. All are in slate rubble masonry, but survive to a height of 1m at the most. The eastern building, also in slate rubble, is aligned east-west and measures approx. 3m by 5m in plan. It too survives to a maximum height of 1m. Both buildings are so heavily overgrown with soft vegetation, saplings and some mature trees as to be almost indiscernible. The homestead is depicted on the tithe map of 1848, when it belonged to the neighbouring farm of Trecyrn-fawr, but only one building is shown, possibly the western of the two. Both are depicted on the Ordnance Survey 6" map of 1891. They appear to belong to the late 18<sup>th</sup>-early 19<sup>th</sup> century and probably represent a tenant homestead which had been abandoned by the late 19<sup>th</sup> century. The homestead appears to be associated with the system of small field enclosures to the west, which are now only vaguely discernible, and may have its origins in the lease of poor-quality land to tenants.

Plate 9 – The remains of the eastern settlement building (PRN 44813), from the west

An overall management strategy for the wooded area, which should be based around the reinstatement of the public rights-of-way and include selective tree and vegetation clearance, and consolidation, could be extended to take in the site of the homestead. It could be cleared of vegetation, the walls made good and maintained as a visible feature.
