Garn Farm W/12/1728

Tir Gofal Farm Visit Historic Environment Report

Report No. 2003/52

CAMBRIA ARCHAEOLOGY

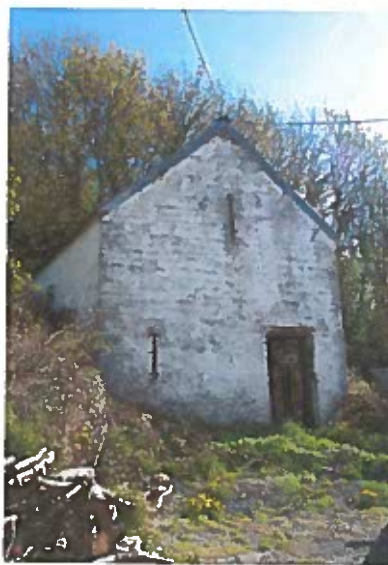
This building is in good condition, and there are no obvious management threats, though brambles and undergrowth growing on the bank by the northwest wall will need to be kept in check to ensure that no climbing plants can penetrate into the stonework. Future repair works should utilise appropriate traditional materials and it should be ensured that the roof is kept weatherproof.

Plate 1. *The south elevation of the barn (PRN 47800) showing the narrow ventilation slits which splay to a wider opening on the inside.*

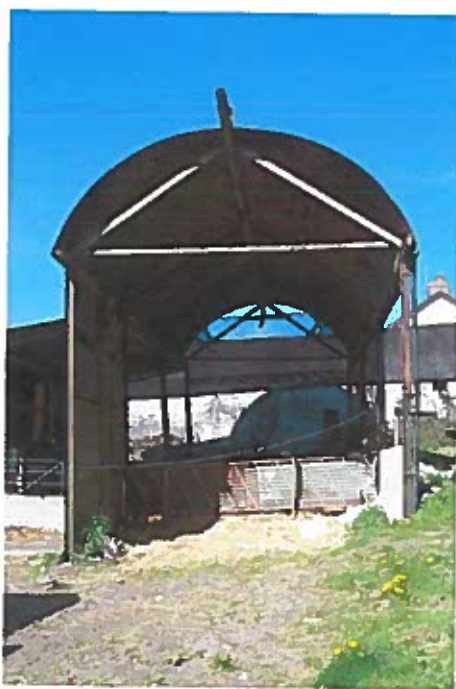
The building itself is in good condition, and in use. There are no immediately visible management issues, and the haybarn should be maintained in its current condition. The pit to the northwest which contained the pulley or mechanism for moving bales is heavily overgrown, and will shortly become invisible. Vegetation should be cut back in this area to ensure that this feature is not lost. Work should be done by hand to avoid damaging the depression itself, or any stonework which may survive in the area surrounding it. Roots should not be dug or pulled out, but should be spot-treated if necessary, to prevent re-growth.

Plate 2. The haybarn (PRN 47801) which originally had a horse-powered mechanism for moving bales.

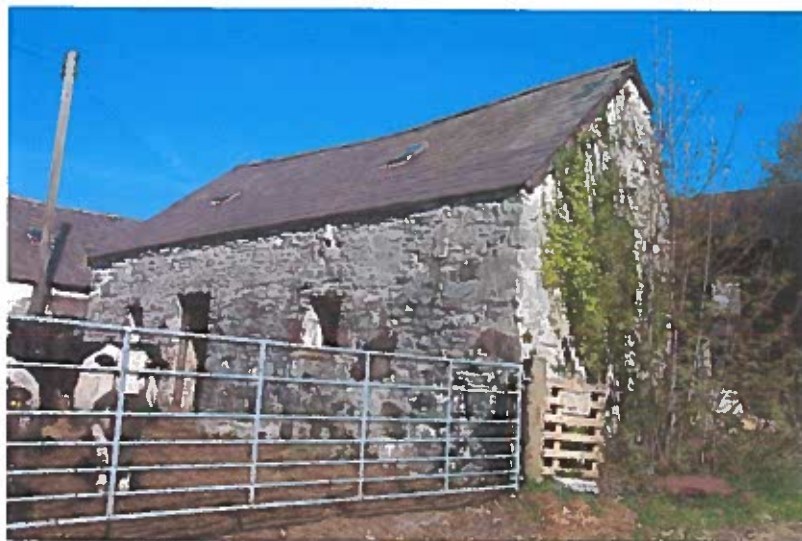
This building is in fair to good condition, and is in use. Future maintenance should ensure that the building remains weatherproof, and appropriate traditional materials should be used in any repairs which are carried out. Some ivy is beginning to grow on the east end of the building, and this should be cut back before it has a chance to damage the stonework. If necessary, the roots can be treated to prevent re-growth.

Plate 3. *The cowshed (PRN 47802) which was converted from a house or cottage (PRN 47807). The southeast corner (in the foreground) has been modified to incorporate what was previously an external chimney. The south elevation, seen in this picture, gives an impression of what the house may have looked like.*

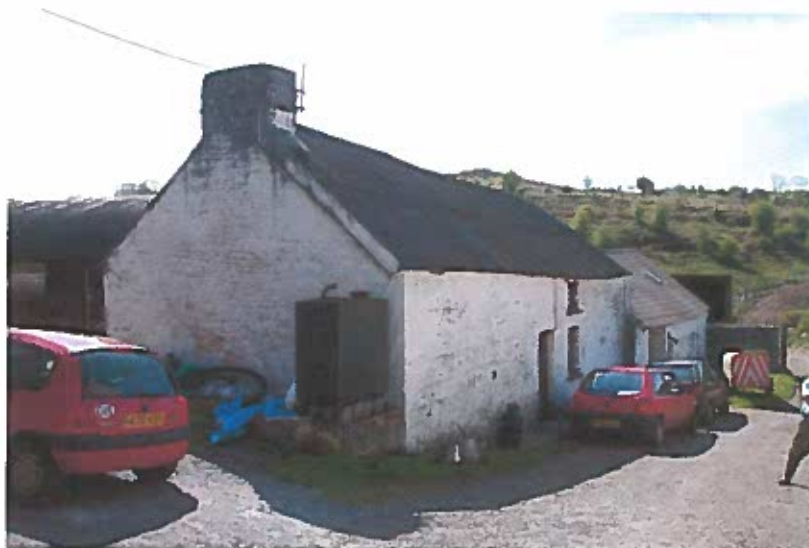
This part of the building is in fair condition and is slate roofed. It is unclear whether the surviving roof timbers are original, or have been replaced at some point in the building's history.

Plate 4. The old farmhouse (PRN 47805) is in the foreground with the attached animal byre (PRN 47804) in the background.

Although the masonry of the house seems to be in good condition, there are a number of serious problems which need to be addressed. The house is now covered with a corrugated iron roof which is beginning to lift. Both the stairs and the floorboards upstairs are unsafe in places, although it is still possible to access both of the upstairs rooms. The visible cruck trusses seem to be in good condition, although other roof timbers have been supported with modern poles and additional pieces of wood. Further details of the house, such as wall plaster and window frames, are in danger of being lost through weathering and damp.

It is essential that this building is kept weatherproof to preserve the internal walls and features. Although the corrugated iron roof has largely kept the water out, this may soon need to be

replaced. When this work is carried out, it is recommended that the new roof has a larger overhang, in order to ensure that water does not run-off onto the walls. Rotten or unsafe floorboards and steps should be replaced, so that access can still be gained into the upper storey. In the longer term, large scale restoration works need to be undertaken in order to reinforce or replace weakened roof timbers, and eventually to re-roof the building. Additional support for the upper storey may also be necessary, depending on the condition of the beams supporting it. The internal walls appear to be in fair condition at the moment, but would deteriorate rapidly if they were exposed.

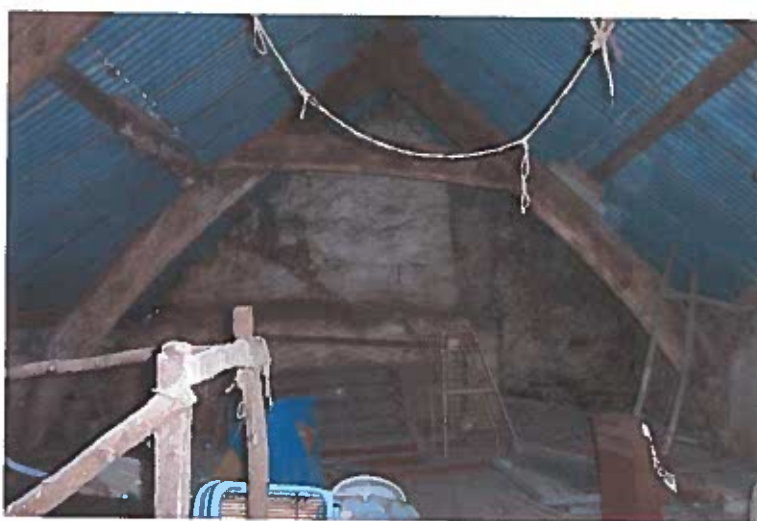
Upstairs the structure of the house is clearly visible. The roof is supported on upper cruck trusses which appear to be in good condition. A wattle partition wall separates the upper storey into two rooms, and there is also a wattle wall at the base of the staircase. An upstairs fireplace, now blocked, can be seen in the north gable wall. A wooden hook protrudes from one of the roof beams. The owner informed Cambria Archaeology that originally there were no stairs, and access to the upper storey was up a ladder. The ladder could then be pulled up through the hatch and hung on the wooden hook. The south room of the ground floor now contains animal pens, and the north room is used for storage. The upper floor is mostly disused, or used for light storage. The building is difficult to date. The range is present on historic maps in the 19th century, but is probably substantially older than that. The 'house and byre' arrangement with an internal connecting door and a structural break between the two parts of the building is typical of Carmarthenshire homesteads in the sub-Medieval phase, beginning in the mid-late sixteenth century (Smith, P:1988:p.201).

Plate 5. *The upper storey of the old farmhouse (PRN 47805.) One of the upper cruck trusses which supported the roof.*

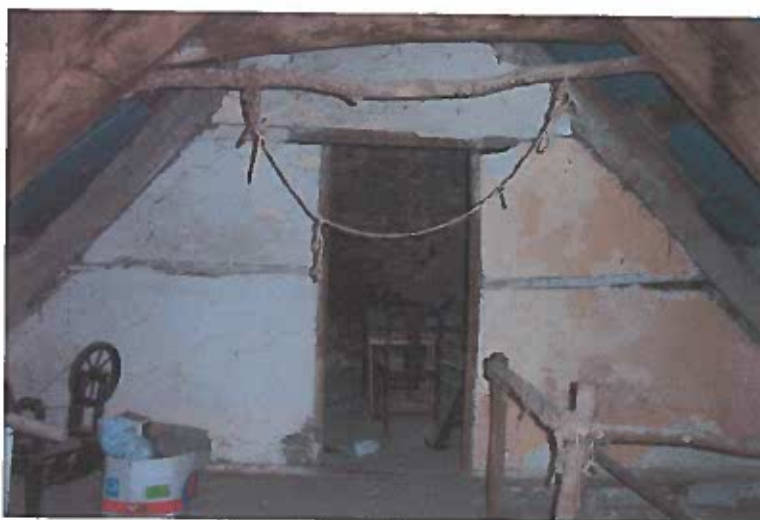
Plate 6. *The upper storey of the old farmhouse (PRN 47805). An interior partition wall. The plaster is beginning to fall off at the base of the left door post, revealing the wattle structure of the wall.*

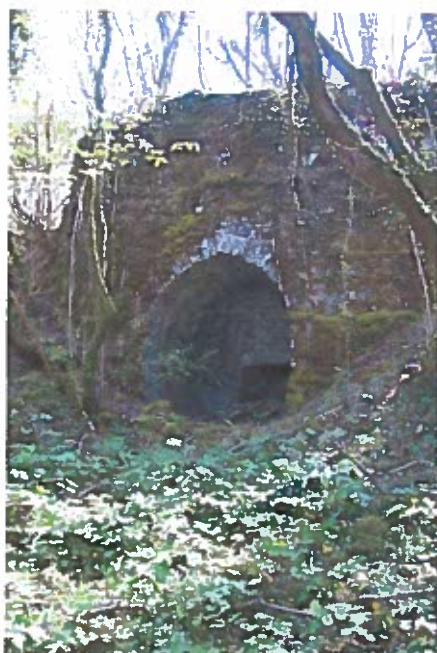
A limekiln in good condition, with a pointed drawing arch and the kiln eye visible. The arch is around 2.2m high and 2m wide, and the masonry is generally in fair condition, although some of it has been penetrated by vegetation and tree-roots. Inside the drawing arch, a timber with scorched edges lies on the floor. This may have been a lintel, though it is unclear where it has come from. The top of the limekiln is on the north edge of the floor of a massive quarry (PRN 22233). Both the parapet and the crucible are still visible as earthworks, with coppiced trees growing from within the crucible. The top of the limekiln is about 6m in diameter.

Plate 7. *The well preserved drawing arch of a limekiln (PRN 27778) with the kiln eye visible inside.*

The primary threat to the limekiln comes from vegetation. It is clear that the land-owners have periodically cleared saplings and vegetation from the limekilns, and this should continue to be done. Although the masonry is generally in good condition, there has been some internal collapse just above the kiln eye. This stonework may need to be re-pointed, using an appropriate lime mortar. Areas where vegetation has been removed from the limekiln may also need re-pointing.

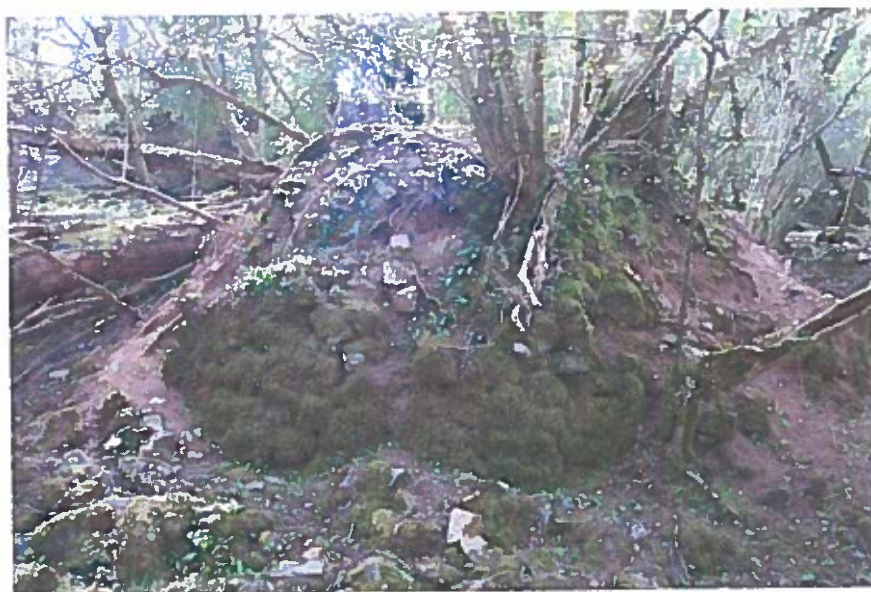
Plate 8. *The remains of a limekiln (PRN 27859) with some faced stone showing in the foreground. The fallen tree in the background has brought up substantial amounts of building rubble with its roots.*

The coppiced trees growing on the top of the site should be cut back to ground level and, if necessary, treated to prevent re-growth. Unstable larger trees should also be removed.
