# **A WATCHING BRIEF AT ST ELIDYR'S CHURCH, LUDCHURCH**

Report No. 2001/17

REPORT NO. 2001/17  
PROJECT RECORD NO. 42305

JANUARY 2001

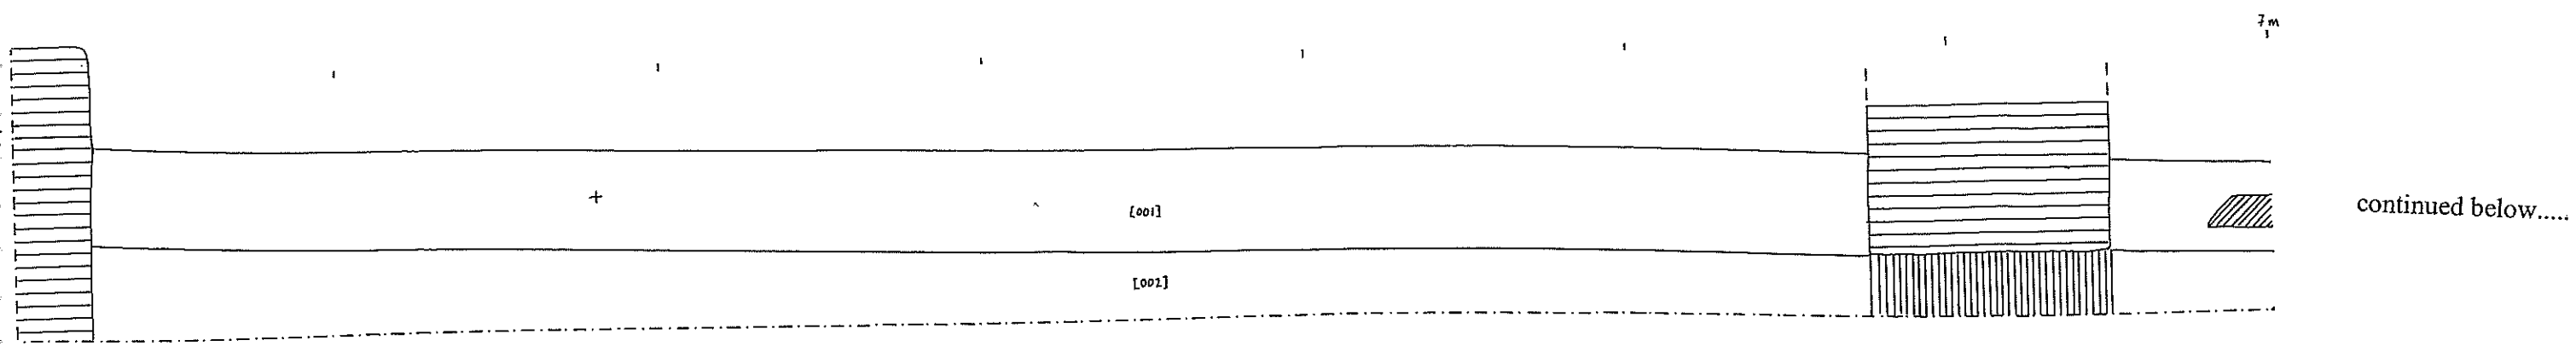
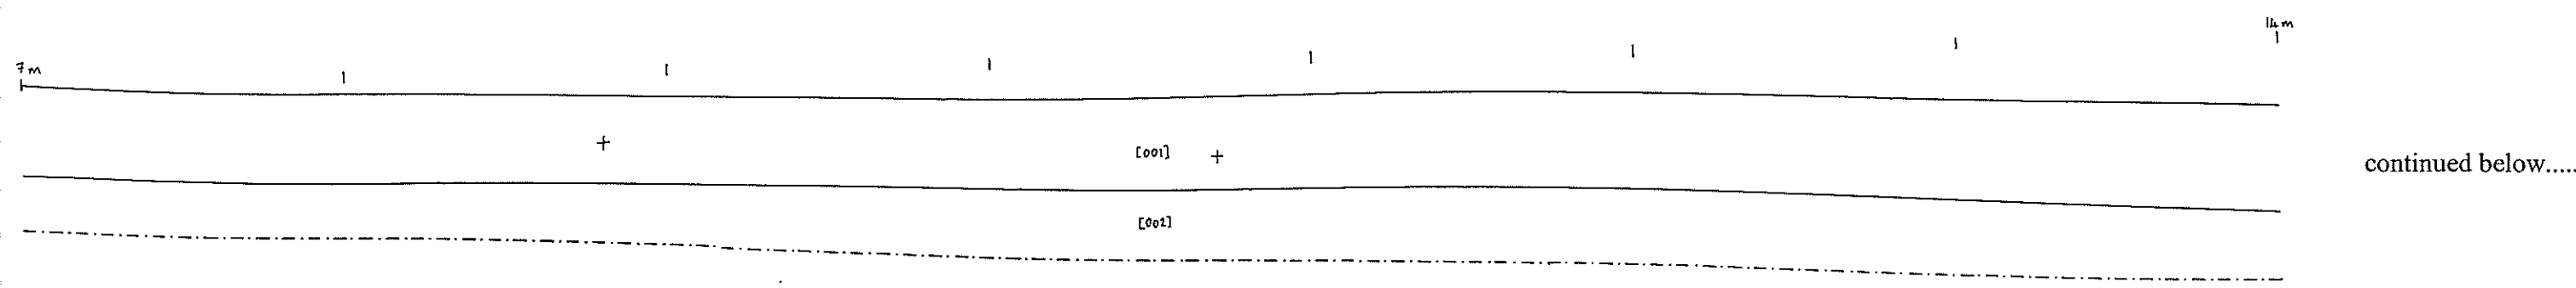
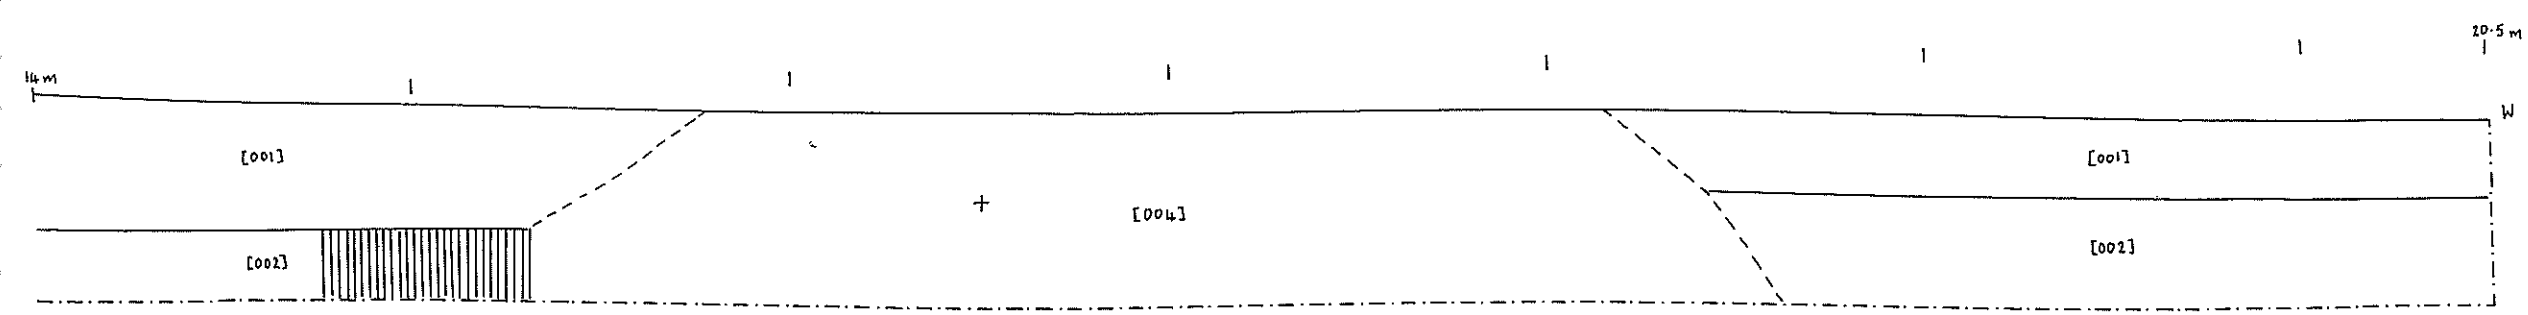
Figure 4 - section 2 - north-facing section, scale 1:20.

The exposed sections of the hand-dug trench (Figs. 4 and 5) revealed several discrete clusters of fragmented and disarticulated human bone. These were not associated with any grave markers or cuts and all appeared to have been disturbed by previous groundworks around the perimeter of the church. None of the bone was associated with any dating evidence although there were occasional coffin nails in the topsoil, which presumably relate to former graves. The trench ran immediately alongside two memorial stones, but the disturbed burials that were recovered did not appear to be related to these. The gravestone in the southeastern corner of the trench was undated. The memorial stone to the south of the church was dated 1794 and dedicated to Esther, wife of William Saei(?).

The trench section along the southern wall of the church also revealed an area of disturbed ground (004) towards the western end of the wall. This disturbance could relate to the use of an earlier entrance to the church in the southern wall that was blocked in during the mid nineteenth-century restoration work. However, the disturbance was not associated with any dating material and no structural remains of the entrance were apparent in the trench. An earlier ceramic drain runs alongside the trench for its entire length and it seems more likely that the disturbance was caused by the installation of this post-medieval drain.
