CARMARTHEN CASTLE PHASE 3 INTERIM REPORT ON WORK UP TO OCTOBER 2001

Report No. 2001/53

REPORT NO. 2001/53
PROJECT RECORD NO. 42641

OCTOBER 2001

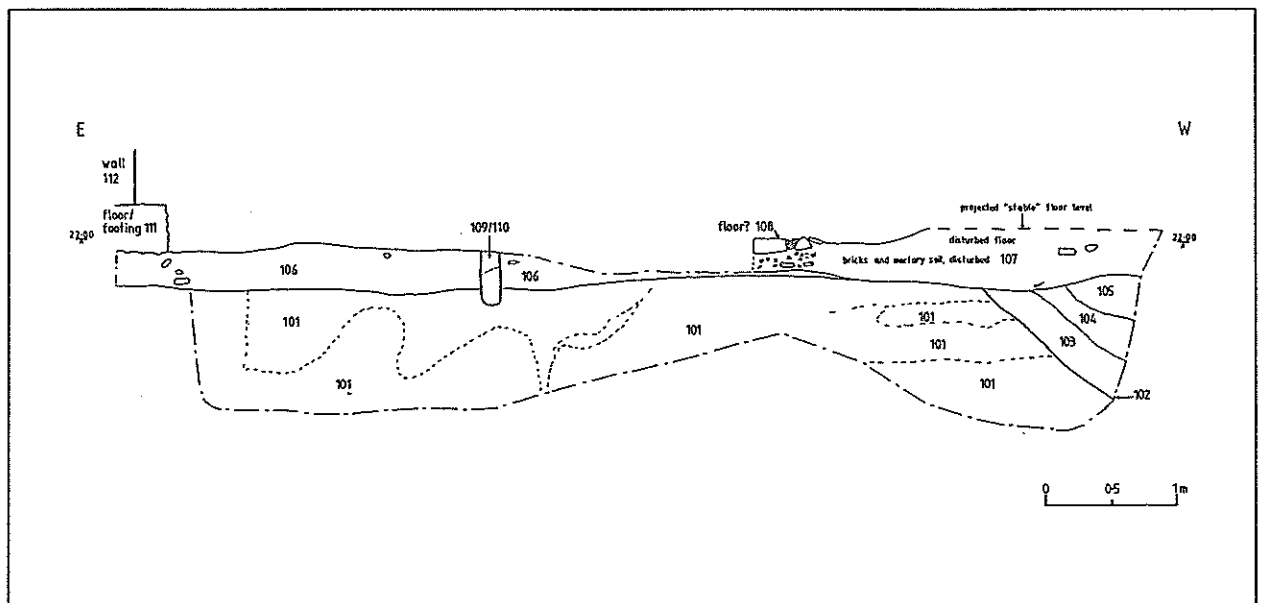
FIGURE 4: Rugby Club Trench 2 Section

Trench 2 (Figures 2 and 4) was again excavated to locate the Square Tower and curtain wall. It was machined to a maximum depth of 1m into similar natural deposits to that encountered in Trench 1 but with more gravel. These natural (101) deposits were cut 6.4m west of the east Rugby Club wall (102). This cut (102) was parallel to the projected curtain wall and appeared to be the edge of a ditch. Three fills (103, 104 and 105) of this probable ditch all contained mortar flecks and would not be inconsistent with late medieval or post-medieval deposits. Above the natural there was again a layer of brown clay loam (106). This clay loam was overlain by a mortary soil (107), which was disturbed, especially in its upper regions, and contained brick fragments, along with two sherds of post-medieval pottery. A floor (108) above this layer, although very disturbed, appeared very similar to that in Trench 1. A post-hole (109) and fill (110) cut through the brown clay loam (106). This post-hole fill contained a piece of wood and a nail, and appeared to be a modern deposit. The concrete floor and footing (111) appeared to be the same deposit, and the Rugby Club wall (112) had then been constructed upon it.

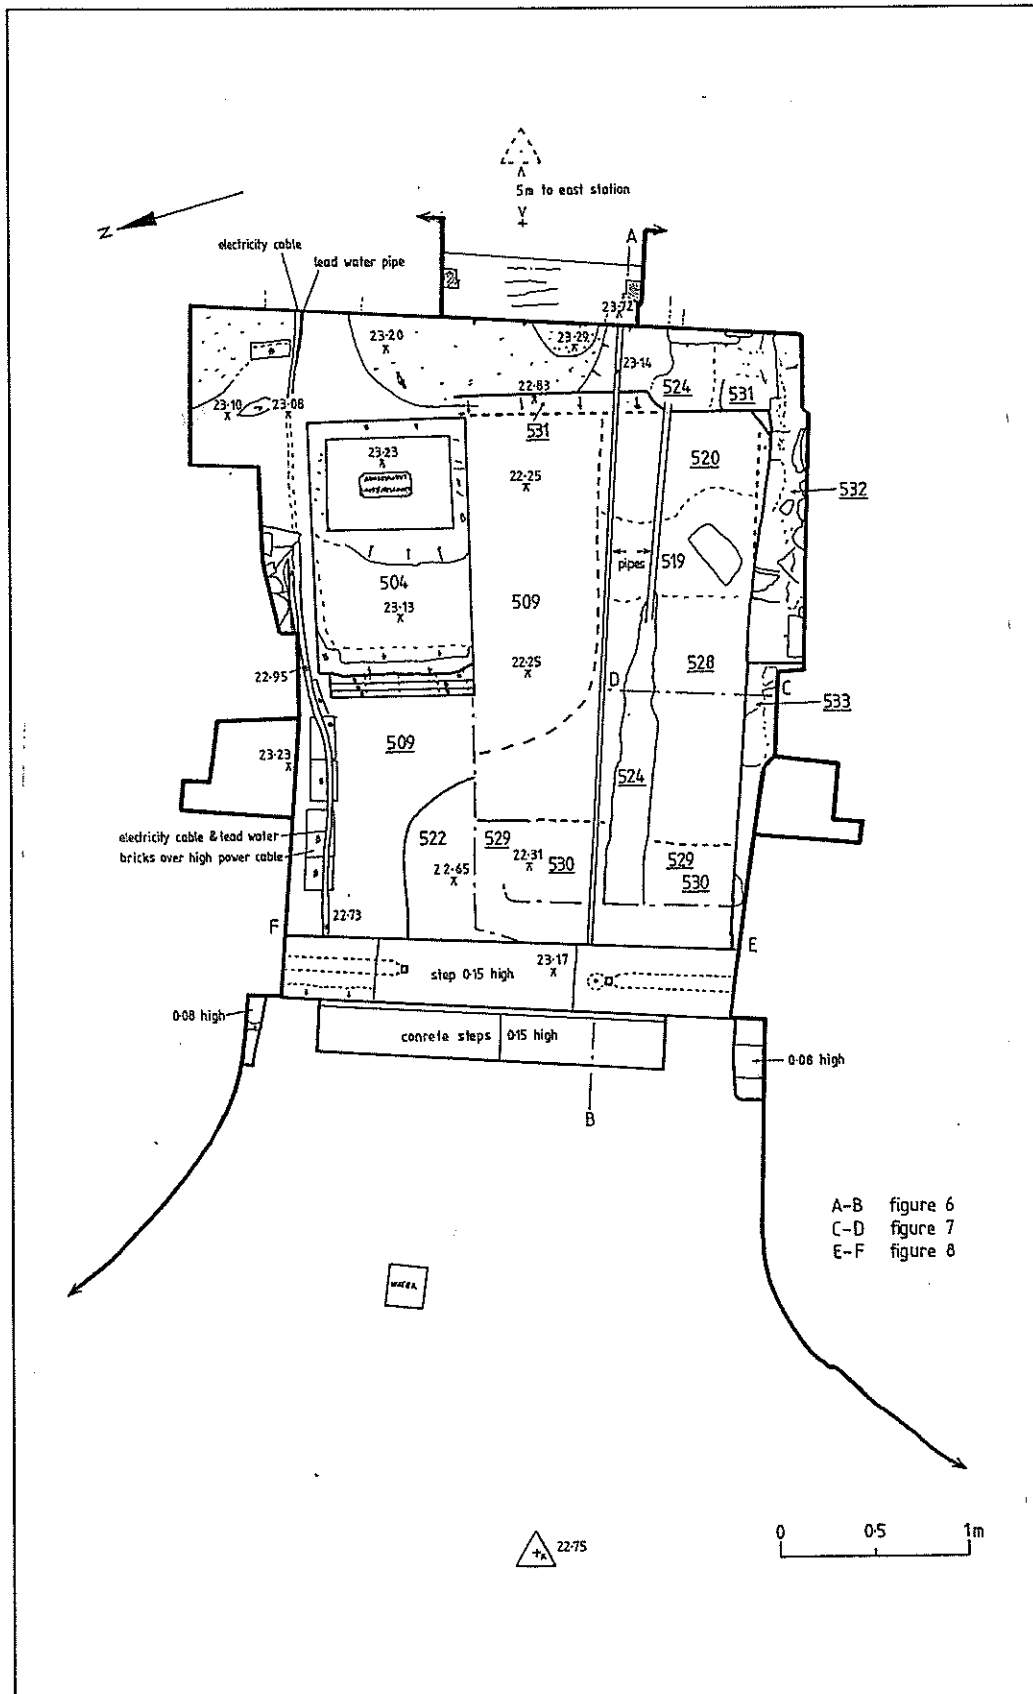
FIGURE 5: Gatehouse Passageway

The earliest features encountered were walls (or wall footings) on the east (531) and south (532 and 533) sides of the excavation (Figure 5). The sequence in which these walls were constructed is uncertain. At the junction in the southeast corner the upper part of the walls (531 and 532) had been disturbed by a service trench and lower down there was an angled stone at the junction (Photo 6). On the south side there was a vertical butt joint between the walls (532 and 531 - Photo 7). All of the walls or footings had good faces, mostly of red sandstone. Bonding of all the walls was sandy soil - that of the east wall (531) and the adjacent southern wall (532) was very similar. The east wall (531) had a battered face (Figures 6). The westernmost of these walls (533) had lime mortar pointing. Although this wall had a modern patch towards the front, its style suggests that it may predate the wall section (532) to the east.

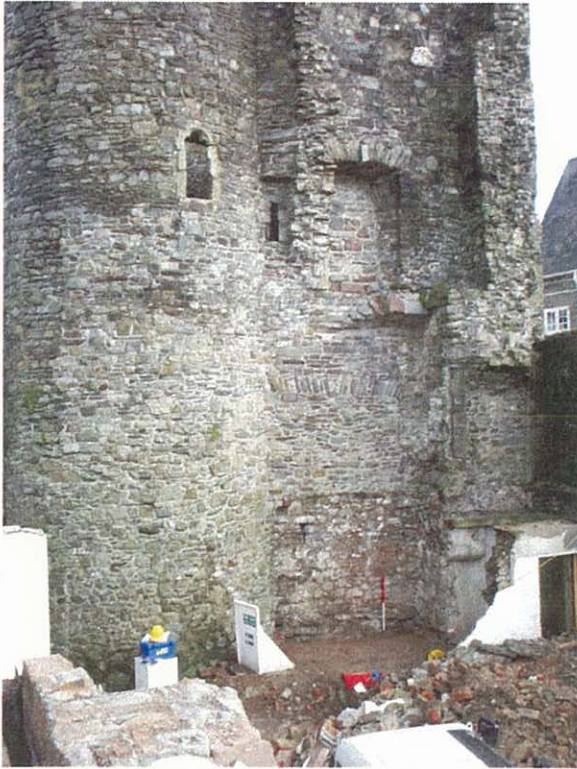
Part of the lower exterior of the south side of the Gatehouse had been covered with hard cement render. It was considered that this might have covered later blockings into the ground floor, as found in previous work on the Square Tower and the Southwest Tower. However, this was not the case and the render simply covered medieval and post medieval stone walling (Photo 1).

Photo 1: Gatehouse south site with render partly removed, view NNE, scale 1m

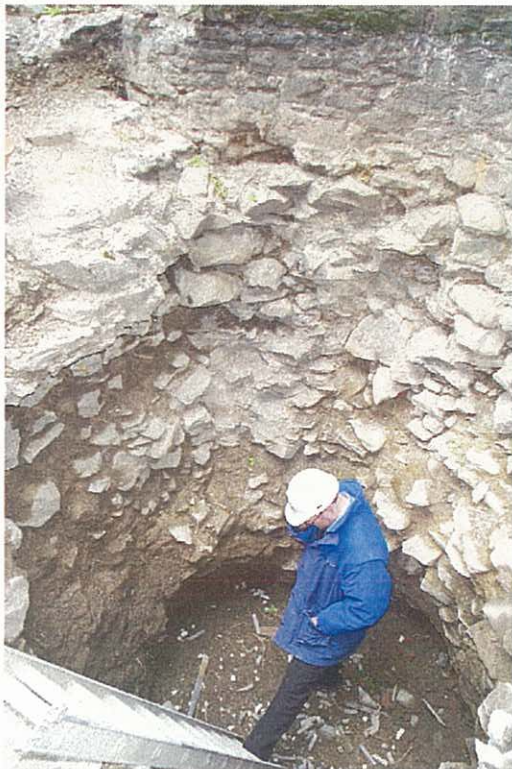
Under an intermittent watching brief the contractor proceeded to empty the interior of the north tower. This was filled with loose, mortary soil containing stones, brick fragments, a little animal bone and one clay pipe bowl of 18th – 19th century date. A few voids were encountered within the fill, one of which was over 1.2m deep. The excavation within the tower did not proceed as expected, as the interior had no internal face but was an irregular hole surrounded by rough masonry (Photo 2).

Photo 2: Gatehouse north tower irregular hole partly excavated, view SW

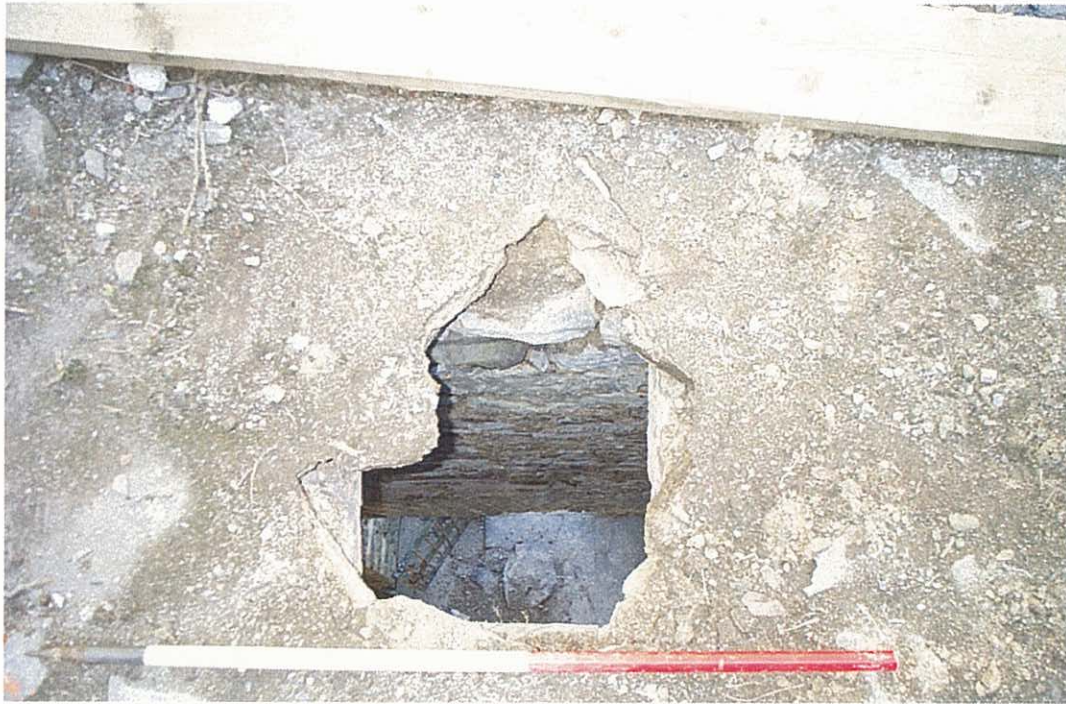
There was a large crack extending up the north side of the north tower, which was photographed before being consolidated by pinning. As the scaffolding was being dismantled a pole was dropped onto the first floor level where the portcullis slot had been covered with stone slabs. A slab broke leaving a 0.5m size hole (Photo 3) and the debris descended 6.5m into the gatehouse passageway, further cracking its concrete surface.

Photo 3: Gatehouse collapse into passageway, view W, scale 1m

The watching brief on the removal of material from the first floor of the Gatehouse has shown that both towers have been infilled with rough masonry at a later date. This was probably to consolidate the towers to resist cannon fire in the period of the English Civil War. This masonry should be preserved as it forms part of the historic fabric of the building. There is no dating evidence for the irregular hole through the rough masonry in the north tower but it would appear to be post medieval and a 19th century date is likely. This hole was probably excavated from the ground floor with access through an arrow slit, this slit being enlarged into a "window". Probably soon after the excavation of the hole, the "window" was blocked up with stonework and the hole infilled. Owing to their fragile condition, the stone slabs above the portcullis slot need attention.

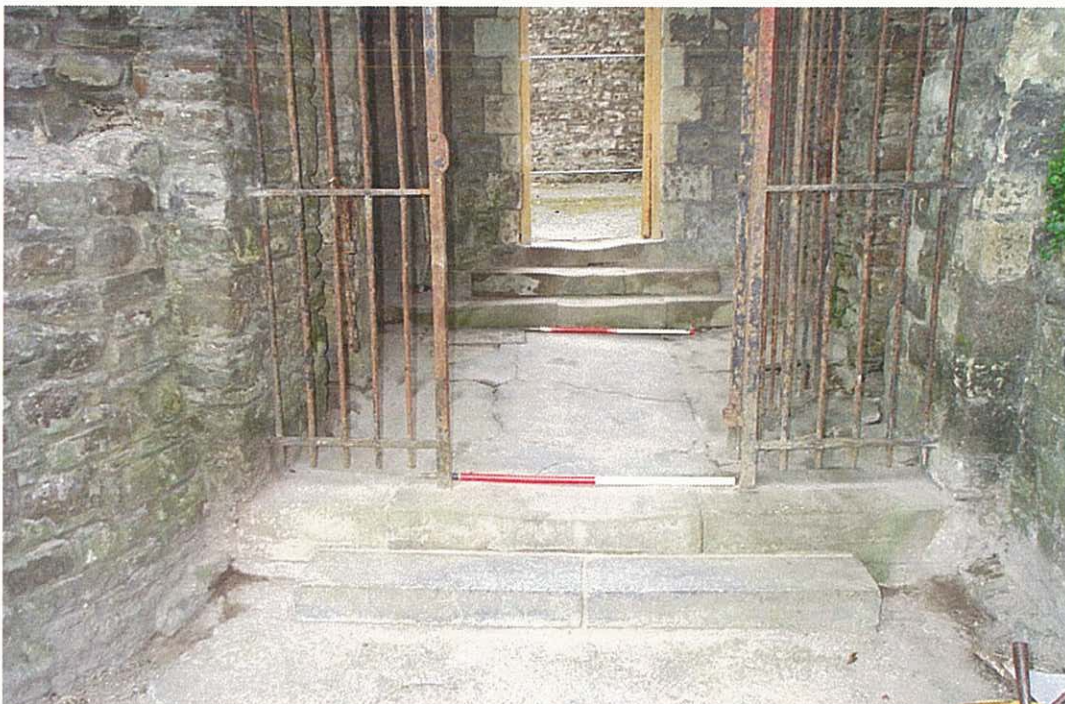
The passageway had been much altered from the medieval period, many of the walls being rebuilt and apparently poorly consolidated. The route through had two steps and railings with a gate at the front, and at the rear two steep steps with a further step into a doorway in a gaol period wall (Photo 4). The concrete floor surface was cracked (502) and contained a manhole cover (504).

Photo 4: Gatehouse passageway before excavation, view E, scales 1m

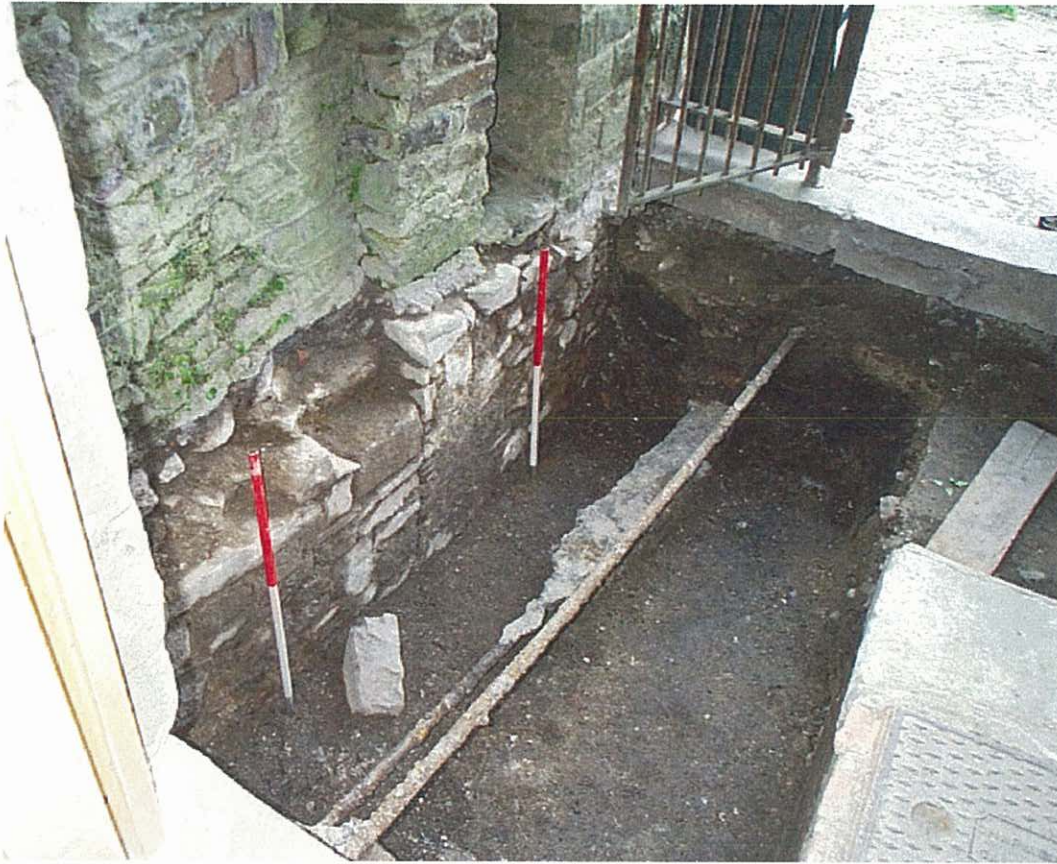
The concrete surface (502) was removed and proved to postdate the manhole construction (504). The interior of the manhole was voided down to c.1m to a soil fill. There were no visible pipes at that level. When the rear steps were removed, these showed wear patterns that indicated that some of them had been re-used. Above or associated with an electricity cable and below the rear step a self seal bag was found dated 23rd Feb. '90'. Owing to the presence of the manhole, a live water pipe, an electricity cable and a further live high power cable below bricks (Figure 5), excavation had to be restricted to the south side of the passageway. The depth of digging was halted at an artificial level c. 1.2m down (Photo 5), as all modern material

Photo 5: Gatehouse passageway as excavated, view SW, scales 1m

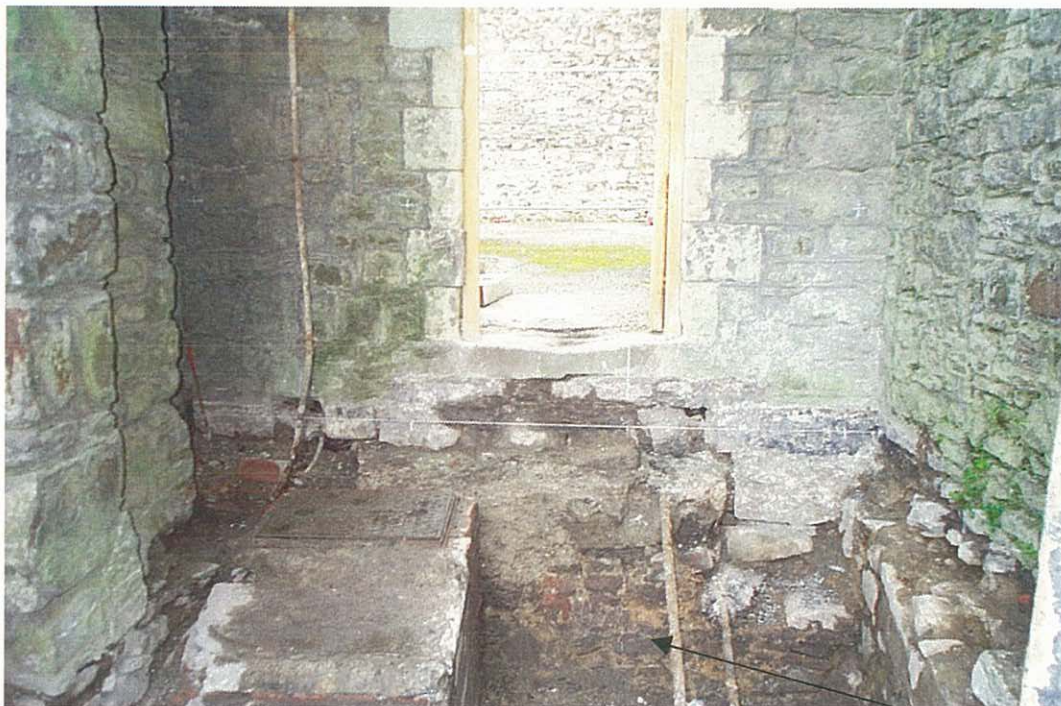
East wall 531

Photo 6: Passageway as excavated, view E
