CAPEL IWAN CRUGYGORLLWYN FIVE ROADS

WATERMAIN RENEWAL SCHEME

ARCHAEOLOGICAL WATCHING BRIEF

MARCH 1995

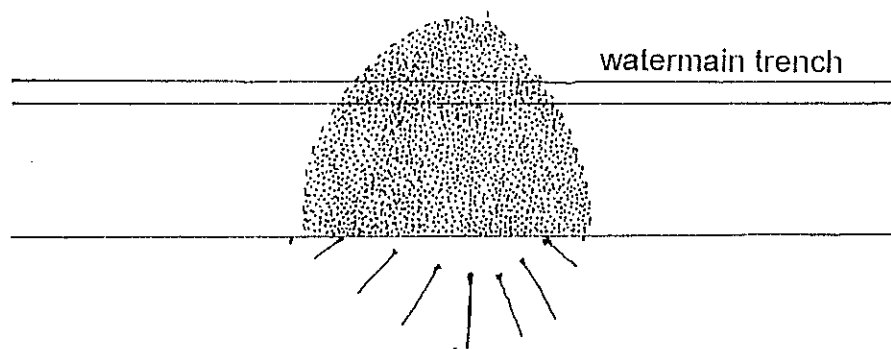
3.2 Burnt Mound 14954 (Fig 2)

A circular mound of small fragments of heat shattered shale and charcoal, originally 9m dia.: only the southern 3.5m of the mound survived the rest had been truncated during topsoil stripping and deep cutting the pipe trench.

The mound was positioned on the northern bank of the Afon Mamog, and when first recorded stood to c.1m in height (Murphy and Sambrook 1994, 7). The surviving section of the mound was only c.0.3m high.

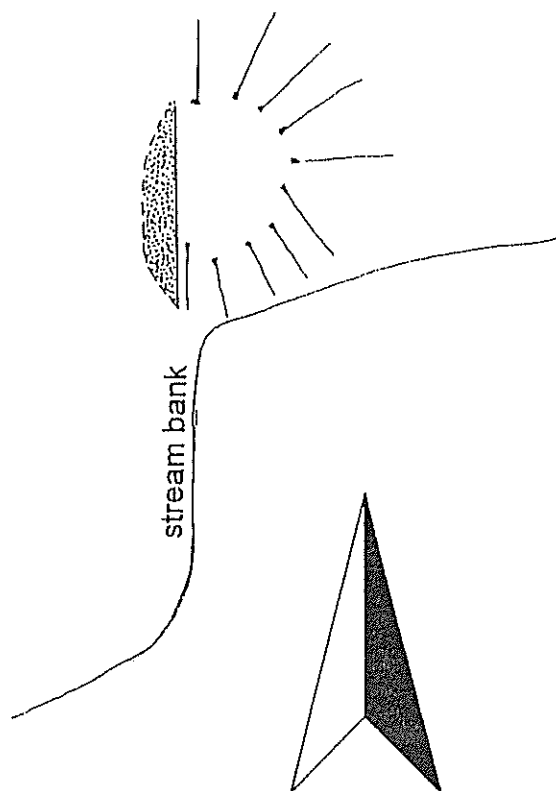
Fig 2:- Burnt Mounds 14954 (top) and 14970 (bottom)

3.3 Burnt Mound 14970 (Fig 2)

An ovoid mound of heat shattered shale and charcoal, formerly c.9m dia.. This mound had been truncated on both its southern edge and its west side leaving a surviving mound c.9m x 4.5m. The southern end had been eroded by the action of the Afon Mamog, whilst the west side had been damaged during topsoil stripping.

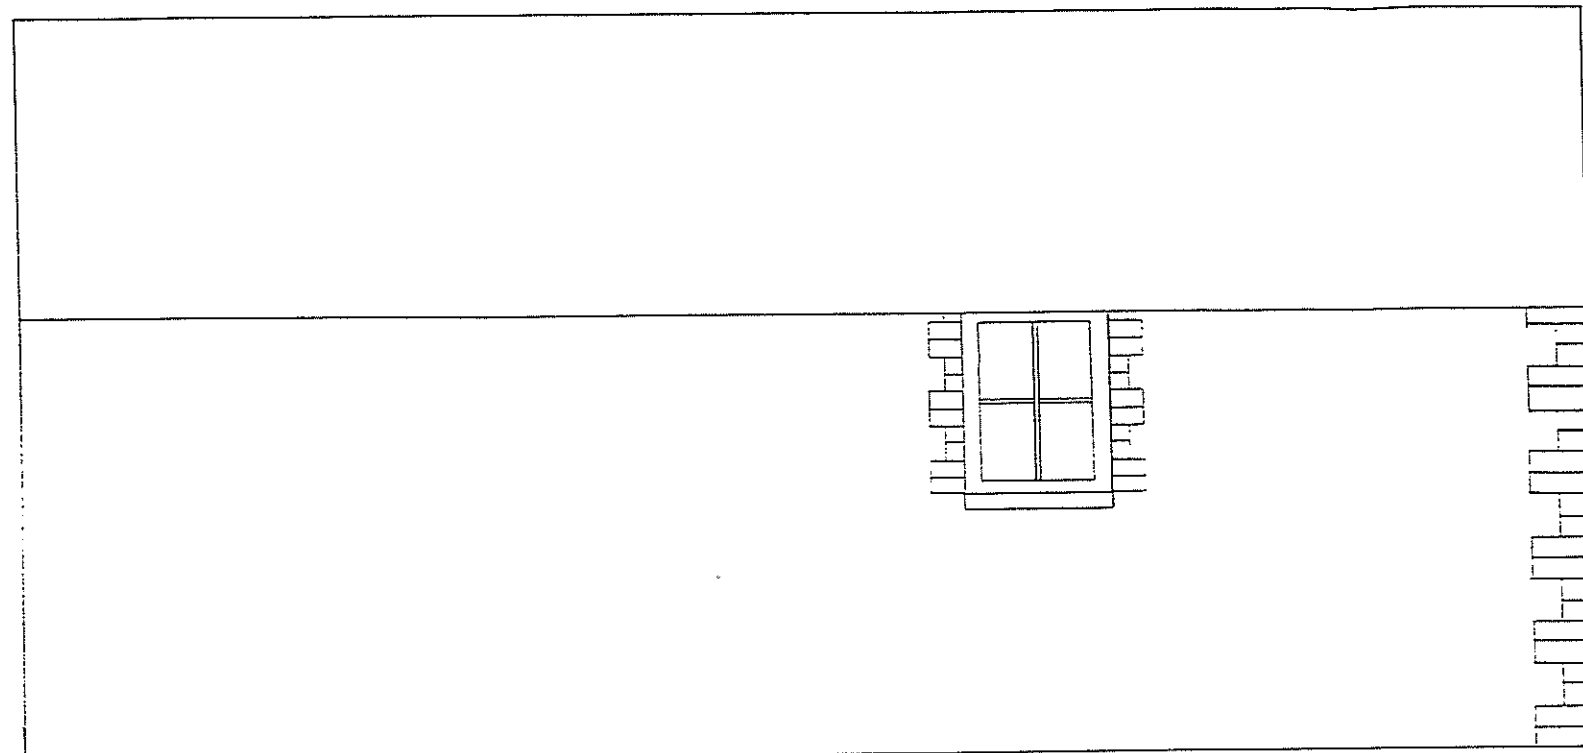
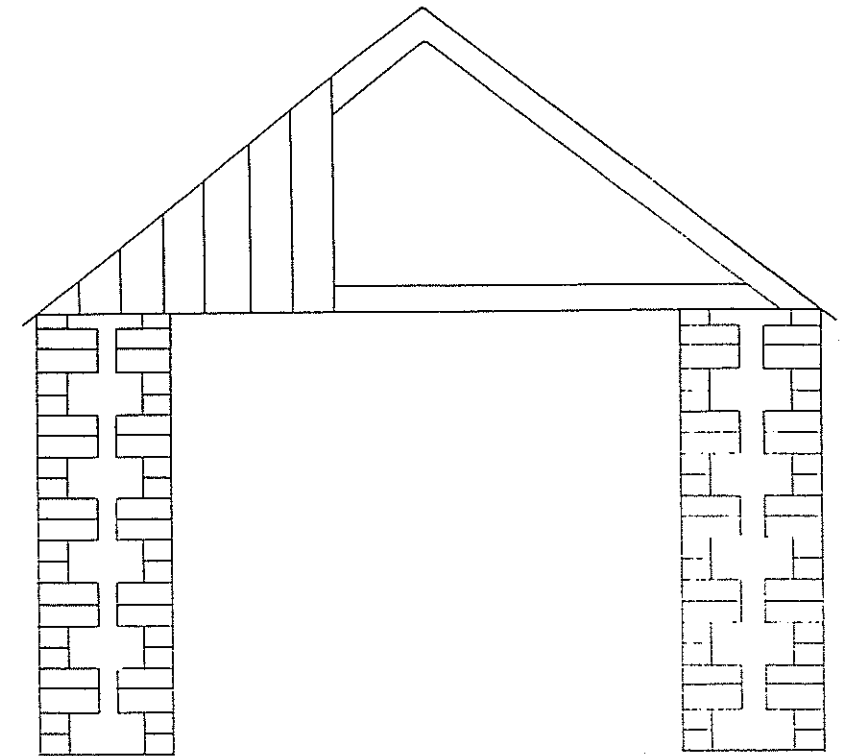
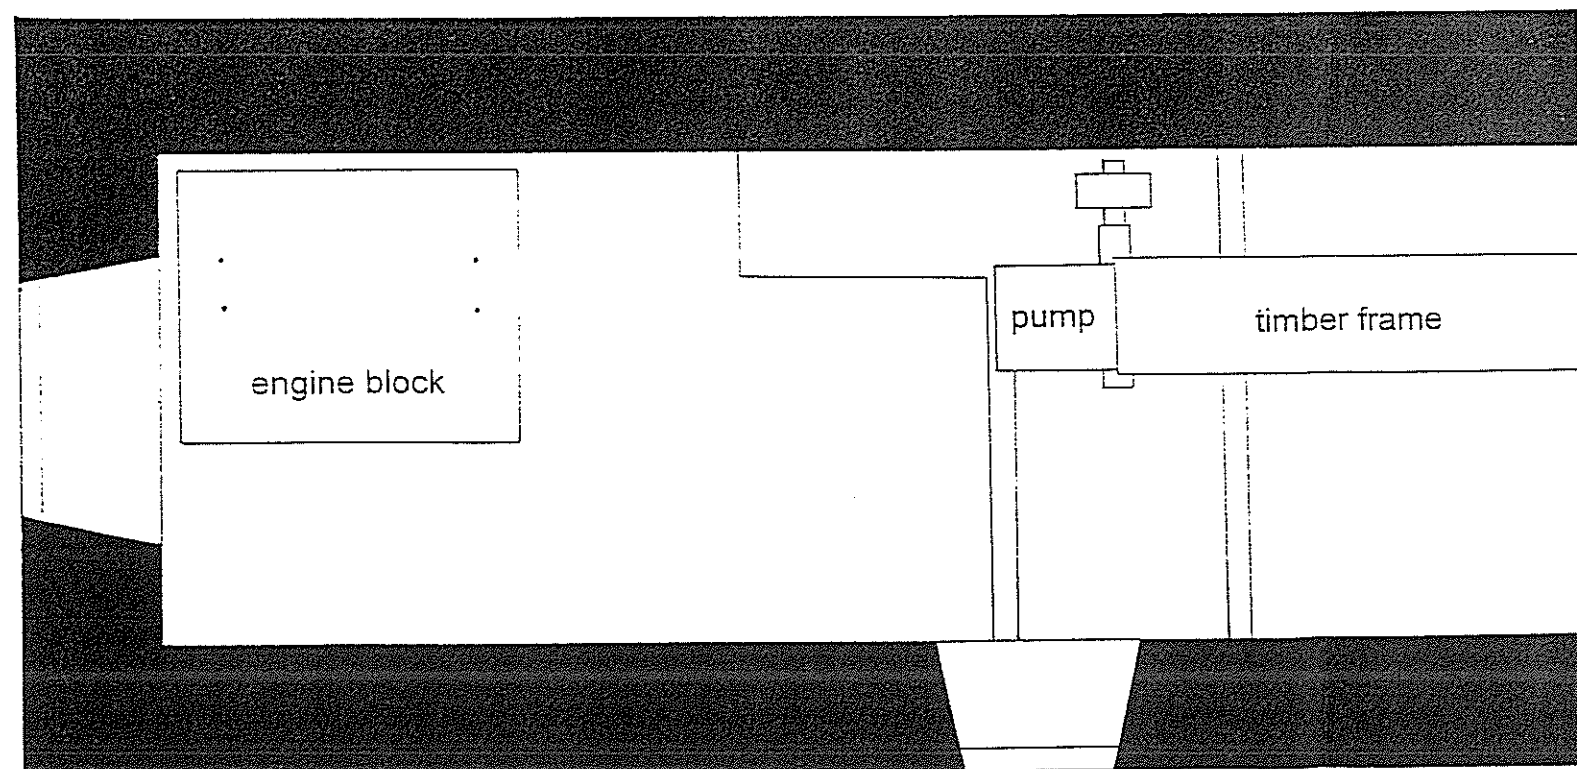
Fig 3:- Pump house

3.4 Pump house (Fig 3)

A stone-built pump house, 6.84m x 2.91m, built to house a water pump that supplied Gelynen Farm which stands on the slope above. The pump is still *in situ*, although now in a fairly rusted state. The water was fed through a 0.2m dia. metal pipe to the farm.

It appears that the pump was driven by a generator which stood on a concrete engine block at the west end of the building. The generator had been removed, but the four mounting bolts were still present, giving an indication of its size. A timber frame which contained the valve gear (operating wheels etc.) stood in the entrance. It appears to have

been necessary to have removed the right hand door to install this frame. The original left hand door was intact.

The excellent construction of the pump house shows the importance of a reliable and convenient water supply to those farms in locations which are difficult to service. Although a relatively small building it reflects a large investment of finance and labour in its construction. Internally it is still remarkably intact, with the pump and valve gear surviving, only the generator has been removed, presumably to work somewhere else on the farm.
