# **Gurnos** E/10/3036

# Tir Gofal Farm Visit Historic Environment Report

Report No. 2003/26

# REPORT NO. 2003/26 PROJECT RECORD NO. 44108

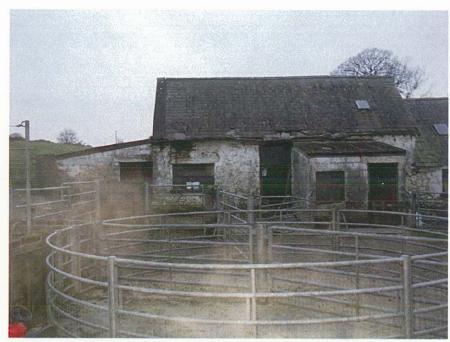
The roof of the building is currently in poor condition and is missing several slates. Ivy is becoming established under the eaves on part of the western elevation and threatens to create further damage to the roof structure.

Plate 1- the cart house at Gurnos (PRN 47371)

The cart house roof is currently in poor condition and is missing several slates. These should be replaced if the building is to be maintained in a stable condition necessary for its long term survival. The ivy, which threatens to damage the roof structure should be cut back and treated. Any vegetation removal should be undertaken as part of subsequent consolidation works using traditional materials and techniques. The guttering along the eastern lateral wall is becoming detached from the building and should be replaced in order to prevent water from running down the walls and damaging masonry bonds.

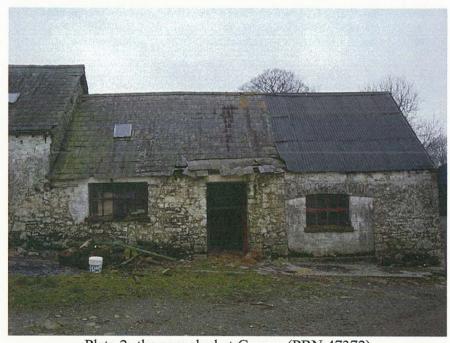
Plate 2- the cow shed at Gurnos (PRN 47372)

The roof of the building is currently in poor condition. It is missing several slates, and many more are unstable. Any missing slates should be replaced in order to bring the building back into a weatherproof condition. A hole has been made in the north gable end of the building, and is a potential area of structural instability. Ideally the hole should be infilled with rubble and repointed with a lime mortar mix.

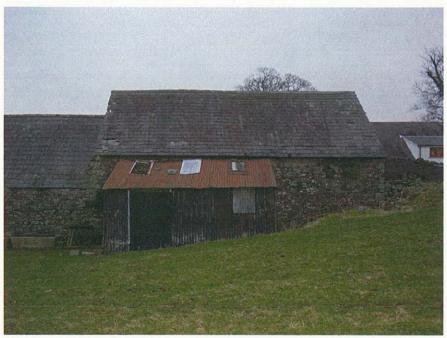
Plate 3- the engine shed at Gurnos (PRN 47373)

The lean-to is currently in an unstable condition. The rotten post footings are the largest single threat to building stability, although the roof supports are weakened and some of the corrugated iron roof panels are working loose. Increasingly structures such as this are lost. The lean-to makes an important historical contribution to the farmstead and should be retained in a stable condition if possible.

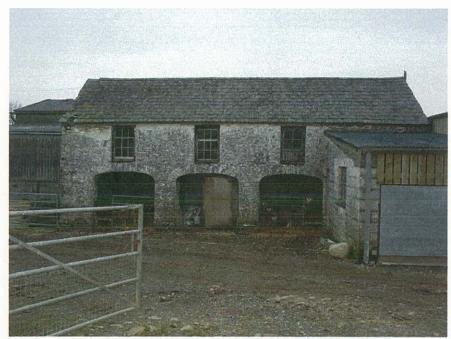
Plate 4- the cart house at Gurnos (PRN 47376)

The building is currently in reasonable condition, although some of the roof slates will need replacing if the building is to be maintained in a weatherproof condition. Masonry bonds in the

brick arches appear to have been eroded by water ingress and would benefit from repointing using a traditional lime mortar mix. The windows, which are an important element of the historic fabric of the building are currently rotten and in poor condition and should ideally be restored.

The building is currently in reasonable condition, although some of the roof slates will need replacing if the building is to be maintained in a weatherproof condition. Masonry bonds in the brick arches appear to have been eroded by water ingress and would benefit from repointing using a traditional lime mortar mix. The windows, which are an important element of the historic fabric of the building are currently rotten and in poor condition and should ideally be restored.

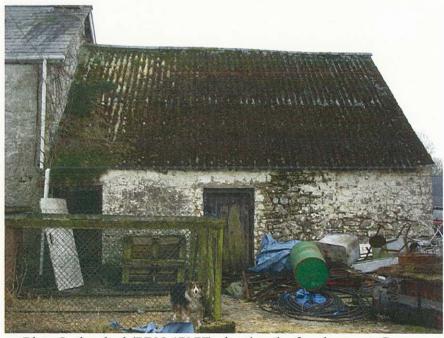
Plate 5- the shed (PRN 47377) abutting the farmhouse at Gurnos

The building is currently in reasonable condition, although there is considerable moss growth over the eastern pitch of the roof, which may be damaging the asbestos covering. Ideally this heavy moss growth should be removed. A large structural crack in the north gable end of the building is a potential source of building instability. This should be repointed using a traditional lime mortar mix in order to prevent water ingress from causing further damage to masonry bonds.

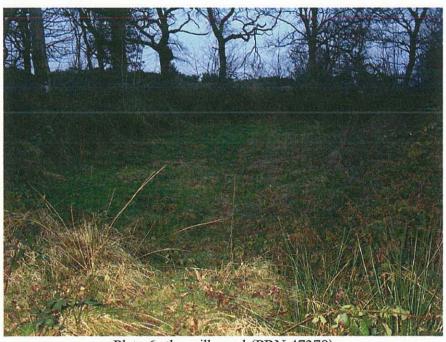
Plate 6- the mill pond (PRN 47378)

The pond is an important historic landscape feature. Vegetation should be kept under control in order to prevent root damage to the stone revetment walls and maintain the pond as a visible historic landscape feature. It should not be infilled and no ground intrusive operations should be undertaken in this area. Ideally the pond should be restored to its original form as a water-retaining feature.

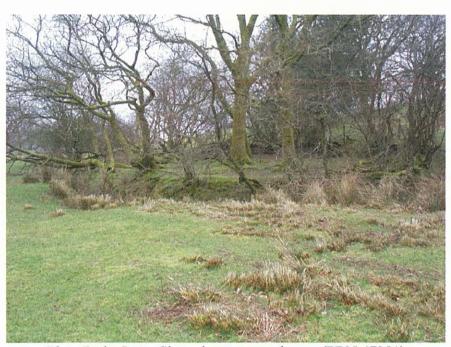
Plate 7- the Letty Shoned cottage enclosure (PRN 47381)

Although there are few visible remains of the cottage surviving, there may be archaeological deposits surviving below ground level. No ground intrusive works should be undertaken within the area of the cottage enclosure.

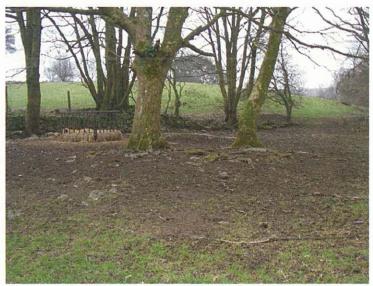
Plate 8- the cottage site at Cwm Du (PRN 47382)

Although there are few visible remains of the cottage surviving, there may be buried archaeological deposits surviving below ground level. No ground intrusive works should be undertaken within 15 metres of this area. The round feeder should be moved periodically in order to reduce poaching by livestock, which could damage sensitive archaeological remains.

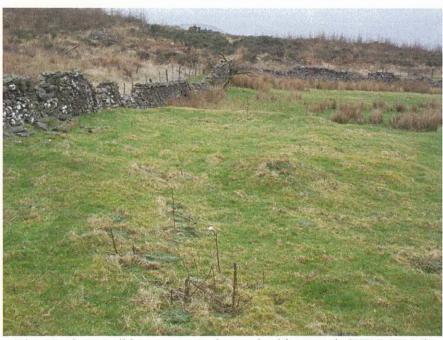
Plate 9- the possible cottage enclosure looking south (PRN 47384)

The enclosure is an important element of the historic upland landscape and should be maintained in a stable condition. The area within 15 metres of the edge of this site should not be subjected to any ground intrusive activity, and the area should not be used as a location for feeding livestock.

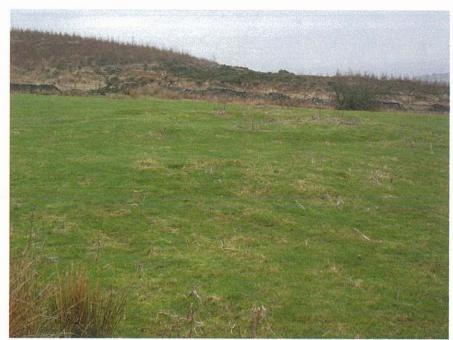
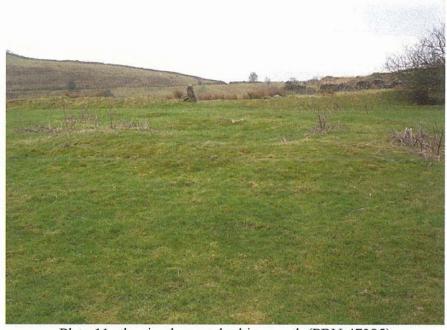
Plate 10- the ring barrow looking north-west (PRN 47385)

Plate 11- the ring barrow looking south (PRN 47385)

The ring barrow at Gurnos a well preserved example of its kind and a nationally important monument. The addition of an interpretation panel in order to explain the significance of this rare monument and the wider prehistoric landscape should be given careful consideration. The provision of educational access to this and other sites on the holding would also be welcomed.

The monument is currently under regularly grazed pasture and this is considered to be the optimum land use necessary for its long-term survival. The area fifteen metres around the edge of the monument should not be subjected to any ground intrusive activity or used as a location for feeding livestock.
