# **Gilfach E/10/3102**

## **Tir Gofal Farm Visit Historic Environment Report**

Report No. 2003/50

10<sup>th</sup> April 2003

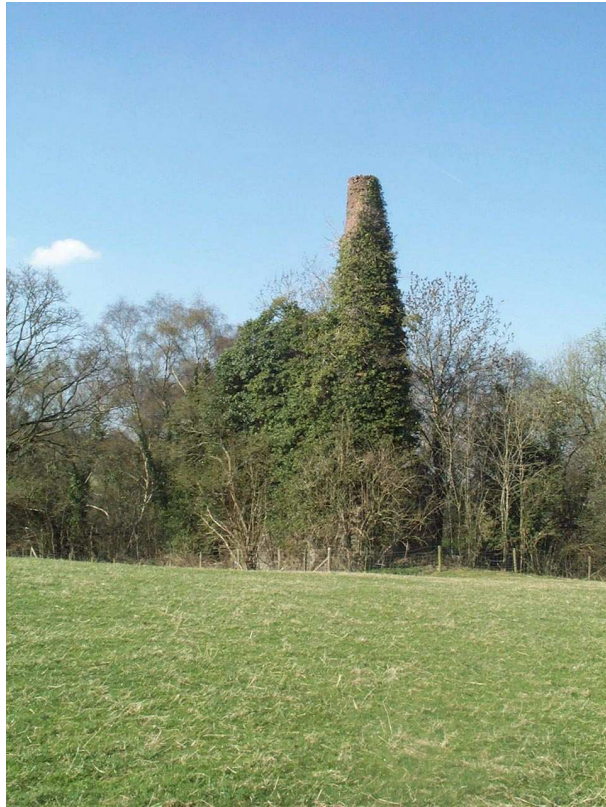
The engine house at Cae Sara is currently in a ruinous and unstable condition. The chimney stack and southwest elevation are almost entirely covered with ivy which continues to weaken masonry bonds, adding weight to an already weakened structure. The collapse of the northeast wall has taken away part of the base structure of the chimney, which is no longer self supporting. Water ingress, washing out lime mortar bonds will continue to undermine this part of the structure if stabilisation works are not carried out. Brickwork at the top of the stack is weatherbeaten and crumbling and needs replacing. A serious structural fault has been identified in the west side of the substantial southwest “bob wall”, which is being undermined by the engine shaft. The western part of this wall is now at diminished height and the apex of the central arch is now broken. Water ingress continues to erode lime mortar bonds here, further weakening the structure.

Plate 1- looking north towards the Cae Sara engine house (PRN 47659)

Vegetation growth continues to displace masonry, whilst water ingress is washing out masonry bonds, further weakening the structure. Acute threats are visible to the southwest where the structure is being undermined by the engine shaft, and to the northeast, where displaced stonework at the foot of the chimney stack threatens collapse. Specialists in building conservation and stabilisation will need to be consulted and their help enlisted if the structure is to be brought back into a stable condition necessary for its long-term survival.

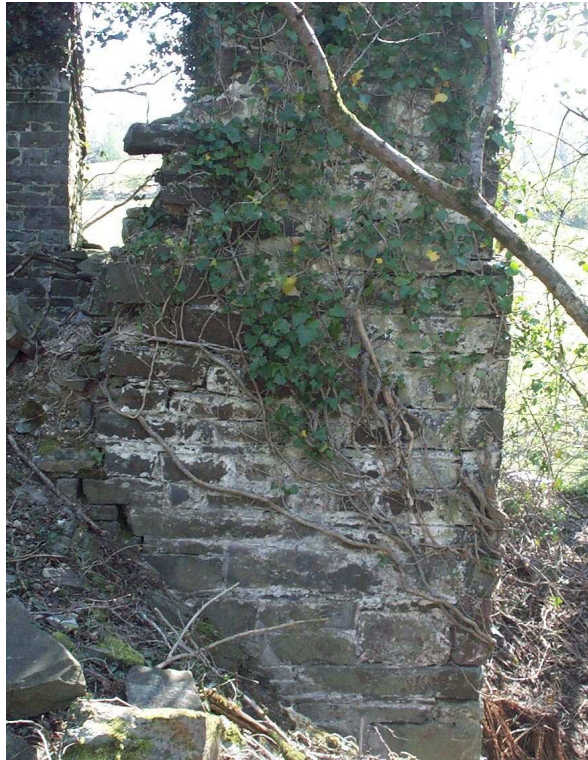
Plate 2- structural damage to the NW elevation of Cae Sara engine house (PRN 47659)

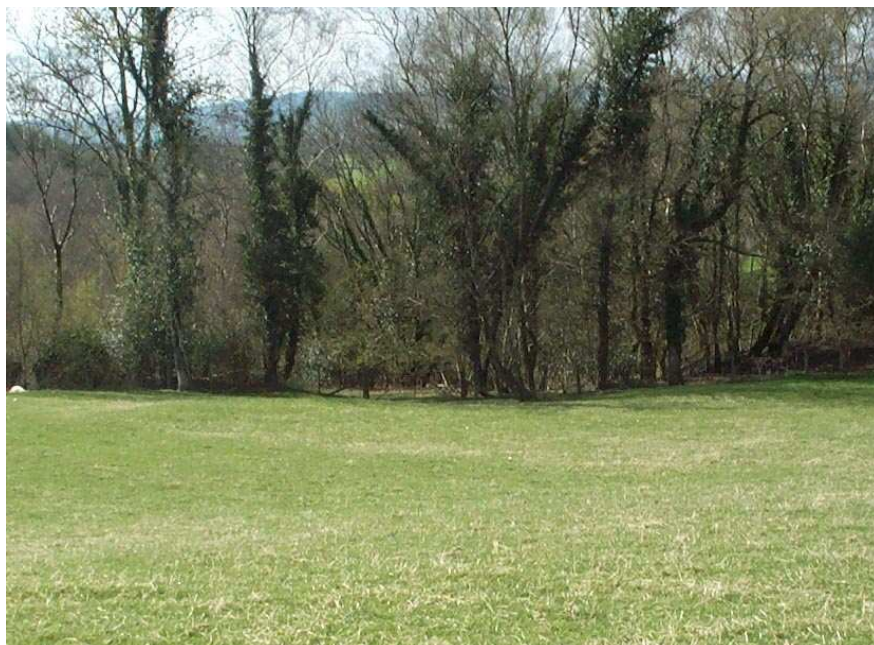
Plate 4- dressing floor (PRN 47662) looking west

No specific threats were identified from the current management regime. The area within 15 metres of the edge of this site should not be ploughed, subjected to any ground intrusive activity or used as a location for feeding livestock.

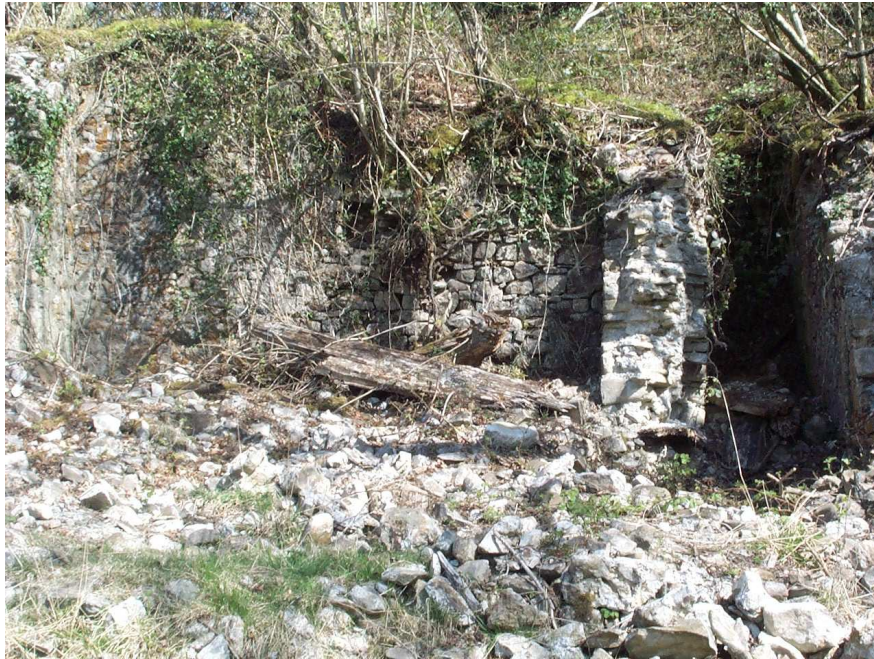
The crushing mill is currently in a ruinous condition. The rear (NE) lateral wall, which is terraced into the back of the hill survives at diminished height up to around three metres at its highest point. The side (SE and NW) walls have been almost entirely demolished, whilst the front (SW lateral) wall has been removed completely, and much of the stone has been removed from the site. The interior of the building is filled with building debris. No evidence for the waterwheel or any machinery apparatus was identified.

The crushing mill is currently in a ruinous condition. Young trees are growing out of the rear lateral walls and the southeast lateral wall and displacing part of the wall structure. Localised ivy growth is also a problem and threatens to damage masonry bonds and promote building instability. Ideally, the young trees and ivy should be cut off at the roots and spot treated to prevent regrowth. The ivy should be allowed to die, then removed. This should be followed up by a programme of masonry reconsolidation and repointing where necessary. Ideally the walls should be capped with a traditional lime mortar mix in order to prevent water ingress from further damaging masonry bonds and weakening the building structure.

Plate 5- SW elevation of possible crushing mill (PRN47664) at Cae Sara

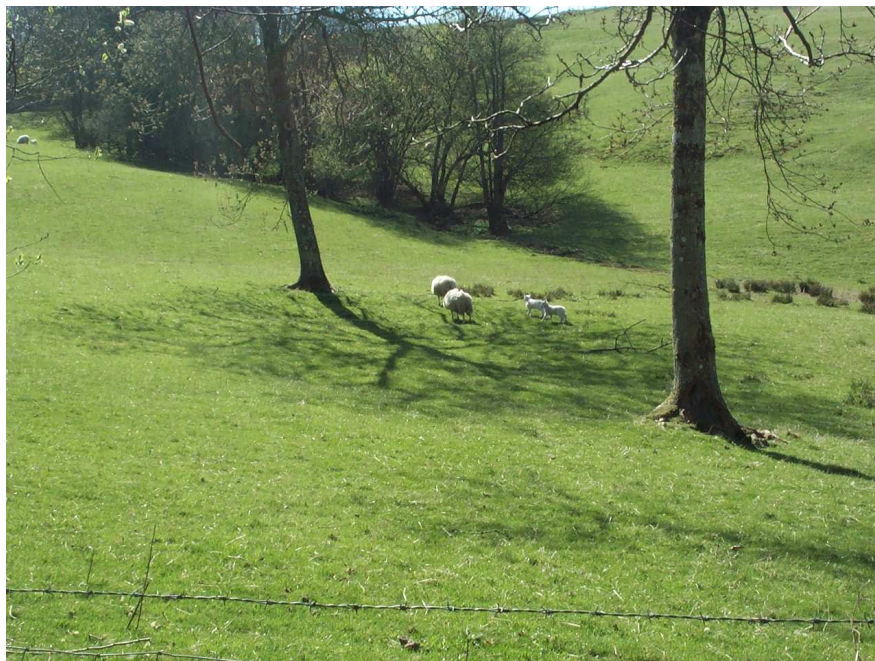
Plate 6- possible dressing floor (PRN 47668)

This should be preserved as a historic landscape feature. The area within 15 metres of the edge of this site should not be ploughed, subjected to any ground intrusive activity or used as a location for feeding livestock.

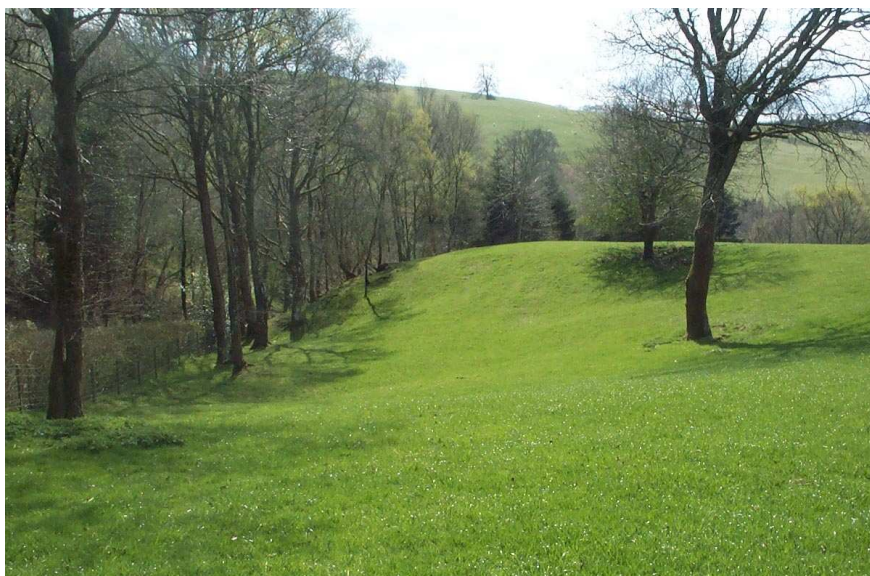
Cut into the side of a south facing slope opposite the engine house (PRN 47659), this former area of opencasting is roughly semicircular in shape measuring about 50 by 30 metres. Hall gives account that in 1851, when Henry Gibson restarted (the area) as the Great Welsh Silver Lead Mine- “very rich ore was found at a shallow depth, one block weighing a quarter of a ton before being sent to London for inspection” (Hall, G.W. 1993: 32). The tops of *lodes* were often initially worked to a shallow depth in this way forming an opencast mine before the point came when drainage was necessary. At this point *adit* or drainage levels were driven in from the lowest point to follow the *lode* or reach it. Shafts were sunk on the *lode* or to intercept it far below. This process is visible at Cae Sara, where three shafts (PRNs 47670,47671,47672), now collapsed remain visible as shallow depressions (up to around two metres diameter) in the ground surface at intervals approximately 18 metres apart.

Plate 7- opencast area (PRN 47669)

The opencast area should continue to be maintained as a visible historic landscape feature. It should not be infilled. No ground intrusive activities should be allowed to take place within 15 metres from the edge of the site.

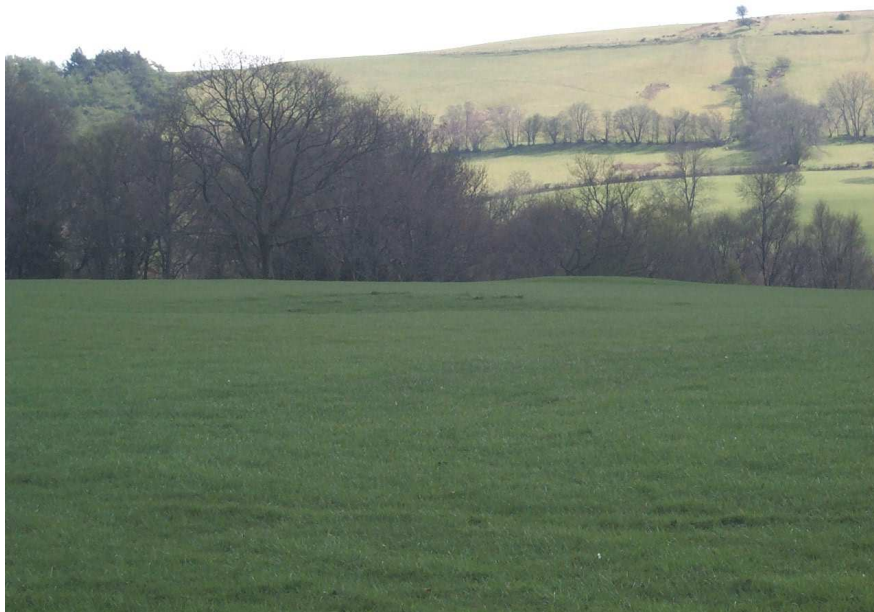
Plate 8- shaft (PRN 47672)

Today the shaft is identified as a shallow depression in the ground surface approximately two metres in diameter. A low spoil deposit, several metres across was observed to the northwest of the shaft.

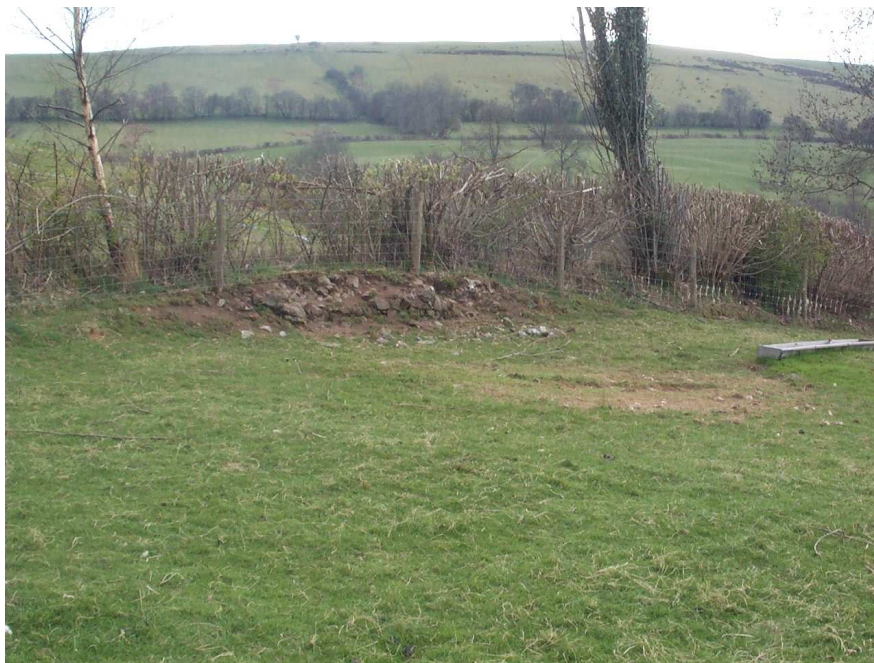
Plate 9- looking east towards mine building (PRN 47674)

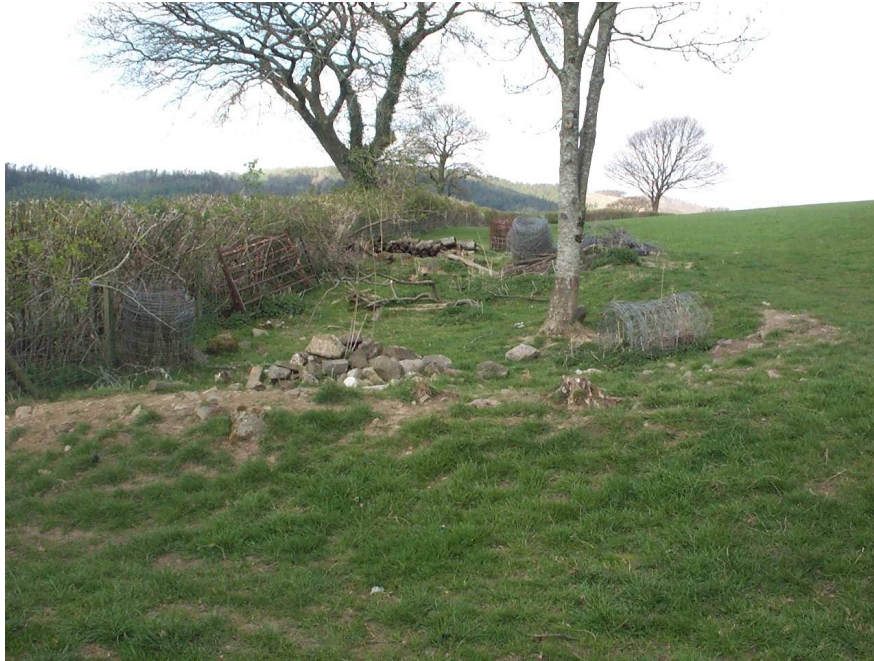
*Ty-newydd-cae-Sara* is first shown on the 1887 Ordnance Survey map around 100 metres to the northwest of Cae-Sara Lead Mine. A cottage and associated garden enclosures are accessed by a short trackway from the road. By the time of the 1906 Ordnance Survey map, the cottage is shown to be in a derelict condition. The cottage was contemporary with the neighbouring lead mining complex and the name *Ty-newydd-cae-Sara* suggests an association with the mine.

Plate 10- *Ty-newydd-cae-Sara* PRN (47675) looking north.

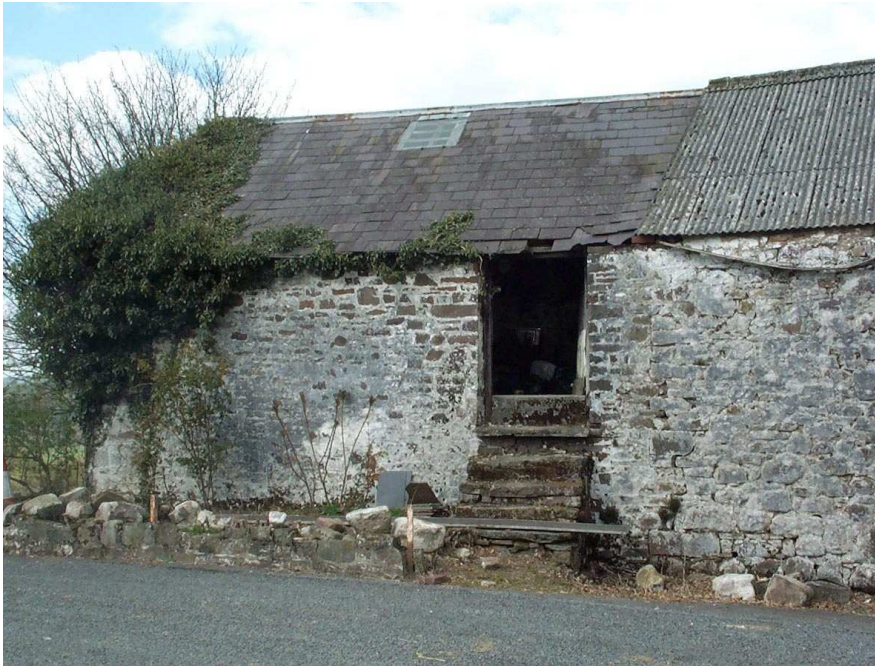
Plate 11- south elevation of combination farm building (PRN 47679)

This two storey building, on the roadside near to the farmhouse at Gilfach forms the western bay of a two unit building range. It is of uncoursed stone rubble construction with a pitched roof. The southern pitch of retains a traditional slate covering, whereas the north pitch has since been replaced with corrugated iron. The lower level is divided into two bays. The western cartshed bay is accessed by a wide cart entrance with a substantial wooden lintel, whilst the eastern bay, formerly a cartshed preserves three concrete stalls with halter bars. The upper storey hay loft is accessed by a low set of stone steps in the centre of the south lateral wall by the roadside.

The building, which is first shown on the 1891 Ordnance Survey map is likely to be of a mid to late nineteenth century date. It is currently in a reasonable condition, although some problems need addressing if it is to be maintained in a stable condition necessary for its long-term survival.

The west gable end of the building and part of the south lateral wall are currently masked by heavy ivy growth, which threatens to damage masonry bonds and promote building instability. The ivy is also penetrating under the roof eaves and displacing roof tiles. The ivy should be cut off at the roots, treated and allowed to die. This should be followed up by a programme of masonry consolidation where necessary using a traditional lime mortar mix. The roof should also be repaired using materials faithful to its original construction.

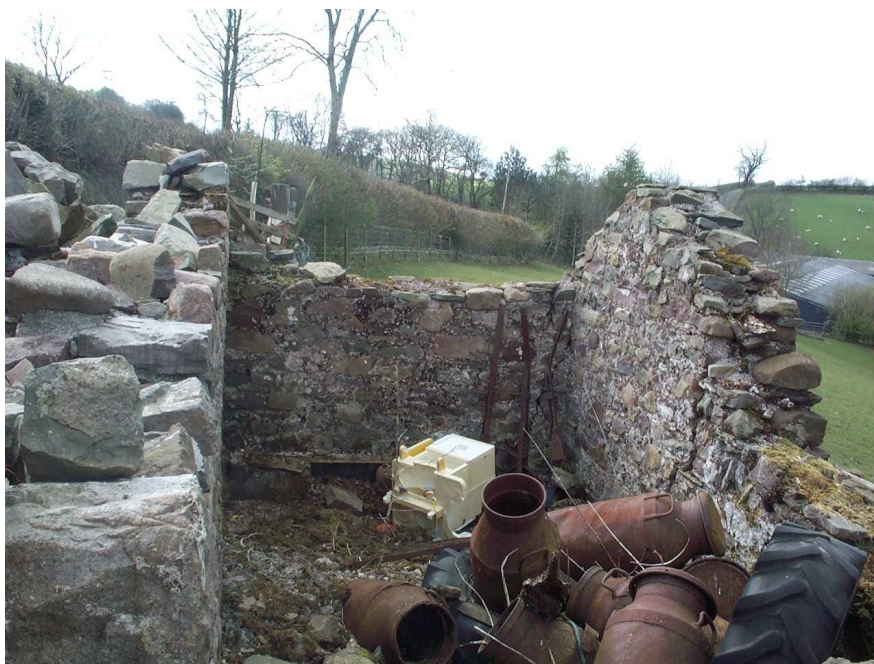
It is currently roofless, in a ruinous condition, with walls surviving to a diminished height. Water ingress continues to weaken lime mortar bonds. The site is currently used as a store for discarded farm rubbish.

Plate 12- pigsty (PRN 47680)

The pigsty is currently in a poor condition. Ideally, masonry should be consolidated and wall tops capped with a lime mortar mix in order to prevent further collapse.

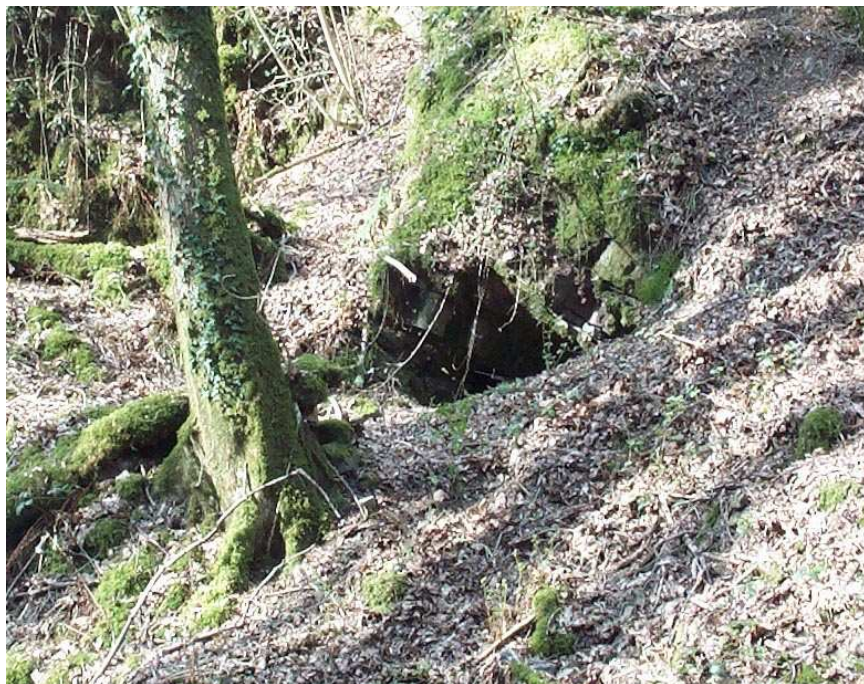
Plate 13- the opening of level (PRN 47888)

This level is situated on the north bank of the steep Nant-yr-hiddl valley around six metres above the water level. The opening remains clearly visible, obscured by little vegetation growth. Hall, who visited Gilfach mine sometime before 1971 noted that it “has been driven 33 paces to the junction with the third lode, 10 paces beyond and 57 paces altogether on the cross load” (Hall, G.W. 1993: 36).

The level should be maintained as a visible historic landscape feature. It should not be infilled. This level is located to the north of the Nant-yr-hiddl and it is not known whether it lies within the Tir Gofal application area.

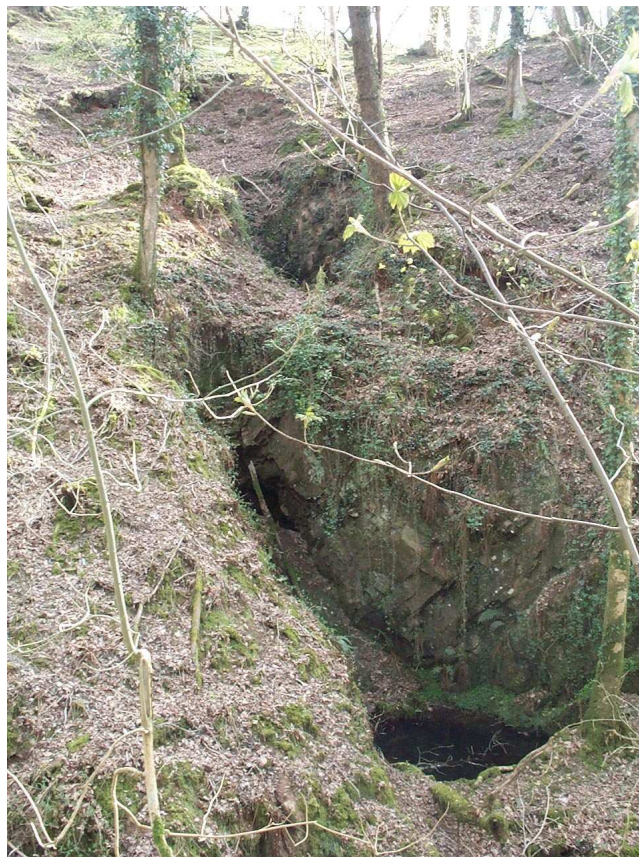
Plate 14- looking south towards level and shafts (PRNs 47889, 4789, 47891)

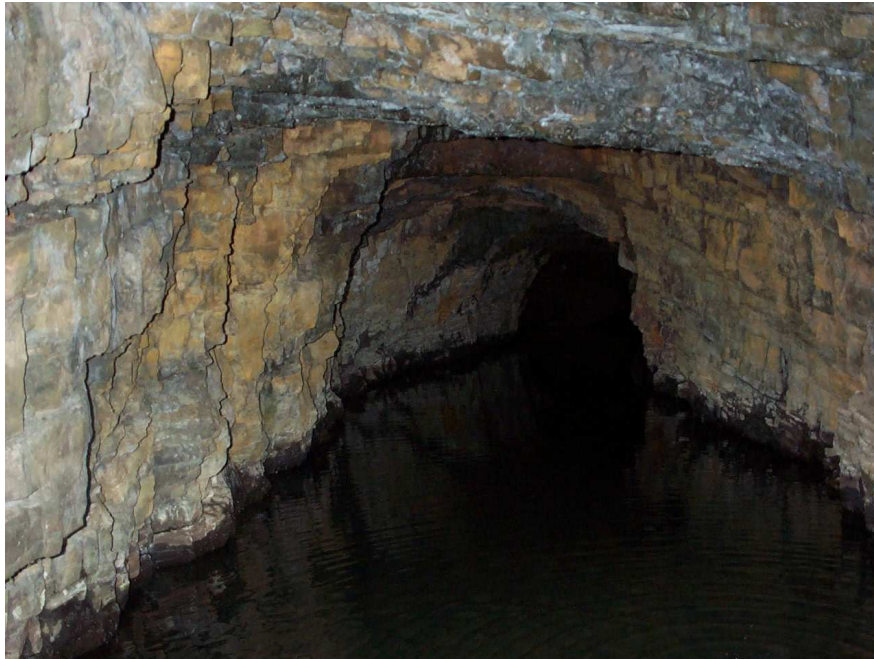
Plate 15- level (PRN 47892)
