# Alltfawr W/11/2618

## Tir Gofal Farm Visit Historic Environment Report

Report No. 2002/52

Alltfawr  
Tir Gofal Farm Visit Historic Environment Report

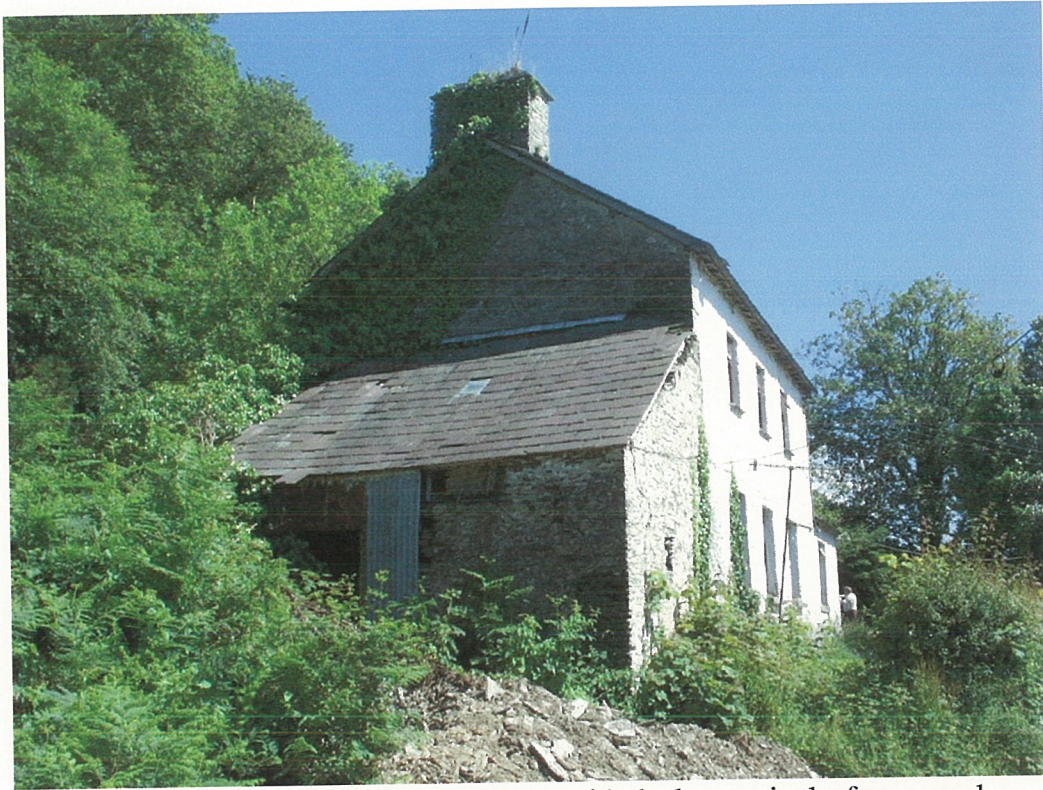
Against the farmhouse, on the west gable end is a lean-to (plate 1). It is built in local shale slabs and bonded with lime mortar. The single pitched roof is covered with slate. It is approximately 5.4 metres by 2.5 metres. The lean-to walls are not keyed into the farmhouse walls, indicating that it is a later build than the farmhouse. The masonry is evidently historic and may have been constructed fairly soon after the farmhouse was built. The south side of the lean-to has an earlier doorway, subsequently blocked with masonry. The current entrance is situated in the west wall and constitutes a wide doorway, approximately 1.6 metres wide. This has been partially unfilled with corrugated iron.

Plate 1 – Alltfawr farmhouse with the lean-to in the foreground.

The current condition of the lean-to is very poor. The slates have slipped in various places but particularly to the north where the ivy has penetrated to a great extent. There has also evidently been some structural movement which has caused cracking in the masonry at the south west corner. The lean-to also appears to have moved in relation to its' position against the house, partly due to the fact that it is not keyed into the masonry of the gable end of the house. The lean-to, previously used for livestock, has not been used for some time.

That the lean-to is in a poor structural condition is evident. However, it could feasibly be restored, although this may require a good deal of rebuild and renewal, which would undoubtedly be costly. If restoration of the lean-to is pursued then this should be undertaken using traditional materials.

If possible the lean-to should be dismantled only so far as necessary to make it safe and the ground surface left undisturbed, in this way much of the historic information about the development of the farm would be retained. Ideally building materials should also be salvaged from the lean-to and re-used in the repair and maintenance of the other farm buildings.

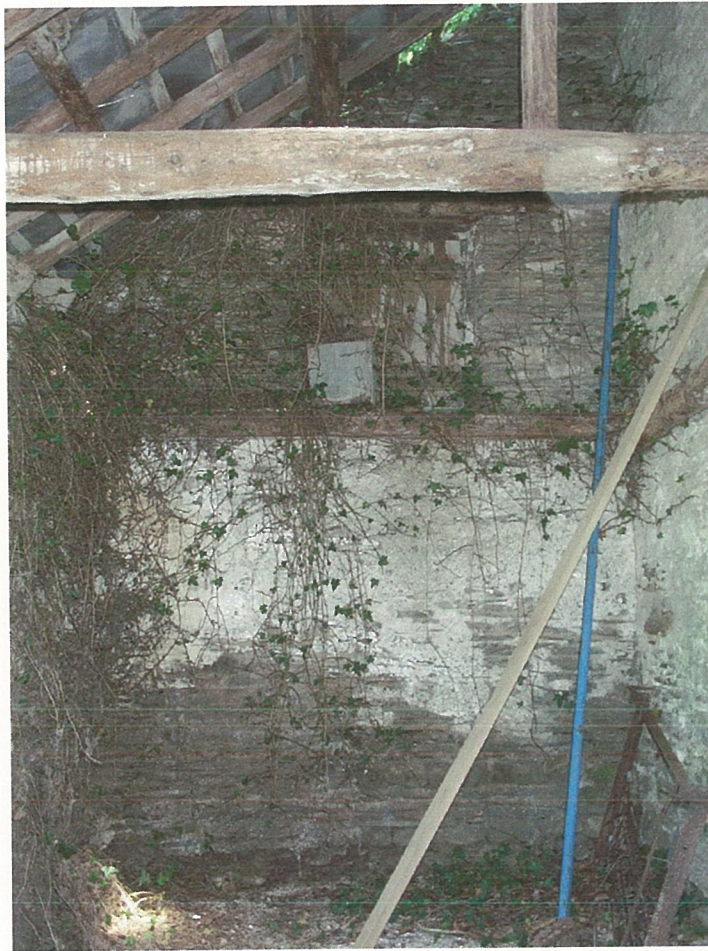
In the north wall there is a hatch situated up at loft level (plate 2). A truss has been inserted across the centre of the lean-to which gave additional support to the roof. This was presumably inserted prior to the doorway being inserted into the west side, since the truss is currently merely supported by being nailed to a post. Two further sockets in the gable wall of the farmhouse are also visible at loft floor height to the south side of this truss.

Plate 2 – the north wall of the lean-to, showing the loft floor level and hatch above

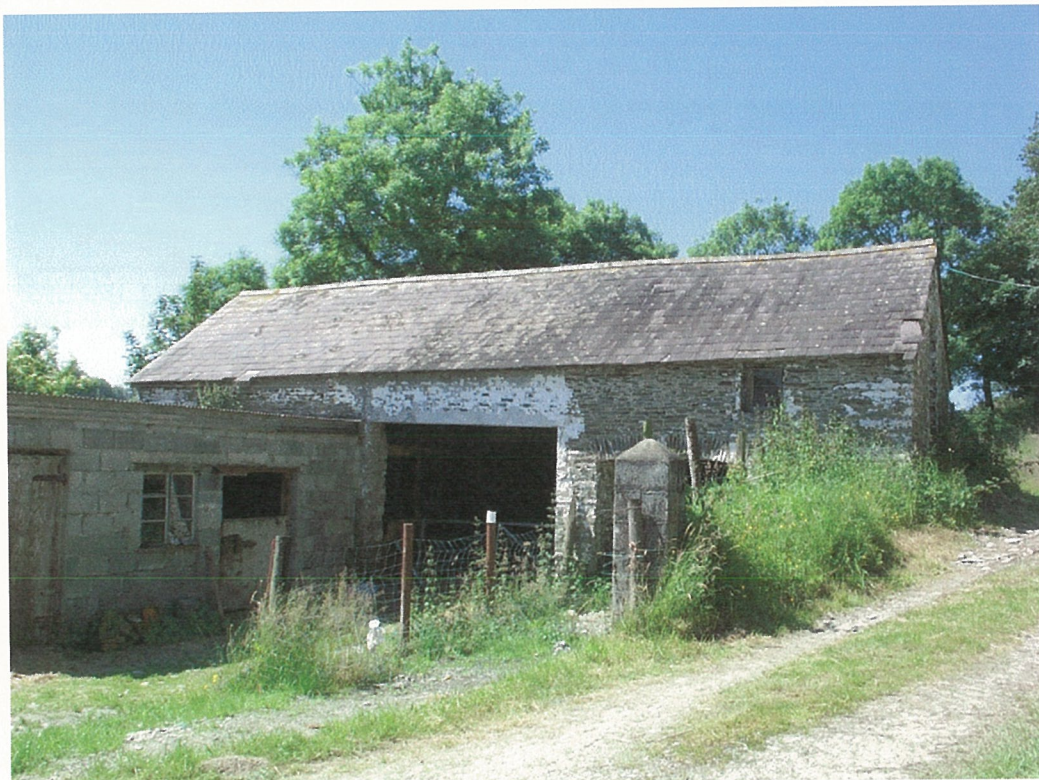
The barn is built across the slope with a granary at the higher (north) end accessed by a few external steps in the gable wall. The barn is constructed out of a mixture of some river worn rubble and course hewn stone, with substantial roughly dressed quoins (plate 3). It has a pitched roof covered in slate. Central to the west elevation is a single doorway.

Plate 3 – the east elevation of the barn

This barn retains much of the original, historic fabric including some significant features in particular the low stone arched openings and the floor cobbling in the lower section. The barn appears to be in reasonable condition and structurally sound. There are only a few roof slates which appear to have slipped. The interior was not seen.

This barn should be retained and maintained using appropriate, traditional materials. The roof slates should be replaced where necessary to maintain an intact and weatherproof covering. Any historic internal fittings should be retained if possible.

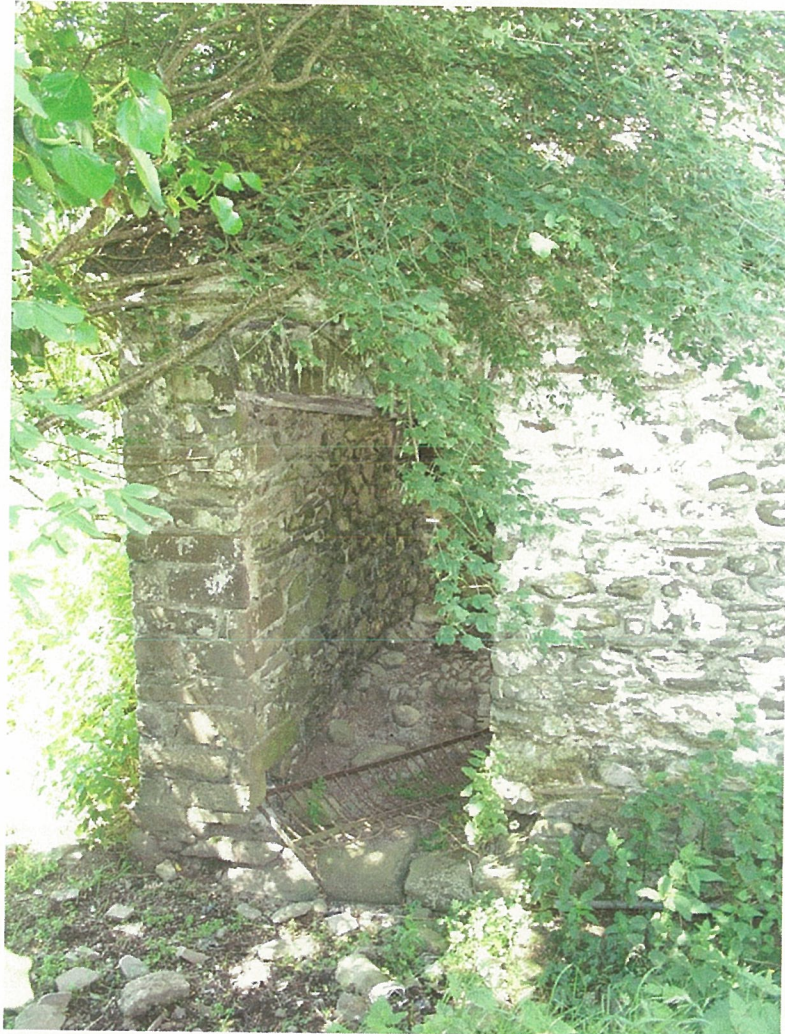
The east elevation retains a cart shed at the north end which is accessed through a low stone arched entrance. The central and lower section of the barn have been modified by a large, almost full height, doorway with concrete lintel and by a breeze block addition extending to the east. At the south end of the barn is a further extension, lower in height, with a pitched corrugated iron roof. The floor of this barn appears to be largely intact cobbles, entered by a doorway in the east elevation (plate 4).

Plate 4 – the lower part of the barn showing the internal floor cobbling.

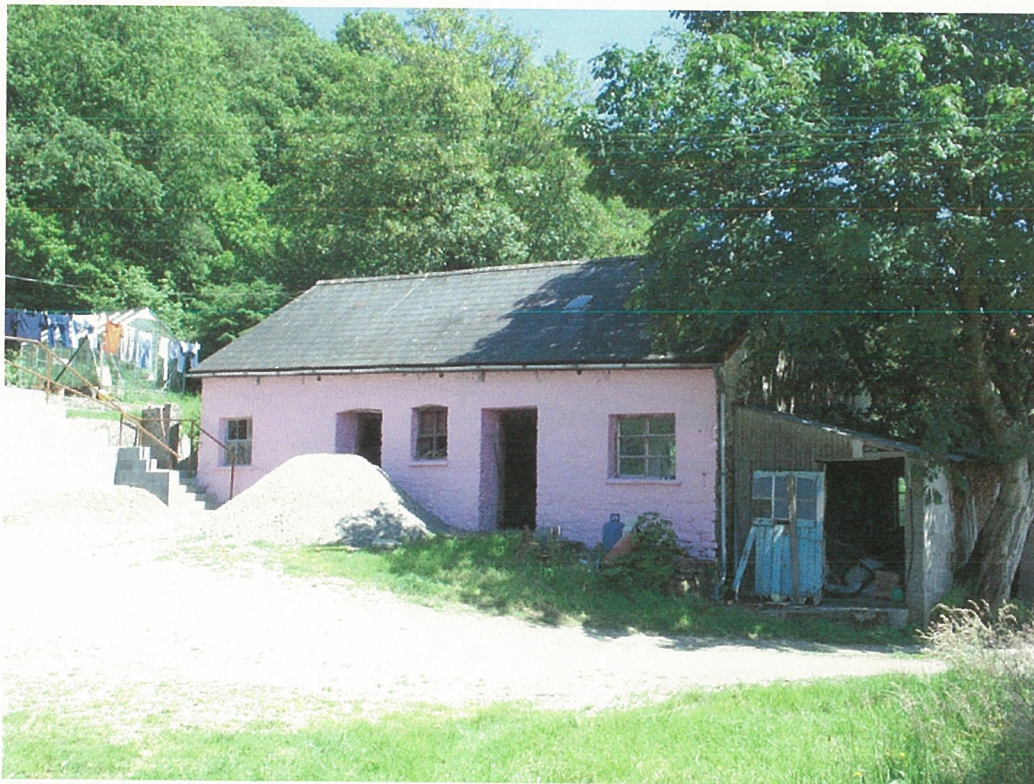
A low one-storey cow shed is situated to the east of the farmyard (plate 5). It is also of rubble construction with a painted finish, it has a pitched slated roof. It has two doorways positioned in the west elevation, alternately spaced with windows.

The cow shed is currently undergoing conversion into a holiday cottage.

Plate 5 – the former cow shed which is now being converted into holiday accommodation.
