CEFN-GWEIROG W/11/2793

Tir Gofal Farm Visit Historic Environment Report

Report Prepared for:
Countryside Council for Wales

REPORT NO. 2003/36
PROJECT RECORD NO. 44165

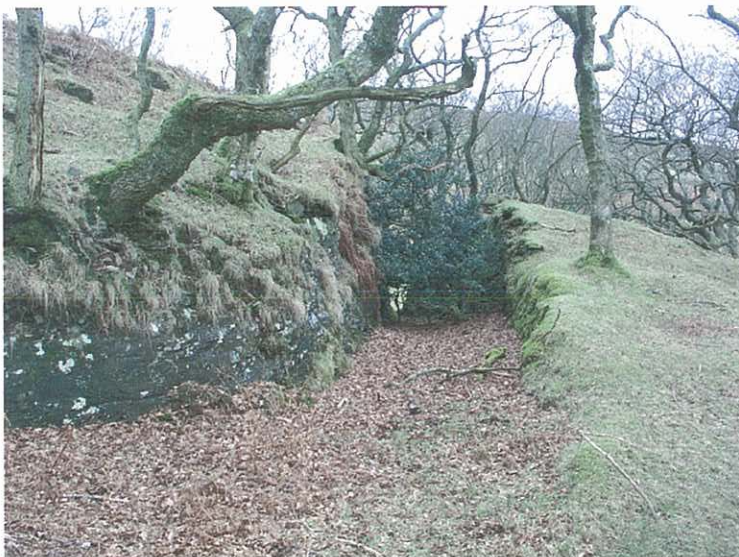
Prn 5442 – a rock cutting for the tramway to serve the mine processing complex

The tramway should continue to be maintained as a visible historic landscape feature, as described above, the central section of the tramway is rather overgrown with brambles. However, this section of the tramway now falls within an area of the holding which has recently been sold.

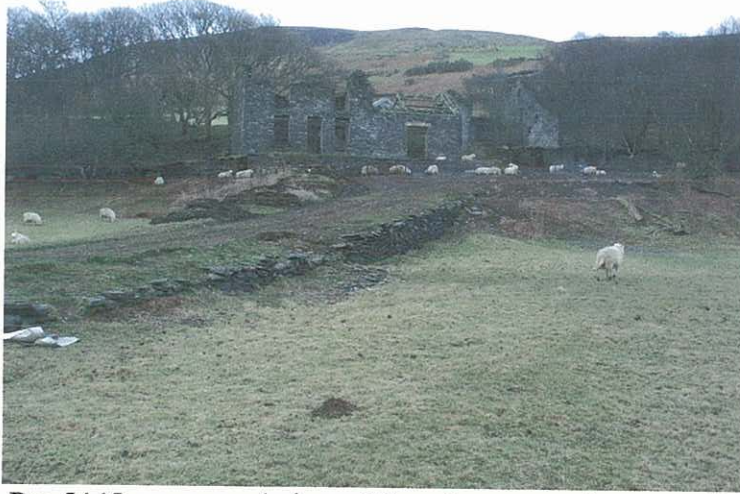
Prn 5445 – a general view of the mine processing complex

As denoted by its scheduled status, this site is of national importance. It is a very well preserved example of the mine processing works, and demonstrates a high quality of construction and engineering in its layout. The site would ideally lend itself to interpretation and educational/open access. However, the site in its current condition is a danger to the public and is understandably a cause of concern for the owner. In the long term, ideally the site should be subject to a programme of conservation which would entail stabilizing dangerous areas and putting gratings over such features as the wheel pits and open levels and shafts.

In the short term, there are various measures which could be undertaken which should help to improve the visibility of the site and also slow the process of deterioration. Please see individual site descriptions and recommendations. As a general point the erosion of the masonry around the buddles and settling tanks could be alleviated by moving the location of sheep feeders away from the scheduled area, a situation which is currently encouraging stock from congregating on the monument.

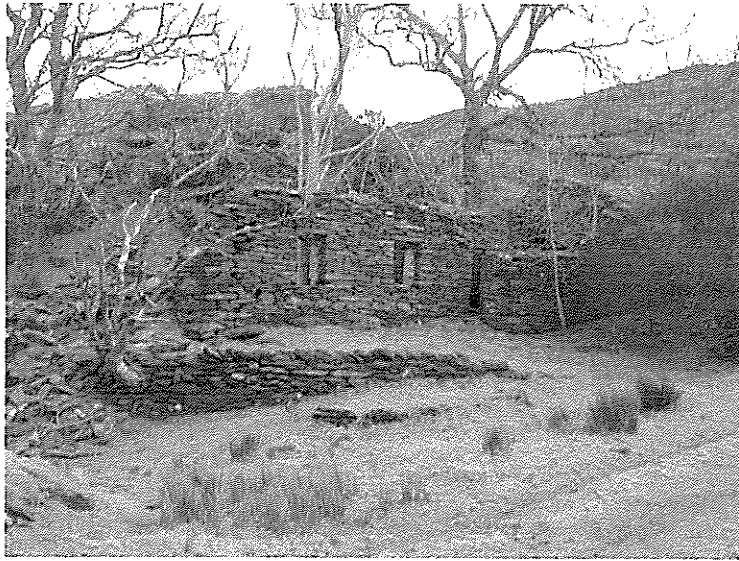
The house is in a deteriorating condition, and the fireplace has now collapsed. It is apparent from the leaning of the external walls, in particular the east gable and the northeast corner, that they are structurally unstable, probably due to a large mature tree which is growing in close proximity to the walls.

Prn 7104 – the remains of Neuadd-llwyd farmhouse

As described above, this building is of historical significance, and ideally efforts should be made to delay its deterioration and try to stabilize the remains. The most important aspect of this work would be to cut back tree growth, particularly where young saplings are becoming established within the masonry walls and in the immediate vicinity. There are also a couple of mature trees growing both within the building itself and also in close proximity to the exterior. Ideally these should also be removed if this could be achieved without causing further damage to the building. In addition the masonry would benefit from consolidation and capping using an appropriate lime based mortar.

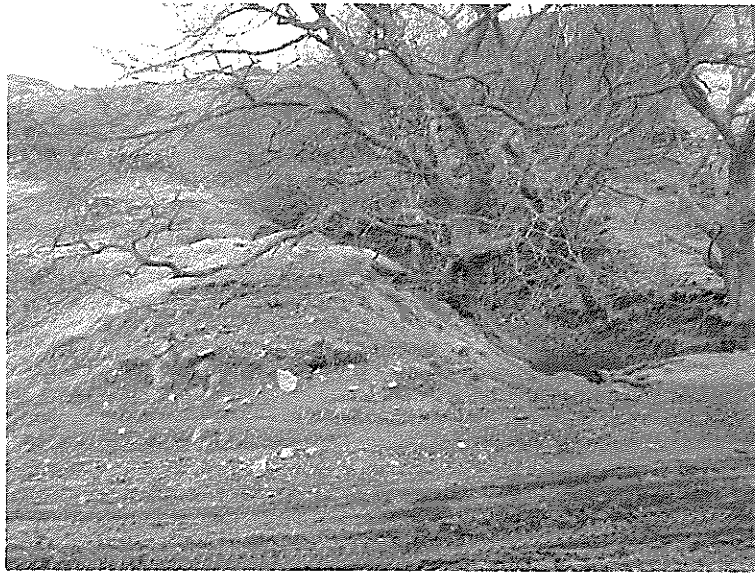
Prn 25818 – a level penetrating the hillside

The farmer is understandably concerned about the safety problems posed by the exposed mine shaft and proposes to fence off the immediate area around the shaft. This would appear to be the most prudent course of action. The rest of this area should preferably be maintained in its current condition and left to be lightly grazed by sheep.

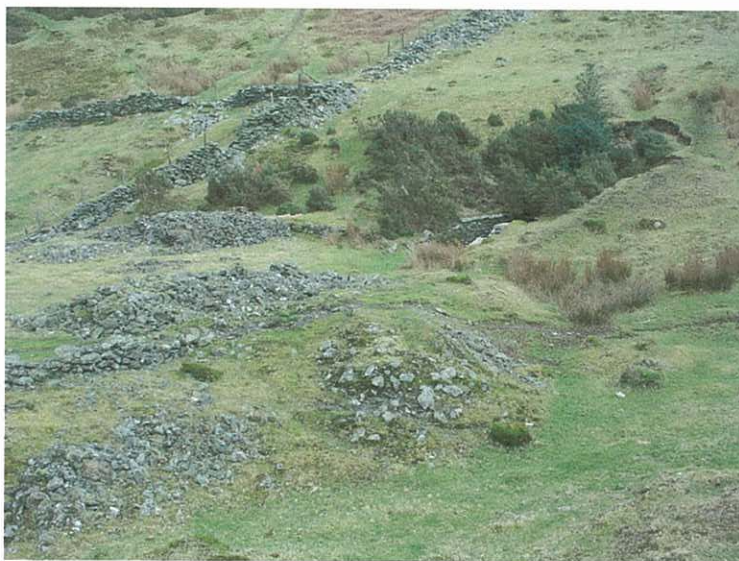
Prn 45785 – the level mouth is served by the tramway Prn 5442

The exposed mine shafts are undoubtedly a cause for concern for the farmer who has undertaken to fence them off. This has caused one of them to become quite overgrown which is an unwelcome side effect of this action. However, in the light of the safety concerns posed by the shafts this appears to be the most satisfactory short term solution. Perhaps in the longer term however, enquiries could be carried out into the feasibility of fixing a grating over the shaft entrance, which would also be a more effective solution to the question of safety.

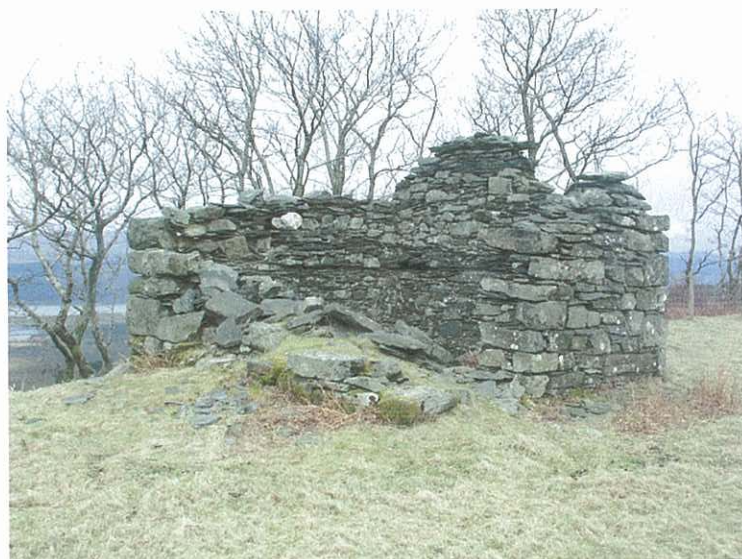
The building appears to have lost much of its bonding matrix and the wall tops and gable appear very loose.

Prn 45786 – the powder magazine associated with the lead mine Prn 5445

The building, although ruinous appears to be in a reasonably stable state, although areas of the wall tops are loose. Ideally in order to prevent its further deterioration the building should be consolidated and repointed using an appropriate lime base mortar.

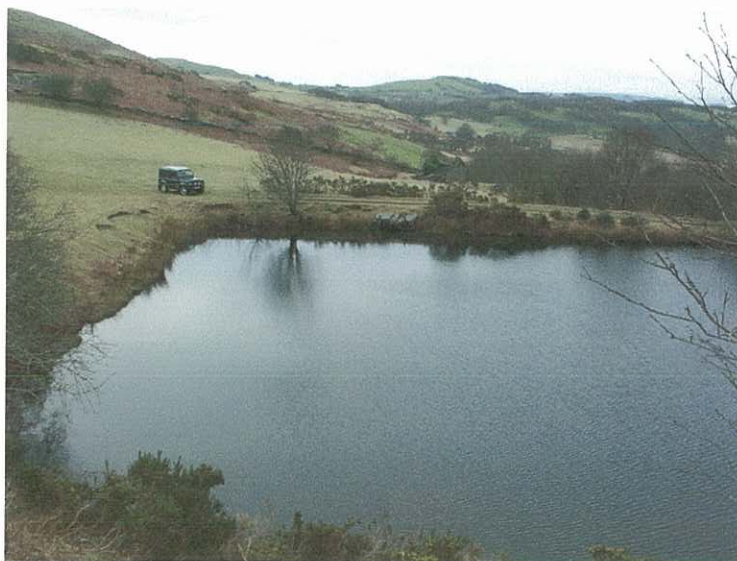
The two upper reservoirs and dams appear to be in a good and stable condition. The lower of the reservoirs is somewhat obscured by tree growth and has in the past been used as a dump.

Prn 45787 – the middle of the three reservoirs serving the mine Prn 5445

The reservoirs and revetment dams should continue to be maintained in their current condition. The lower reservoir should be cleared of rubbish and left open. This area should be monitored to remove any trees which may pose a threat, by falling, which may damage the sluices and the dam wall. If resources allow, it would be preferable to fell those trees in the immediate area of these structures.

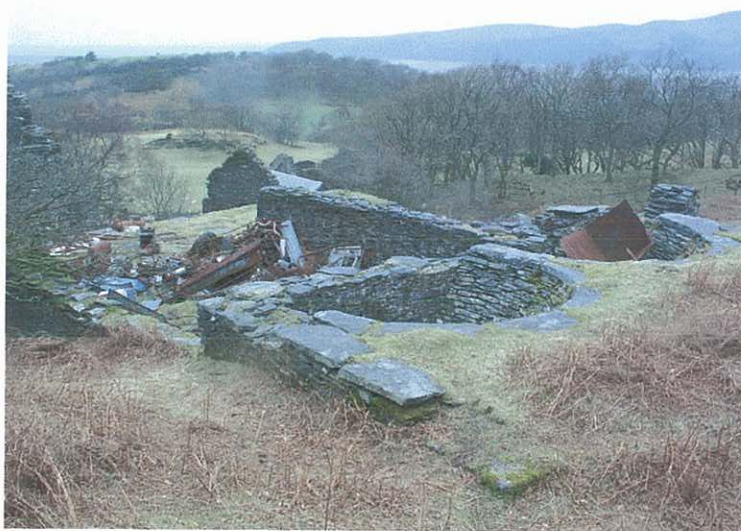
This platform is situated at the upper most extent of the lead ore treatment works. This area is defined as a paved area enclosed by walls to the north west and south east which are approximately 2 metres high, it is unclear whether these walls survive largely at full height, although to the west they have degraded a little. At the north east end are two semi-circular ore bins, which survive largely intact although the northern one has lost a supporting lintel over the front opening.

Prn 45788 – two ore bins situated above a paved platform.

This area should be cleared of debris and rubbish. However, it is clear that this area has been used for dumping machinery for many years and within the material there may be historically important artefacts, which may or may not relate to the mine workings. Indeed during the farm visit a drive shaft with a couple of fly wheels was identified along with a wrought iron picket gate which appears to match that still *in situ* at SN67989330. Therefore it is recommended that there is an archaeologist present during the clearing process to identify those remains which should be retained. Please inform Cambria Archaeology when these works are to be carried out.

Otherwise the structure should be maintained in its current condition. It is recommended that those branches which overhang the south east wall are also cut back to prevent them dislodging stones along the wall top.

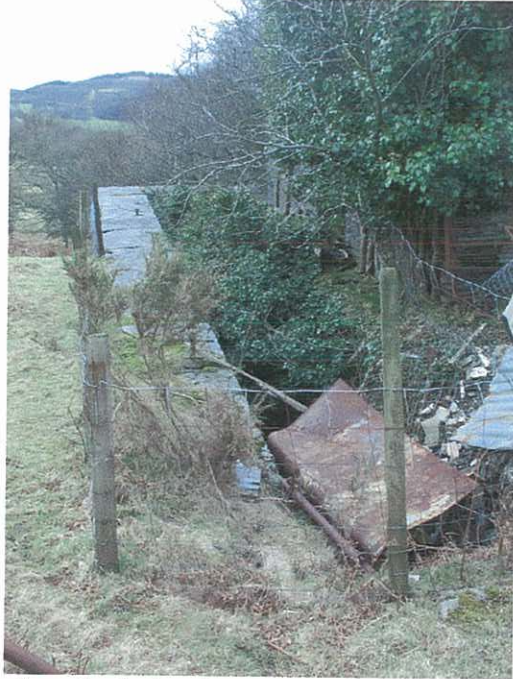
Prn 45789 – the wheel pit adjacent to the crushing mill Prn 45790

The ivy, which is growing within the pit, should be cut at its base to prevent its further spread and the roots should be treated to prevent regrowth. In the short term the ivy should be left to die back in place, as its removal at this stage would probably cause more damage to the stonework. In the longer term, ideally the ivy should be removed and a programme of consolidation should take place to stabilize the masonry. This would involve repointing using an appropriate lime based mortar.

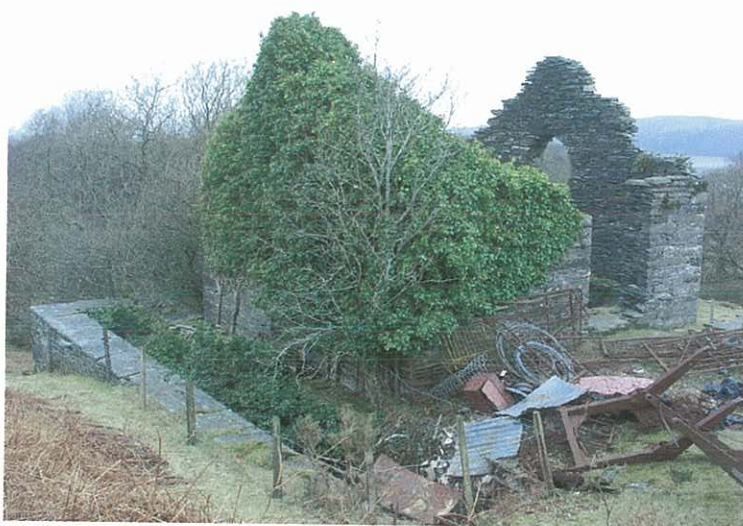
The crushing mill is situated along the northwest side of the wheel pit. In the north west gable end is a round window high in the wall in the south east gable there is a tall arched window rising from the external ground level and a small window in the apex. The building still stands to full height although its roof has long since gone and the wall tops are beginning to degrade quite seriously.

Internally the building is completely empty, all the machinery workings appear to have been removed. However traces of machinery fixtures remain imbedded in the walls, for example the stubs of two large beams remain at floor level. The main areas of instability appear to be the northwest gable wall, which is leaning inwards, and the southwest wall where various areas of stonework have collapsed. An opening at ground level has lost its supporting lintel and the stonework above is cracking and collapse appears likely, some areas of internal facing have been lost. Although many areas look under immediate collapse it appears from the notes and recollections of the Cadw field monument warden that these same areas were threatening collapse some 15 years ago. The other major problem is ivy growth which has become well established and engulfed the south east gable wall almost entirely. There is also a substantial sapling growing at the foot of the wall.

Prn 45790 – the crushing mill, little survives of the internal workings

The crushing mill appears to have been reasonably stable over the past few years. However, the condition of the fabric is in decline and without remedial works large parts will inevitably collapse. In the short term the ivy which is engulfing the south east gable wall should be cut at ground level and the roots should be treated to prevent regrowth. The ivy should then be left in place to die as removing it, without a programme of consolidation at the same time, would probably cause further damage and would be potentially dangerous. The sapling, which grows at the foot of this gable, should also be cut down and roots treated to prevent regrowth.

In the longer term the building should be subject to a programme of consolidation. The advice of a structural engineer should be sought to identify the best means to stabilise the building.

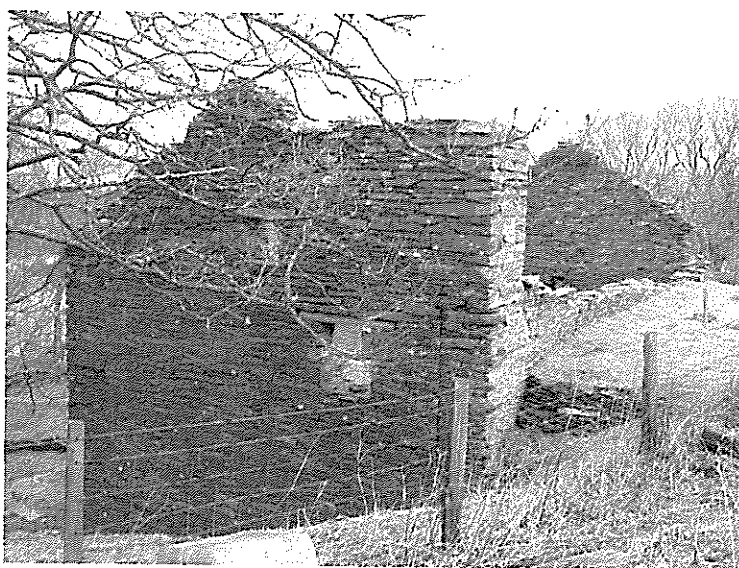
Prn 45791 – a mine building of unknown function; possibly a store or a jigger shed?

This building appears to be reasonably stable, however like the crushing mill (Prn 45788) without some intervention the fabric will inevitably deteriorate.

In the short term the vegetation should be controlled and ivy cut at ground level. It should then be left to die in place. Ideally the whole building should undergo a programme of repair and restoration using appropriate materials.

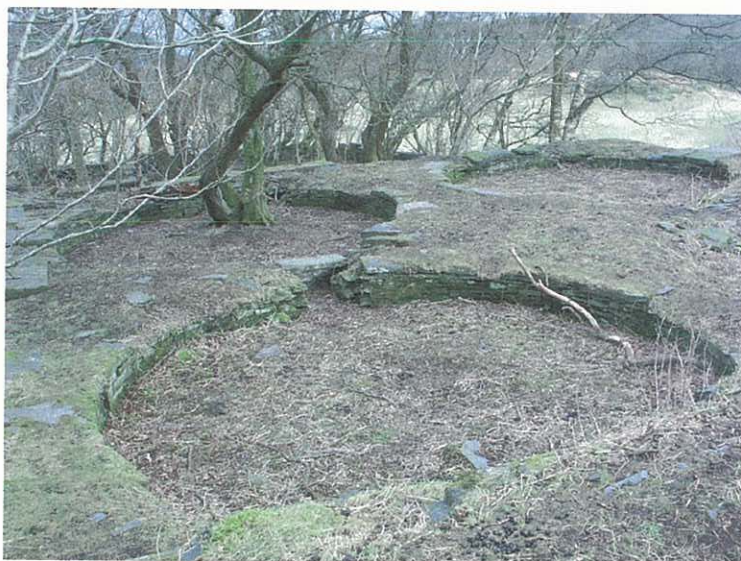
Below the mine building (Prn 45792) there are four buddles, constructed out of stone and approximately 0.3 metre deep. The northern most buddle which is most accessible is quite degraded and has lost the definition of the stone revetted sides. A tree grows out of the centre of the southern buddle.

Prn 45792 – a system of four buddles, with interconnecting sluices

Ideally the tree in the southern most buddle should be cut down to ground level and the roots left in place and treated to prevent regrowth. This should be carried out with utmost care to prevent damage being sustained to the masonry structures.

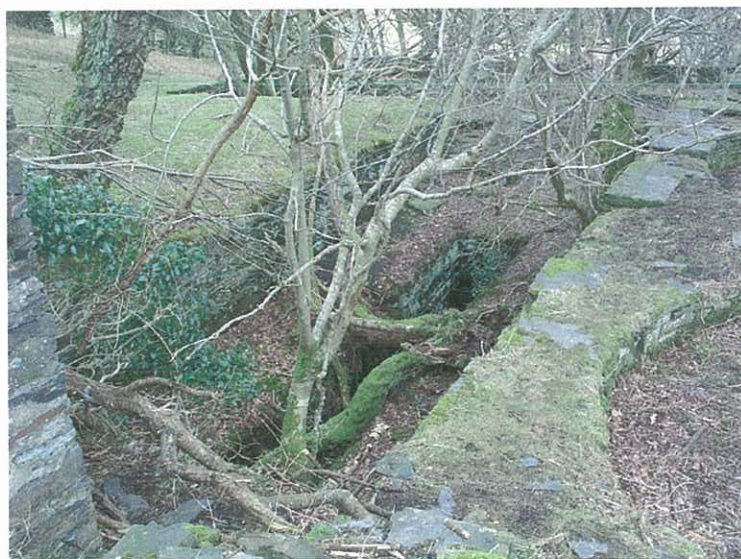
To the south, adjacent to the buddles (Prn 45793), is a wheel pit which widens out part way up. The wheel pit appears to be in structurally sound condition, although a close inspection was not carried out. A large mature tree has grown up at the east end of the wheel pit and now appears to be dying off. A further younger sapling is also growing up in this are.

Prn 45793 – the wheel pit which provided power for the buddles

The wheel pit appears to be in reasonable condition. However, trees growing in the masonry could potentially cause damage to the structure. Trees growing in this area should ideally be cut back at ground level and the roots treated to prevent regrowth. Care should be taken with cutting down and removal in order to prevent any damage to the structure.

The regrowth of young saplings in this area should be monitored and cut back on a regular basis.

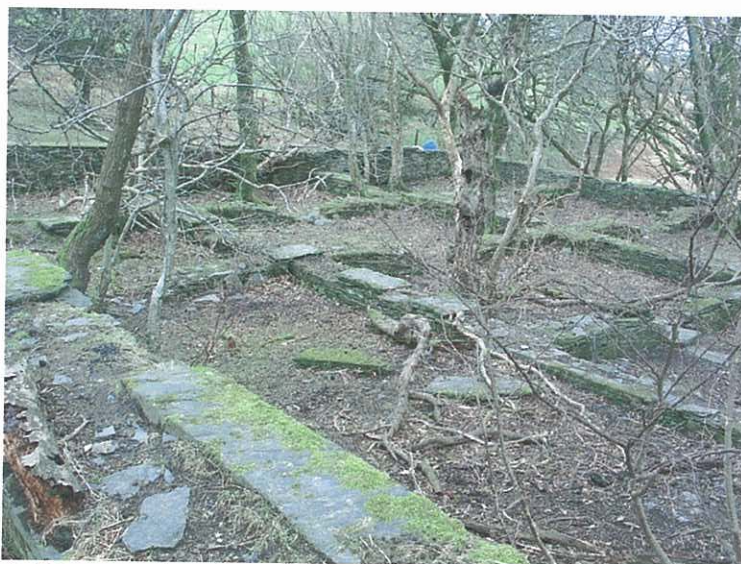
At the lower end of the mine are a series of 18 rectangular settling tanks, divided up by low masonry walls approximately 0.4 metre high. Each tank is roughly 3 x 4 metres with interconnecting sluices from side to side in an east-west direction. The dividing walls survive at their best to the south but have almost entirely been degraded at the northern end. There also appears to be only one capping stone surviving which indicates the full height of the dividing walls.

Prn 45794 – a series of 18 settling tanks, rather overgrown with trees.

If there is the opportunity for consolidation works to be undertaken then the trees should ideally be cut down. This should be carried out with great care to avoid damaging the fragile dividing walls of the settling tanks.

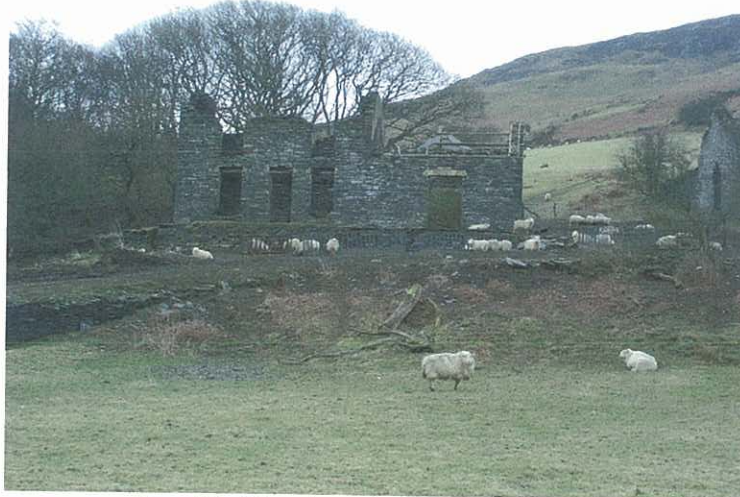
Prn 45795 – the mine complex offices

Ideally the building should be consolidated before the wall tops begin to degrade further.

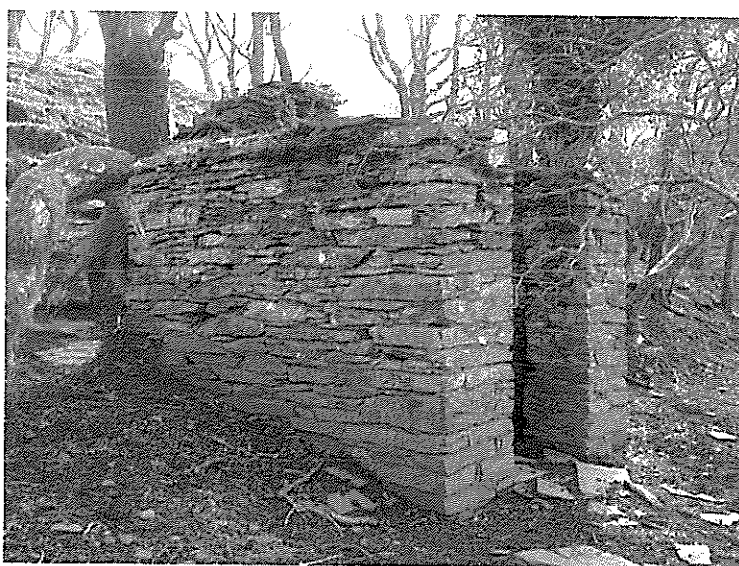
Prn 45796 – the ty-bach, built to serve the mine offices

The ivy should be cut at ground level and left to die in place.

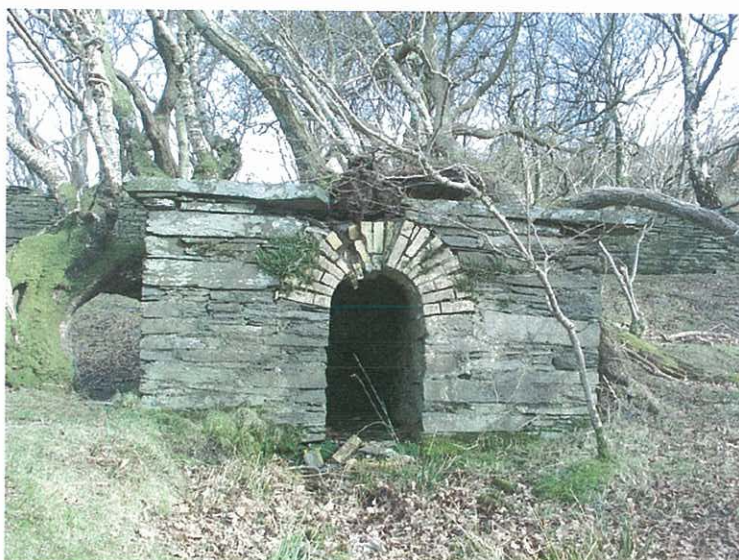
To the west of the lead ore treatment complex is a masonry outfall. At its western end is a yellow brick arch over the outfall. This brick arch has partially collapsed due to tree growth over the cappings which appear to have loosened the stonework and brickwork.

Prn 45797 – the outfall from the mine processing complex

The trees which are growing on the top of the outfall should be cut back at ground level and the roots treated to prevent regrowth. Care should be taken to prevent further growth of intrusive woody vegetation which may cause further damage to this structure.

Ideally the brick arch should be consolidated and stabilised to prevent further deterioration of the structure.

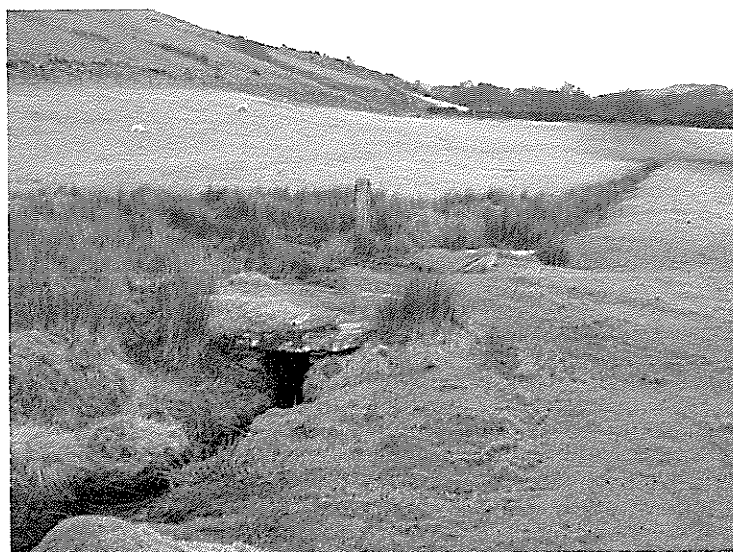
Some of these stone slabs appear to have become dislodged or have possibly fractured.

Prn 45798 – the culvert and leat exiting the mine processing complex

Ideally the stone culvert should be repaired using appropriate materials similar to existing.

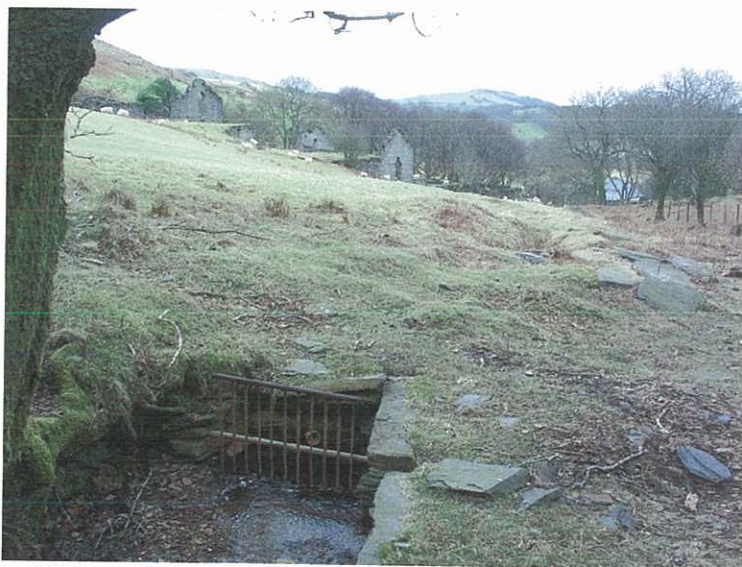
Prn 45800 – the head of the leat below the reservoirs Prn 45747

Maintain as a visible historic landscape feature.

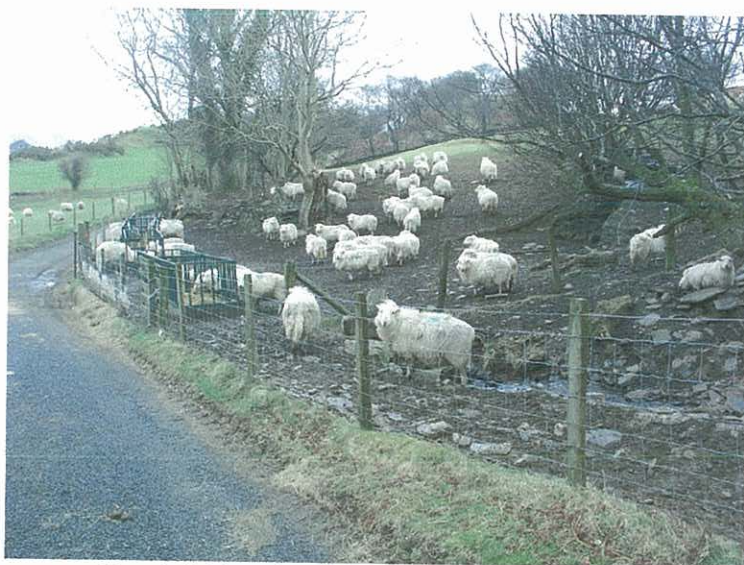
Prn 45801 – the site of Ty'n y nant cottage.

Although this obviously is a very convenient place to feed sheep, this action is causing some erosion to the remaining stone walls of the old cottage site. It would be preferable if an alternative area could be found in which to feed sheep to prevent any further damage to the masonry remains.

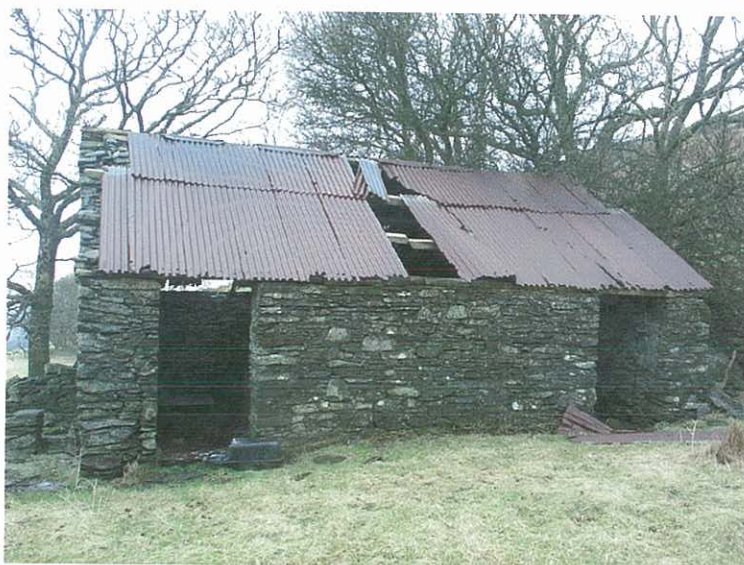
Set within a small stone walled enclosure is a long building arranged on an east-west orientation across the hill slope. There are two sections of building in plan; the upslope section is roofless and the walls are degraded to an approximate height of 1 metre. The down slope section of building appears to have been a cow shed with two doorways in the south elevation and a single central doorway in the north. It has a ventilation slit high in the west gable end. This section of the building is still roofed with corrugated iron, although the iron sheeting is corroded and some sheets have been lost.

The remains of a pigsty are visible at the lower end of the building, although the walls have degraded to almost ground level.

Prn 45803 – the cow shed at Ty'n yr Helyg

The farmer hopes to replace the roof on the lower section of the building. This action is to be welcomed and will help ensure its long term survival and usefulness. Before any works are to be carried out it is advised that a photographic record of the building should be carried out, this could be done either by the farmer or the Tir Gofal Project Officer, please see the attached guidelines.

It would also appropriate to cut off some of the overhanging branches of adjacent trees to prevent further damage being caused to the structure.

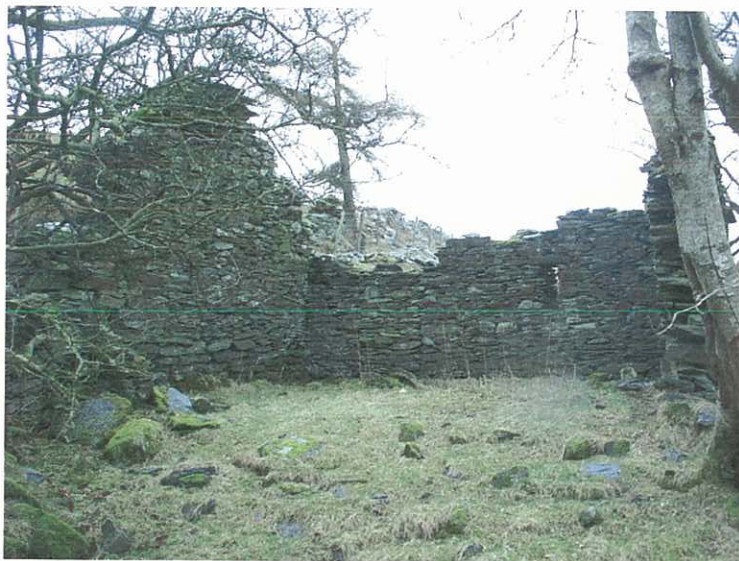
Prn 45803 – the remains of a barn at Ty'n yr Helyg

The remains of this building should be retained in as stable a condition as possible. Any intrusive vegetation which begins to establish itself within the masonry, or within close proximity to the building should be cut back.

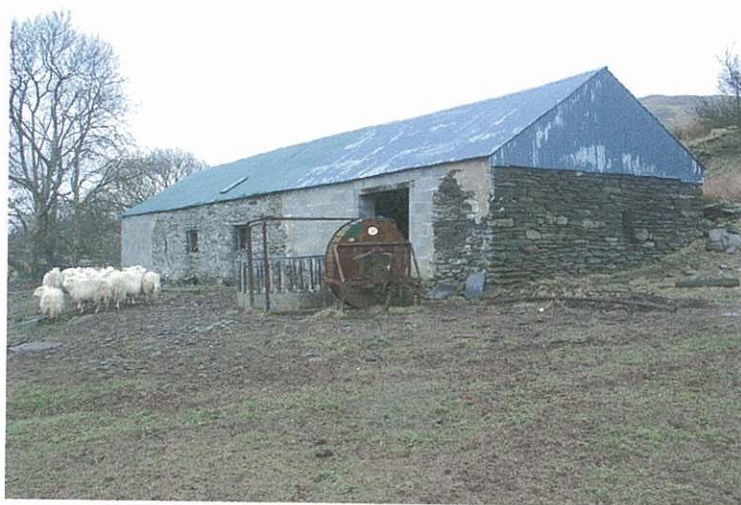
The remains of a pigsty are also visible to the north of the building, although the walls are much degraded and stand no higher than 0.5 metre high.

Prn 45805 – the cottage and animal shed at Llwyn Walter

The building is currently in a stable condition having recently been repaired and reroofed. It should continue to be maintained as existing.

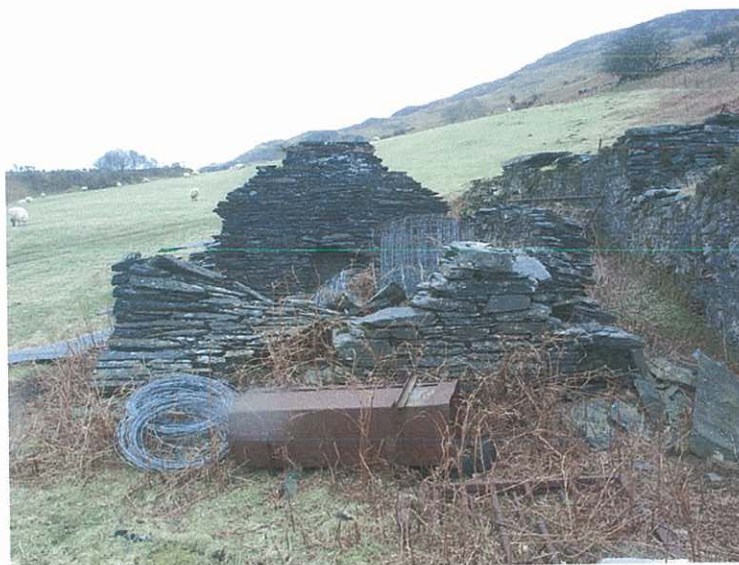
Prn 45810 – the remains of a small building.

This building should be consolidated, to prevent further collapse of the external walls. The fencing materials and other items which have been left within and around the building should be removed and stored elsewhere.
