TALWRN COCH W/11/2778

Tir Gofal Farm Visit Historic Environment Report

REPORT NO. 2003/25
PROJECT RECORD NO. 44166

20th February 2003

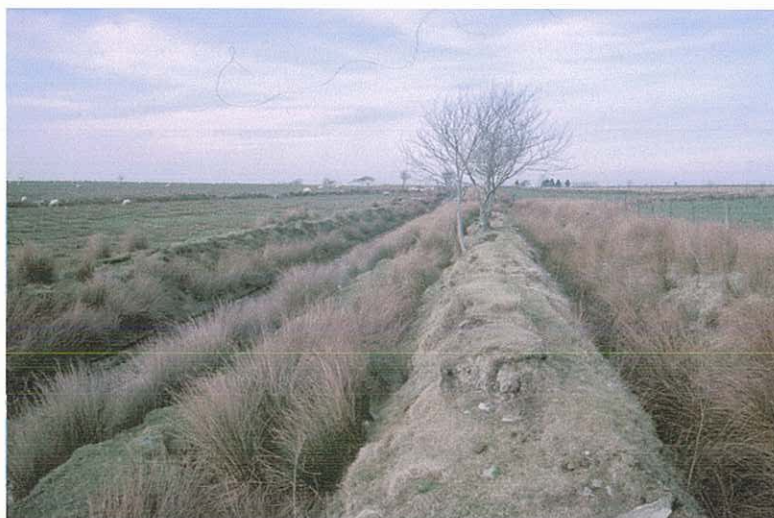
The stone walls themselves, run on each side of the track way and are in varying degrees of collapse. In some places the original structure of the walls is visible, consisting of relatively large stones at the base, with smaller stones laid in a herringbone pattern, above. It is understood that the intention is to rebuild the walls and to erect stock proof fencing on both sides. Since they would not originally have been hedged, any scrub, saplings or other vegetation that is adversely affecting the structure of the walls, should be removed and no re-planting should occur.

Plate 1: The trackway Looking North.

Assuming that materials and techniques appropriate to the locality are used in the repair of the boundaries, it is recommended that a portion of the boundary that is in relatively good condition be examined as a basis for the repair of the boundary as a whole.

Assuming that the existing width of the track is not altered there are no objections to the route being re-surfaced with Tarmac.

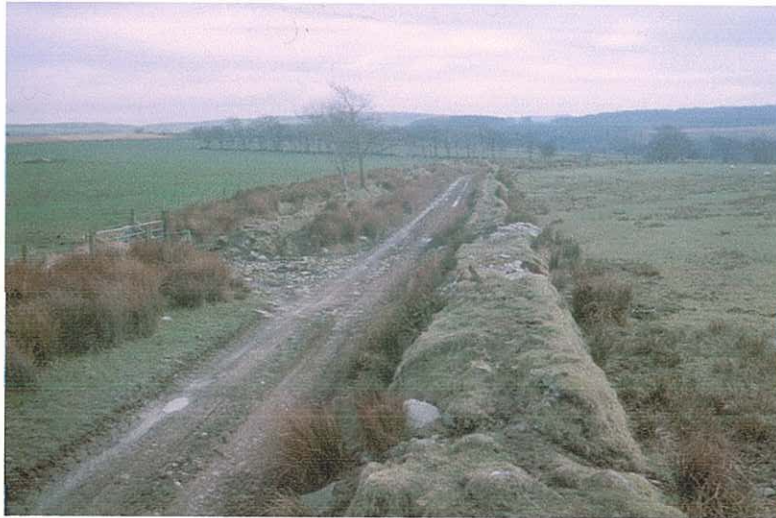
Plate 2: The Trackway Looking South.

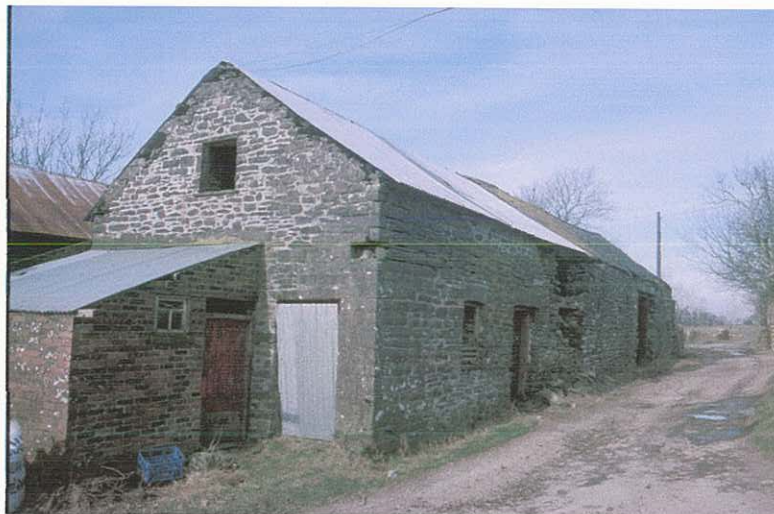
Plate 3: Front View of the Farm Building Looking North.

bought back into use for agricultural purposes. It is recommended that materials and techniques appropriate to the area are used and that lime mortar is used in the rebuilding and re-pointing of the walls. Although much of the building appears to be structurally sound, professional advice as to the structural integrity of the front of the building where masonry has collapsed should be sought. Any surviving internal fixtures, fittings or other features should be retained. Modern brick dividing walls within the building can be removed if desired. If possible, any viable roofing timbers should be retained.

It is recommended that a photographic record of the building is made both before and during the renovation work in order to record its original condition and any interesting features and fittings that may come to light during the work. Advice on making a photographic record is included at the end of this report.

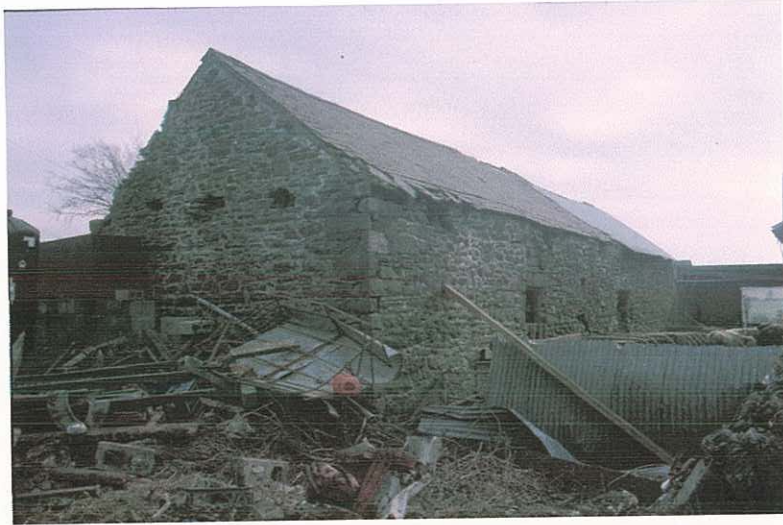
Plate 4: Back View of the Farm Building Looking South.

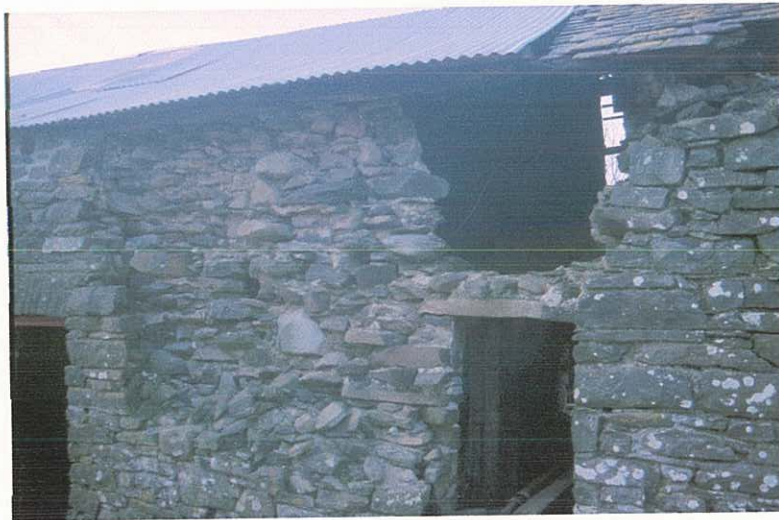
Plate 5: Detail of Farm Building Showing Collapsed Masonry.
