**TIR GOFAL MANAGEMENT PLAN:
HERITAGE MANAGEMENT INFORMATION
(Call Out)**

**Prepared for:
Parc Twad
Tir Gofal Reference No: W/11/2860**

**Project Record Number: 44175
Report Number: 2008/49**

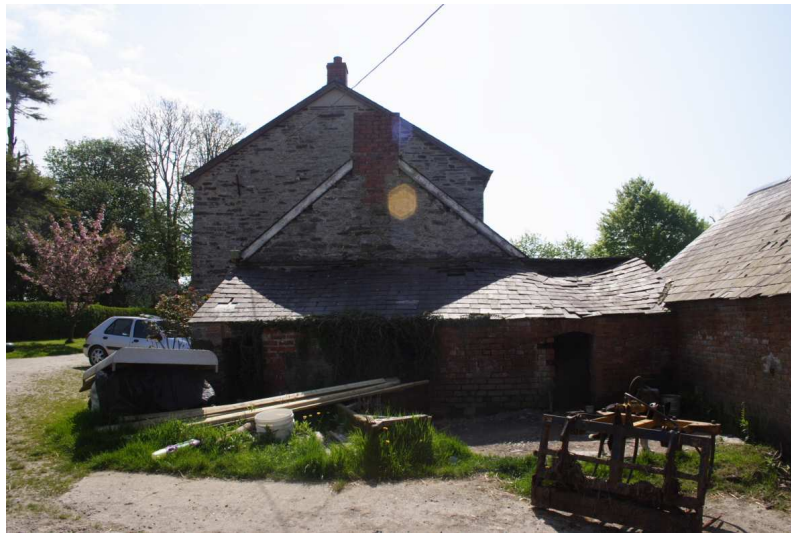
Facing south-east towards the pigsties and brew house with the farmhouse to the rear.

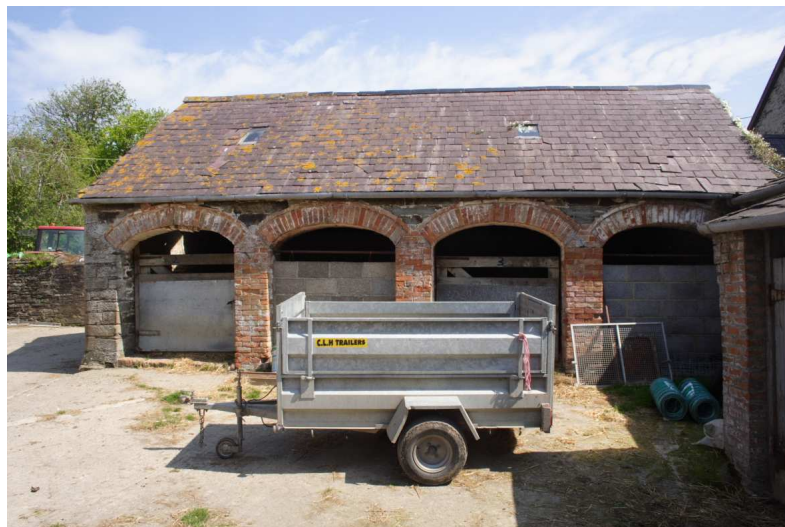
On the north east side of the farmyard is a four bay *stock shed*, of stone and slate construction with a brick rear wall, having four large red brick arched openings and facing onto the farmyard. The floor is of red brick construction. No original internal features survive.

The front elevation of the stock shed.

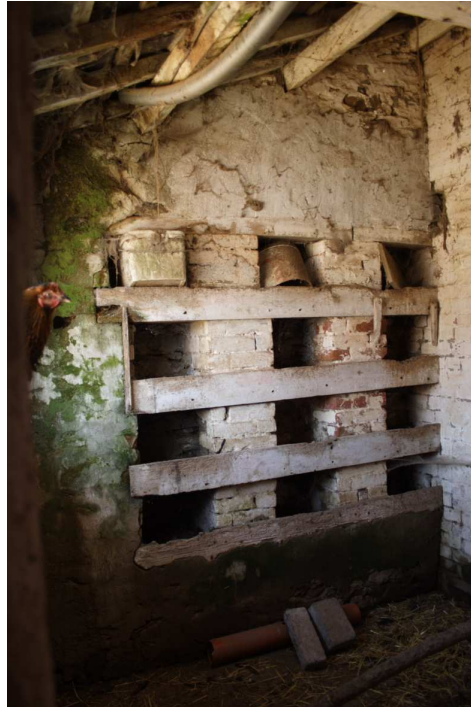
Nesting boxes inside the poultry house.

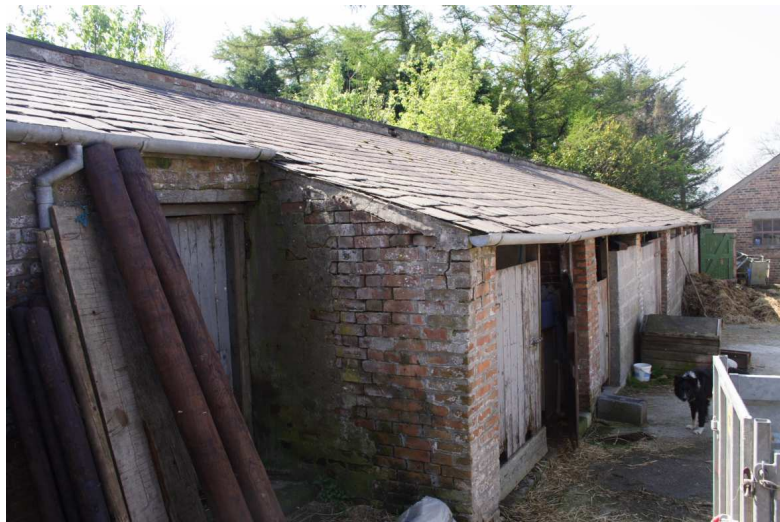
At right angles on the south east side of the yard is a long single pitched *poultry house and shelter shed* range of stone and slate roof construction, also with a red brick rear wall. The range is open fronted, with red brick piers originally closed off with double doors facing onto the farmyard. Few of the double doors now survive and many of the

openings have been blocked in. Internally a line of modern c.1950s cattle stalls back onto the rear wall. At the north-eastern end of this range, is the poultry house of mainly brick construction with several tiers of nesting boxes in the walls. A wide metal framed (c.1950s) window has been inserted into the front wall of this building.

Facing south along the front wall of the shelter shed.

The traditional farm buildings at Parc Twad are generally in a reasonable condition although some slates are missing or displaced from the roof of the barn range and the shelter shed opposite, whilst parts of the masonry walls are also in need of consolidation. The roof of the brick pigsty buildings adjoining the brew house is also in need of repair.

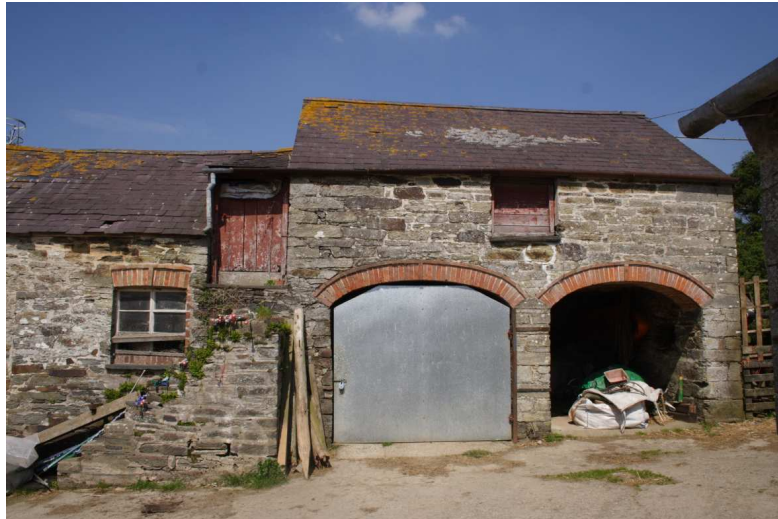
A *cart house* with joist floor to granary over with external stone steps against the gable end wall giving access to a granary door. Two large red brick arched cart openings face onto the farmyard below.

The front elevation of the cart house. Stone steps to the stable hayloft are visible in the left of picture.

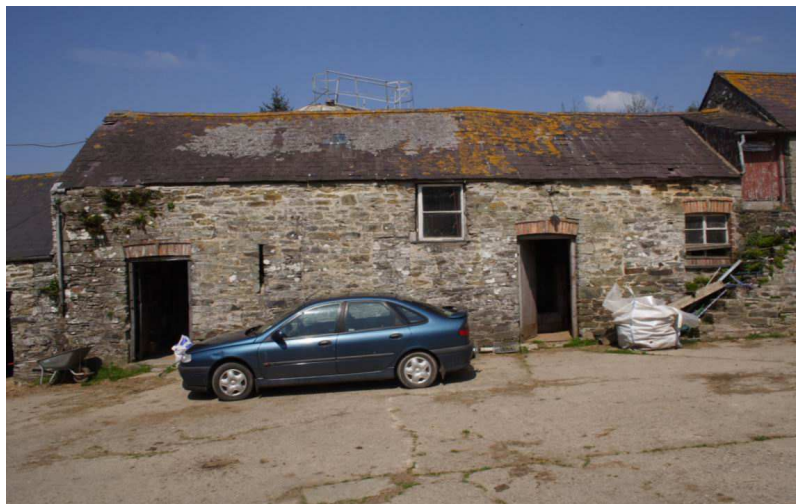
An adjoining stable with hayloft over, separated by a structural stone wall, with a wide doorway and small pane casement window in the front wall and an inserted metal framed window (c.1950s) in the rear wall. The hayloft is accessed externally through a dormer door up a set of stone steps in the front wall.

Next is the threshing barn, separated by a red brick partition, with opposed small doorways, once for hand threshing, and ventilation slits. The OS map of 1889 shows a horse “ginny ring” (now gone) in front of the range. The axle shaft opening survives in the base of the wall to the right of the doorway. Between the two doorways is a slate slab threshing floor. At the upper (north-east) end of this unit is an inserted window opening.

The middle part of the barn range showing the threshing barn to the left and stable to the right.

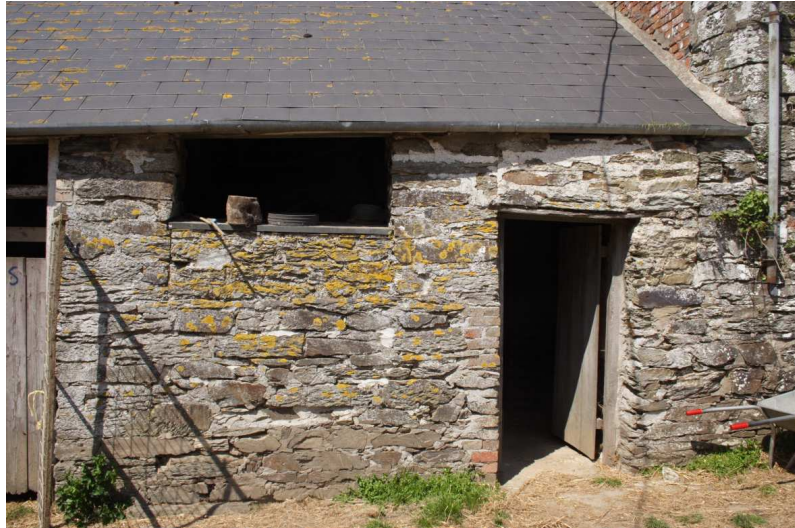
The lower part of the range is marked by a drop to single storey roof level. It has two inserted standard width doorways in the front wall and one standard width doorway in the rear wall. Any original internal arrangements have been lost and the original function is now difficult to discern, although latterly the building appears to have been used as a cow house. The absence of original doorways suggests that this part of the range would have been accessed from the threshing doors. One possible explanation is that it served as storage bays for crops. Along the front wall of the range are the

walled in remains of a series of evenly spaced rectangular window openings, which could have acted as pitching holes whilst providing added ventilation. Several identical blocked in openings are visible on the opposite (right) side of the threshing doors also.

The lower part of the range. The filled in remains of former openings are visible in the walls.
