# North Down Farm W/13/2812

## Tir Gofal Farm Visit Historic Environment Report

Report No. 2002/73

CAMBRIA ARCHAEOLOGY  
REPORT NO. 2002/73  
PROJECT RECORD NO. 44179

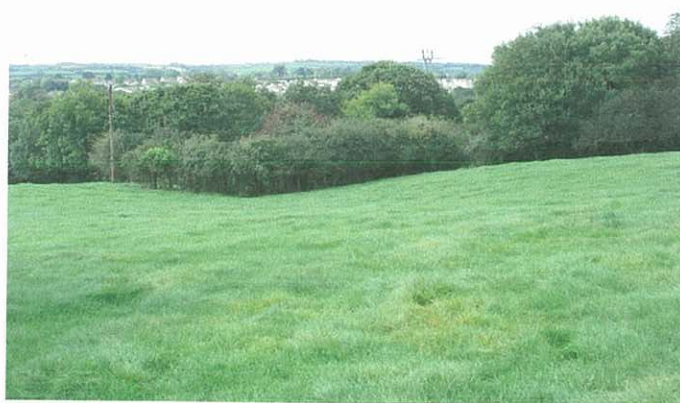
Although the site of the burnt mound (PRN 3512) is outside the farm boundary of North Down, it occupies a south facing depression of land straddling a water course and the farm boundary. This area is shown as a small enclosed area on the 1839 Tithe Map and apportionment for Lamphey parish and called 'Willow Hay'. It survives as an overgrown depression and is of no use as pasture.

Plate 1 – Area to the east of PRN 3512, 'Willow Hay'.

No ground disturbance should take place within this area and 'Willow Hay' should be retained as a visible landscape feature. If any clearance or woodland management works are to take place, please contact Cambria Archaeology in advance.

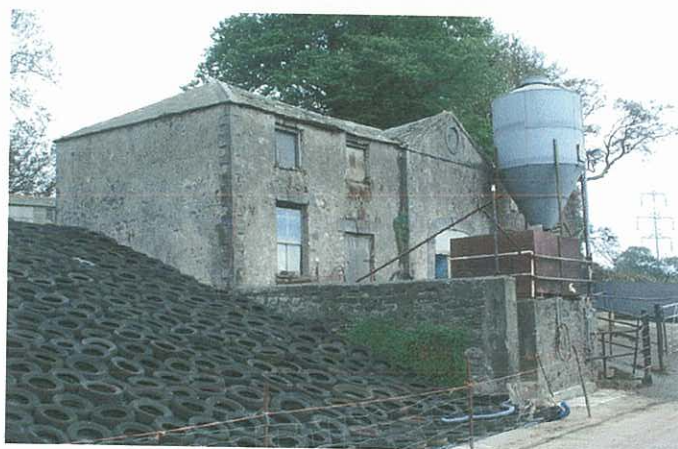
Plate 2 – Coach House PRN 45725

The building is in fair condition and its constructive reuse is to be applauded. Externally the rendered finish is wearing well but the arches over doors and windows are showing some degree of sagging. The real area of concern is the roof cover and structure below. Mr. Thomas, the farmer, stated that some of the trusses are in poor condition and from an external inspection the slating appears to be in a poor to fair condition with the cement skim (or grouting) in poor condition and in need of renewal

Maintaining the roof cover of this important building is essential to retaining the historic nature of the farm. If it is to be reroofed it would be essential to carefully remove the slates and reuse them

on the forward facing parts of the roof. This should help retain the character of the building and help reduce the cost of replacement slates. Any replacement slates should be a good match for the existing slates.

As no access was gained to the loft area, these recommendations cannot cover the roof structure itself.

It is recommended that any works to be undertaken on this building are run in conjunction with an archaeological watching brief and short programme of recording. Access to the loft area will provide evidence of the roof construction and may contain evidence of the functioning of the stables.

Before any works are undertaken consultation should be made to the relevant local government officers regarding Listed Building Consent and representatives of the appropriate special interest group

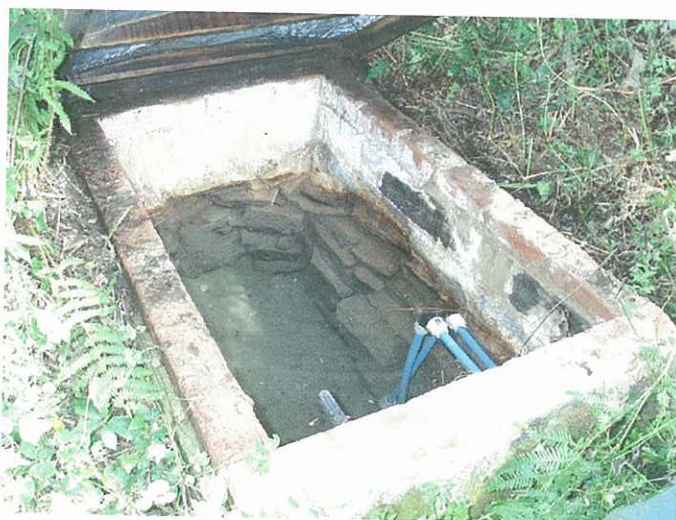
Plate 4 – Well PRN 45727

A dry stone and brick top course constructed cistern measuring 1 by 3 metres, located 60 metres to the west of North Down cottage. Currently in use as the main water supply for North Down cottage.

Maintain as existing.

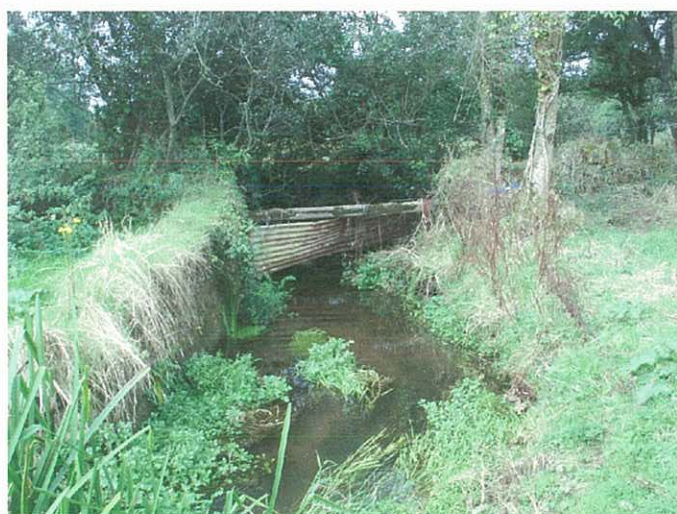
this point as been diverted to perform a dog leg north around the field boundary and then west again. Stone walls have been constructed to form the water course, and although they no longer appear as substantial above ground structures, they survive for at least 1 metre below the current ground surface.

Plate 5 – Site of possible mill PRN 45729

There should be no ground disturbance within 15 metres of the masonry remains. Selective clearance of any vegetation growing in or around the masonry will help to prevent any further damage or erosion of this site.

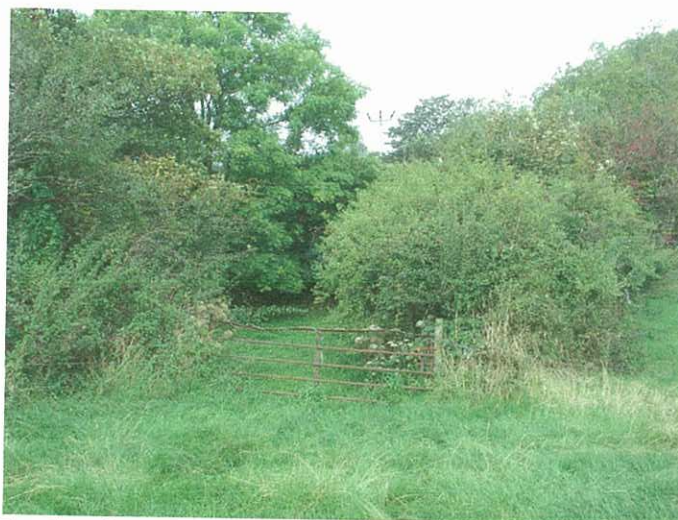
This is a triangular stone built enclosure at the head of Fifth Lane and adjoining the possible mill site (PRN 45729). It is shown on the first edition 25" map of 1866 as a water filled feature labelled as Callans ditch, although this may be a name with a much older origin, or indeed represents the right angled cutting (PRN 45729). The site also bears the abbreviation 'FW', denoting 'Face of Wall'. At the time of the site visit this site was largely overgrown and inaccessible, however traces

of the structure could still be seen and the farmer, Mr. Thomas, indicated that there were three access points into the enclosure from the surrounding fields.

Plate 5 – South east entrance to enclosure / pond site PRN 45730

They should be maintained as historic landscape features. Ideally the length of Fifth Lane (PRN 46523) and the enclosure should be cleared to allow access, and possibly further interpretation. There should be no ground disturbance within 15 metres of any surviving masonry remains. Selective clearance of any vegetation growing in or around the masonry will help to prevent any further damage or erosion to this site.

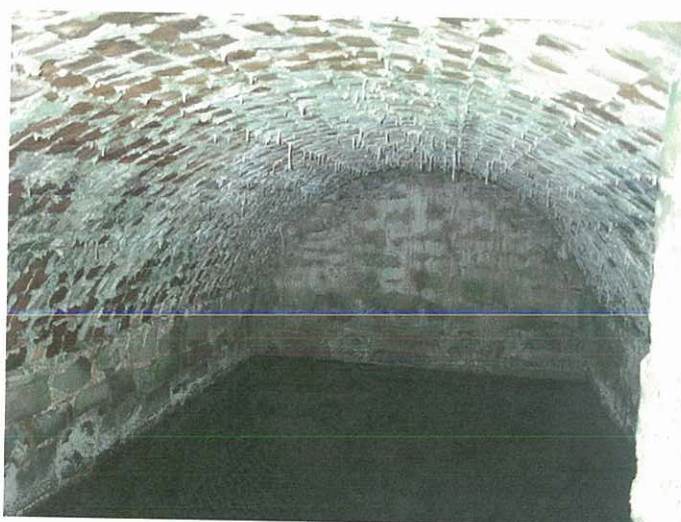
Plate 6 – Interior of PRN 45731

Survey map of 1908. It is built into the slope of the bank, measuring approximately 4-5 metres in length, 4-5 metres in depth, and 3 metres in width. As most of the cistern is buried in the slope of the bank, only the upper 1 metre of the front elevation is visible. Within this elevation an arched central opening provides access to the interior of the cistern, an oak door previously covered this opening, only it's frame now survives.

This well is used and maintained as part of the farm water supply system. It is recommended that it is maintained in its current condition, possibly restoring the door structure using timber and sympathetic methods.
