Pentwyn Mwyn W/12/2658

Tir Gofal Farm Visit Historic Environment Report Project Record Number 44211

Report No. 2003/51

Pentwyn Mwyn
Tir Gofal Farm Visit Historic Environment Report

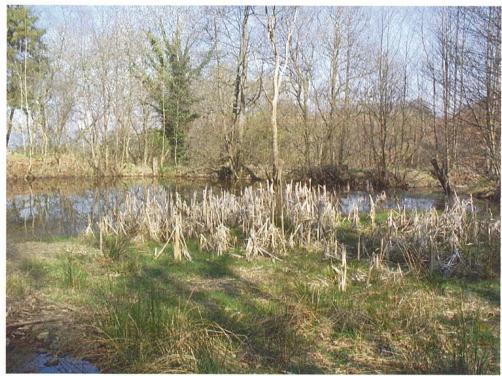
The south side of the pond (about a third of the total area) is blocked with bulrushes and silt, and this has formed an almost solid layer which is to be removed during the proposed restoration works. Immediately south of this silt is a slight earthwork which represents what is probably an older pond bank.

The pond has been formed by damming the stream in a small valley, and the north bank of the pond (see picture below) is an earthen dam which stands around 4.5m tall at its highest point. About a quarter of the circumference of the pond is bounded by the dam at this height, in the steepest part of the valley. Either side, as the slope of the valley sides becomes less steep, the dam becomes smaller until, in the south (the foreground of the photograph below) the pond bank is only a slightly raised earthwork. The top of the dam is between 1 and 2m wide along its length.

Plate 1. The area in the middle ground, seen as a patch of rushes and grass, is part of the modern silting which is to be removed. At the right hand side of the picture, next to an old tree stump, is the point at which water rejoins the stream, via a narrow channel. In the foreground, in front of the rushes, a slight earthwork shows the line of the old pond bank. The far bank of the pond is an earthen dam which stands to between 4m and 5m high.

The removal of modern silt and rushes should only continue as far as the original bank in the south. When working back from the banks it should be ensured that no material is removed from the banks themselves. Extreme care should be taken in the vicinity of the present exit from the pond since there is the potential that remains of a sluice or other mechanism are still present.

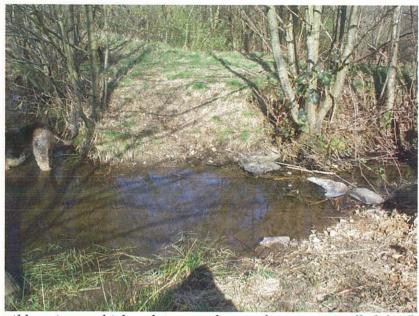
The other possible location is at the point of the present exit from the pond, in the northeast. The stream at this point is quite narrow, and easy to block. Currently, a series of large stones are visible at approximately the position where a sluice would be expected (see plate 2).

Plate 2. The possible point at which a sluice or other mechanism controlled the flow of water from the pond.

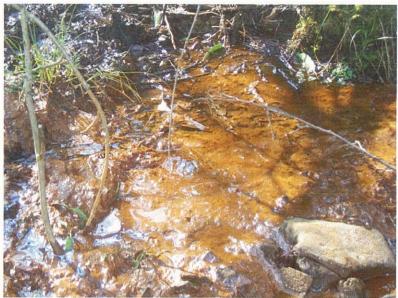
Plate 3. A small area of exceedingly iron rich water, just north of the dam. Mineral rich water is typical of mining areas, though it normally affects whole watercourses rather than isolated areas like this.
