## **Tir Gofal Farm Visit Historic Environment Report**

**PENLAN FARMSTEAD**

Report No. 2002/85

REPORT NO. 2002/85  
PROJECT RECORD NO. 44213

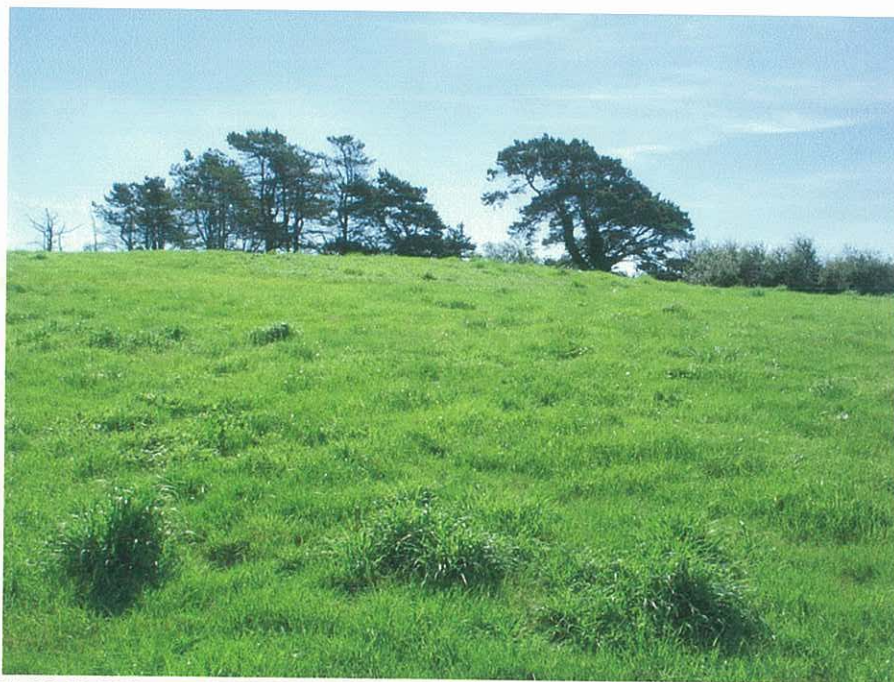
Although there is little indication of the hillfort on the ground, there are probably sensitive archaeological deposits surviving below ground level. It seems likely that the current field boundary to the south and west may indicate the line of the defensive bank and ditch; indeed the existing boundary banks may well be the remnants of the ramparts.

PRN 3963 PEN Y GAER HILLFORT – viewed from the north west.

The site of the hillfort is currently under permanent pasture and appears to be under no threat with the current management regime. Any renewal of the fencing in this area should ideally cause as little disturbance as possible, using the existing fence line and post holes where possible. Please consult with Cambria Archaeology if this is being considered. Any ground disturbing activities in this area should be avoided.

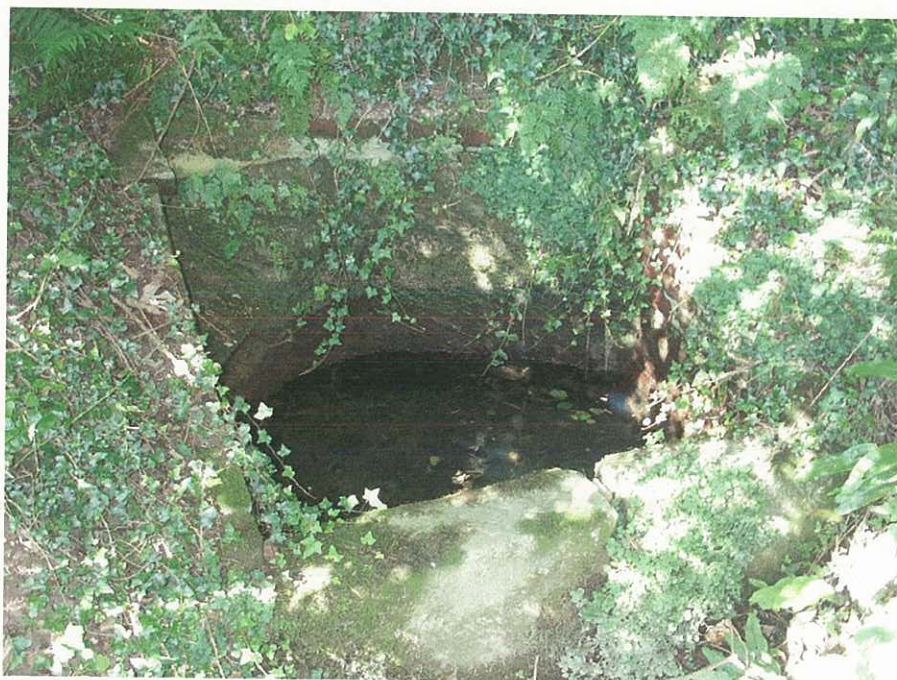
A well is situated to the west of the historic farmstead of Penlan to the north of the farm trackway. It is cut into the rock with a brick built coping. Remnants of a sloping roof can be identified though the well is now uncovered. A post to the south remains, part of an electric pump and hoist which served the well.

PRN 45056 PENLAN WELL – situated to the north of the farm track

If there are any works to be carried out on this well, please inform Cambria Archaeology.

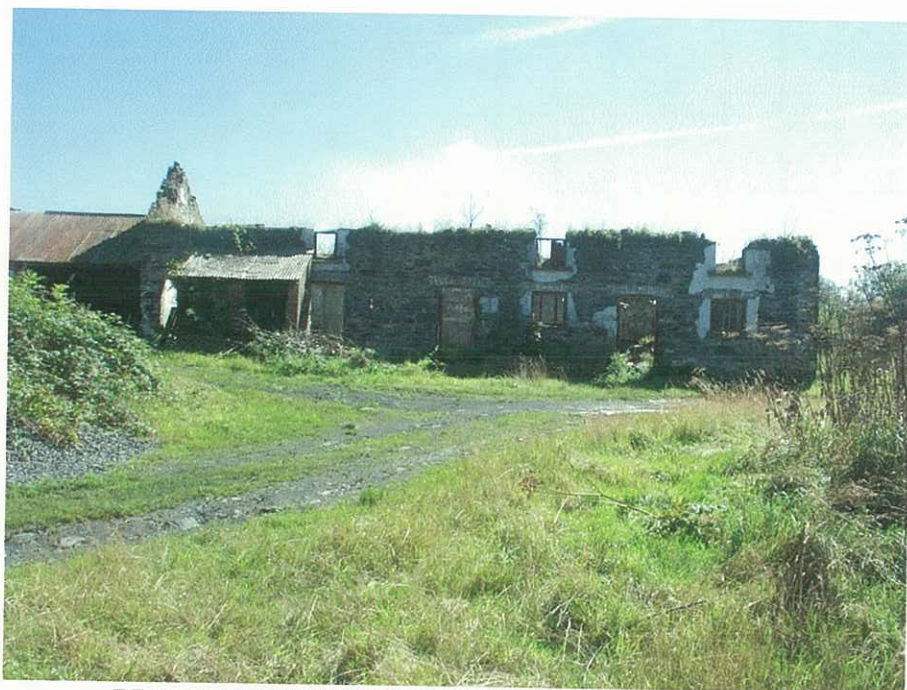
A stone built range situated on the south side of the old farmyard, orientated on a roughly east – west axis. This two storey building has lost it's roof in recent years and the west (gable) wall has largely collapsed together with the western end of the south wall. The building appears to have functioned as a stable at the west end with a central doorway flanked by window openings to either side. At the east end the remains of cow stalls remain, accessed by a central transverse doorway with opposing doorway to the south, leading to a central feed passage with flanking manure passages to either side. The double cow stalls are partitioned in large pieces of slate. Vegetation has begun to become established within the exposed wall tops and within the building.

PRN 45737 PENLAN – combined stable and cowshed

Intrusive woody vegetation which is growing within the masonry or building itself should be cut back and the roots treated to prevent regrowth. The wall tops should be consolidated and capped to prevent further water penetrating the wall core and eroding the masonry bonding. In the event of the building undergoing further restoration works it is advised that a photographic record should be carried out, before and during the works being carried out.

The owner hopes to be able to undertake its restoration at some time in the future and this would be a very worthwhile project. In the short term, the building should be maintained in as stable a condition as possible. In the longer term this building could potentially be restored and reused. Intrusive woody vegetation which is growing within the masonry or building itself should be cut back and the roots treated to prevent regrowth. The wall tops should be consolidated and capped to prevent further water penetrating the wall core and eroding the masonry bonding. In the event of the building undergoing further restoration works it is advised that a photographic record should be carried out, before and during the works being carried out.

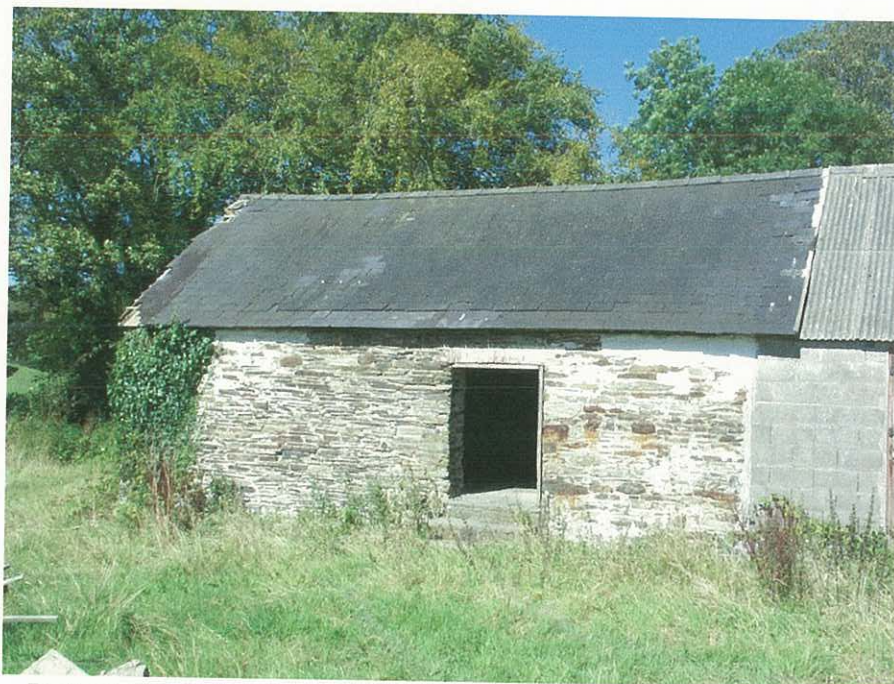
A stone built range is situated to the north side of the farmyard. The west end of this range is stone built with a slated roof, to the east is a brick/breeze block extension with a corrugated asbestos roof. The lower barn, to the west is of great interest, with the remains of a drive shaft and internal fly wheels at the west gable end driven by some form of external engine on the north side. The slate roof is in a poor condition and the supporting timbers are beginning to fail. The stone work appears to be in a fair condition, although in some areas the pointing has eroded.

PRN 45738 PENLAN BARN – with drive shaft surviving internally

This building would also be a worthwhile restoration project especially considering the owner is keen to undertake the repair and maintenance of the building. The slate roof requires urgent repairs before water ingress begins to damage the masonry structure. The stonework should be repointed using lime mortar.

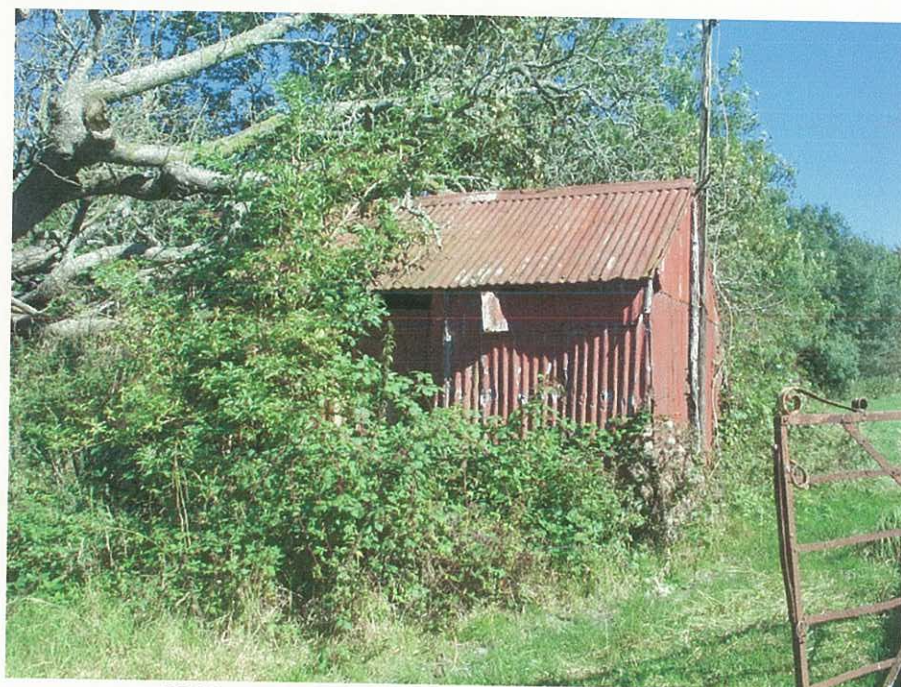
A small rectangular corrugated iron shed is situated to the east of the farmyard set on a concrete hardstanding.

PRN 45744 SHED – part of Penlan Farmstead

Although this shed is a relatively recent addition to the farmyard it is nevertheless historically significant. Increasingly structures such as this are lost. This small building makes an important historical contribution to the overall character of the farmyard.
