# **Grondre Fach W/13/3174**

## **Tir Gofal Farm Visit Historic Environment Report**

Report No. 2002/67

18<sup>th</sup> September 2002

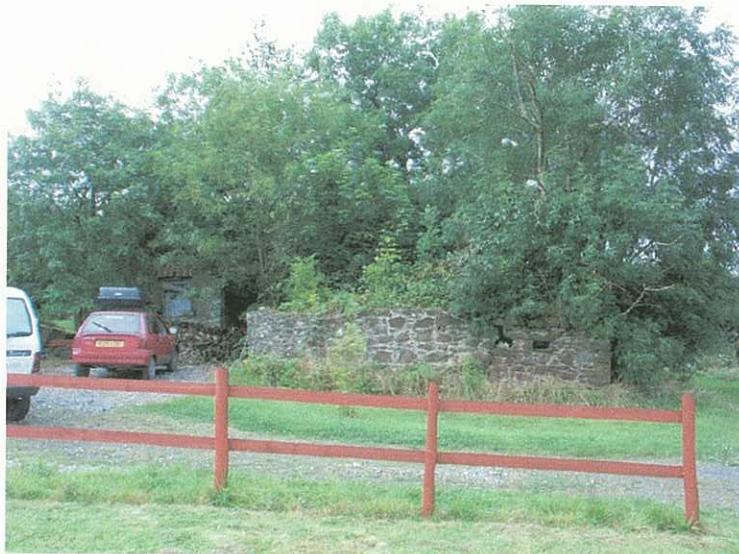
Plate 1 – the building from the south east

The main threat to the building are a range of very large trees growing very close to the walls and also within the building, as well as some ivy and bramble growth.

The prospect of consolidating this building is to be welcomed. The building evidently suffers from a number of structural faults as well as extensive intrusive woody growths, but attempts should be made to make safe and stabilise the structure.

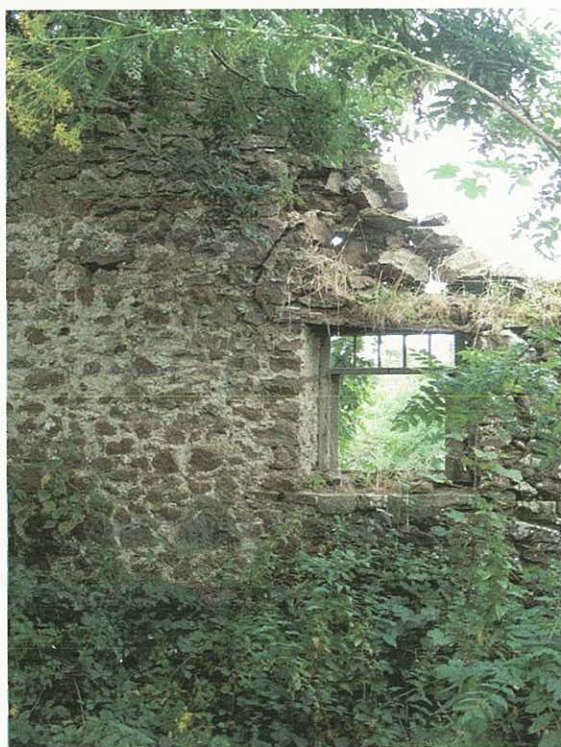
Plate 2 – decayed lintel and stonework above

Where vegetation growth has caused a particular structural fault, most notably to the stonework on the south side of the pigsty, consideration should be given to more specific repair and consolidation work in order to ensure the safety of the building. The decayed lintel over the window in the east wall is of particular concern, the stonework above is in an extremely precarious state as it is no longer bonded, and together with the lintel, is supporting much of the weight of the gable and any further deterioration would bring about a serious collapse of stonework. In both of these cases general vegetation clearance should not take place until the structure of the building is stabilised.

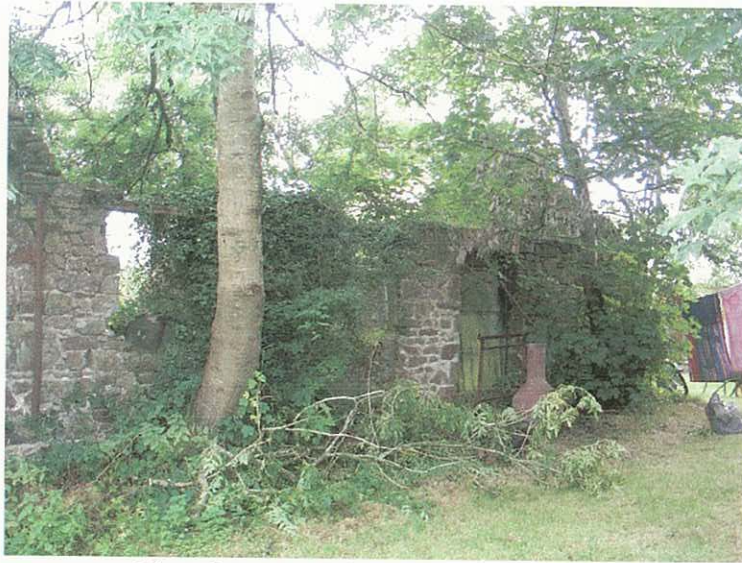
Plate 3 – vegetation around north face

The trees surrounding, and also within the building should be cut down and at the same time any damaged masonry that is revealed should be repaired using traditional materials. Attention should also be paid to the treatment of tree stumps to prevent re-growth in further seasons and thereby preventing potential problems caused by roots.

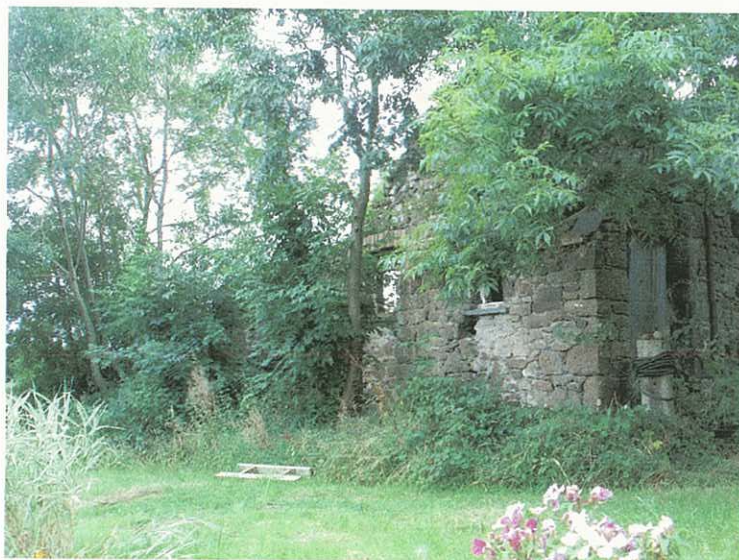
Plate 4 – vegetation around east face

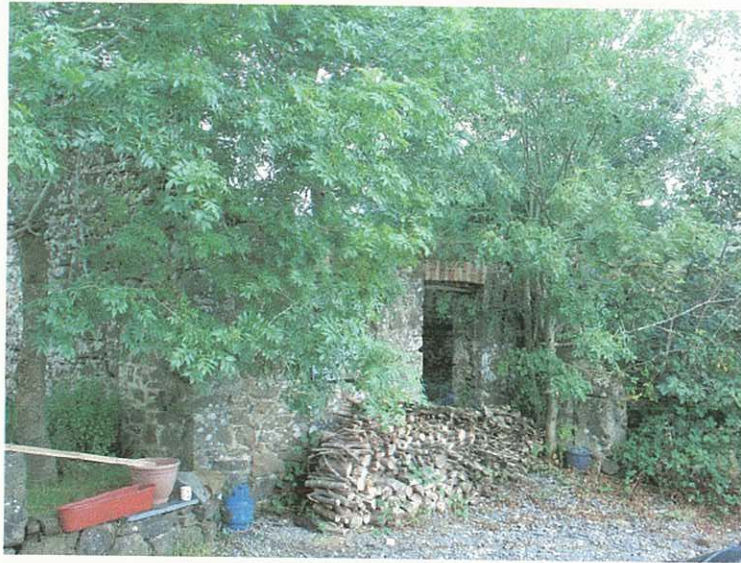
Plate 5 – south face and doorway
