Cwmrhyddan W/12/3021

Tir Gofal Farm Visit Historic Environment Report Call Out

Report No. 2002/102

Cwmrhyddan
Tir Gofal Farm Visit Historic Environment Report
Call Out

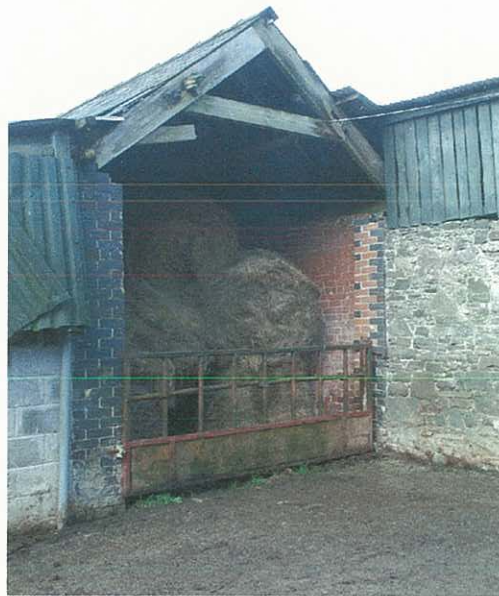
Plate 1 – The east end of the hay barn

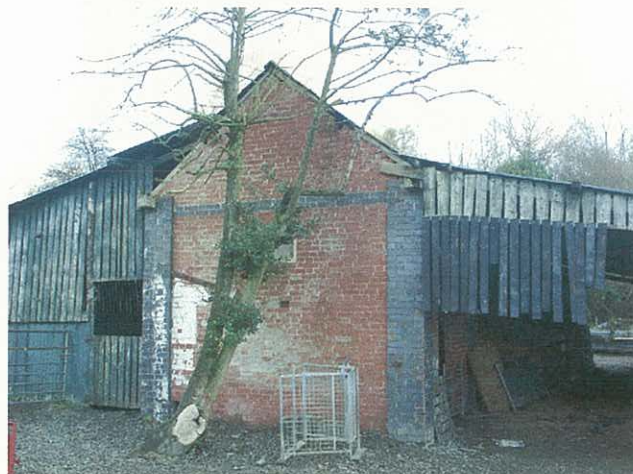
Plate 2 – The west end of hay barn

Consideration should also be given to any excessive nearby tree growth, especially at the west end of the hay barn, in order to prevent damage. Also the long term structural integrity of the surrounding outbuildings at Cwmrhyddan should be given consideration. Please contact Cambria Archaeology for further advice if works are planned for the other outbuildings.

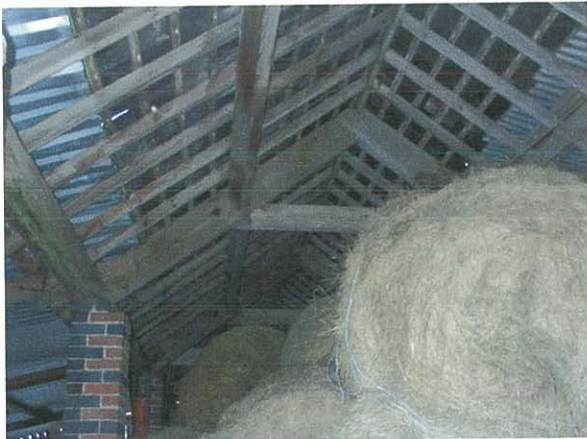
Plate 3 – Hay barn roof internal

The roof trusses appear to have survived in reasonable condition except the ones at each end. Once the roof cover is lifted closer inspection of the condition of each truss will be possible. However, the presumption should be to minimal repair rather than wholesale replacement. Where

replacement is absolutely necessary careful attention should be made to the choice of replacement timber and the style of construction. The wall plates would appear to be in poor condition and will probably need replacing. Again any replacement should be an appropriate material and stylistic match for the original.

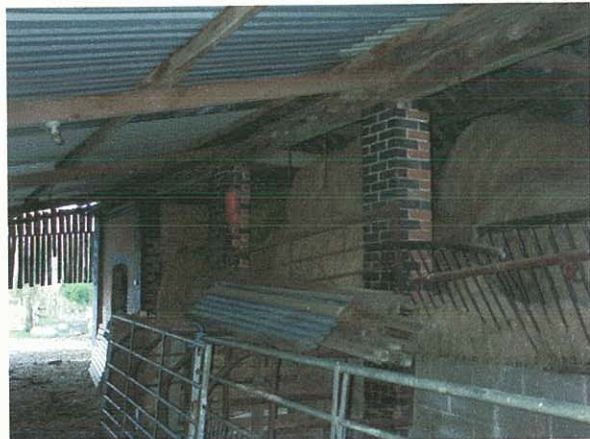
Corrugated sheet extensions have been added to both the north and south faces of the hay barn. Their cat slide roofs adjoin the slate roof of the hay barn above wall plate height. This has resulted in the removal of the slate roof covering of the hay barn below the junction with the corrugated sheet roof.

Plate 4 – South face of the hay barn, view west

Ideally the slate roof of the hay barn should be completely reinstated and the roof of each modern extension lowered so that they sail off from the wall plate level of the barn. This will produce a more effective weathertight roof cover, as well as one which preserves the structural and stylistic integrity of the original structure. If this is not to be done and the current roof system is maintained then it is essential that any open areas at each end elevation are boarded or in some way enclosed.

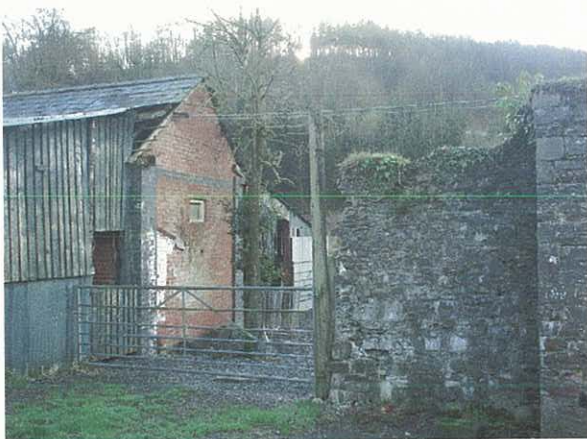
Plate 5 – North west corner of the hay barn

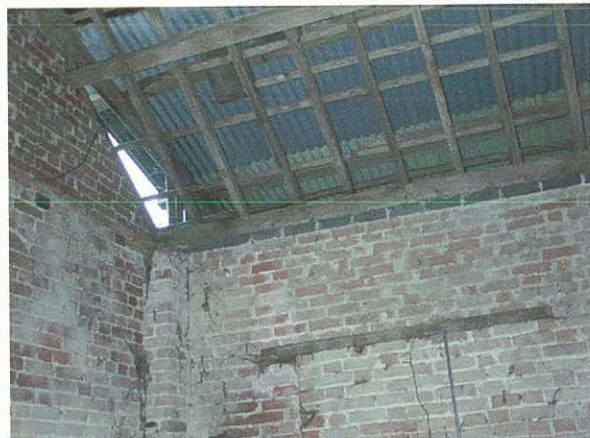
Plate 6 – North wall, internal face

The brickwork of the supporting piers' especially at the top, should be made good, using appropriate matching brickwork and a suitable lime based bonding material. Any hungry joints in the brickwork should also be repointed using a suitable lime mortar.

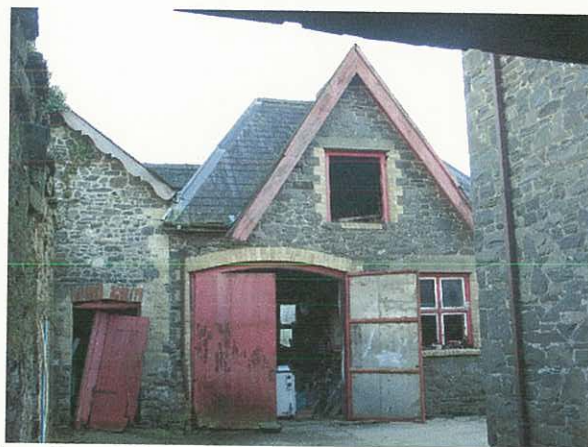
Plate 7 – W face of the coach house at Cwmryddan

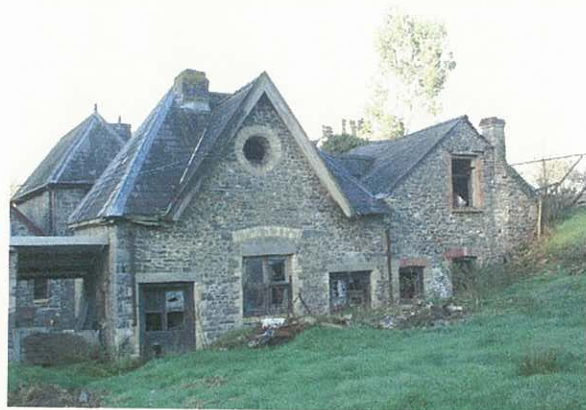
Plate 8 – E face of the coach house at Cwmryddan
