TIR GOFAL FARM VISIT REPORT CERRIGANAU

Report No. 2002/38

APRIL 2002

CERRIGANAU
Tir Gofal Farm Visit Report

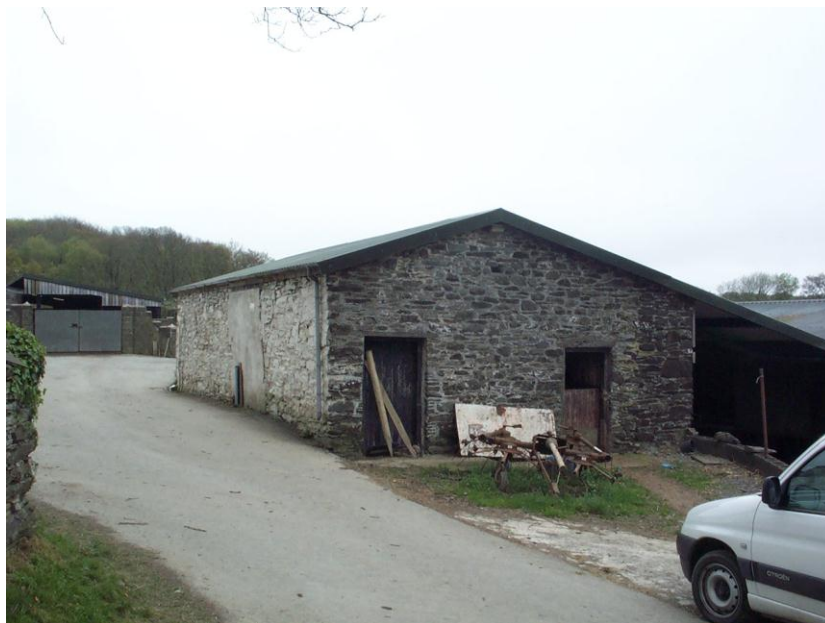
The cowshed is constructed from random rubble, with a slate gabled roof. The building has been altered in the recent past, when the north wall was rebuilt and the building re-roofed to include a large lean-to shed to the north. A blocked opening visible at ground level in the south elevation, is evidence of much earlier alterations. This building is in good condition.

PRN 44863, cowshed showing the modern extension to the rear.

The yard buildings should be maintained in their present condition. The roof structure on the possible pigsty building could be repaired using traditional materials.

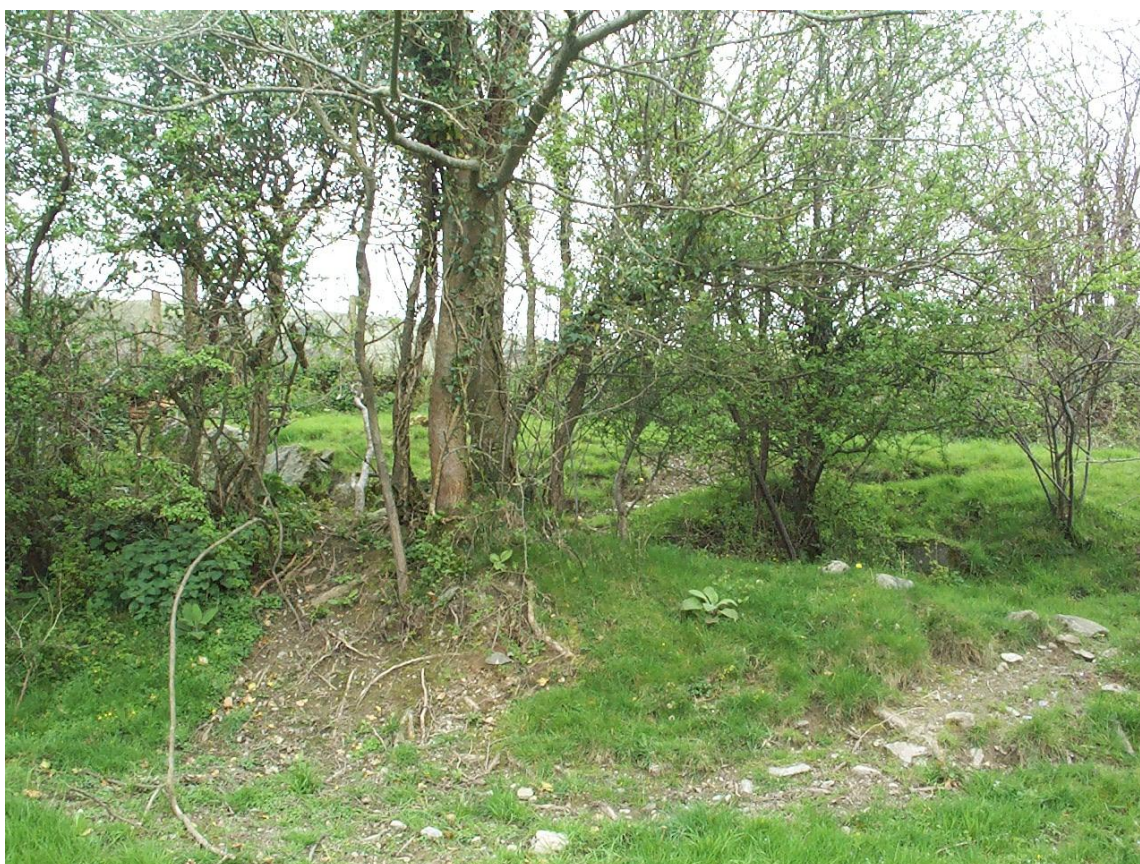
A group of three structures shown on the Llanfair Genau'r glyn Parish tithe map of 1847 as cottages and gardens. They had disappeared by the time the Ordnance Survey 1st edition 1:10560 map (sheet Cards.III.NW) was produced in 1891. There are no above ground remains of any of these structures, although a probable building platform and a stone-faced bank do survive. This site is currently excluded from major farming operations such as ploughing, but there is some erosion from animal tracks.

PRN 44864, a raised platform and several banks are all that remain of a small group of cottages. Note the erosion of the animal tracks across the banks.

Maintain this site in its current condition and continue to exclude the area from ploughing or other ground breaking operations. Restrict animal numbers on the site, although regular grazing will prevent the site from becoming overgrown.

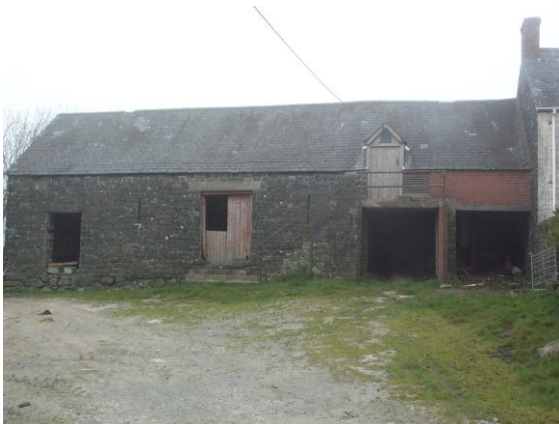
The barn is currently in good condition and both the roof structure and the walls appear sound.

PRN 44865 18th century threshing barn showing cart openings and central winnowing door

This building should be maintained in its present condition and the cobbled threshing floor should be retained. Regular monitoring should be carried out to identify any defects before they can cause structural problems. Any repairs that are required should be carried out using traditional, preferably local materials to retain the overall character of the building.

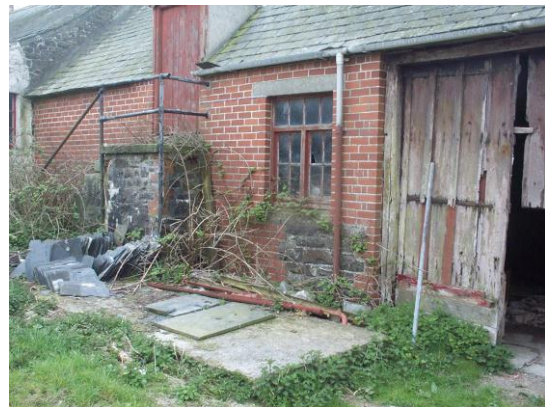
PRN 44865 wheel pit capped with concrete in 1961. Note the extensive rebuilding.

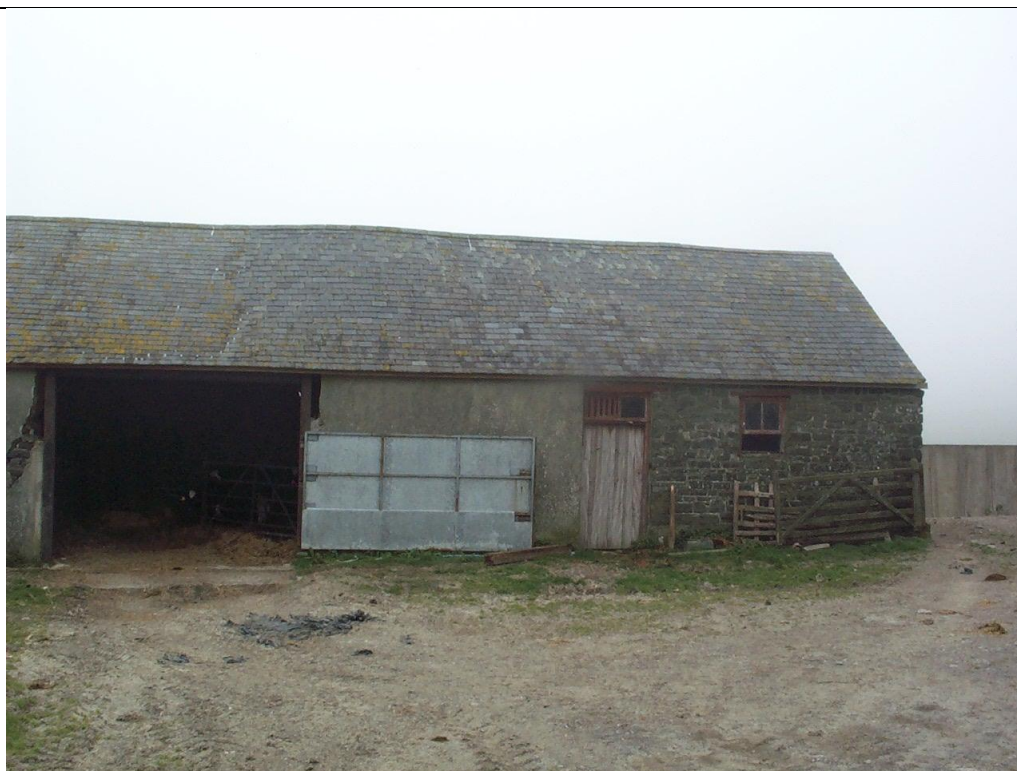
Single storey cowshed, constructed from roughly coursed rubble with a slate gabled roof. This building was shown on an 18th century estate map (NLW ref: Gogerddan Collection R.M. B86), but it has been heavily altered since. The central section has been adapted to a loose shed by removing the front, southeast facing, wall. It is possible that only the northeast end of the building survives to any great degree in its original form, although, even this has been altered by the insertion of simple square headed openings. The building is in good condition and the roof structure and walls appear sound.

PRN 44867 northeast end of 18th century cowhouse.

Maintain this building in its present condition. Regular monitoring should be carried out to identify any defects before they can cause structural problems. Any repairs that are required should be carried out using traditional, preferably local materials to retain the overall character of the building.

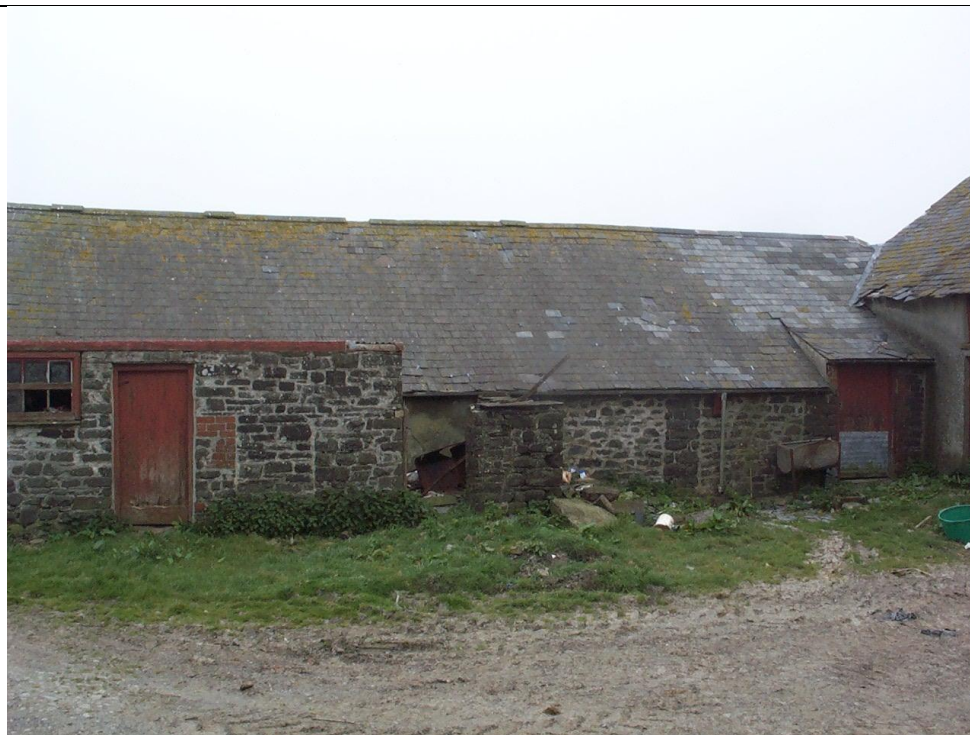
Recent renovation has included replacing some of the roof structure. A later addition on the northeast wall housed a single in-and-out pigsty and possibly a small boiler house for preparing feed. There is slate feed chute in the yard wall of the pigsty.

PRN 44868 former loose shed showing blocked openings and pigsty.

This building should be maintained in its present condition. Ongoing renovation works on the building should retain its historic character.

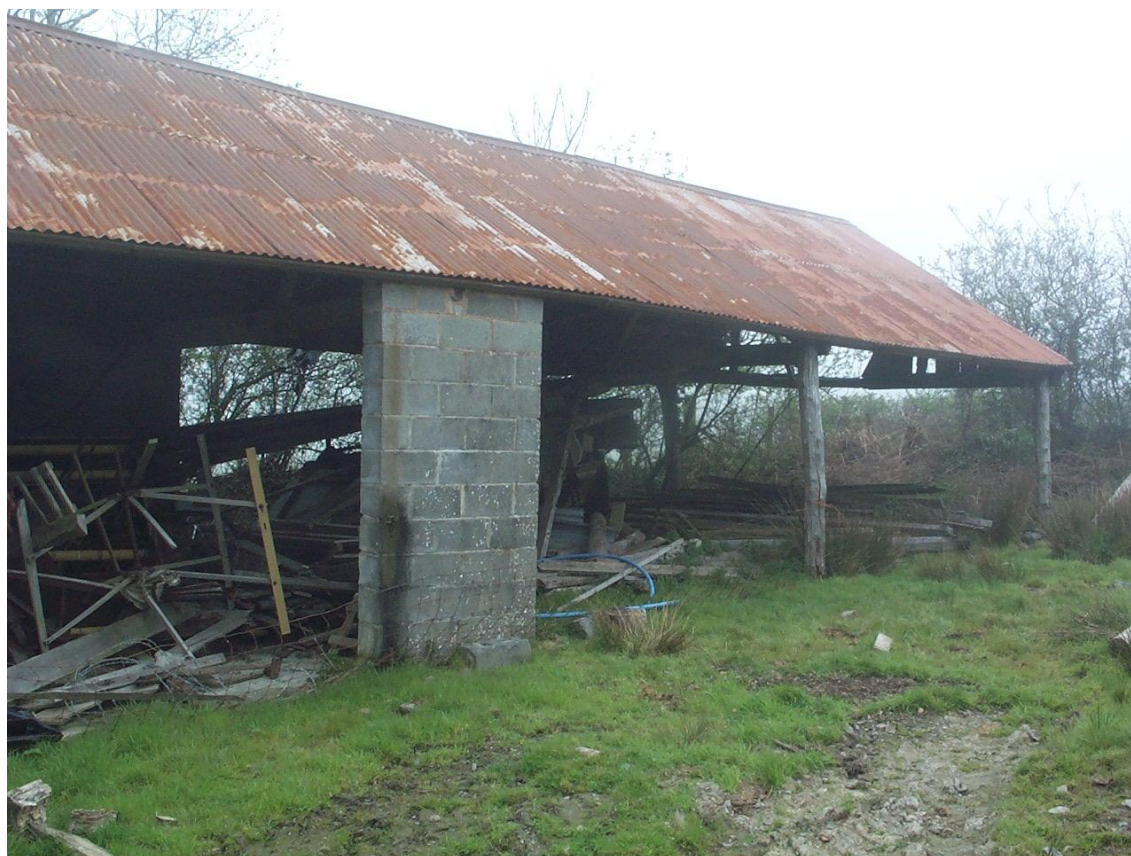
Open hay barn, first shown on the Ordnance Survey 2nd edition map (sheet Cards.VI.NW) of 1906. The barn consists of timber uprights supporting a corrugated tin roof. The southwest end has been partially rebuilt in concrete blocks.

PRN 44869 Open hay barn, first shown on Ordnance Survey 2nd edition map of 1906.

Maintain this building in its present condition. Regular monitoring should be carried out to identify any defects before they cause major structural problems, particularly to the roof structure.

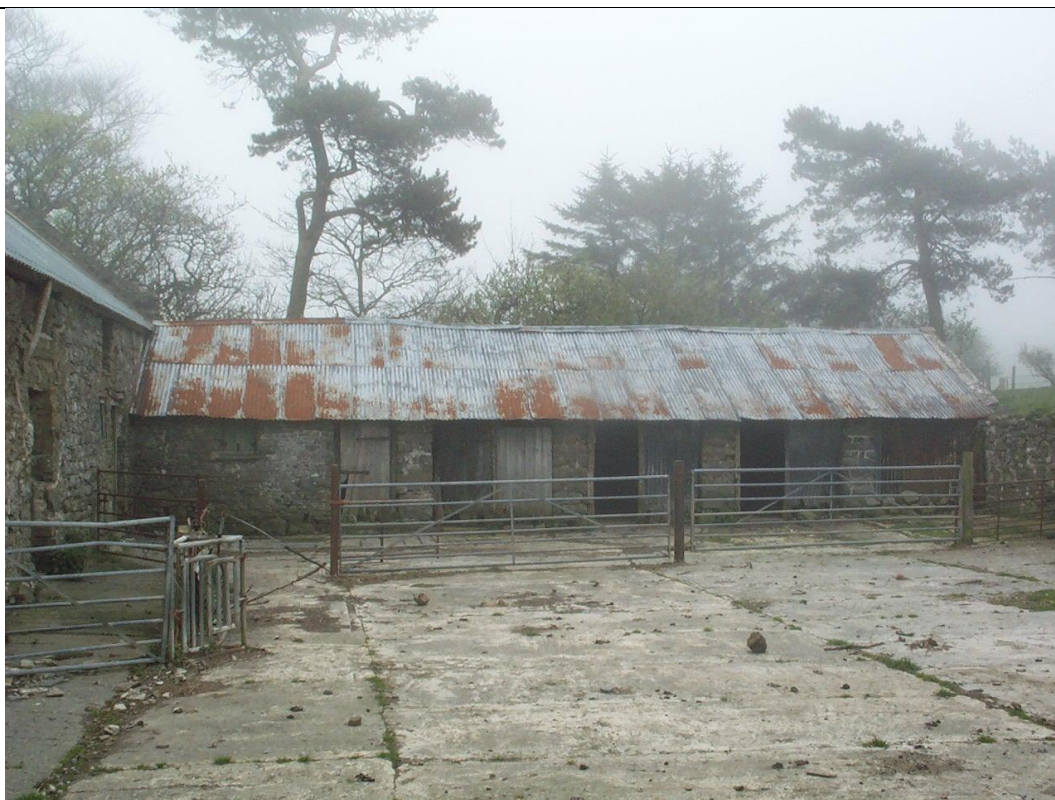
Small cowhouse and loose sheds opening onto a yard. This building was first shown on the Ordnance Survey 1st edition 1:10560 map (sheet Cards.VI.NW) published in 1891 and it was constructed as part of a major rebuilding programme that also included the construction of the house on its present site. The building is of rubble construction with a slate gabled roof. The piers for the loose boxes are of stone. The loose box openings have been partially blocked using corrugated tin and concrete blocks.

PRN 44870 Cowshed and loose boxes.

This building should be maintained in its existing condition. Regular monitoring should be carried out to identify any defects before they cause major structural damage.

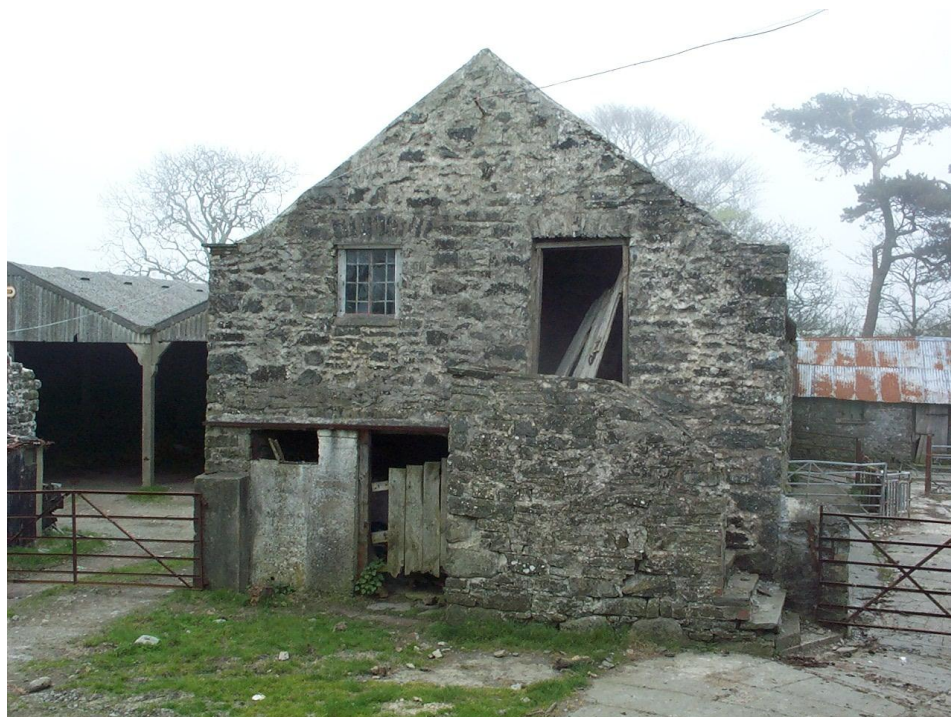
PRN 44871 the northwest gable wall of building showing blocked cart opening and stone steps to first floor granary.

This building should be maintained in its present condition. Specialist advice should be sought on how to preserve the section of clom walling. The building should be considered for a visit from the Royal Commission on the Ancient and Historic Monuments of Wales to provide a more detailed inspection and survey.

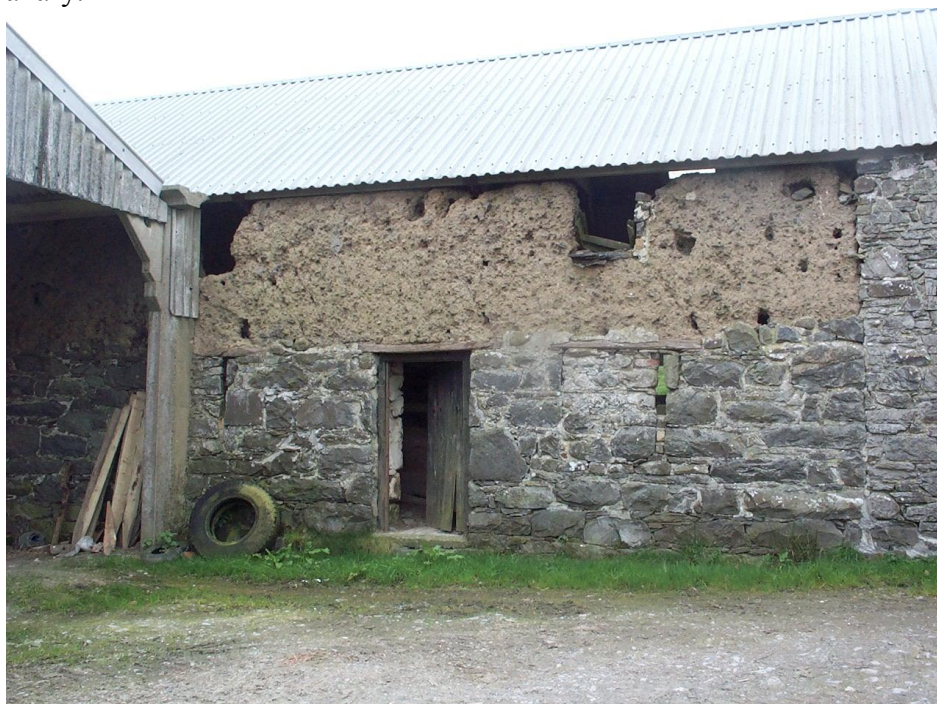
The northeast wall of the ground floor of the central section has two vent loops, which appear to have been adapted from larger openings, which clearly indicates a change of use for this section of the building. It is possible that this was the original farmhouse, converted to agricultural use when the new house was built during the expansion of the farm in the mid- to late-19th century. More detailed recording and analysis is required to unravel the complex history of this building. The building is in generally good condition, with a new roof, although the sections of clom walling are vulnerable to weathering.

PRN 44871 the central section of the building showing the clom wall to the loft. The vent loops on the ground floor have been adapted from larger openings. The break between the central section and northwest section of the building (to the right) is clearly visible.

PRN 44871: The building should be maintained in its present condition and specialist advice should be sought on how to preserve the sections of clom walling. This building should be considered for a visit from the Royal Commission on the Ancient and Historic Monuments of Wales in order to carry out a more detailed inspection and survey.

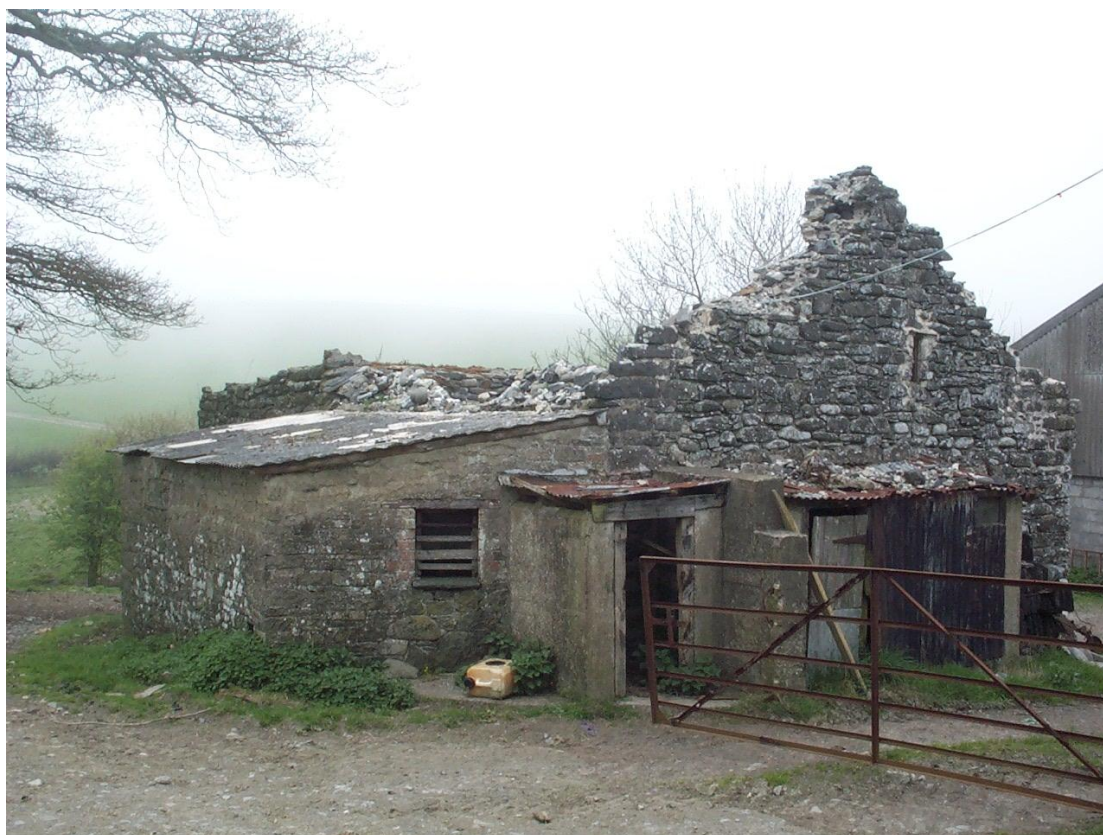
A small stone-built barn, which formerly had a gabled roof. This building appears to have been shown on an 18th century estate map (NLW ref: Gogerddan Collection R.M. B86). The walls are stable, but the roof has gone and the roof structure removed, although the slates have been saved by the owner.

PRN 44872, small 18th century barn, with oil-pump engine house extension.

The surviving walls should be maintained in their present condition. Any areas of loose or unstable masonry should be consolidated and made safe. Consolidation works should be carried out using traditional, preferably local materials.

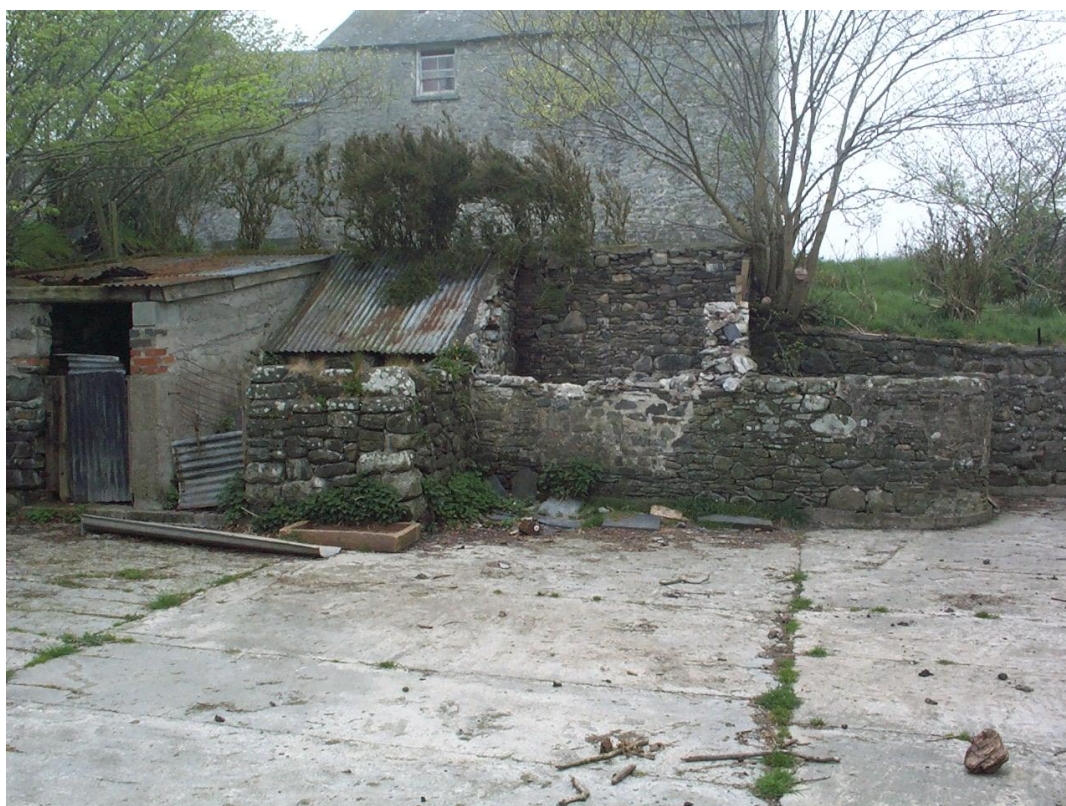
Two in-and-out pigsties constructed sometime between 1891 and 1908. Stone-built with pitched corrugated zinc roof. Only of the sties is still roofed. The surviving roof and the walls are sound.

PRN 44873 late 19th century pigsties with a small shed to the left of the photograph. Although small, these structures could still be used as lamb or sheep holding pens.

Maintain the pigsties in their present condition. These structures could be brought back into use as lamb or sheep holding pens.
