Report No. 2003/10
Report Prepared for:
Countryside Council for Wales

REPORT NO. 2003/10
PROJECT RECORD NO. 45640

Cwmtywyll
W/12/2878
Tir Gofal Farm Visit Historic Environment Report

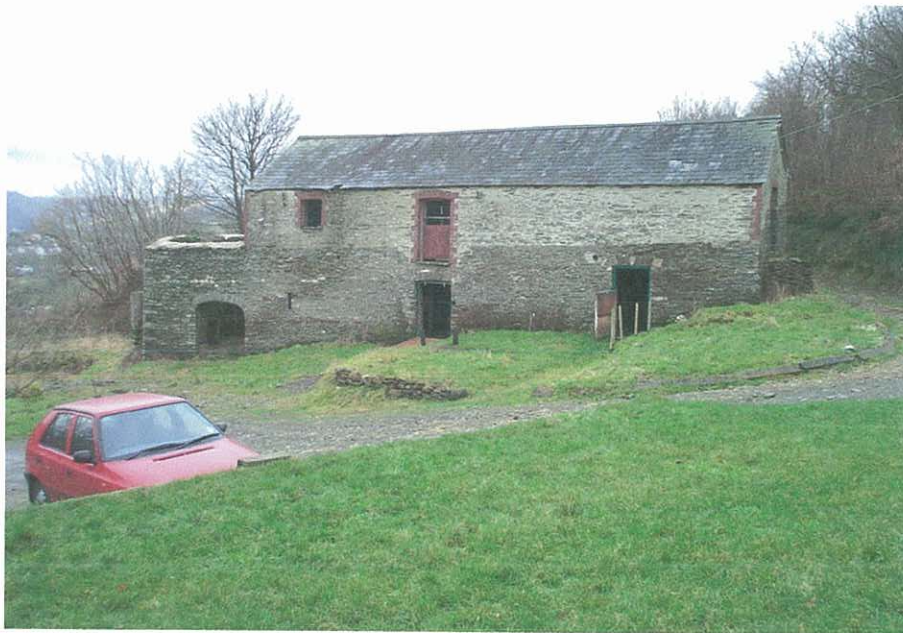
Plate 1- western elevation from farmyard

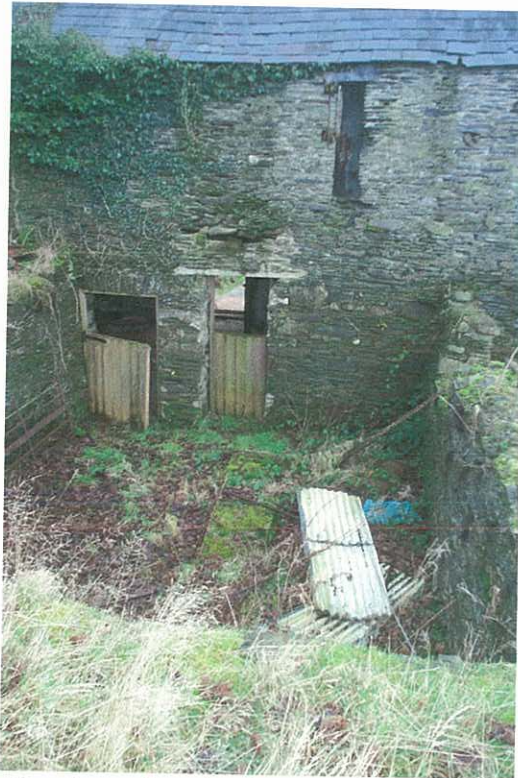
Plate 2- view of engine house with engine mount

An engine house to the rear (east) of building with cement mounting for a possible oil engine was constructed in rubble with lime mortar and possibly a corrugated iron roof. The roof has collapsed and much of the roofing debris remains within. No traces of the original engine workings survive. The engine house appears on the 1881 Ordnance Survey map and was built onto the eastern lateral wall sometime before this. A slot appears to have been created in the eastern lateral wall of the main building to permit access to a horizontal drive shaft mounted on the wall interior.

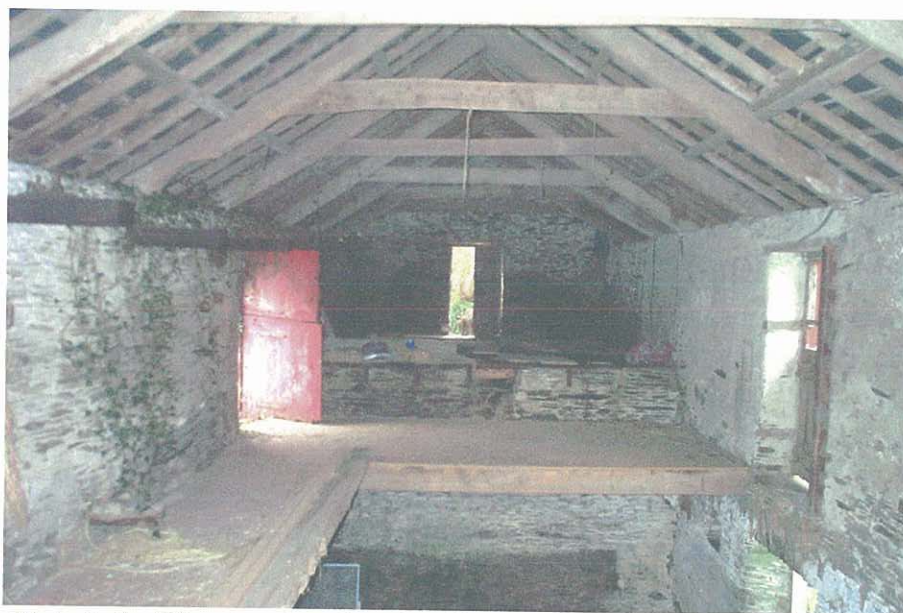
Plate 3- building interior showing floor removed from central section.

The floor has been largely removed from the central section of the upper storey. This may be exacerbating the structural problems. The interior of the eastern lateral wall retains four mounts with the retaining brackets for a large horizontal drive shaft. Neither the drive shaft nor any gears

It is possible that the removal of floor joists in the central building bay may be directly contributing to building instability, as the building is no longer benefiting from their stabilising influence. Ideally, these floor joists should be replaced in the traditional way in order to regain maximum structural stability necessary for long- term building survival. The upper storey of the south bay is presently in a precarious condition. Care should be taken during any restoration works not to damage or destroy the historic wooden stalls and hay rack, which survive in the cow house beneath. The cobbled floor of the cow house survives in remarkable condition. If any cobbles become loose or dislocated they should be stabilised using a traditional lime mortar mix.

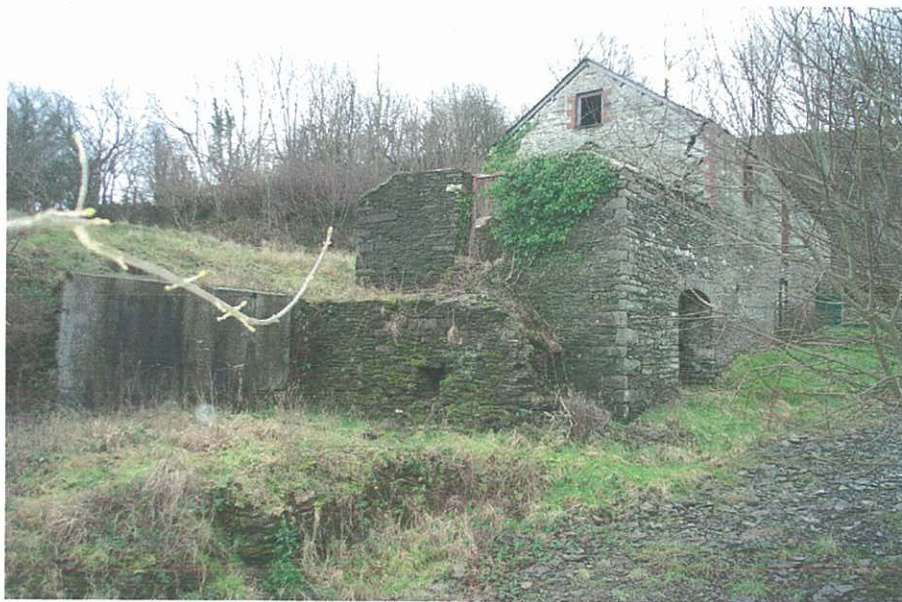
A building has been built onto the north of the main building range but is not part of the original structure. Now derelict, only the eastern lateral wall (revetted with concrete) survives. A concrete building platform and traces of the western lateral wall indicates its former extent. Of particular interest is a kiln, which survives in the northern wall. The chimney has since been dismantled and is now capped by a large slate. The ruinous condition of this building makes assigning function difficult, although it may have been a corn drying kiln.

Plate 5- the building to the north of the main building range, the kiln entrance can be seen facing.

The kiln is an important historic feature. Any loose materials should be stabilised using traditional building techniques.

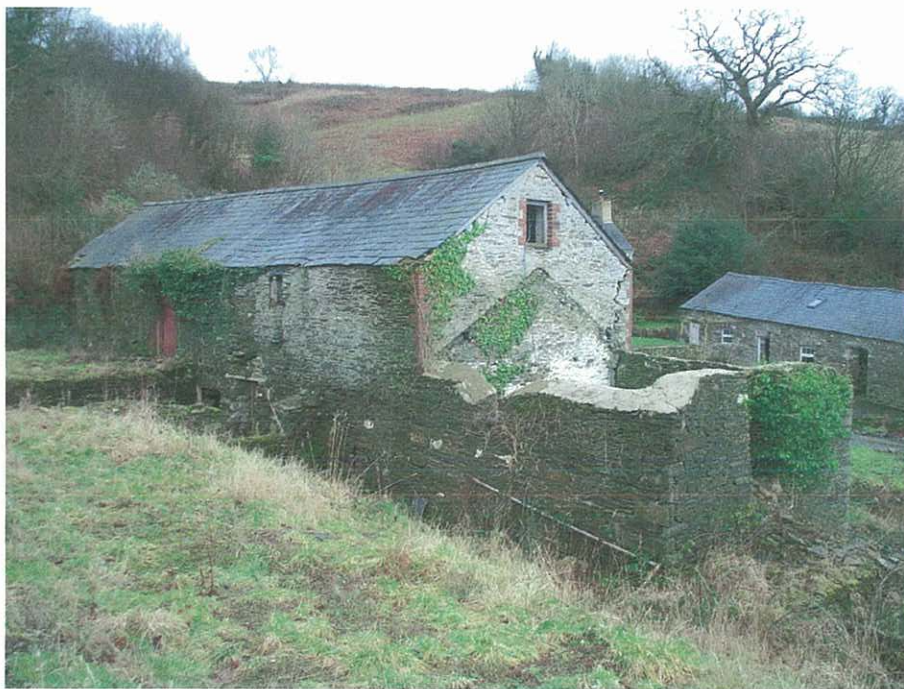
Plate 6- view from NE gable end showing extent of ivy growth

Intrusive ivy growth is a concern noted in many areas around the building and threatens to weaken masonry bonds and damage roofing. In order to prevent damage to masonry and roofing, the ivy should be cut back, allowed to die and then removed. Stumps should be spot treated in order to prevent regrowth. The masonry will then require consolidation using a traditional lime mortar mix.
