Llwyncrwn W/12/2911

Tir Gofal Farm Visit Historic Environment Report

Report No. 2003/41

CAMBRIA ARCHAEOLOGY
REPORT NO. 2003/41
PROJECT RECORD NO. 45646

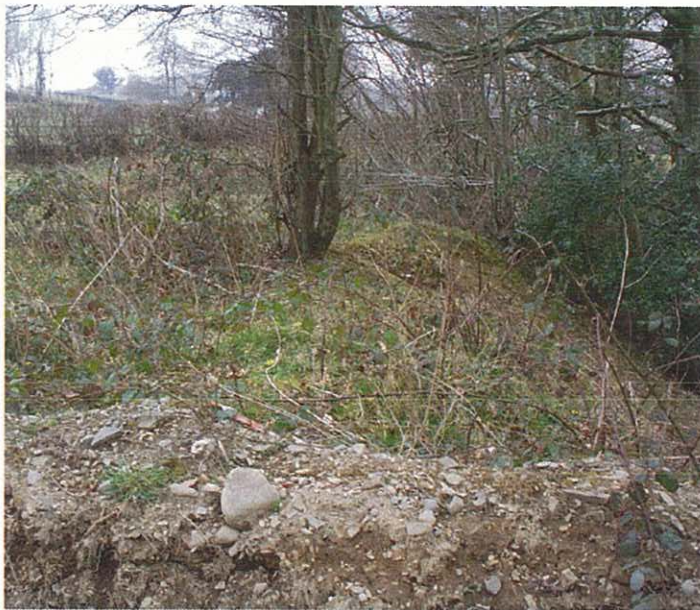
The present condition of the earthwork is considerably worsened from that described above. The earthwork banks although now much eroded, could still be identified. The original extent of the earthwork can still be traced, although an off-road motorbike course over the site has eroded some sections of the earthwork banks, and their preservation is no longer uniform over the site.

The denuded north bank is faintly visible as a spread earthwork up to around 0.3 metres in height. The south bank of the monument is less visible still and wheel ruts have completely eroded the earthwork remains, although a small section of bank remains visible in the hedge near to the road up to around half a metre. The west bank of the earthwork is most well preserved, and lies on the margin of a wooded slope. Much of it is now masked by a low covering of bracken and brambles, and a few mature trees have also become established. No traces of the four foot wide entrance mentioned in 1913 by the RCAHMW could be identified. A wide trackway, around 1.8 metres wide has been recently bulldozed in this part of the monument and may explain this. The flat interior lies under pasture, which is grazed periodically. The landowner recalls that a mains sewer laid in 1972 and an earlier water mains both bisect the monument.

The earthwork is in a considerably worse condition from that described by the RCAHMW in 1913, and ongoing threats to its survival have been identified. Bulldozing has destroyed part of the western bank, whilst erosion caused by motorbikes continues to erode the fragile earthwork banks. The interior of the enclosure holds potential for the survival of buried archaeological remains, which are at risk if the site continues to be used as an off-road course for motorbikes. The area within 15 metres from the edge of the site should not be subjected to any ground intrusive activities, used as a location for feeding livestock, or used as a course for off road motorbikes. The trees growing on the west bank should be monitored and any unstable trees

Plate 1- part of the western earthwork bank of enclosure (PRN 766), with the bulldozed trackway visible in the foreground.

should be cut off close to the roots in order to prevent falling trees from uprooting the earthen banks. The brambles, bracken and any young trees should also be removed from the earthen banks.

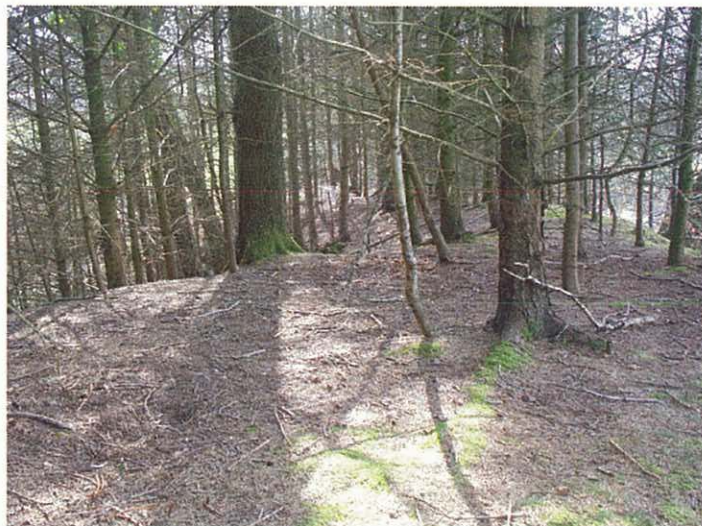
Plate 2- looking south from the top of linear earthwork (PRN 767)

The earthwork is currently under a commercial forestry plantation, which is shading out the ground surface and increasing the risk of erosion. Light is able to penetrate the steeper western elevation, and an understory of hazel and ivy is becoming established. Mature oaks are overhanging the river in this part of the monument. These may be remnants of a pre-plantation covering of scots pine and oak, which is shown on aerial photos taken in 1955 and indicated today by remnant tree stumps. The western elevation is being undermined by the river and there is evidence for soil creep at the north end, with the additional risk of soil slump. In the southeast corner of the monument, a fallen tree has created a large scar, around one metre deep and two metres square.

The tree bowl in the southeast corner indicates the potential for root damage if mature trees are allowed to become unstable. The overhanging oak trees on the western elevation will need monitoring for signs of instability. Although they are currently stable, the fir trees, which cover the monument will eventually pose a threat if left alone. Ideally they should be cut down and removed, and the area should be reseeded if necessary. This should be followed up by sensitive grazing in order to maintain a stable grass sward and prevent the growth of scrub species. The aim of the management should be to create a good grass cover over the site with no erosion or breaking of the ground surface.

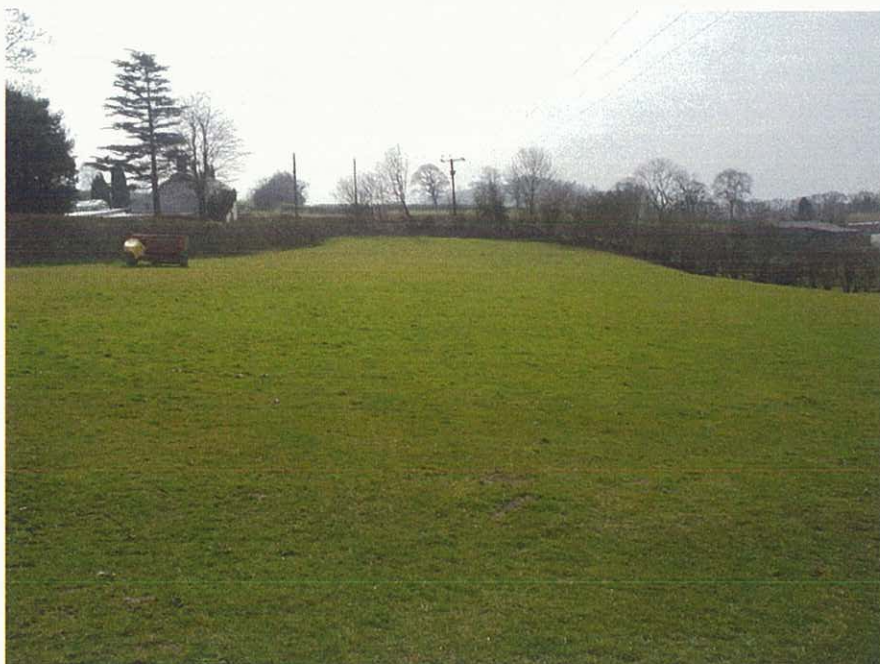
Plate 3- looking southwest along the line of Sarn Helen (PRN 47657)

No apparent threats to this stretch of Sarn Helen can be identified from the current management regime. The pasture should continue to be sympathetically grazed in order to maintain a stable grass sward, which is considered to be the optimum land-use necessary for the long-term survival of the earthwork bank and buried archaeological remains. The area within 15 metres of the edge of the monument should not be ploughed, subjected to any ground intrusive activity or used as a location for feeding livestock.

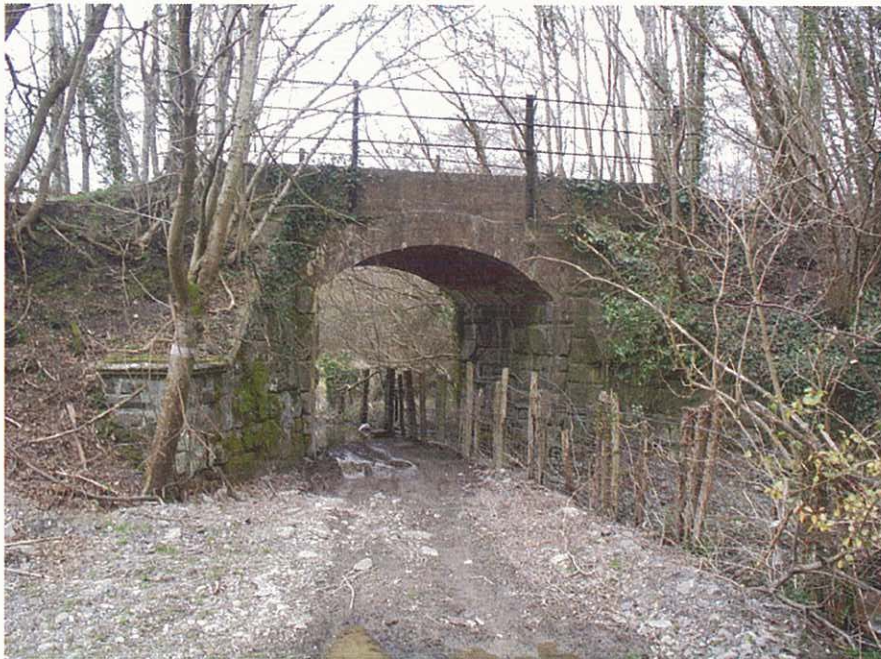
This disused bridge, which crosses a farm trackway forms part of the Manchester to Milford Railway, which was opened in 1886. The bridge footings are of faced limestone blocks, whilst the arch is of red brick construction. The bridge is currently in a stable condition, although it lies on the boundary of the application area and is no longer used.

Plate 4- the railway bridge (PRN 47757)

The bridge, which forms part of the historic Manchester to Milford Railway should be retained as a historic landscape feature.

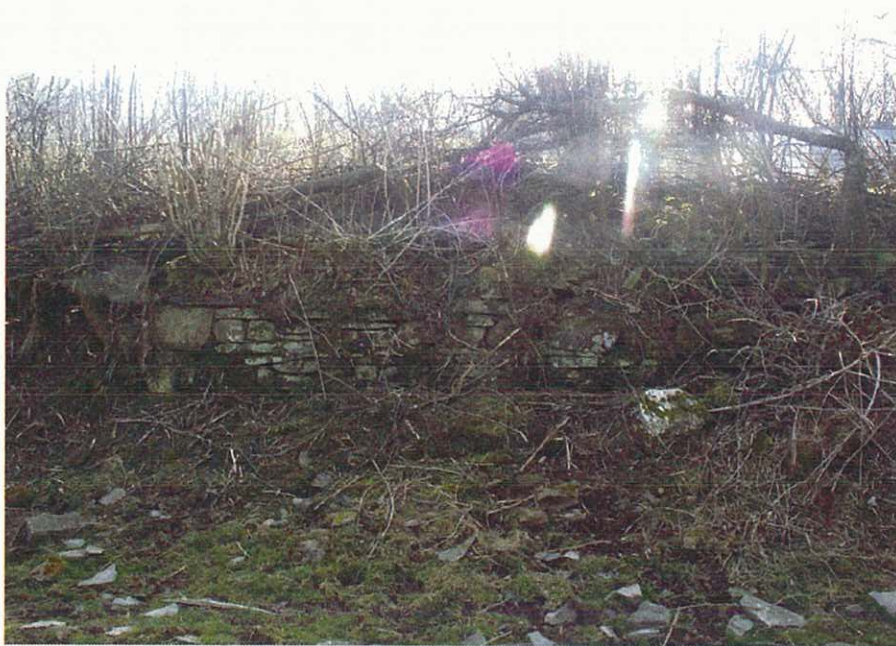
Llwyncrwn-Uchaf farmstead is first shown on the 1891 Ordnance Survey map, around 100m to the east of Llwynocrwn. Two buildings are depicted in an L-shaped arrangement to the east of a farm trackway. Only an outbuilding survives today and the cottage, which formed the northern arm of the complex has since been lost, apparently destroyed to create a forestry trackway. Only the footings of the north gable end survive, which now form part of a hedge bank.

Plate 5- the remnant walls of cottage (PRN 47560) looking south

The footings of the north lateral wall provide the only visible evidence of a former cottage at this location and should be preserved. Although no additional visible remains of the cottage survive, there is potential for buried archaeological deposits. No ground disturbing activities should be undertaken within 15 metres of this site.

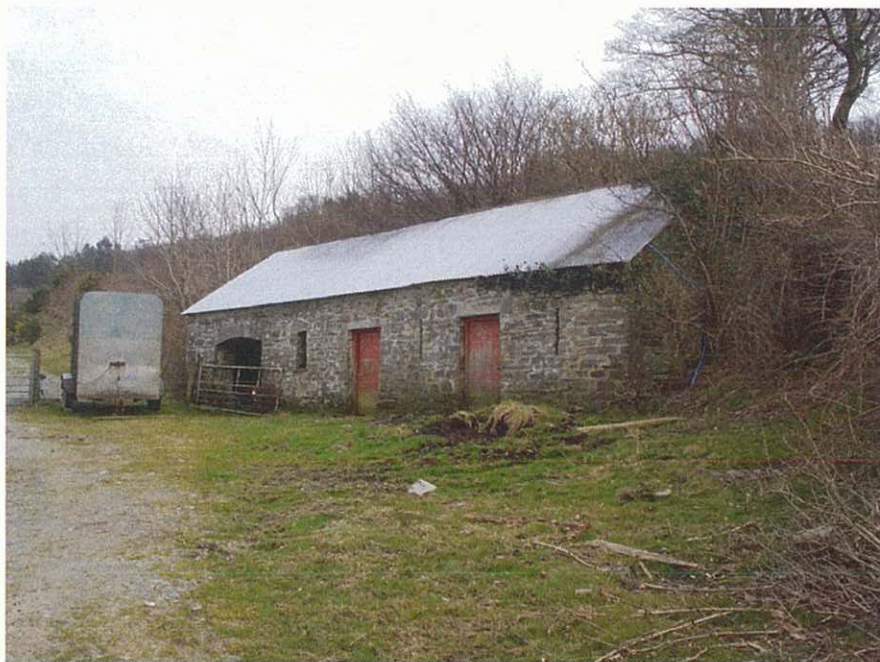
Plate 6- the cart house/ cowshed (PRN 47561) looking east.

This two unit building is aligned ENE-WSW and measures around 14 metres by 6 metres. It forms part of the L-shaped farmstead of Llwynocrwn-Uchaf, which the landowner recalls fell out of use around 50 years ago. It is constructed of stone walling, built to rough courses with a pitched corrugated iron roof. A cart house identified by its wide arched stone entrance comprises the eastern unit of the building. The western two thirds of the building consist of a long cowshed, which is accessed by two evenly spaced doorways in the north lateral wall. The interior of this part of the building is divided into three bays. Some of the historic interior arrangements have been preserved and brick partitions divide the cowshed into three bays. Of particular interest is the cobbled floor in the western bay, which appears to survive in a stable condition and defines the individual stalls and drainage channel layout. Three concrete stalls with halter bars, which are likely to be of an early mid twentieth century date remain intact in the central bay, and an iron hay rack survives on the rear wall in the eastern bay. The former presence of an upper storey, most likely a hay loft is indicated by a single surviving cross beam in the west end of the building which would have supported the floor. An infilled pitching hole in the east gable end of the building further supports this. The building is currently in a reasonable condition, although some areas of instability have been identified. The western end is overgrown with ivy, which has penetrated the interior of the building beneath the eaves. A tree growing out of the base of the west gable end threatens to displace the wall footings and promote building instability. In addition to this, some of the stonework in the north lateral wall has become displaced and are likely to contribute to structural instability if not replaced. Corrugated iron sheets on the southern pitch of the roof are rusted and breaking up.

In order to prevent further damage to masonry bonds by intrusive ivy growth, the ivy should be cut back, treated, allowed to die, then removed. This should be followed up by a programme of masonry consolidation and roof repairs using traditional building techniques and materials. The tree growing out of the west gable end of the building should also be cut off at the roots and then retreated to prevent regrowth. This should be followed up by reconsolidation of the stonework if necessary. The detached stonework at the base of the northern wall should be reinstated and re-pointed using a traditional lime mortar mix in order to keep this part of the building in a stable condition. The rusted corrugated iron sheets on the southern pitch of the roof will need to be replaced soon if the building is to be maintained in a stable condition necessary for its long-term survival. Preferably the building should be re-roofed using traditional slate, which is the most durable long-term roofing material. The historic internal building arrangements should be retained.
