# **Marloes Court Farm W/13/3283**

## **Tir Gofal Farm Visit Historic Environment Report**

Report No. 2002/99

Marloes Court Farm  
Tir Gofal Farm Visit Historic Environment Report

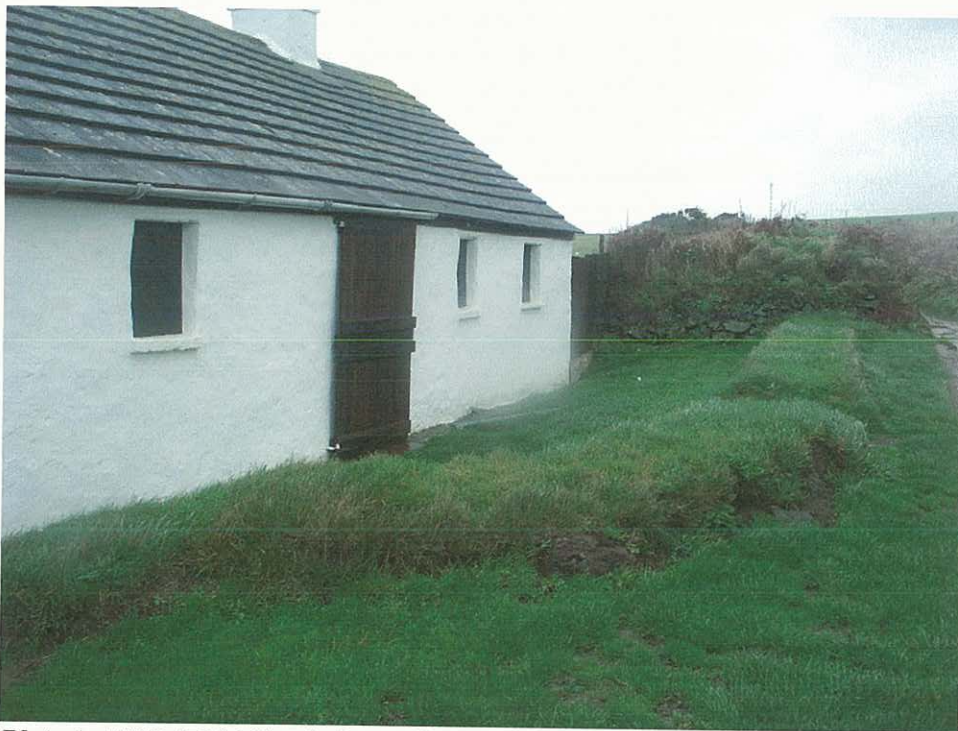
Late 19<sup>th</sup> century cottage. One storey, stone built, now with cement tile roof. In good condition, though not inhabited but used for agricultural storage. A small garden or enclosure is around the cottage, marked with low stone and turf walls to the east and west, and a field boundary on the north side.

**Plate 1: PRN 47014 Sandy Lane Cottage**

Maintain in current condition. Any future repairs to the building should be carried out using appropriate traditional materials and techniques.

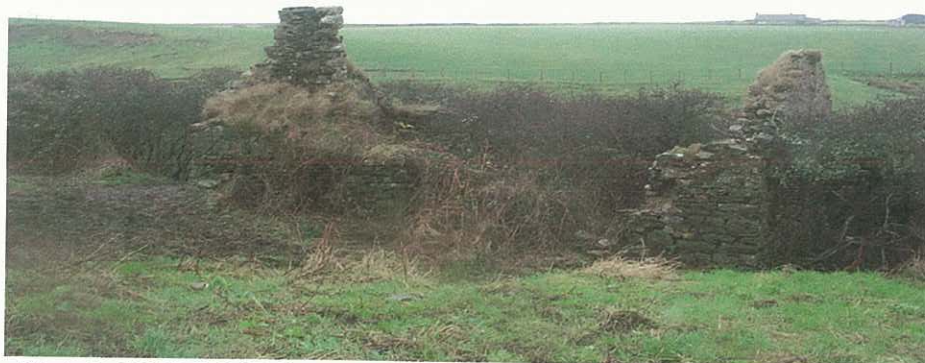
Cottage site seen on the tithe map for Marloes Parish (1843). Now ruined, and heavily overgrown. Approximately 5m north-south and 9m east-west. The end walls stand to gable height, with a stack at the west end. The other walls are largely collapsed, though two windows can be seen on the south side. To the north some traces of the original enclosure can be seen in the form of a slight curved earthwork, and a hedge line.

The cottage lies in a hollow, and is largely hidden by the vegetation. In addition, the lower parts of the collapsed walls are becoming overgrown, and vegetation is damaging the upstanding parts of the cottage. Although the area is fenced off there are recent signs of cattle being inside the enclosure. The ground is very wet, and livestock have the potential to cause serious erosion.

**Plate 2: PRN 47015 Cants Cottage. The bushy vegetation behind it marks the original enclosure.**

This cottage is already ruined, and all that can be hoped for is to slow the rate of decay and preserve what remains in a stable condition as a visible historic landscape feature.

Vegetation should be cut back throughout the enclosure and around the cottage and any branches which touch the stonework should be removed, though roots which penetrate the stonework should be left in place. The removal of cuttings and waste should only be undertaken in dry weather, since the ground is prone to waterlogging.

Some controlled grazing by sheep will keep the undergrowth low, but animals should be excluded during very wet weather.

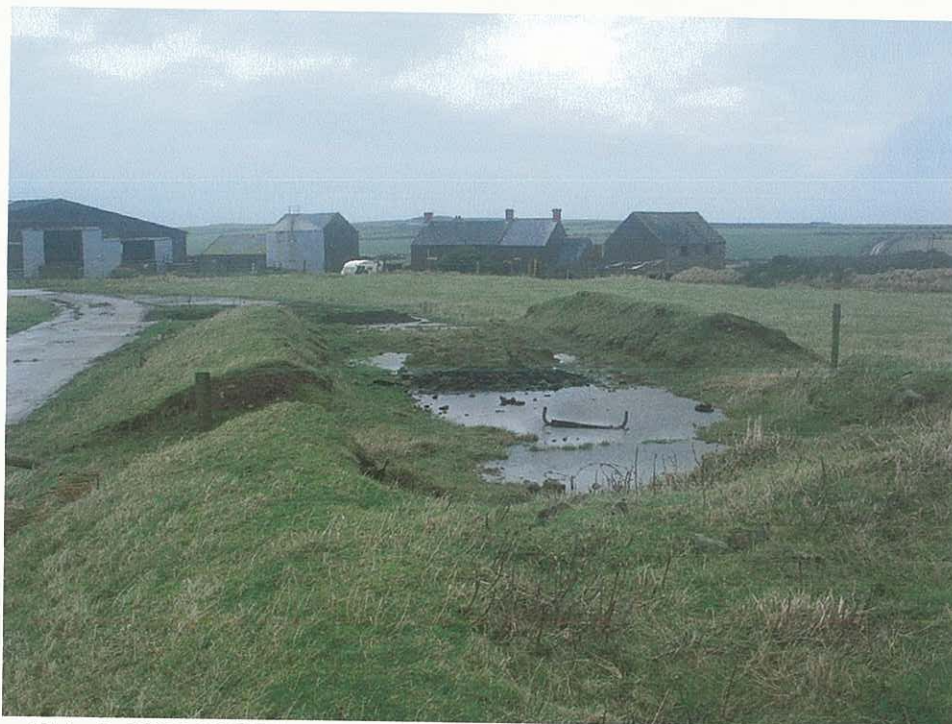
There is some erosion of the bank by the roadway, and a fence line has been cut through both banks.

**Plate 3: PRN 28607 Bomb Fuzing Point with fence line cutting across the earthworks.**

Maintain a smooth turf covering over the earthworks, and monitor for erosion. If the erosion becomes significant, the site should be recorded before the shape of the bank is lost. This site should not be disturbed further, and future fencing should be put in at least 5 metres away from the site. The remains of the building should be kept clear of any vegetation.

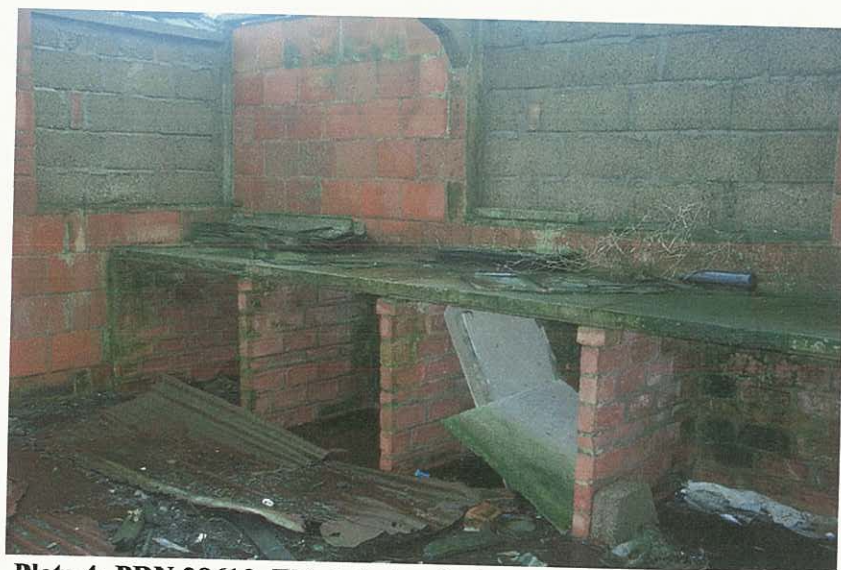
The building is in poor condition. The west end of the main range is no longer roofed, and both end walls of this range are lost. Some internal features, and traces of a dividing wall built of hollow ceramic blocks can still be seen, but these are beginning to break up and form piles of rubble. Approximately half of the windows still contain some glass. The building seems to be used by cattle for shelter.

**Plate 4: PRN 28610. This interior feature – possibly a workbench – is made of hollow ceramic blocks topped with stone slabs.**

Ideally, the building should be re-roofed to protect the walls and surviving interior features. It could then be brought back into use for agricultural purposes. If restoration works are not possible, then the building should be maintained in as stable a condition as possible and a record made before the structural damage proceeds any further.

Since military buildings were normally built to specific and identifiable plans, the rarity value of this building, whose type is unknown, further increases its significance. Ideally, the building should be re-roofed to protect the walls and surviving interior features. If restoration works are not possible, then the building should be maintained in as stable a condition as possible and a record made before the structural damage proceeds any further.

Although the use of the building as a cattle shelter is not an immediate problem, the surviving interior features should be protected from livestock.

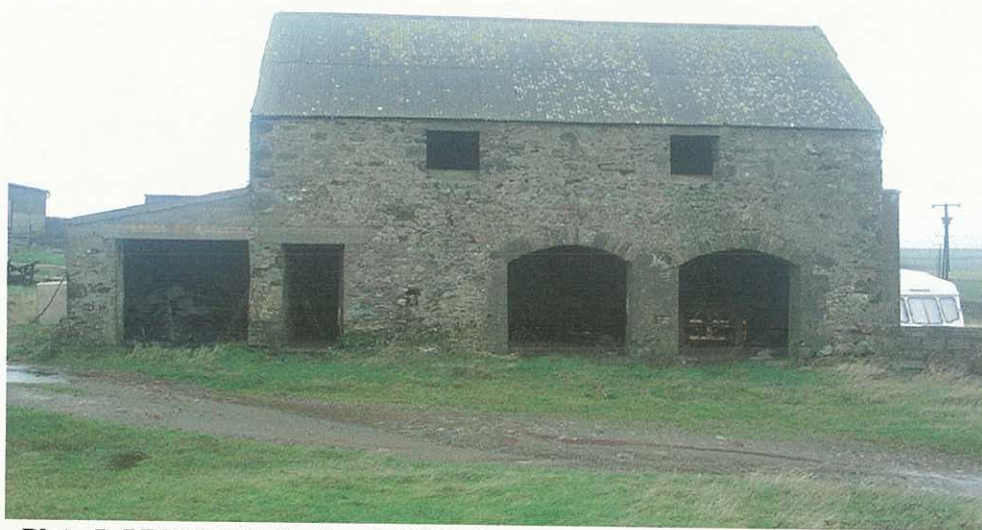
A fine stone-built coach house with two arched bays and an upstairs granary, reached by external steps at the north end of the building. Built between 1843 and 1887. The building is in good condition, and used for agricultural storage.

**Plate 5: PRN 47019 Cartshed, Little Marloes.**

Maintain in current condition. Any future repairs to the building should be carried out using appropriate traditional materials.

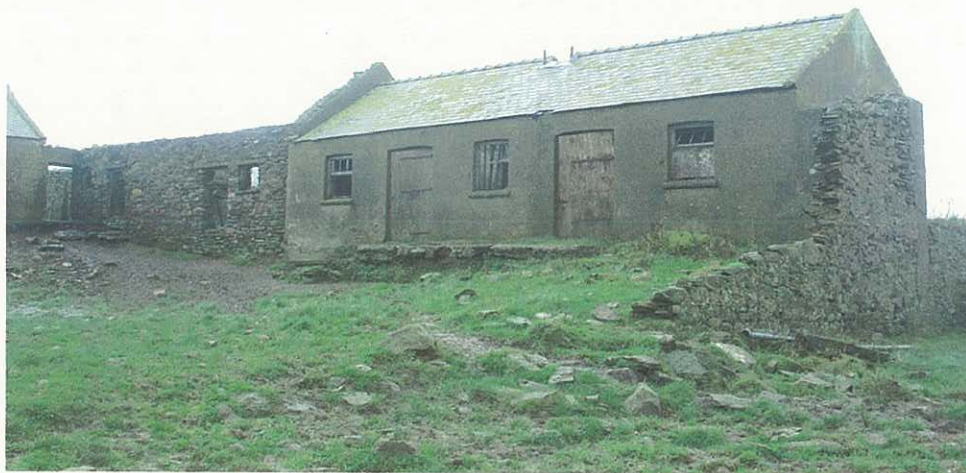
Two-door stable block probably built as part of the re-modelling of the farmstead between 1843 and 1887. Three fair sized windows and the lack of a central feeding passage suggest this building's use as stables rather than a cow-shed. The building is in a fair condition and the slate roof seems weatherproof, though the building appears to be unused. There has been significant erosion of the ground in front of this building, and the erosion may begin to undercut its footings.

**Plate 6: PRN 47022 Little Marloes stables.**

The building should be maintained in a stable and weatherproof condition using appropriate materials. The erosion in front of the building prevents it being used as an animal shelter, but ideally it should be brought back into use to secure its long term future.

The building should be monitored for any cracks or structural damage resulting from the ground erosion.

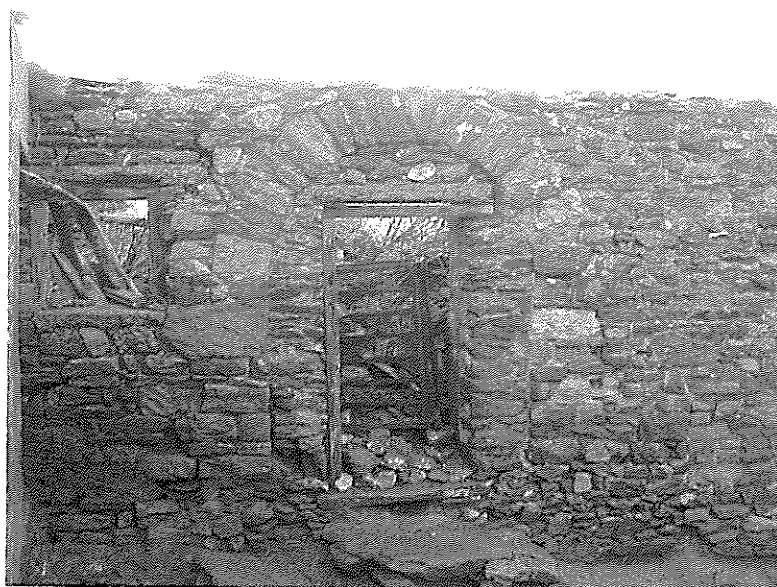
Plate 7: PRN 47023 Arched entrance and later doorway to the building.

The building is now derelict. However it should be maintained in a stable condition where possible. Any vegetation encroaching into the building should be cut back, and if roots have penetrated the stonework they should be treated to prevent re-growth.

Any accessible modern rubbish inside the building should be removed and no further dumping should take place. The building rubble can be left in situ as removing it is potentially damaging to the structure. Little can be done to protect the building from the weather, however it should be maintained in a stable condition where possible, as a visible historic feature. Any vegetation encroaching from the rear of the building should be cut back, and if roots have penetrated the stonework they should be treated to prevent re-growth. Ideally the wall tops and areas of eroded pointing should be consolidated. Capping the walls should also be considered to prevent water penetrating further into the stonework.

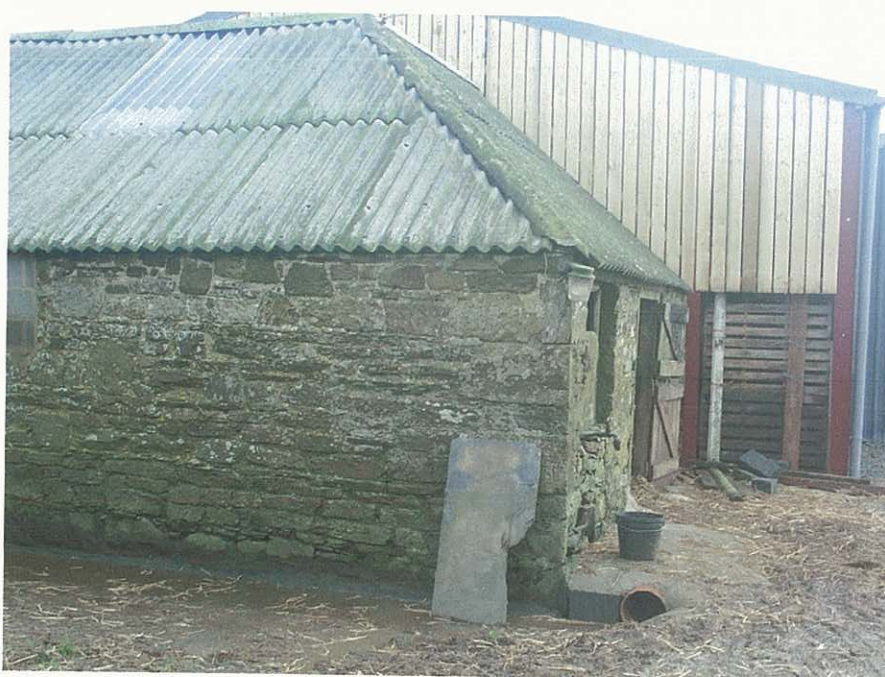
**Plate 8: PRN 47026 Cowshed.**

Maintain in current condition, and carry out future repairs using appropriate traditional materials. Where the stonework butts or rests on concrete it should be monitored for any problems caused by damp. The building is a good example of a typical Welsh animal shed, and some consideration should be given to its future if further modernisation is to take place around it.
