# Venterin W/13/3668

## Tir Gofal Farm Visit Historic Environment Report

Report No. 2003/44

Venterin  
Tir Gofal Farm Visit Historic Environment Report

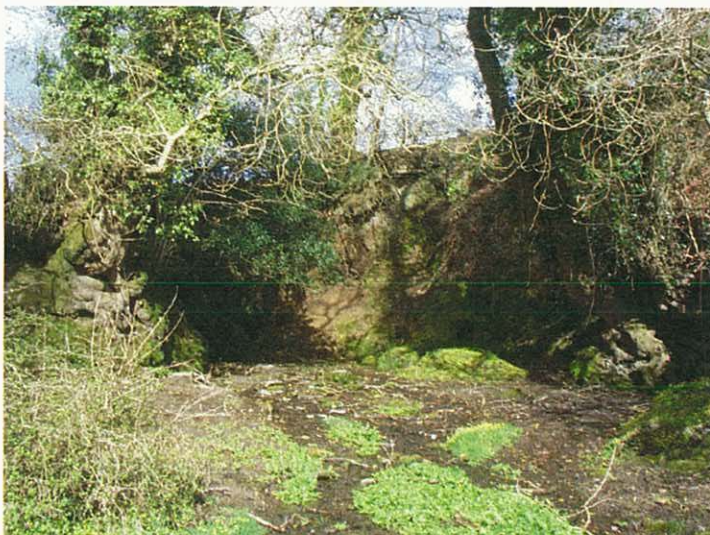
This is a spring flowing from the wall of an old quarry (PRN 47783). The quarry is roughly semi-circular and is steep-sided with walls around 6m high. The spring emerges some 50cm above ground level. It was apparently dedicated to St Teilo, and was described in 1896 as having a reputation for curing disease (Jones, F:1954:p.206). There are no clear signs of any built structure around the spring, though there are some angular lumps of stone scattered on the surface around the site. These may be natural.

Plate 1. *Ffynnon Teilo (PRN 3747) which is reputed to have curative powers. The two mature trees at the front may have been planted to mark the entrance. Inside an old quarry (PRN 47783).*

The spring and quarry require very little maintenance beyond occasional vegetation control.

Undergrowth is currently kept in check by light grazing, and this regime should continue.

The land-owner has included this site in new area access as part of their Tir Gofal agreement. The provision of some information about holy wells and traditions associated with them may be of interest to visitors.

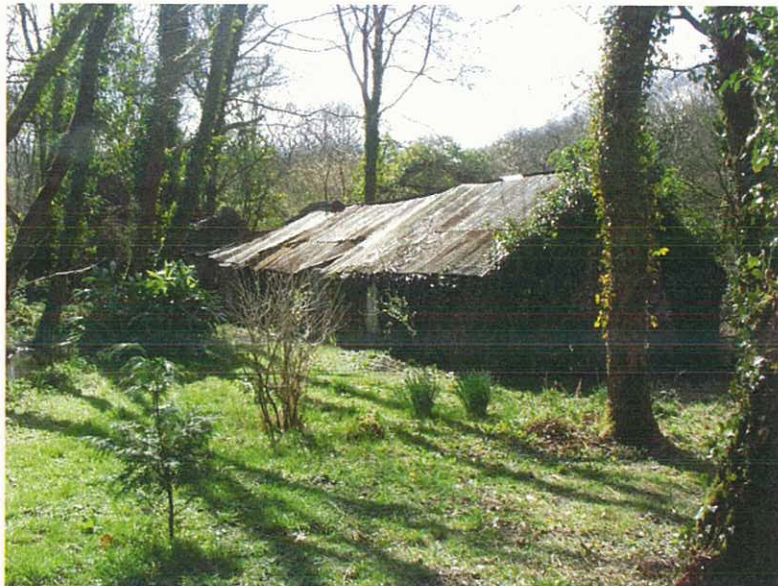
The mill building is in three parts – the dye house itself at the north end, a small central room, and the wheel house at the south. The dye house is a single storey stone building which measures about 15m north-south and 5m east-west. Generally the building is in a fair condition. It is roofed with corrugated zinc, and some of the exterior has been cement rendered. Some doors and windows have been blocked with breeze-blocks, and gaps in the original fabric of the building have also been infilled with breeze-blocks. The central room seems to have originally been a continuation of the dye house, which has now partially collapsed. At their highest, the walls stand to around three-quarter height and a temporary roof has been constructed of corrugated iron and wood.

Despite its derelict condition, this mill is significant since it has not been converted, and aspects of the machinery are still visible.

Plate 2. *The mill at Venterin (PRN 47785) viewed from the north. In the foreground is the main dye house (now used as a calf pen). The gable of the ruined wheel house is just visible beyinf the metal roofing.*

The main mill building (the dye house) is in fair condition, and in use as a calf pen. At the north end, some ivy has worked its way under the roof and will need to be removed before structural damage is caused. The ivy should be cut back and treated to prevent re-growth, and the area re-pointed. Future maintenance should use lime mortar for re-pointing rather than cement.

The dye house is in fair condition, and in use as a calf pen. Future maintenance should ideally use lime mortar for re-pointing rather than cement. At the north end, some ivy has worked its way under the roof and will need to be removed before structural damage is caused. The ivy should be cut back and treated to prevent re-growth, and the area re-pointed.

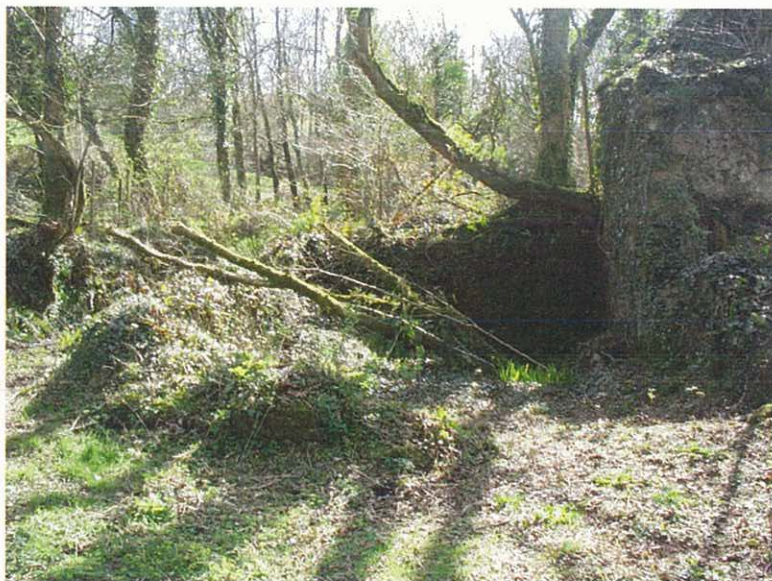
The wheel house is completely derelict. The building itself measures around 10m north-south and 5m east-west, and on the west side the remains of the wheel pit can be seen, partially enclosed by low walls. The south gable end stands to full height, and it can be seen that the building was originally two storey. A collapse in the centre of the gable end may mark the location of a now-lost chimney. Very large, well-dressed stones were used in the construction of the wheel house, and some of the original lime mortar pointing is still seen. The walls are heavily overgrown with ivy.

The interior of the wheel house contains a trench dug into the east side, which is likely to have housed the pit-wheel. This is aligned with a square shaft in the west wall that is, in turn, aligned with the wheel pit outside. The main waterwheel would have been linked to an axle which passed through the shaft and turned the pit-wheel, driving the rest of the machinery.

The wheel pit itself is partially infilled with earth and vegetation. Several semi-mature trees are growing in and around the wheel house, and two have fallen.

Plate 3. *The housing for the water wheel. On the right, next to the wall of the wheel house, is the main wheel pit.*

The wheel house and surrounding area is heavily overgrown. Trees and saplings within the building and immediately outside it should be cut to ground level and treated to prevent re-growth. The two fallen trees need to be carefully removed to prevent further damage to the masonry. The ivy on the south gable end should also be cut back and treated, but the roots embedded into the stonework should not be removed.

Modern rubbish and farm machinery should be removed from the wheel house and wheel pit.

Ideally a photographic survey should be carried out during and after any works on this building, in order to record features like the wheel pit and the axle shaft. These are often the most vulnerable features, but are also the most informative about the detailed workings of the mill.

The wheel house and surrounding area is heavily overgrown. Trees and saplings within the building should be cut to ground level and treated to prevent re-growth. Fallen trees should be carefully removed. The ivy should also be cut back and treated, but the roots embedded into the stonework should not be removed. Modern rubbish and farm machinery should be removed from the wheel house and wheel pit.

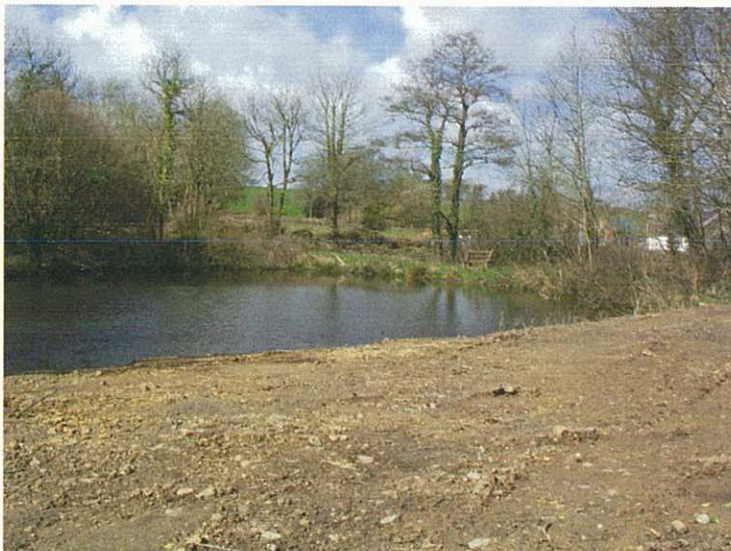
A series of ponds located in an area listed in the tithe apportionment (1842) as a "watering place". There are now a number of recently excavated ponds which are separated by earthen dams. The most northerly of the ponds is roughly circular. Around the east, west and north edges, the pond is bounded by banks which appear to be substantially older than the banks around any of the other ponds. This area seems to have undergone little or no alteration and probably represents one edge of the stock watering place.

Plate 4. *The modern pond (PRN 47788) which is in the location of a 19<sup>th</sup> century "watering place". It respects older banks on its north side (the far side of this picture).*

No further ground-intrusive works should take place in or around the northernmost of these ponds.

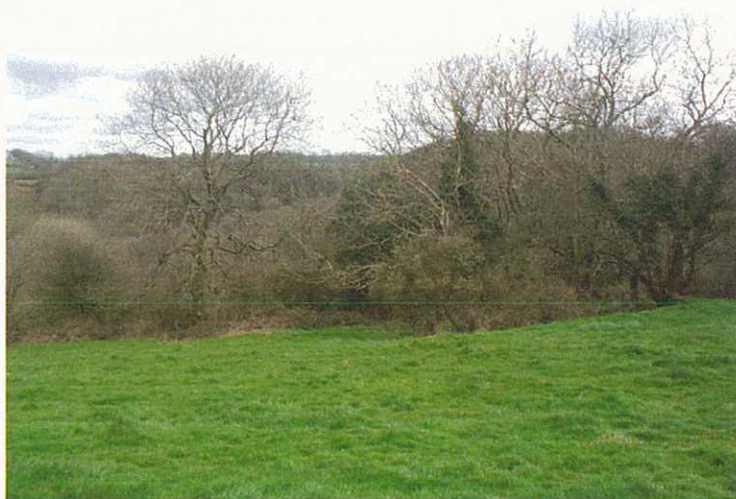
Remains of a farmstead located in a field named in the tithe apportionment as "Park yr Hendy". "Hendy" normally means "old house". No buildings are marked on the tithe map or the 1819 Ordnance Survey map, so the farmstead had clearly fallen out of use by the early 19<sup>th</sup> century. Several earthworks lie in scrubby undergrowth, showing the location of the farmstead. At least 2 (and probably 3) building platforms could be seen as well as what is probably a garden enclosure. The building platforms are roughly 6m x 4m. Some form of track or road appears to run through the middle of this site, and the whole complex is slightly terraced into a southeast facing slope. Building stone lies scattered across the surface of the whole site.

To the east, a raised linear feature runs downslope from the farmstead towards the stream. This is a substantial earthwork, between 1m and 2m wide in places. It has the appearance of a ploughed out field boundary, though no boundaries are seen in this location on the tithe or Ordnance Survey maps. It is clearly associated with the farmstead site.

The site is currently under pasture, though bramble and hawthorn are growing in and around the earthworks.

Plate 5. The abandoned farmstead in Park yr Hendy (PRN 47791). The site of the farmstead can be seen in the middle ground, amongst the patch of trees, slightly terraced into the hillside.

The site should be maintained under pasture. No ground intrusive activities should take place within 5m of the edges of the farmstead site, or along the associated linear feature.

Ideally, some vegetation clearance should be carried out. Larger hawthorn and bramble bushes should be cut flush with the ground and removed from the site. To prevent damage to buried archaeology the work should be carried out by hand, and roots should not be dug or dragged out.

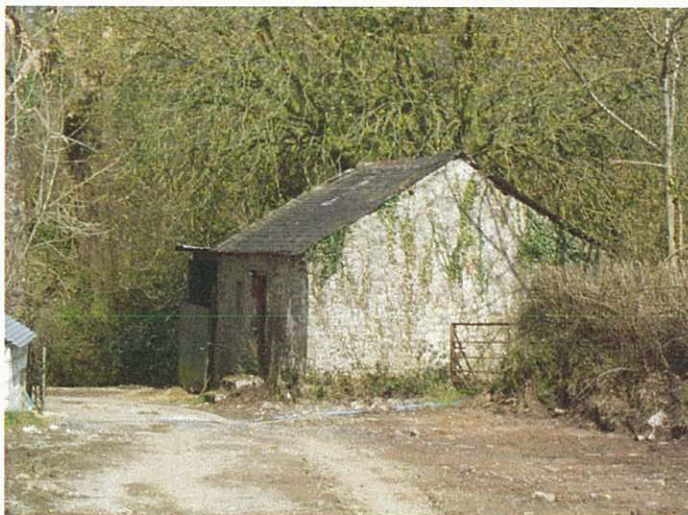
A small one and half storied cottage situated just on the edge of Venterin Farmstead (PRN 47799). The landowner informed us that this building was used as a pig shed in the past. The cottage is stone-built and slate roofed, with a small window in each long wall. It is now only one room, but it can be seen where a half storey loft was originally found. To the north a small extension has been added, which is now partially derelict. In the main body of the cottage is a surviving fireplace with a wooden lintel in the north gable end. The fireplace is not central, but set to the left. In the centre of the wall is a line of soot-blackened stonework which may mark the location of another chimney which has since been removed. This implies several phases of re-building of this cottage. Initially it was probably only one room with a small fireplace. Some time later a larger fireplace and an internal chimney stack were added, and an outhouse built onto the north end. Later still the chimney stack and fireplace were removed, and no chimney survives today. The outhouse to the north still stands in places but has largely been re-built with modern materials. What survives best today is probably the original body of the building which was built between 1819 and 1842. In layout, this building is typical of the one-roomed cottages found throughout west Wales (Davies, M:1991:p.7) The building is in fair condition, and seems to be weatherproof.

Plate 6. Cottage (PRN 47793) originally from the first half of the 19<sup>th</sup> century. An extension was later added to the far side, and this has been largely re-built in modern materials.

It is important that this building continues to be maintained. The survival of simple 19<sup>th</sup> century cottages like this is rare since many have been modernised or demolished. Traditional materials should be used for future repairs and maintenance. Ideally a use should be found for this building before it becomes derelict.

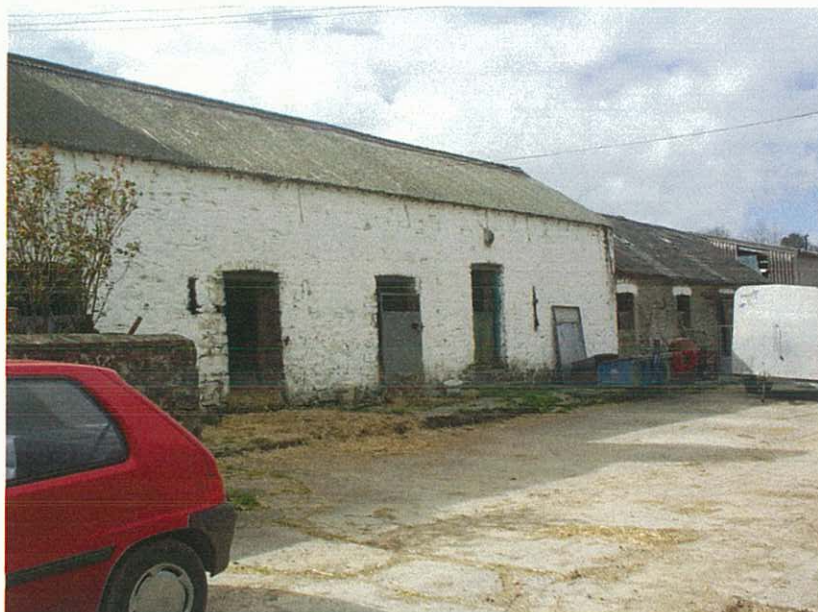
The building is in good condition and in use.

Plate 7. Two cow sheds (PRNs 47796 & 47797) at the north end of the main farm building in Venterin Farmstead.

Generally the building is in good condition, and still in use as a cow shed. It should be maintained in its current condition, but some consideration may be given to the replacement of partially buckled iron doors with more traditional wooden doors to preserve the character of the building.

Generally the building is in good condition, and still in use as a cow shed. It should be maintained in its current condition and future works should be carried out using appropriate traditional materials.

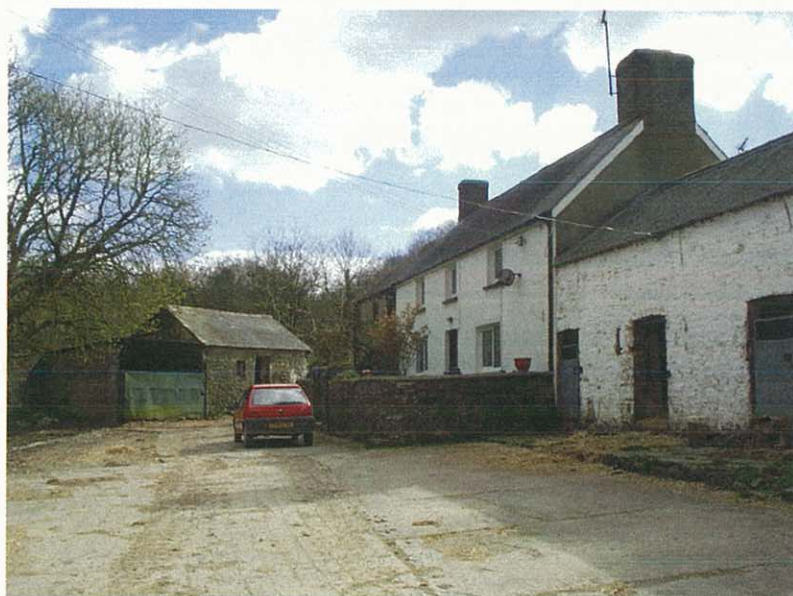
This is the southern end of a range of farm buildings which also houses the farmhouse (PRN 47795) and two cow sheds (PRNs 47796 and 47797). At present this part of the building is in fair condition, and the ground floor is used as a calf pen. However, the external steps do not appear to be used, which would imply that the granary or hayloft is also unused. Some of the steps are damaged, though the risers appear to be intact.

This section of the building is in good to fair condition, with the loose box still being used for calves. The steps leading to the upper storey are not currently useable, and the granary or hayloft does not seem to be in use.

Plate 8. Looking south along the same building. The cow shed (PRN 47796) in the foreground, followed by the house (PRN 47795) and the granary/hayloft (PRN 47794).

It is important that this section of the building is maintained, and ideally the upper storey should be brought back into use. The external staircase should be repaired before the damage renders it completely unusable. Given the good condition of the rest of this building it is especially important to ensure that the granary end is not allowed to become structurally unsound.

It is important that this end of the building is maintained in good condition in order that the appearance and character of the whole building range is maintained. Future restoration and maintenance should utilise traditional materials wherever possible. The upper storey and external staircase should ideally be brought back into use before their condition significantly deteriorates.
