Hackett Farm W/13/3281

Tir Gofal Farm Visit Historic Environment Report

Report No. 2003/64

22nd May 2003

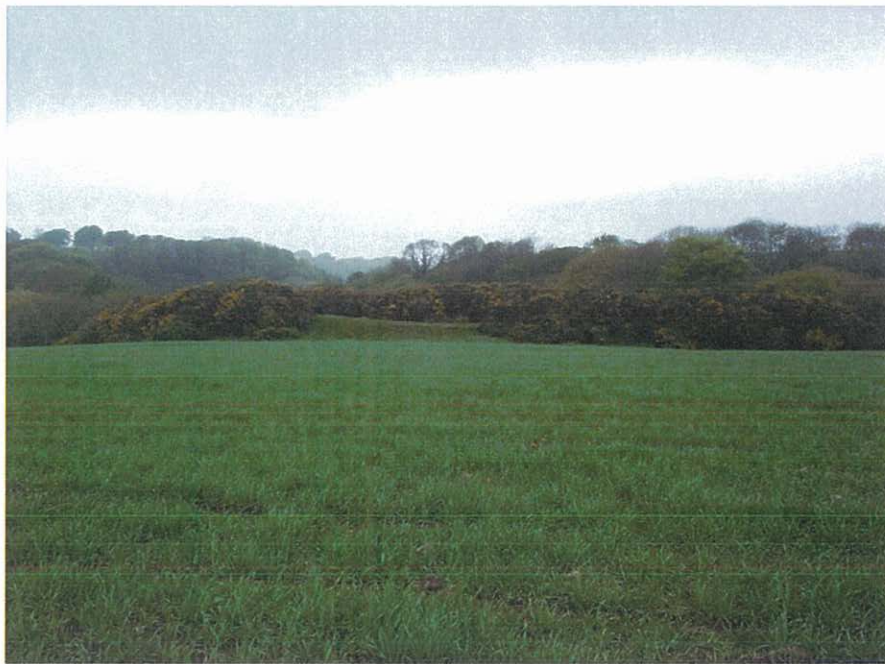
The Blaengwaith-Noah promontory hillfort is a fine example of its type. Its national importance is recognised by its status as a scheduled ancient monument. It is protected to the north and west by a steep facing natural slope down to the confluence of two streams below. Parallel earthwork banks and ditches form a third of a circle to the south and enclose a triangular shaped interior. This area holds high potential for the preservation of buried archaeological features such as hut circles and storage pits for example. There are breaks at either side of the banks, where they may have been cut back at some time in the past to allow access to the interior, although the original entrance should presumably be at one of these positions. Banks are between about one and one and a half metres high, and are highest on the south side. The ditches are now largely silted up and only about 0.3 metres in depth.

The interior of the site lies under grass, which is grazed periodically, although the banks themselves are heavily overgrown with gorse and brambles in most places resulting in lessening of grass cover and a higher risk of erosion. Cattle paths have created localised erosion hotspots at both the east and west ends of the southern earthwork bank. Although recorded as under pasture during a field visit by CADW in 2000, the field in which the monument lies has since been cultivated. During the archaeological farm visit it was noted that recent ploughing had come to within four metres of the edge of the monument.

Plate 1- looking north towards Blaengwaith-Noah hillfort (PRN 3796)

“The gorse bushes should be cut and removed. Care should be taken to avoid damaging the ground surface by machinery.

The exposed ground surface will be susceptible to erosion. The area should be protected from grazing animals by excluding stock from the field or by the use of electric fencing to close off the scheduled area.

The amount of gorse to be cut and removed is considerable. This will require a capital payment. The gorse will require recutting on the following two years at least. This may be achieved by

topping the gorse on the banks when the field is routinely topped. If the banks are too steep for this method to be practical, then hedge trimming equipment may be employed.

The condition of the monument itself appears to have changed little from that recorded in 2000 and these management recommendations still apply. The field within which the monument lies has since been ploughed however and the area up to four metres of the edge of the earthworks was under cultivation during the archaeological farm visit. This is potentially a highly sensitive area archaeologically. In order to protect any buried archaeological remains, the area within 15 metres of the edge of the monument should not be ploughed, subjected to any ground intrusive activities or used as a location for feeding livestock.

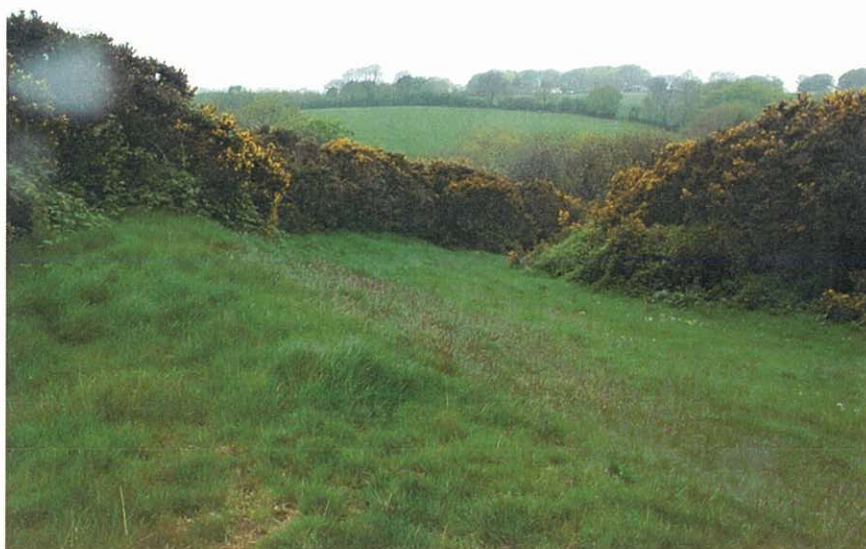
Plate 2- the overgrown southern earthwork banks of Blaengwaith Noah hillfort (PRN 3796)

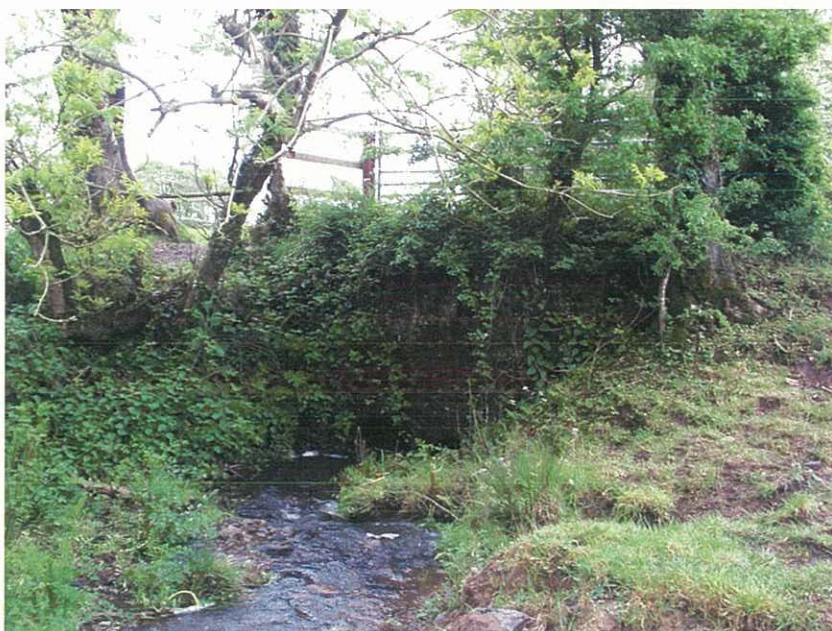
This small railway bridge is aligned east-west and carries the railway over the stream. It forms part of the Reynalton Extension of the Saundersfoot Railway (PRN 44359). It is of lime mortar bonded stone rubble construction, with a circular ceramic culvert a little less than a metre in diameter. It is approximately three metres high and four metres wide. Although overgrown, the bridge is currently in a stable condition and is maintained for use as part of a farm trackway.

Plate 3- the northern elevation of railway bridge (PRN 47951)

The bridge is the only structural element of the Reynalton railway to survive on Hackett Farm. It should be maintained in a stable condition using materials faithful to those of its original construction. In order to prevent damage to masonry bonds, vegetation growth should be kept under control

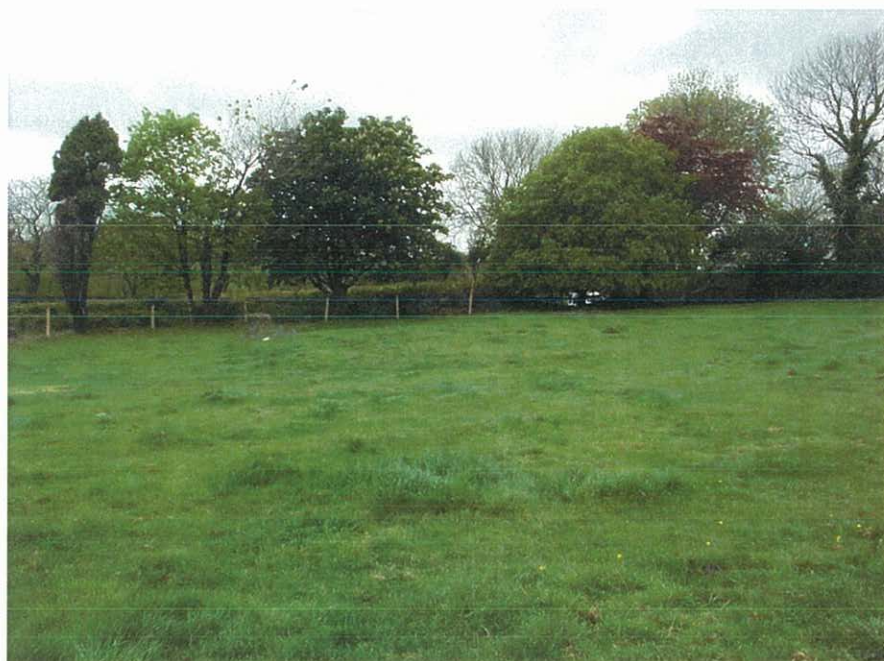
Plate 4- the site of the now infilled shaft (PRN 47956) looking west.

No specific management recommendations.

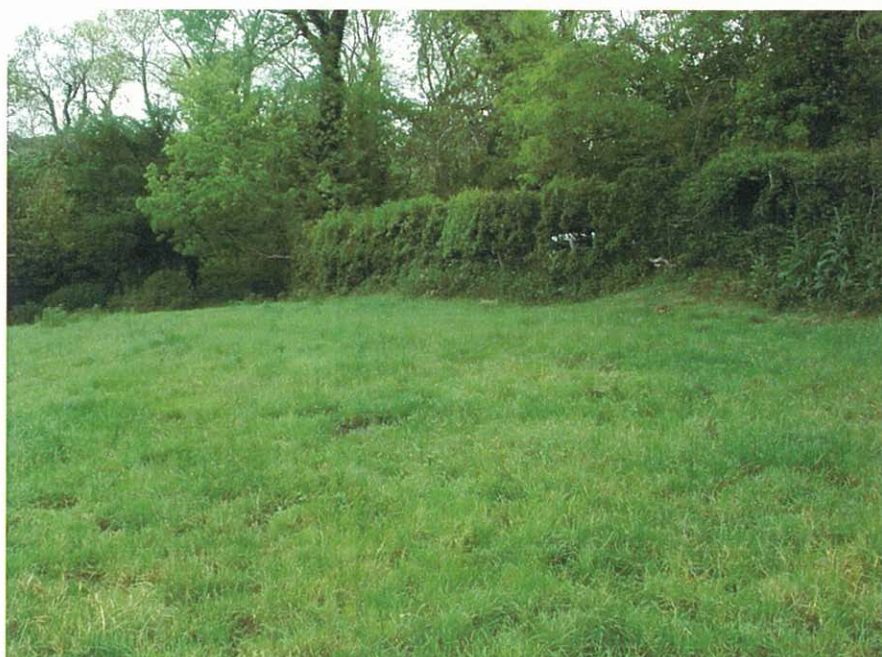
Plate 5- possible former cottage site (PRN 47963) looking west.

Although no evidence of the house survives above ground, there is high potential for the preservation of sub-surface archaeological remains here. Archaeological deposits may survive within the field margin or beneath the current depth of cultivation. It is therefore recommended that further cultivation does not extend further into the field margins or below the current depth of cultivation.

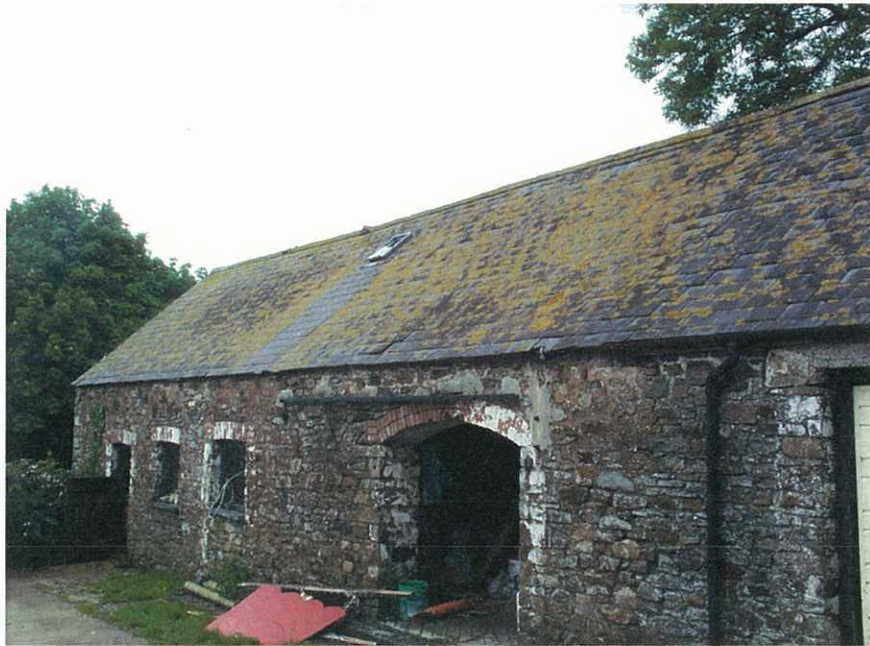
The building, which is likely to be of a late eighteenth century date, is currently in a reasonable condition, however the roof is in need of attention if the building is to be maintained in a stable condition necessary for its long term survival. Several slates are missing from the western pitch and water is running down the walls in places, washing out lime mortar masonry bonds. Some of the roof batons above the hayloft are becoming rotten and will need replacing.

Plate 6- part of east elevation of combination farm building (PRN 47947)

The rotten roof batons above the hayloft should be replaced and missing roof tiles reinstated in order to bring the building back into a weatherproof condition. This should be followed up by a programme of re-pointing and reconsolidating weakened masonry bonds with a traditional lime mortar mix.

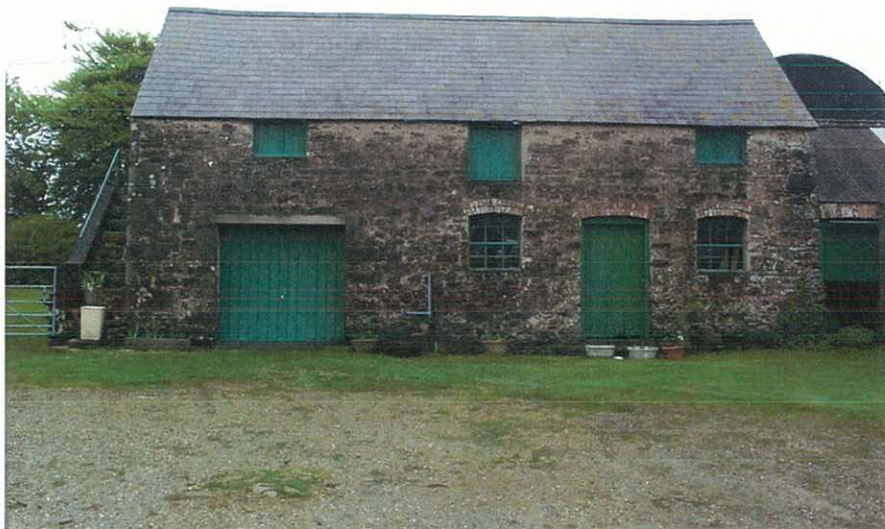
Plate 7 –southeast elevation of combination farm building (PRN 47965)

The building is important to local history and was used from 1846 as a meeting place (PRN 33811) for non-conformist worshippers before the chapel was constructed. It also served as a school (PRN 33812) until 1876 when the pupils transferred to the New Board school at Loveston. The building, which may be of a late eighteenth or early nineteenth century date is currently well maintained and in good condition.

This building, which is an important component of the local history of the area should continue to be maintained in a stable condition using traditional building materials and techniques.

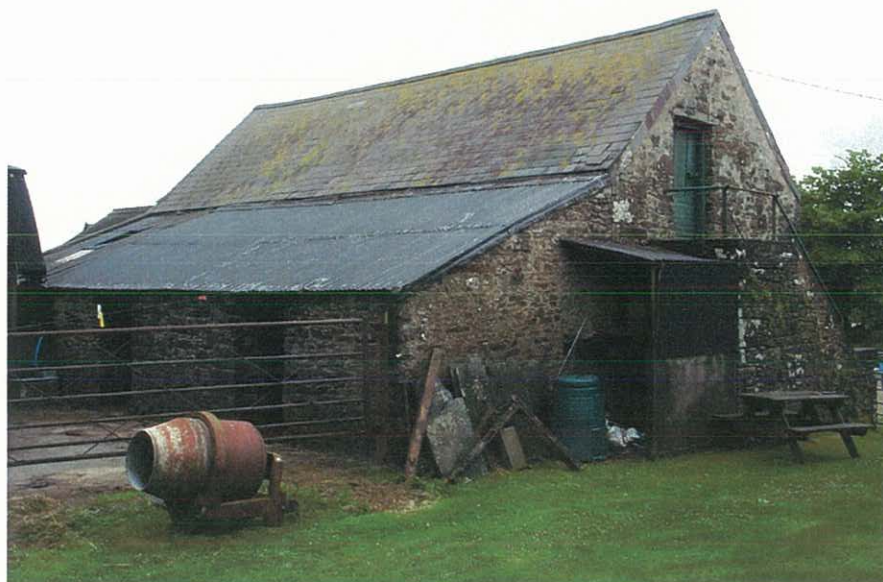
Plate 8- looking east towards cow shed (PRN 47966) abutting cart shed granary (PRN 47965)

Unstable masonry should be repointed using a traditional lime mortar mix. The building should continue to be maintained using materials and techniques faithful to those of its original construction.

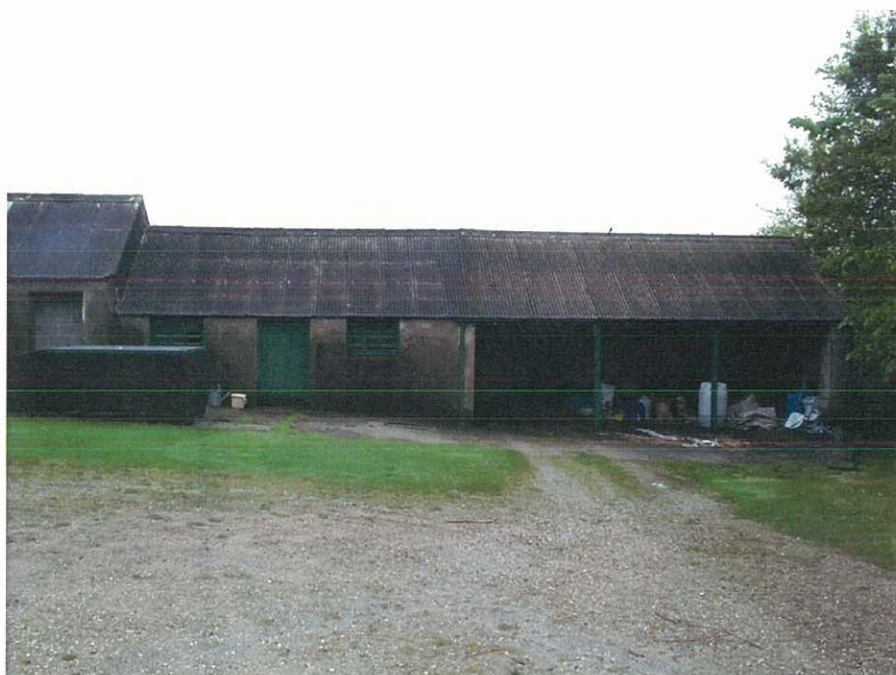
Plate 9 – northern elevation of modified cow shed (PRN 47969)

Unstable masonry should be repointed using a traditional lime mortar mix. The building should continue to be maintained using materials and techniques faithful to those of its original construction.

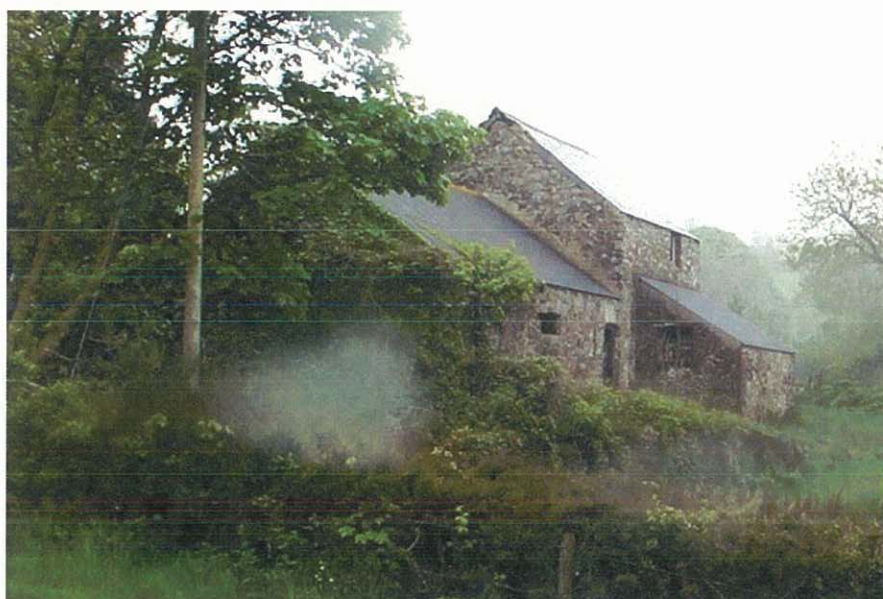
Plate 10- looking south towards farm buildings at Blaengwaith-Noah (PRNs 47971, 47972, 47973)

The building, which is of a possible early nineteenth century date is currently in a poor condition and requires attention if it is to be maintained in a stable condition necessary for its long-term survival. Ivy growth against the east lateral wall is weakening masonry bonds and promoting structural instability. It is also penetrating under the eaves, weakening the roof structure. Several slates are missing from the hayloft roof and water ingress is promoting rot in the floor joists and roof structure. This is of particular concern as the building may lose the stabilising influence of these floor joists, which help to bind the walls together.

The building, which may be of an early nineteenth century date is currently in a reasonable condition, although requires attention if it is to be maintained in a stable condition necessary for its long-term survival. The north gable end and the east lateral wall are heavily overgrown with ivy, which is weakening masonry bonds and promoting structural instability. It is also penetrating under the eaves, weakening the roof structure.

This lean-to abuts the west lateral wall of the cart shed at Blaengwaith Noah. It is of roughly shaped stone construction with red brick corner quoins and a single pitched corrugated iron roof. Access is by a doorway, with a wooden lintel in the south wall, which faces a window in the north wall. The building is not shown on map sources before 1908 and is likely to be of an early to mid twentieth century date. It is currently unstable and in poor condition. Some of the masonry bonds have been washed out and the south end in particular is unstable.

The building is currently falling into a ruinous condition and reconsolidation and repair works are necessary if it is to be brought back into a weatherproof condition necessary for its long term survival. Roof batons should be refitted where necessary and missing roof slates replaced. Rotten floor joists will need to be replaced in order to preserve the structural integrity of the building. Ivy growth poses an additional threat. It should be cut off at the roots, allowed to die and removed, then spot treated to prevent re-growth. This should be followed up by a programme of masonry consolidation and re-pointing using a traditional lime mortar mix.

Reconsolidation and re-pointing works are necessary to bring the building back into a stable condition. It should continue to be maintained using building materials and techniques compatible with those of its original construction.
