## **Dolau Isaf W/13/3825**

### **Tir Gofal Farm Visit Historic Environment Report**

Report No. 2003/54

REPORT NO. 2003/54  
PROJECT RECORD NO. 45849

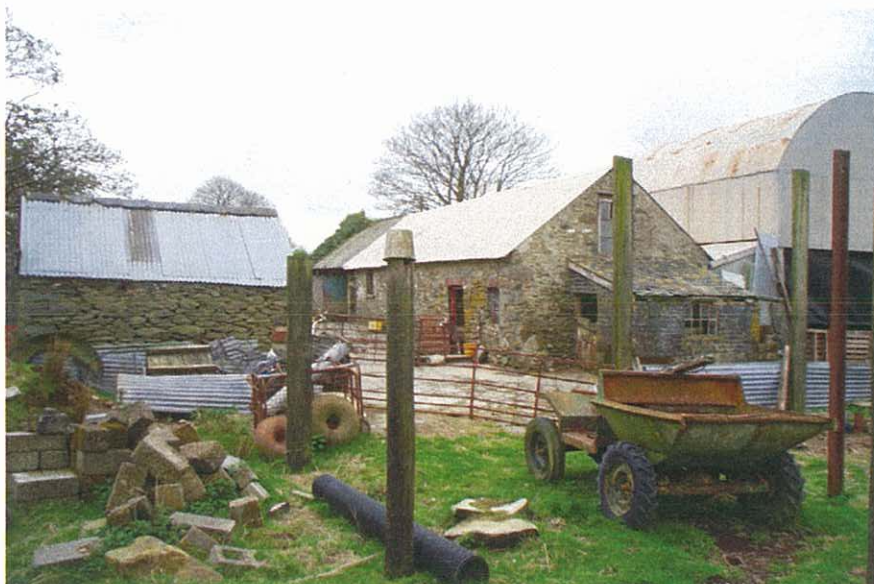
Plate 1- looking south towards the cow shed and pigsty

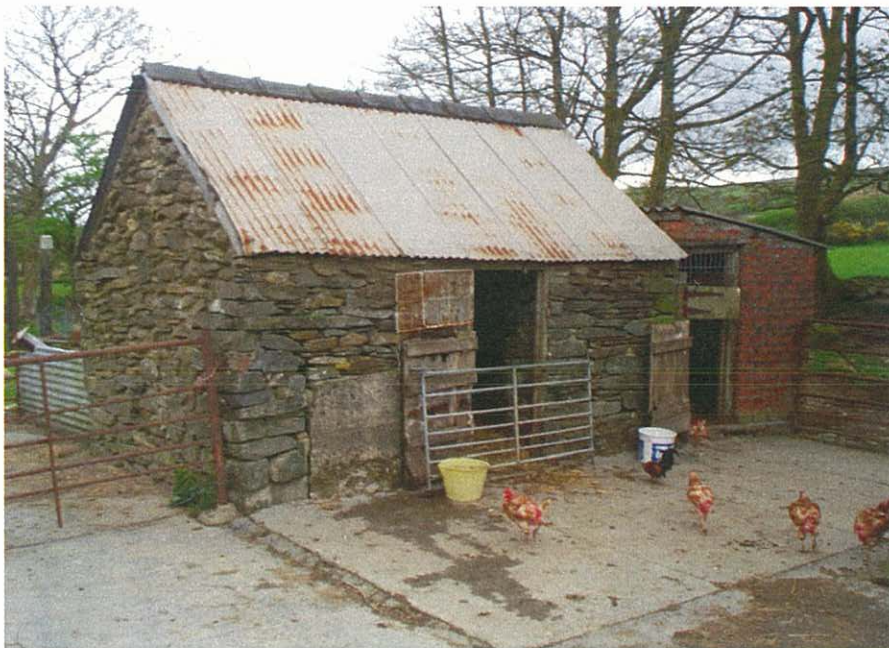
This simple building measures approximately four by three and a half metres and follows a northwest-southeast alignment. It is uncoursed stone rubble construction with faced squared quoins and a lime mortar bonding. The current pitched corrugated zinc roof has replaced a slate roof and some of the original slates are stacked nearby. A blocked off doorway, with a wooden lintel approximately 1 metre high and 0.8 metres wide in the west end of the southwest lateral wall indicates that the building originally functioned as a pigsty, and the thick walls support this. A small square window in the southeast lateral wall is also part of the original build. A more recent doorway with a wooden heck door has been added in the centre of the southwest lateral wall. The building is currently redundant, although the landowner recalls that it was last used as a hen house. It is currently weatherproof and in a reasonable condition, although masonry bonds are weakened in the west corner and some of the quoins are becoming dislodged. Parts of the building have been repointed with cement in the past. The pigsty is not shown on the 1891, 1907 and 1964?? Ordnance Survey map sources. This is surprising given the traditional materials used in its construction, which would indicate an early 20<sup>th</sup> century date at the latest, and it appears that it has been overlooked by the Ordnance Survey. The faced sharply squared quoins are stylistically different from the roughly squared quoins of the cowshed and it is likely to have been built later than other traditional elements of the farmstead. An early twentieth century date is therefore likely.

A small red brick shed, measuring approximately two and a half by three and a half metres with a single pitched corrugated asbestos roof has since been built against the east gable end of the pig sty. It is accessed by a wooden heck door in the west of the southwest lateral wall and currently serves as a hen house. It is likely to date to the latter half of the 20<sup>th</sup> century.

Plate 2-the pigsty/ hen house building  
**THE COW SHED AND LEAN-TOS**

The importance of the pigsty lies in its contribution to the group value of the farmstead, although it may be of a later date than the other traditional buildings. It is a simple and unremarkable example of its type, constructed of local building materials by a local craftsman, in response to contemporary agricultural demands. Whilst there is a general presumption in favour of retaining traditional agricultural buildings, it is recognised that the expenditure necessary for maintaining traditional buildings has to be weighed against the justification of that expenditure. The building is currently redundant and at risk of becoming neglected.

In the event that an archaeological site or historic building is to be destroyed, it is recommended that an appropriate record should be made. The photographs and field notes taken during the archaeological farm visit are considered to be an adequate record in this instance.

Although not ideal, if the building is to be demolished, it is hoped that the new stable block will use traditional building materials in keeping with the traditional character of Dolau Isaf farmstead.

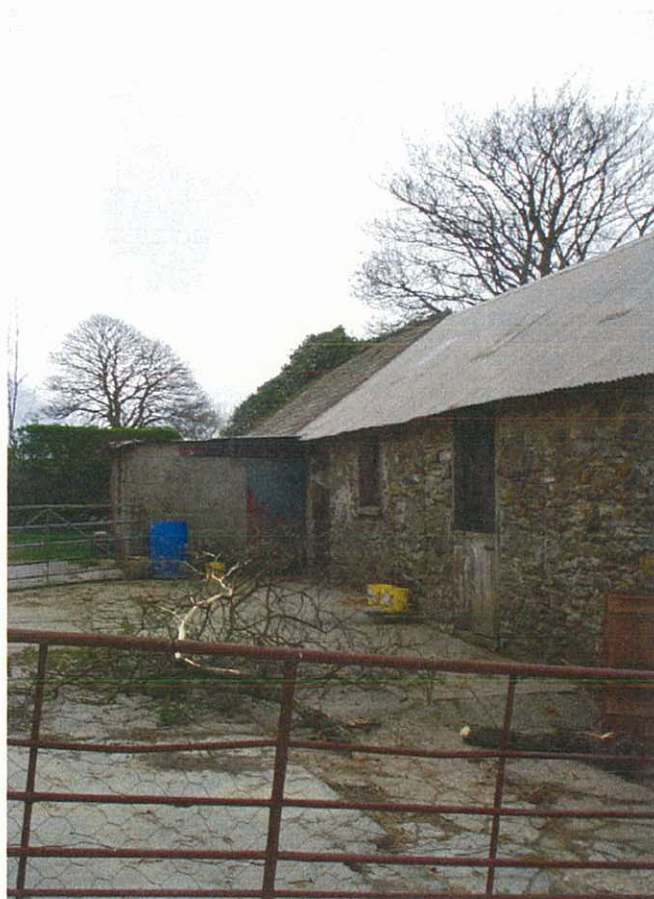
The cowshed follows a broadly north-northeast-south-southwest alignment and defines the western extent of the farmyard at Dolau-Isaf. It is of uncoursed stone rubble construction with roughly squared quoins and a pitched roof. Only the south bay remains retains its traditional slate roof, and the rest of the building has since been re-roofed with corrugated iron. Heavy ivy growth at the south gable end of the building threatens to weaken masonry bonds and dislodge roof tiles. A previous fire in the building has blackened many of the roof timbers and weakened some. Some of the roof batons in the southern bay of the cow shed are rotten and will need replacing.

Plate 3- the cow shed looking south

The landowner has also expressed an interest in re-roofing the cow shed range. Some of the roof batons in the southern bay of the cow shed are rotten and will need replacing. The building should be re-roofed as a whole for maximum structural integrity. The desire to use slate to re-roof the building is to be encouraged as it will restore the historic integrity of the building. The ivy growing up the south gable end of the building should be cut off at the roots, allowed to die and then removed. Stumps should be spot treated in order to prevent re-growth. This should be followed up by a programme of repointing and building consolidation in areas, where masonry bonds have been weakened by intrusive vegetation growth.

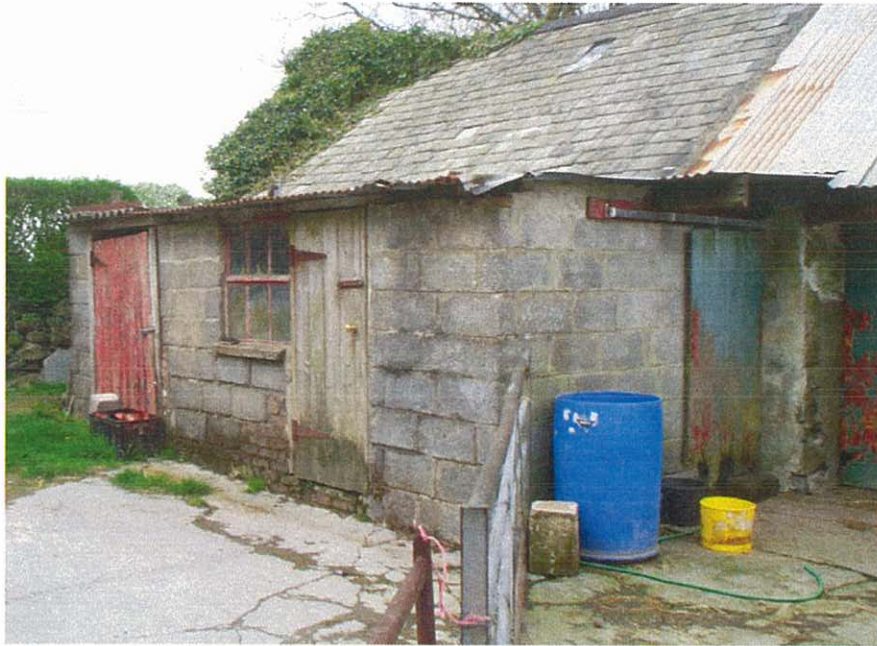
The lean-to, at the south end of the east lateral wall is of breeze block construction, with a single shallow pitched corrugated iron roof and measures approximately five metres by three metres. It is accessed by two doorways in the front (east) wall, and one in the east wall. A window is located in the centre of the front wall next to the right doorway. The lean-to, with a shallow pitched corrugated asbestos roof abutts the north gable end of the cowshed. Engineering brick courses have been laid above breeze block footings. It is accessed by a doorway in the east wall, a single window is in the centre of the north wall.

Plate 4- the lean-to abutting the south end of the east lateral wall of the cow shed.

A desire to demolish the two cow shed lean-tos has been expressed. Both buildings are comparatively recent additions to the farmstead and are of little historic importance. The removal of these sheds, which give little architectural contribution to the farmstead, will enhance the appearance of the cow shed, whilst also making necessary repair work to the cow shed roof easier.

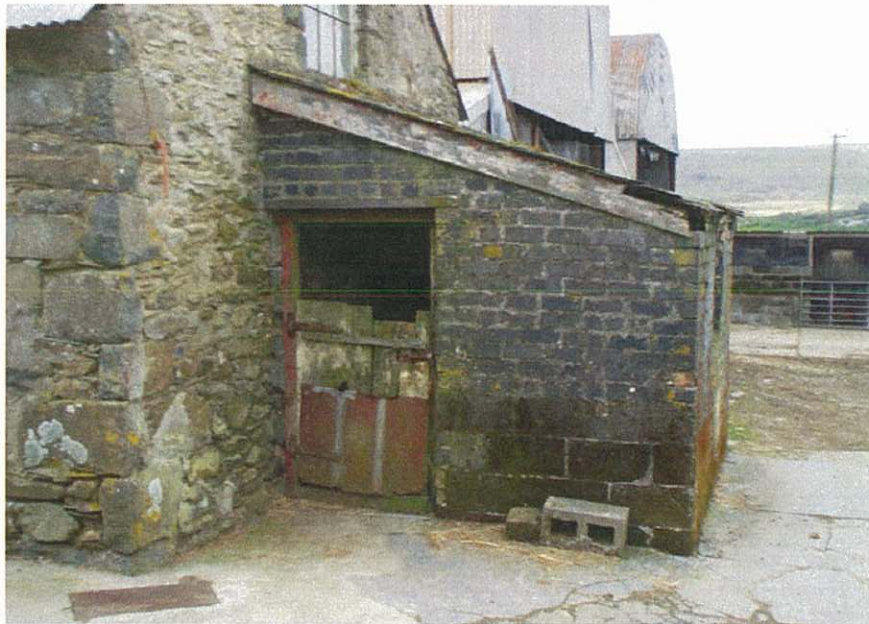
Plate 5- the lean-to abutting the north gable end of the cow shed.
