## **Langdon Mill W/13/3827**

### **Tir Gofal Call-Out Visit Report**

Report No. 2003/85

REPORT NO. 2003/85  
PROJECT RECORD NO. 45851

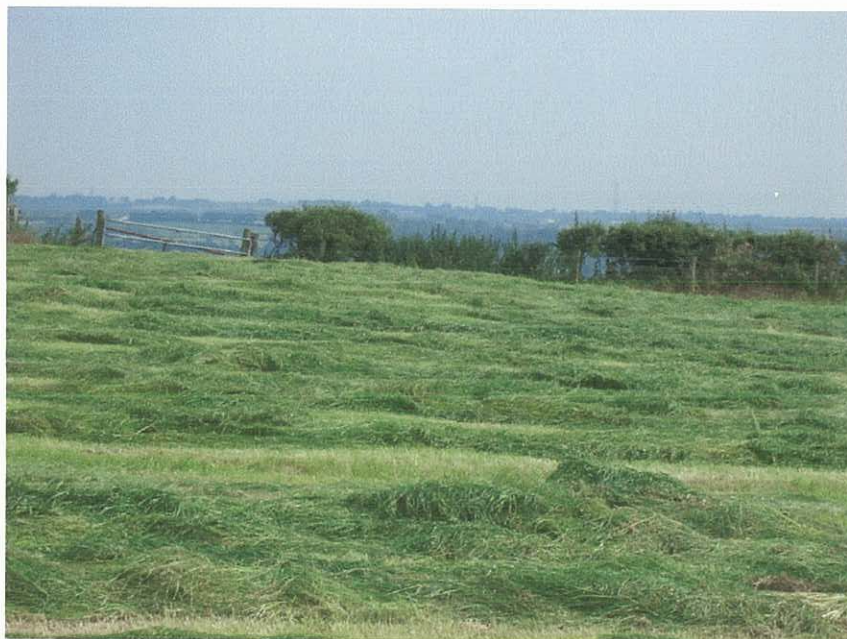
**Plate 1.** *The defended enclosure (PRN 3475). The banks are very slight – the outside of the east bank can be seen as a rise in the ground just to the right of the gate in the hedge.*

The condition of the site is currently poor. The banks are heavily plough damaged and denuded, and their condition will continue to deteriorate as long as the land is in arable use. The very north of the site, within the 'bulge' of the hedge, is currently rough ground and seems to be unploughed. The ground in that area is very stony, and this may represent clearance of stones from other areas of the field.

This site and the immediate surrounding area should ideally be taken out of cultivation. This would protect surviving buried archaeology, as well as the slight visible remains of the banks themselves. Once a stable grass surface is established, then light grazing should be sufficient to prevent scrub incursion and maintain an even vegetation cover.

If the site continues to be ploughed, then all visible traces of it will soon be lost. If it is impossible to prevent this, then it should be ensured that future ploughing does not penetrate beyond the depth to which the land has been cultivated in the past. Root crops should not be grown in this field.

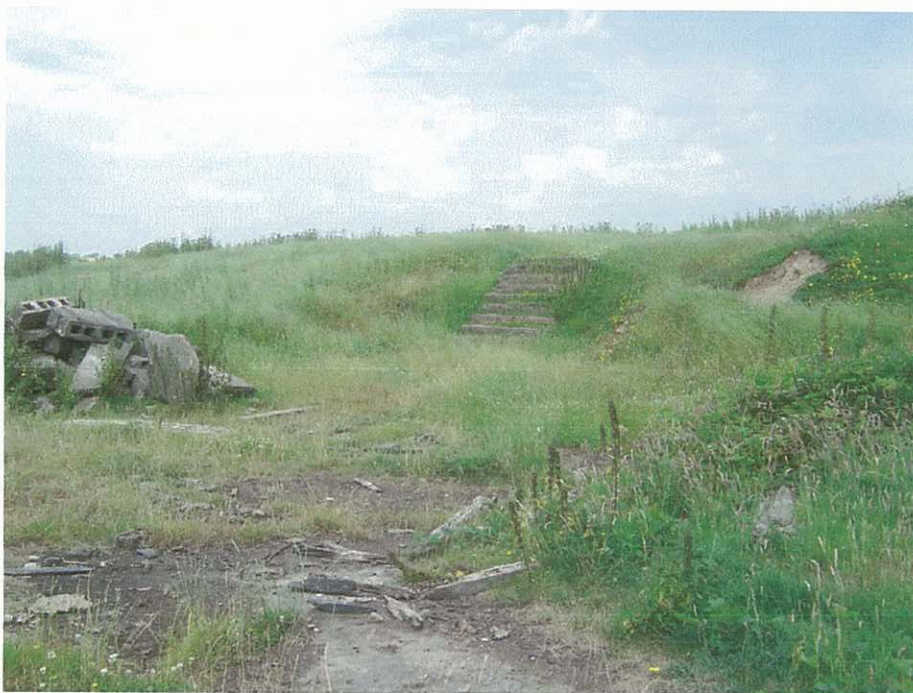
The remains of a bomb or incendiary store. Two rectangular concrete platforms remain, which are terraced deeply into the hillside on their north sides. An earth embankment surrounds the other sides. Building rubble is scattered around the site, but the actual buildings themselves have been dismantled. A short flight of concrete steps leads up the embankment on the north side.

The site is overgrown, but is still visible and is in a stable condition.

**Plate 2.** *The remains of a bomb or incendiary store (PRN 48627). The embankment around the site is clearly seen, with the flight of steps surviving on its north side. The building foundations are in the foreground and to the right of the picture.*

Some vegetation control – possibly through light grazing – would benefit the site. No further building rubble should be removed from this complex.

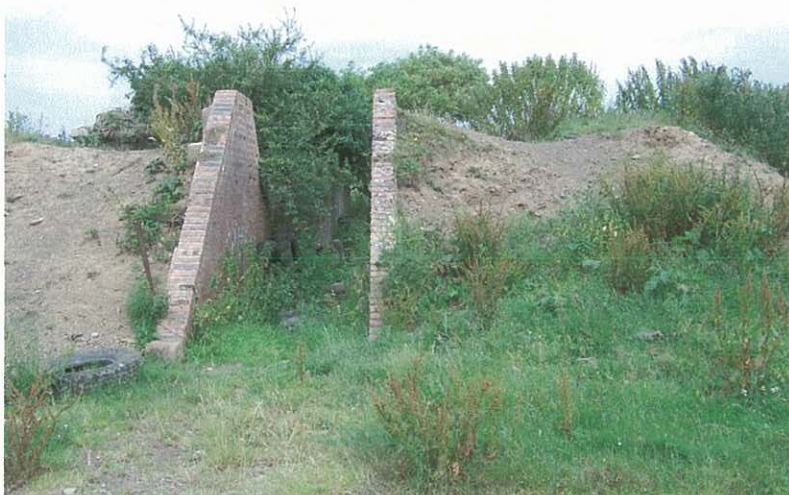
The site is very overgrown, but seems to be in a stable condition. Both buildings have water troughs in them, and appear to have been used for animal shelters in the past. The earth banks surrounding the buildings are still clearly visible, though the one on the west of the site is degraded along its west edge.

**Plate 3.** A brick supported entrance through the blast wall which surrounds a bomb store (PRN 48628). The building itself is behind the vegetation, just to the left of the entrance.

Vegetation control would benefit the site, increasing its visibility and aiding the preservation of the buildings. Vegetation growing on both buildings and earthworks should be cut back, either flush with the walls or to ground level, and then removed. It should not be dug or dragged out.

The best way to ensure the long-term preservation of buildings is generally to bring them back into use. The usefulness of these buildings for agricultural purposes is very restricted due to their small size and the difficulty of access into them. However they may be of use for sheep shelters or storage.

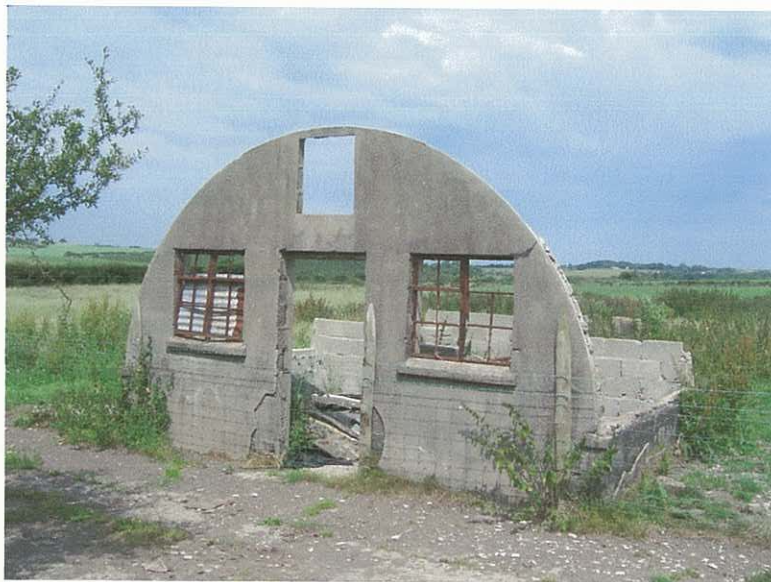
The remains of a military building. The building was originally constructed of low breeze-block walls which supported an arched roof of corrugated asbestos. A cement-rendered gable at the south end still stands and would have helped to support the roof. The breeze-block walls on either side also stand to their original height, though the roof is now gone. Traces of internal divisions are still discernible.

The remains of this building are in a stable condition and rubble in the interior of the structure is probably original construction material.

**Plate 4.** *The remains of a military building (PRN 48629). This building would have had an arched corrugated metal roof – the walls and gable stand to their full height.*

Building rubble should not be taken out of this building. Vegetation should continue to be kept in check around the site.

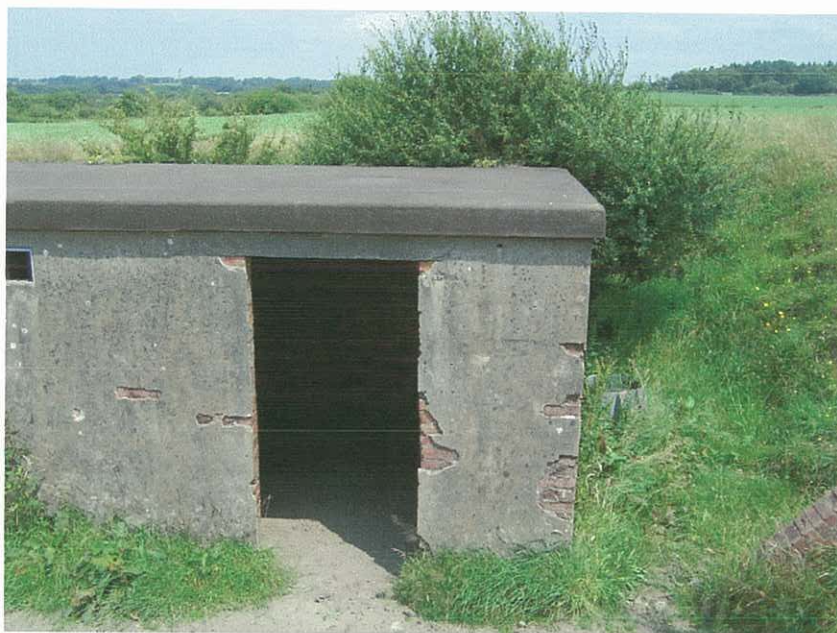
The site is in a fair condition, though currently derelict. There is some erosion of the west bank, and vegetation is beginning to colonise the east wall of the building.

**Plate 5.** Incendiary store (PRN 48632). Although some vegetation is beginning to colonise the building, the earthwork enclosure around it is well preserved and the building itself is stable.

The well-preserved and clearly visible nature of this small bomb store makes it especially significant. It is important that it is maintained in its current condition.

The vegetation across the east wall should be cut back flush with the wall and removed. If the erosion on the west bank continues to worsen then it may be necessary to restrict access across the earthwork. However, it is probably the accessibility of this site which is allowing vegetation growth to be controlled by grazing livestock, so restrictions should not be imposed unless the erosion continues to worsen.
