## **South Headborough W/13/3845**

### **Tir Gofal Farm Visit Historic Environment Report**

Report No. 2003/102

REPORT NO. 2003/102  
PROJECT RECORD NO. 45865

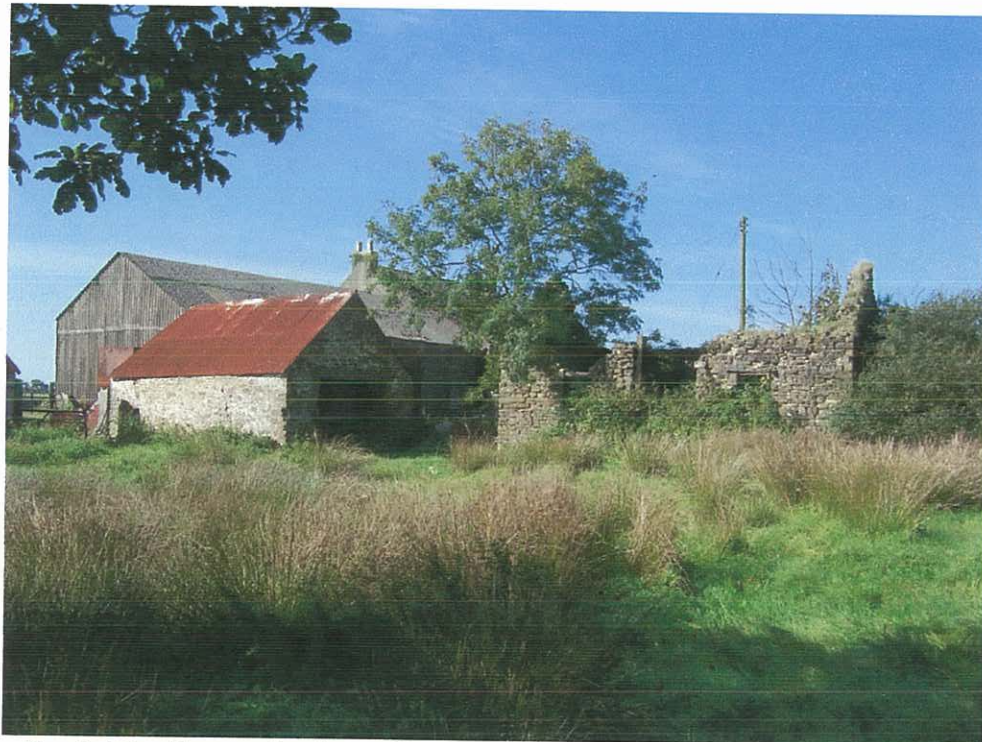
*South Headborough: the stable and cart shed with the farmhouse behind*

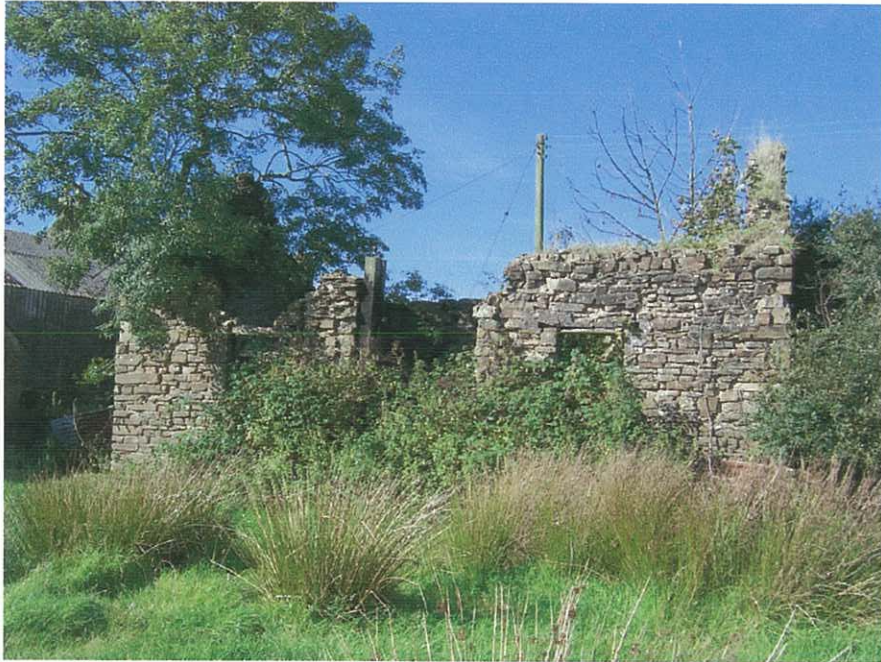
The stable is currently roofless although the walls appear secure and stand to roof height. It is orientated on a north south axis with the frontage facing towards the pond to the east. A central doorway is placed in the east elevation with flanking windows to either side. Internally sockets are visible along the rear lateral wall indicating the position of a loft.

The stable is currently very overgrown with brambles and a number of self seeded ash trees are growing within and in close proximity to the structure. The walls themselves appear to be stable and straight; there is no indication of any leaning or buckling.

*Prn 48682 - the old stable which stands to the west of the farm pond*

The stable is the largest building in the group around the farm pond. It is also in the most vulnerable condition, since without a roof the wall tops are exposed to the elements and will quickly degrade. The most important aspect of the restoration is to replace the roof, in order to restore the building to a watertight and weatherproof condition. The preferred option is to re-roof the building in slate, however, if this is not possible the next best solution would be to roof the building in corrugated sheeting. As a short term measure the vegetation (mostly brambles) which have colonised the interior should be cut back to ground level and treated to prevent regrowth. A number of self seeded ash trees have also grown in close proximity to the structure and a fairly mature tree grows adjacent to the south gable, the branches of these trees are brushing against the masonry and will undoubtedly cause instability. These should ideally be cut down at ground level and the stumps treated to prevent regrowth.

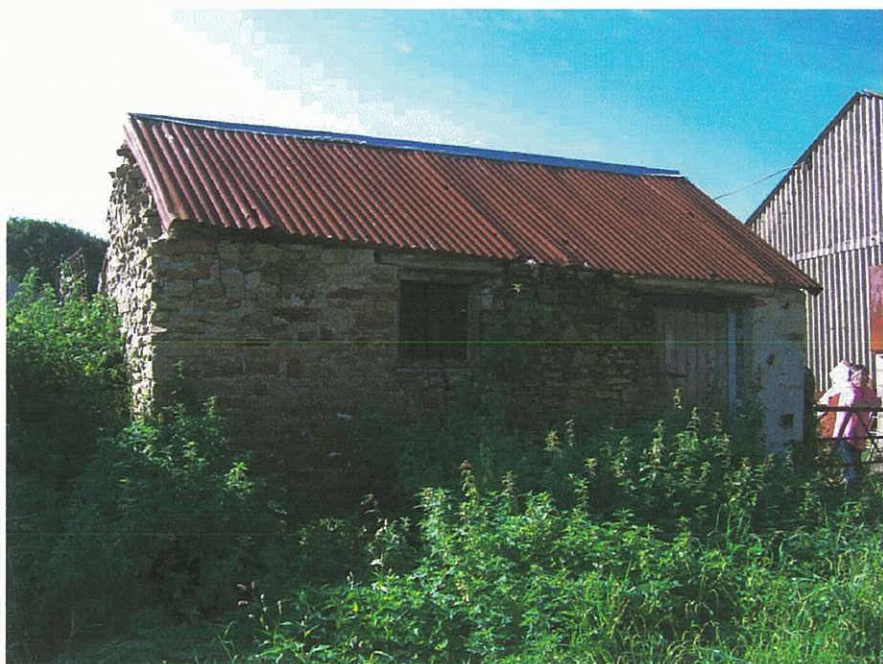
To the southeast of the stable is a small one unit building which is thought to be a calf house. Its front elevation, facing north overlooking the pond has a single doorway to the west side and a small square opening with metal bars. The calf house is roofed with corrugated iron which is corroding. The rear elevation (south) has been almost entirely rebuilt in breeze block and the west gable end has been heavily repointed in cement.

Although complete the calf house is beginning to look unstable particularly around the east gable end where the wall tops are collapsing. Another area of collapse is at ground level around the west gable end. The interior of the roof was not inspected so the condition of the structural members is unknown.

*Prn 48683 - the calf house*

Although the calf house has been substantially rebuilt in breeze block in the south elevation the bulk of the building is still intact. The stonework is beginning to loosen around the east gable and this may in part be due to the lack of adequate roof covering over the wall tops. The corrugated iron sheeting which covers the building at present is beginning to seriously degrade resulting in the building no longer remaining watertight. Ideally the building should be recovered in slate, although corrugated sheeting would also be a satisfactory alternative. The masonry around the two gable ends should be repaired using materials similar to the original construction.

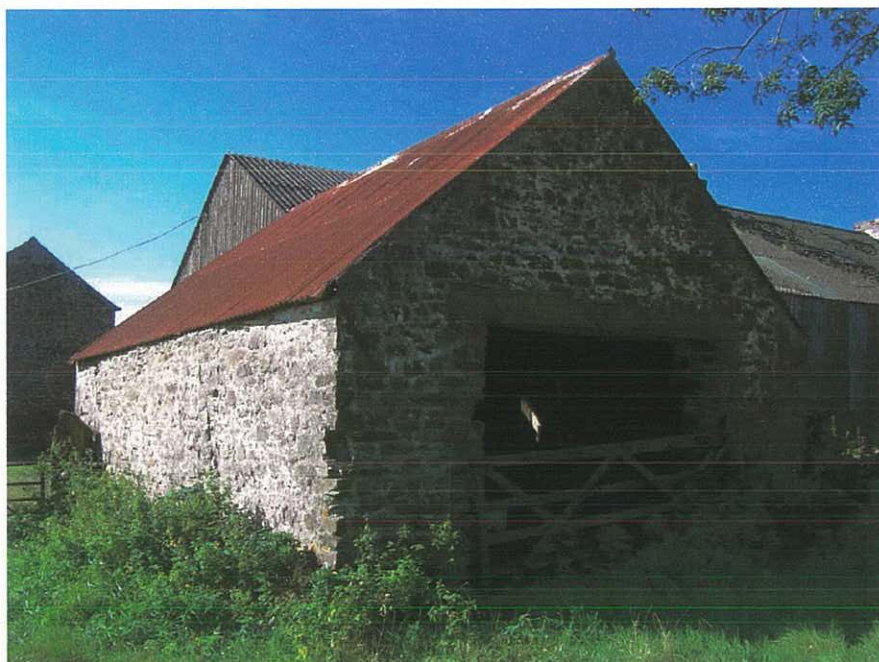
Immediately to the south of the stable is a single unit cart shed, with a wide double entrance in the north gable end. In common with the other traditional buildings which surround the pond, the cart shed is rubble built, although it has been repaired in brick at the south gable.

The cart shed appears structurally sound. However, the roof covered in corrugated iron is beginning to corrode and is probably nearing the end of its lifespan.

*Prn 48684 - the cart shed*

Although the cart shed is at present in a reasonable state of repair the corrugated iron sheeting on the roof is degrading through lack of treatment. It appears to still be watertight at present however it will need repairing or replacing in the not to distant future. In common with the other buildings discussed above, slate would be the preferred roofing material, however corrugated sheeting would also be acceptable.

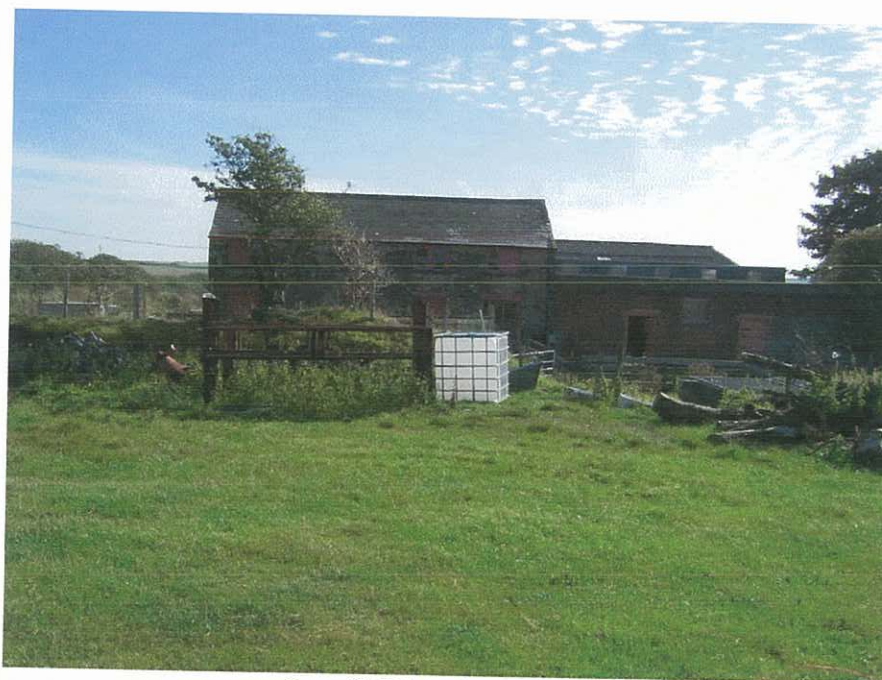
The cow shed is a long two storey range constructed in rubble stone with a slate roof. Although the tithe map of 1840 indicates a building in this approximate position it does not appear to be as large as the existing building. The 1<sup>st</sup> edition Ordnance Survey map of 1891 does show a better representation of what may be the current building and it indicates a circular 'horse gin' to the east.

The cow shed has been recently repaired and appears to be in a stable condition.

*Prn 48685 – the cow shed*

This building should continue to be maintained in a stable and watertight condition.

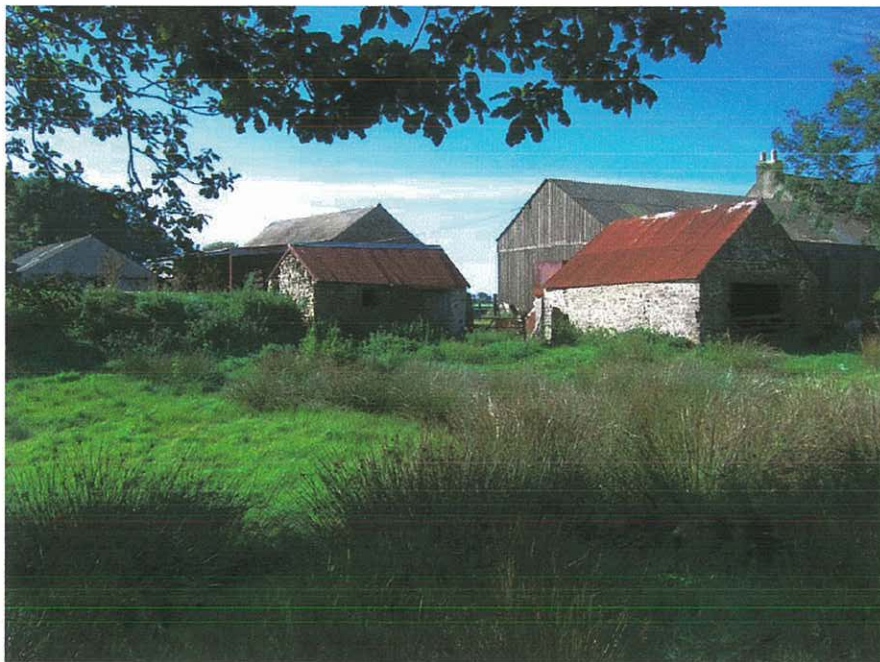
A pond is clearly marked on the 2<sup>nd</sup> edition Ordnance Survey map of 1908 suggesting that it was established when the farm of Headborough was subdivided into two. It is situated to the east of the enclosure in which the farm buildings above are located. The eastern extent of the pond appears to have been formed by the boundary bank which is extant today.

The pond was largely dried up when the farm was visited in September, although the ground was clearly still damp and boggy. The pond appears to have been silted up for some time. There do not appear to be retaining banks on any side but the east which forms the enclosure bank.

*Prn 48686 - the pond has almost completely silted up and is now only denoted by the rushes*

The restoration of the pond would be a worthwhile undertaking and restore some of the historic character to the farmyard. The excavation of silt and vegetation which currently choke the pond should be carried out with care not to damage the existing boundary bank to the east.

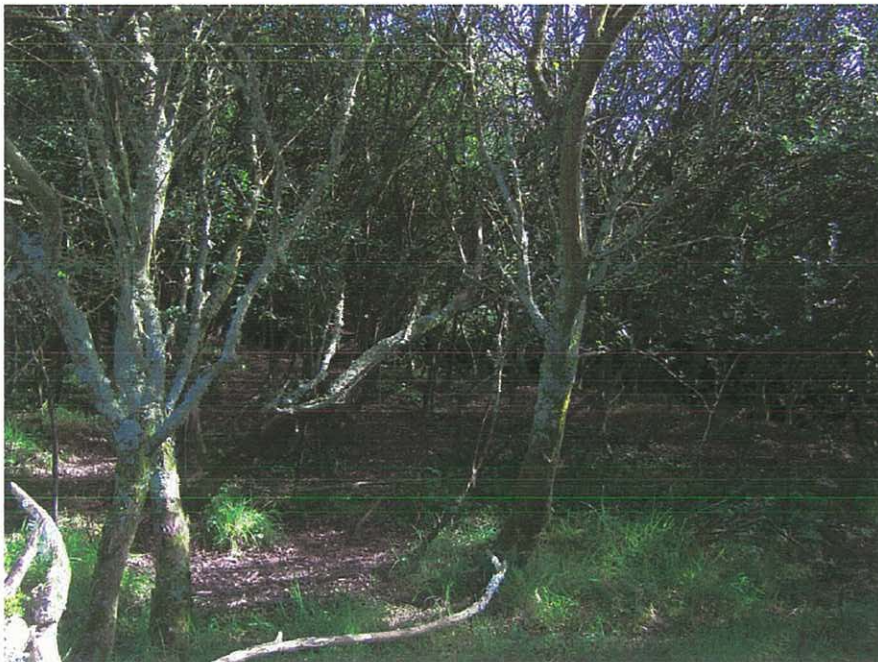
A circular feature to the east of the farm holding is identifiable on the 1<sup>st</sup> and 2<sup>nd</sup> edition Ordnance Survey maps of 1891 and 1908, although no function or status is attributed to it. It is defined on the maps as a roughly circular feature with dense hachures indicating a steep slope around the edges and a flat and featureless centre.

The area around this feature is currently densely covered with thorn trees, making assessment difficult. The nature of the feature did not appear to be as regular as suggested from the early Ordnance Survey maps, however a definite hollow with steep sides was observed.

It is unknown what this feature may have been derived from, but it is possible it may have been a quarry or extraction pit of some sort, although it appears to exist in isolation.

*Prn 48687 - the mysterious feature identified from the early Ordnance Survey map editions.*

This feature is currently in a stable condition although not very easily accessible or visible. If any further information comes to light about the nature of this feature please inform Cambria Archaeology.
