Pengwern-Isaf

Tir Gofal Farm Visit Historic Environment Report Call Out

REPORT NO. 2003/115
PROJECT RECORD NO. 47222

22nd October 2003

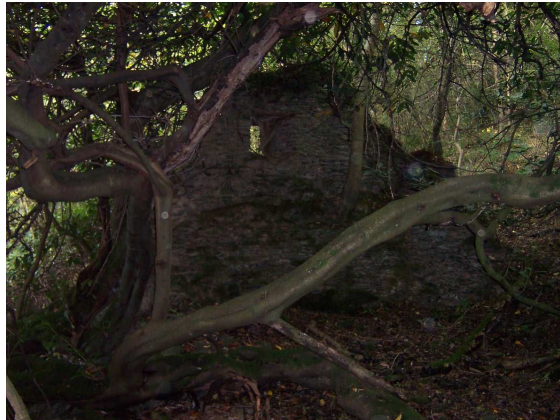
Plate 1- the west gable end of Cottage A. from the interior.

The cottage now lies within established woodland, which is grazed occasionally. It is now masked by a combination of young and mature trees. Some of these specimens are potentially threatening to the long-term survival of built structural remains. A young beech tree on the interior east gable end is adding weight and threatening to de-stabilise this wall. A large rhododendron, rooted in the southwest corner is now sprawling over much of the buildings interior and obscuring the site.

The beech and rhododendron trees, which are obscuring the site and threatening to de-stabilise built structural remains should be cut off at the roots and spot treated to prevent re-growth. Fencing the site off into un-grazed woodland has been proposed within the Tir Gofal scheme. This is to be welcomed. Future management of the site should involve the monitoring and management of exiting trees in order to prevent damage to structural remains by root damage or falling trees. Young trees should be prevented from becoming established over the site. No ground intrusive activities should be undertaken within the enclosed area of the site.

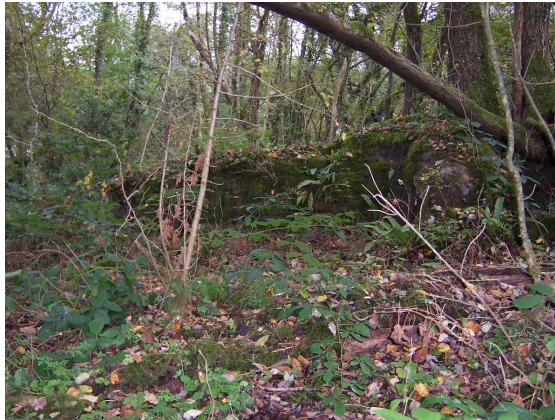
Plate 2- looking east towards the remnant walls of the annex (Cottage C)

The cottage now lies within woodland, which appears to be grazed occasionally. Mature trees have become established around the site and some are rooted in the surviving walls. These appear stable at present and pose no threat to surviving built structural remains. Some saplings and scrubby vegetation growth are interspersed between these mature trees.

If any trees do become unstable in future, these should be cut off at the roots and prevented from falling naturally in order to prevent roots from uprooting structural remains.

Fencing the site off into ungrazed woodland has been proposed within the Tir Gofal scheme. This is to be welcomed. Vegetation growth should not be allowed to obscure the surviving walls of the cottage and annex.

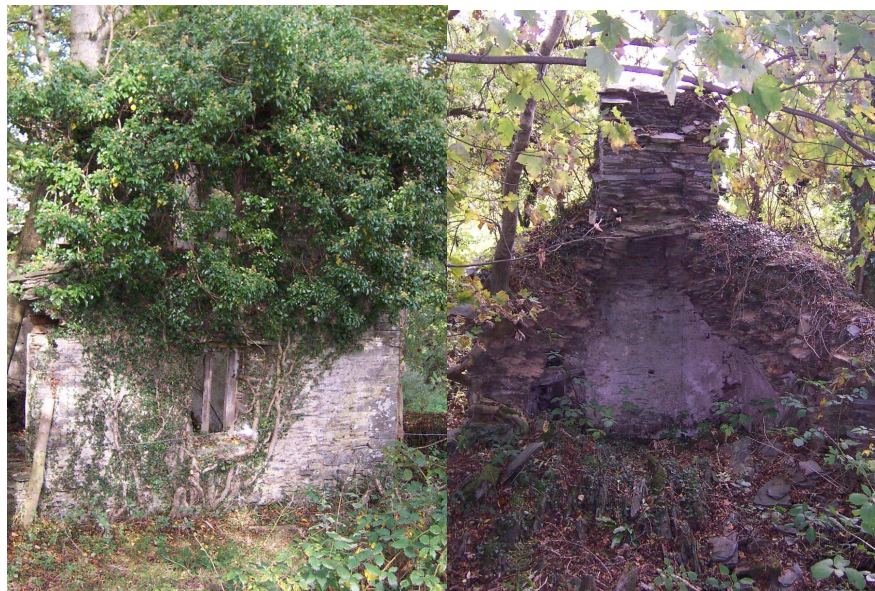
Plates 2 & 3- the southern elevation is now heavily overgrown with ivy; internal view of the fireplace from the north.

The ruin is now in a precarious and unstable condition. Mature beech and sycamore trees, interspersed with saplings, have become rooted around the site. Not only are these masking standing remains, but when rooted in the wall footings they are a potential source of instability. Heavy ivy growth, particularly around the south and eastern sides of the building is adding weight to an already weakened structure. Added to this is the problem of natural decay through water ingress, and frost action which is eroding lime mortar masonry bonds in the unprotected walls.

Mature trees should be monitored for signs of instability in future. Any unstable specimens should be felled or pruned in a controlled manner before being allowed to cause damage to built remains. Some of the bushy ivy growth should be cut back from the walls in order to reduce weight and wind resistance on this already weakened structure. This should only be undertaken if it is considered safe to do so.

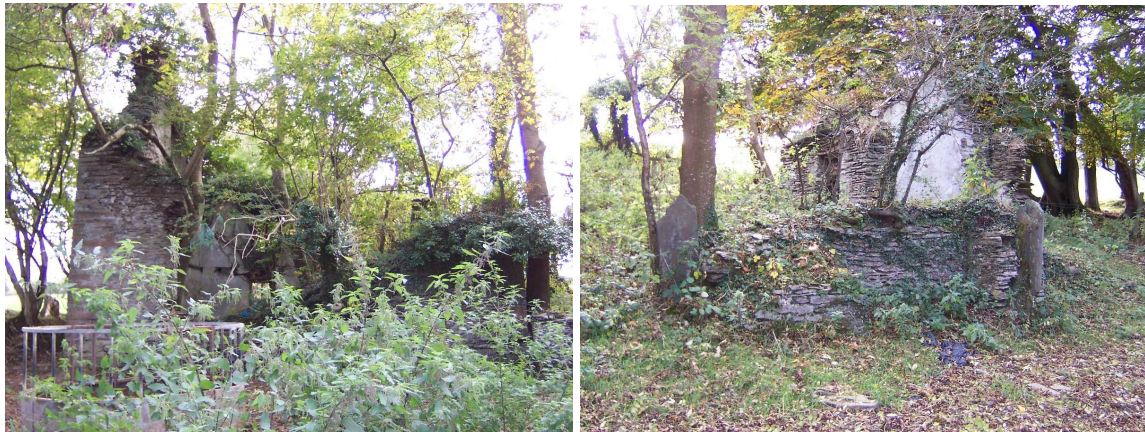
Plates 4 & 5- Blaen-dwylan farmhouse and outbuilding from the north.

A ring feeder is positioned five metres to the north of the structure. Spent bale wraps and other agricultural debris have been dumped inside the ruin. No visible damage to the ruin or other elements of the historic farmstead was observed from cattle congregating here. This should not be moved to within five metres of any built or buried structural remains.

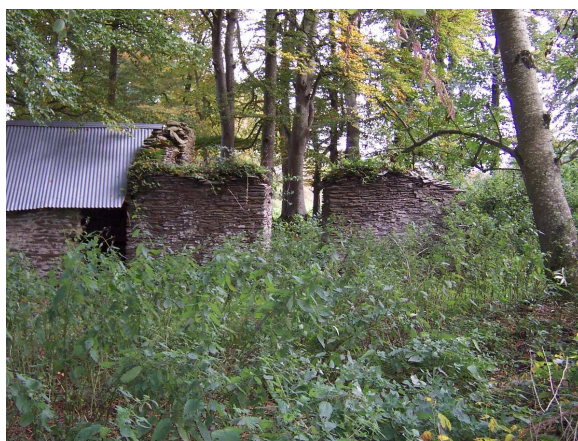
The walls are exposed and vulnerable to erosion. The north gable end is becoming increasingly unstable. This gable end supports the wall plates of an abutting agricultural building (C) to the north.

Plate 6- west elevation of ruinous agricultural building (B)

It is important that this gable end is stabilised in order to ensure the long-term survival of the abutting building to the north. This could be achieved by re-pointing and capping the wall tops in order to prevent water ingress from further de-stabilising masonry.

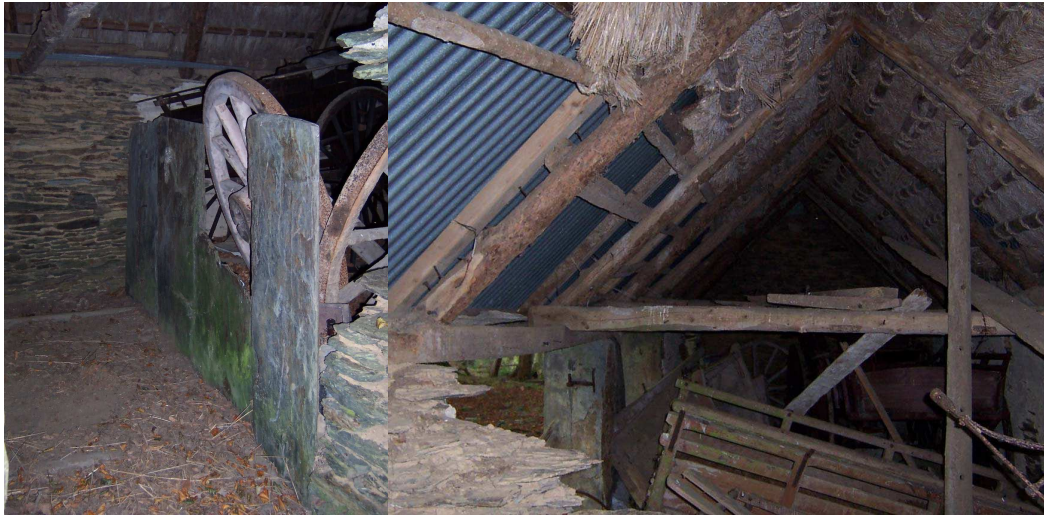
The building remains in a stable and weatherproof condition, although lime mortar bonds are washed out in places. A possible source of future instability can be identified towards the southern end of the building. Here, the wall plates are supported in the gable end of neighbouring agricultural building (B). This gable end is exposed and becoming unstable. If this were to collapse it is likely to compromise the long-term survival of the building.

Plates 7 & 8- Agricultural Building C; internal slate partitions, interior looking north.

The importance of this building lies not only in the rare survival of the thatch roof and internal slate partitions, but also in the assemblage of historic carts and farm machinery, which remains undisturbed inside. It is important that it continues to be maintained in a weatherproof and watertight condition in order to protect these elements.

Ideally, the abutting south gable wall, which supports the wall plates at this end of the building should be stabilised by re-pointing and capping of the wall tops using a traditional lime-mortar mix.

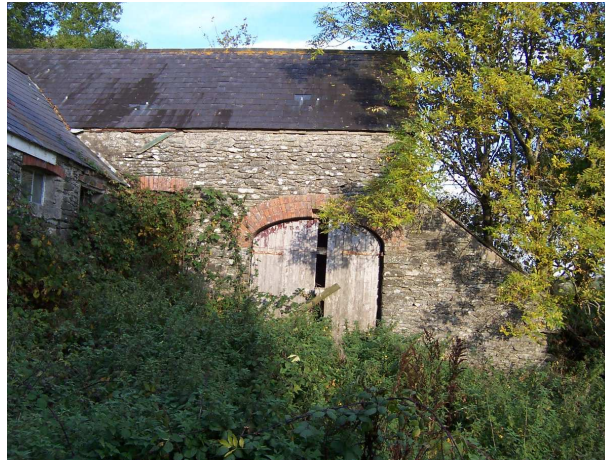
The building is now redundant, although remains in a reasonable condition. Young ash trees have become established around the site and are growing out of the wall footings of the east lateral wall

and north gable end. Root action is displacing masonry and is a potential source of building instability.

Plate 9- looking east towards the combination farm building and pigsty at Pengwern-Bica.

The young trees which have become established around the site should be cut off at the roots and spot treated in order to prevent re-growth. This should be followed up by a programme of re-pointing and masonry consolidation where necessary. Branches, which are currently rubbing against the roof and walls of the building should be pruned. Mature trees and their branches should be monitored for signs of instability, and felled or pruned in order to prevent damage to the buildings. In order to ensure that the building does not become neglected, some consideration should be given to how it can best be used in future.

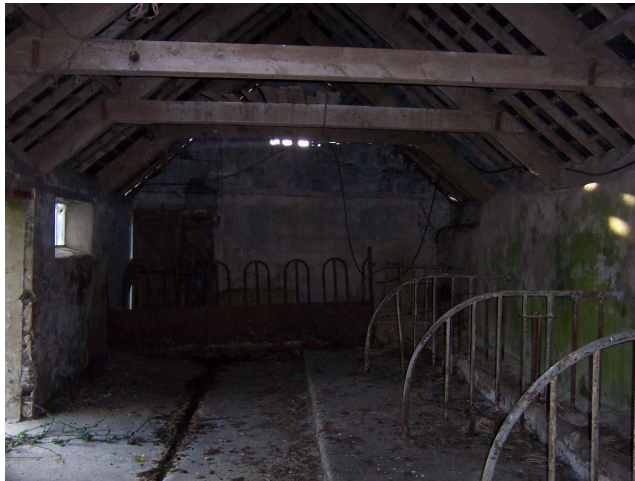
working life of the building. The building is now redundant, although it remains in a stable condition. A few roof tiles have become displaced, and several others are loose.

Plate 10- the interior of the cow shed at Pengwern-Bica looking west

The building should continue to be maintained using materials and techniques, which are faithful to those of its original construction. Trees surrounding the site should be monitored for signs of instability, and felled or pruned if necessary in order to prevent damage to the buildings.

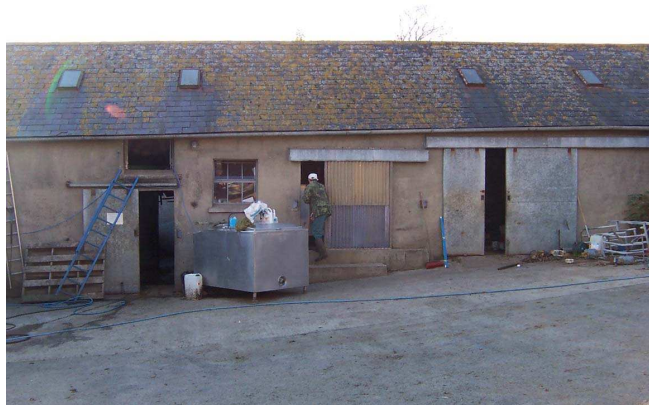
Plate 11- part of the east elevation of the combination farm building at Pengwern-Isaf
