# **Penrallt W/11/3523**

## **Tir Gofal Farm Visit Historic Environment Report**

Report No. 2003/89

Penrallt  
Tir Gofal Call Out Visit Report

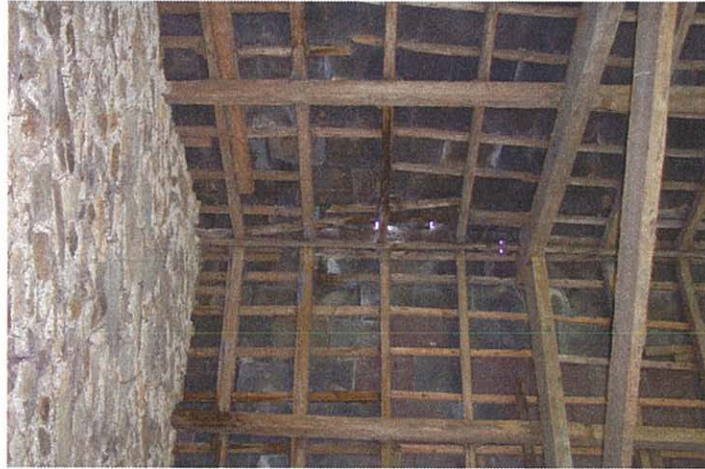
The roof is a particular concern, and several early signs of instability have been identified. Its condition at the southeast end of the granary is perhaps the principal area of concern. Several of the battens on its eastern pitch are broken, and displaced, and the tiles have slipped. Water is entering the building through the apex of the roof, running down the rafters and promoting rot in the timbers, which is further undermining stability. Some of the purlins are showing evidence of rot, and it has also become established at the base of one of the trusses.

Plate 1-The unstable granary roof.

Although several areas of weakness were found in the roof, much of it remains in a sound and weatherproof condition. Repairing and replacing the damaged elements described above will be necessary if the building is to be returned to a stable condition in the long-term. Roof sections above the cart house and stable appear to be in reasonable condition and re-roofing these areas may not be necessary. The door in the northwest gable end of the building should be replaced in order to prevent water from further damaging floor joists. Unstable areas of the walls should be re-pointed and reconsolidated as necessary. Ideally, this should be followed up by a more general programme of re-pointing. Building materials used should be compatible with those of the original construction.

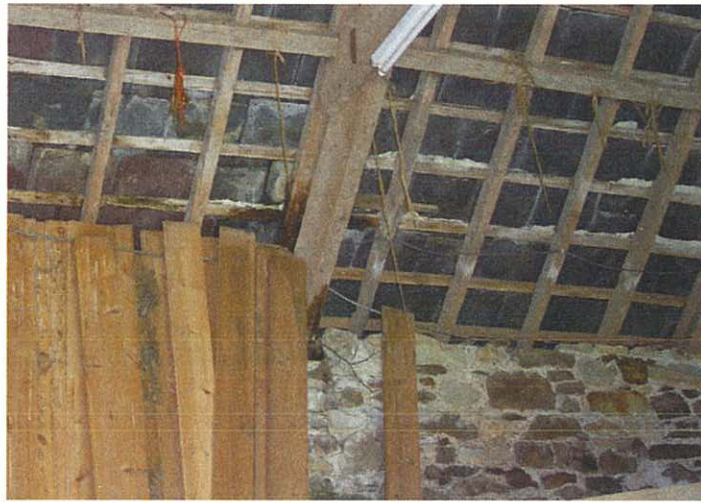
Plate 2-Rot has become established at the base of one of the roof trusses.

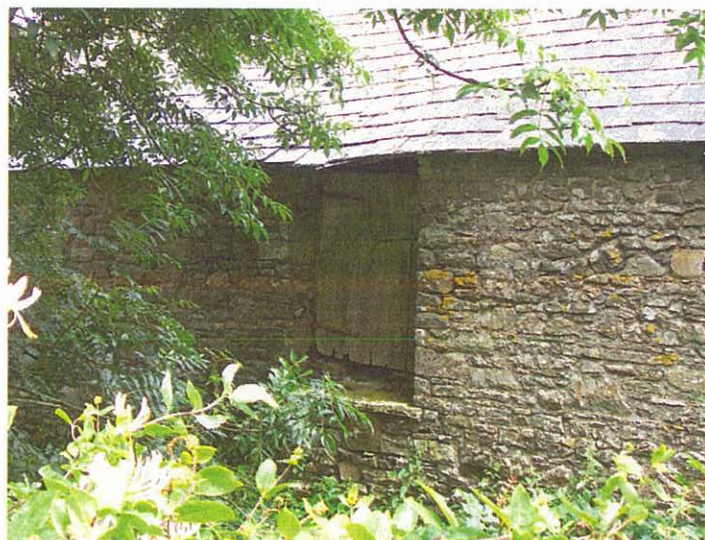
The area above the loading door in the granary loft is also showing early signs of instability. A wall plate spanning the door has broken, and the rafters are no longer supported. The roof is visibly sagging, and this is putting pressure onto the roof timbers and displacing some of the slates. Accompanying this is the threat of loss of slates and damage to exposed roof timbers.

Plate 3-Instability in the roof above the granary loading door.

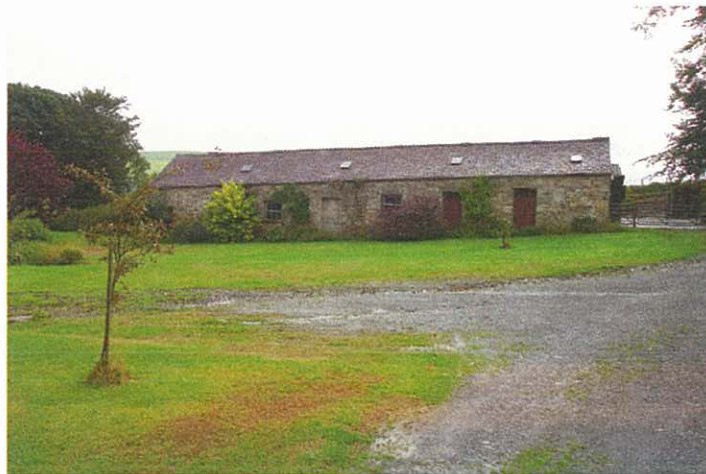
This cow shed defined the southeastern extent of the farmyard at Penrallt. It follows a northeast-southwest alignment and measures approximately 7 by 25 metres. It is of stone rubble construction, with roughly squared quoins and a pitched slate roof. It has been modified from its original appearance to permit access for agricultural vehicles, and the southwest gable end has been partially re-built with breeze blocks. A wide entrance with an iron lintel now provides access for machinery. None of the original internal partitions survive, and a line of stalls against the southeast lateral wall indicate its most recent agricultural use as a cow house. The original door and window openings remain visible in the northwest lateral wall. Four narrow doors and four windows remain visible in the northwest lateral wall, although one of the doors and one of the windows have since been blocked up with breeze blocks. A small window opening, slightly offset from centre in the northeast gable end is the only other original opening. Three wide, low doorways in the southeast lateral wall are later additions. The exact date of this cow shed is not known, although it may be consistent with a building first identified at this location on the 1846 tithe map. An earlier nineteenth century date is therefore possible. It is well maintained and in a good condition. The only structural concern is in the southwest gable end of the building, where some of the masonry bonds have become unstable and breeze blocks and masonry are working loose.

Plate 4- The cow shed at Penrallt

The building, which is an important element of the historic farmstead, should continue to be maintained using materials and techniques, which are compatible with those presently used. Unstable areas of masonry should be re-pointed and re-consolidated.

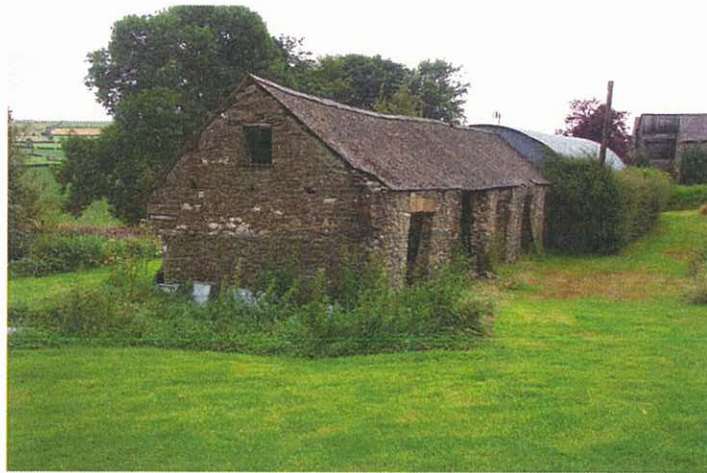
It is currently in a ruinous condition and near to collapse. Parts of the northeast and southwest lateral wall have already fallen and remaining walls, particularly at the northwestern end are leaning outwards and unstable. The roof is also sagging inwards without the full support of the walls and is also in a precarious state. This is a stylistically distinctive and unusual building, and it would be a great loss to the farmstead and wider historic landscape if it were to collapse completely.

Plate 5-Looking east towards the building in the northern corner of the farmyard at Penrallt.

The building is currently in a ruinous and unstable condition. The splayed out walls will need to be replaced, and a general programme of masonry consolidation and re-pointing undertaken if it is to be brought back into a stable condition. Ideally, the building should be brought back into active use following restoration.
