## **Coed Perthi W/11/3565**

### **Tir Gofal Farm Visit Historic Environment Report**

Report No. 2003/73

16<sup>th</sup> June 2003

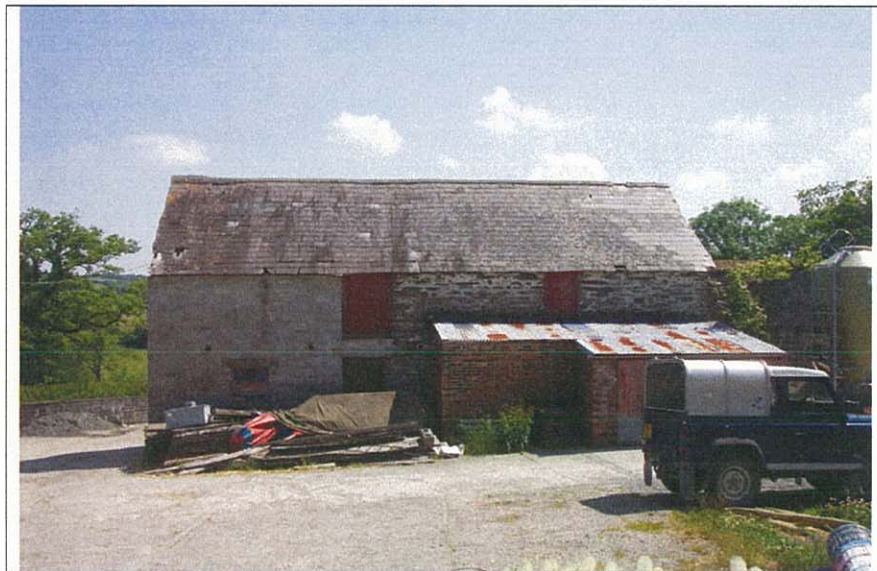
The upper storey loft retains two evenly spaced door openings in the western elevation, a wooden shuttered window in the centre of the north gable end and three evenly spaced wooden shuttered windows in the east gable end. The loft is in an unstable condition and is no longer accessible.

Plate 1- western elevation of combination farm building (A)

It is now disused, unsafe and falling into a ruinous condition. Several roof tiles are missing, above the northern bay (A), whilst many others are unstable. Missing roof tiles have promoted rot in the roof trusses, batons and floor joists. This is particularly advanced at the south end of the bay, which is exposed due to the lack of a complete partition wall. Floor joists are close to collapse here. This is of particular concern as the building may lose the joists stabilising influence, which help to bind the walls together. Structural integrity may be questionable at the north gable end, where a crack spans the height of the building. A more general, although less acute source of instability is visible around the building, where lime mortar bonds are being washed out, and some of the stonework is loose.

At the core of the complex is the long cow shed; loft building (farm building A,B), which is likely to be of a mid-late nineteenth century date. It is a typical example of its type, constructed out of local building materials in response to contemporary agricultural demands. Similar examples are found on farms throughout southwest Wales. It has been substantially modified, and these additions are out of character with its original historic appearance, lessening the architectural integrity of the building. The conversion to a dairy, has meant that historic internal arrangements have also been lost. The building is currently redundant, neglected and unsafe. The southern bay has been allowed to fall into a ruinous condition, and although partially rebuilt it remains roofless. The exposed eastern wall is unsafe. Water ingress is washing out masonry bonds, and it is becoming increasingly unstable. Although it remains substantially intact, the northern bay is in an unstable and worsening condition. Missing roof tiles and the exposed southern end, have promoted rot in the roof trusses, batons and floor joists. Floor joists are close to collapse at the south end of the bay. This is of particular concern as the building may lose the stabilising influence of the joists, which help to bind the walls together. Structural integrity is also of concern in the north gable end, where a crack spans the height of the building. Added to this is the more general, although less acute threat of weakened masonry bonds where stone is becoming loose in places. It is clear that a considerable amount of work is necessary to bring the building back into a safe, stable and usable condition. Some of the roof trusses and floor joists will need to be replaced, some of the walls rebuilt and a programme of general masonry consolidation carried out.

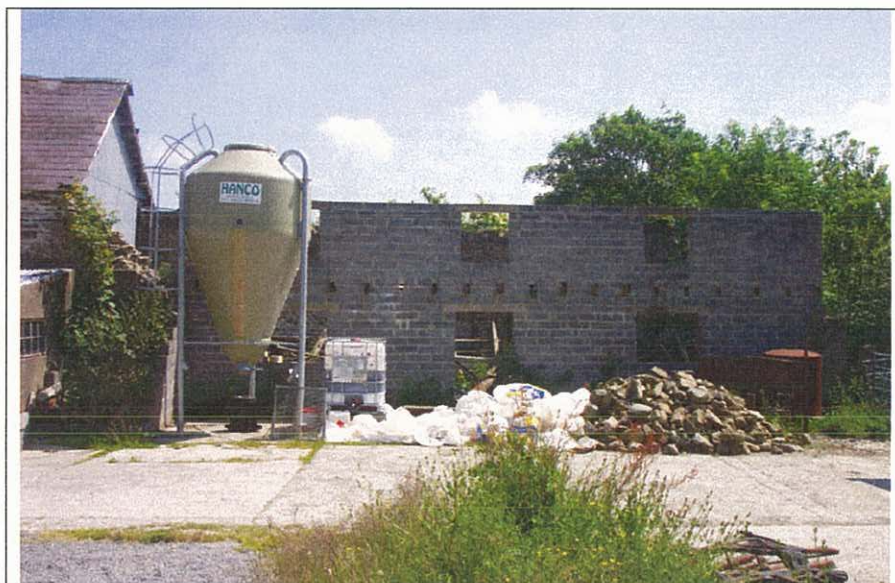
The southern bay (B) is in a ruinous condition and only the complete eastern lateral wall survives, the other walls having since been rebuilt with breeze blocks. A wooden framed doorway in the centre of the wall provides the only opening at lower level. A single upper storey opening, slightly offset from centre has since been blocked up. This part of the building is roofless and none of the internal arrangements or partitions survive. There is insufficient evidence to interpret the original function of this part of the building.

Plate 2- western elevation of combination farm building (B)

The southern bay (B) of the building has almost entirely been lost, and only the east lateral wall survives. This wall is exposed to the elements and unsafe. Water ingress is washing out masonry bonds, and it is becoming increasingly unstable.

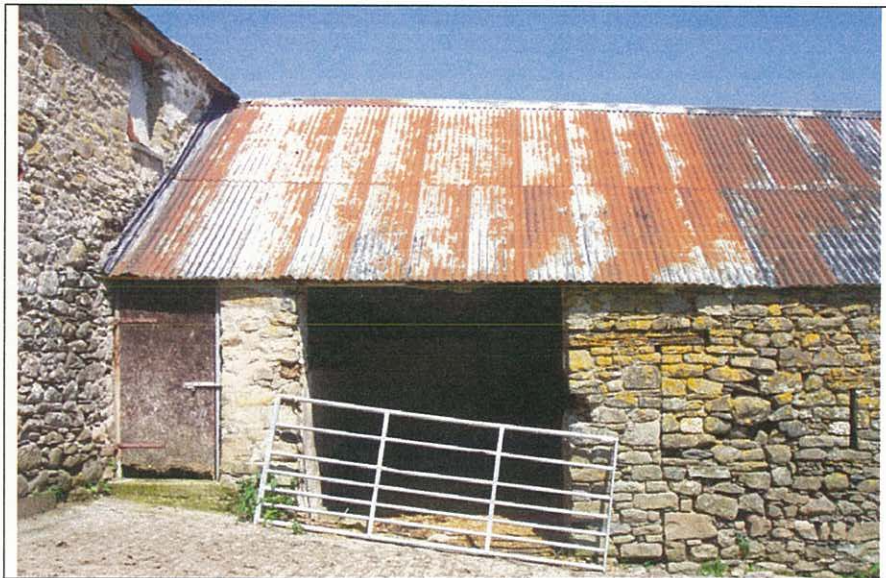
Plate 3- southern elevation of farm building (C)

The walls of the building are not keyed onto those of the cow shed/ loft building, which it abuts and it is of a later date. It is first shown on the 1891 Ordnance Survey map and may date to the late nineteenth century. Although weatherproof, it is currently in a poor condition. A large crack in the east gable end is a possible source of building instability. Lime mortar bonds are washed out in many areas, and some of the stone is becoming unstable. This is particularly acute in the centre of the southern lateral wall and under the eaves of the east gable end.

The landowner wishes to erect livestock handling facilities in the area currently occupied by traditional farm buildings (C and D). Farm building C remains in a weatherproof condition. It is becoming neglected however, with masonry bonds washed out and stone becoming loose in places. Reconsolidation and some building works are necessary in order to bring this building back into a stable condition. Although unremarkable in design, it does nevertheless add to the historic character of the farmstead, and should ideally be maintained for agricultural use. The site of farm building D is overgrown, ruinous, and the walls are beginning to collapse. The walls should ideally be capped with a lime mortar mix in order to bring the ruin back into a stable condition necessary for its long-term survival. Although ruinous, it remains an important historic element of the farmstead.

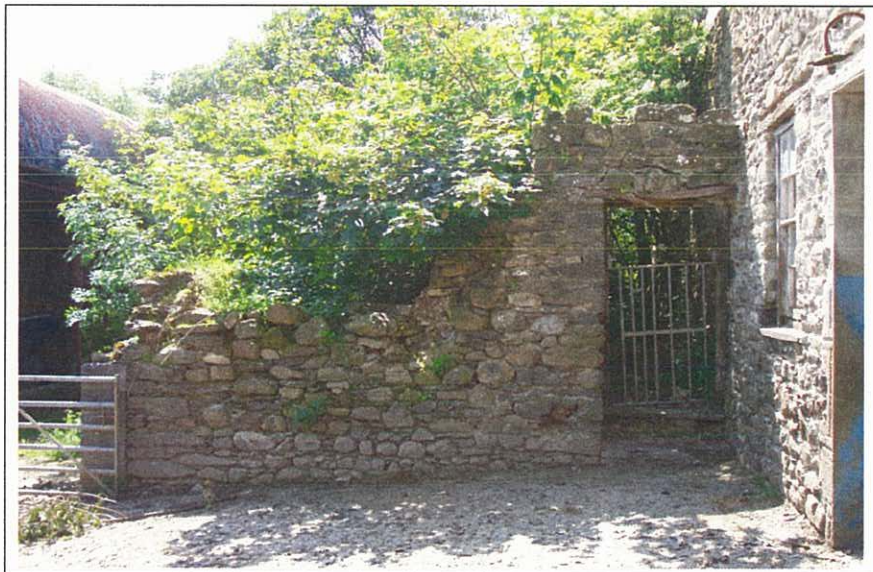
Plate 4- northern elevation of farm building (D)

The building is now in a ruinous and unstable condition, and the site is much overgrown with young trees and scrub. Water ingress is washing out masonry bonds in the exposed walls further weakening an already unstable structure.

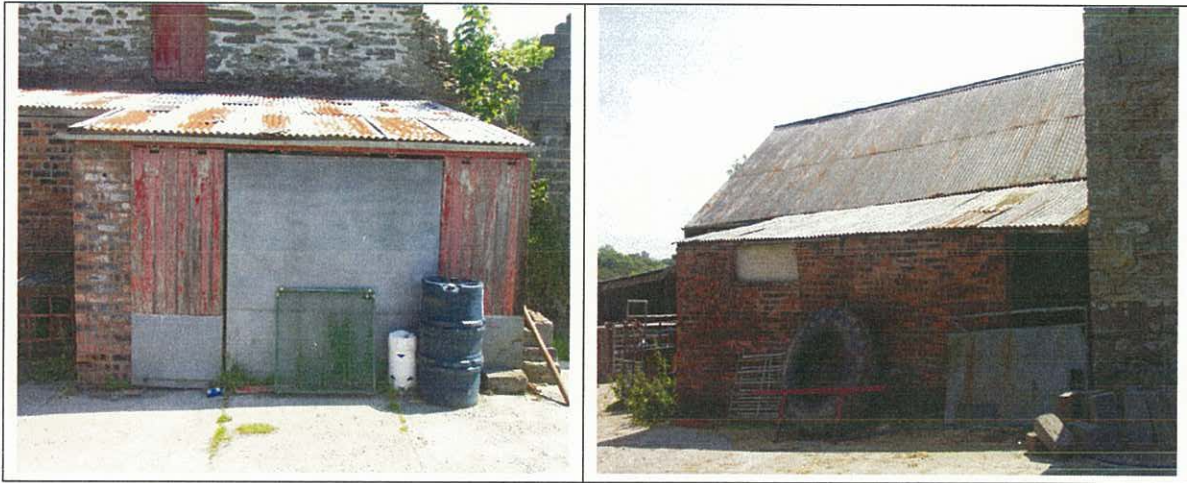
Plate 5- western elevation of shed (E); looking east-southeast towards shed (D)
