**TIR GOFAL MANAGEMENT PLAN:  
HERITAGE MANAGEMENT INFORMATION  
(Call Out)**

**Prepared for:  
Tanralltddu**

**Tir Gofal Reference No: W/11/3633**

**Project Record Number: 47330  
Report Number: 2009/20**

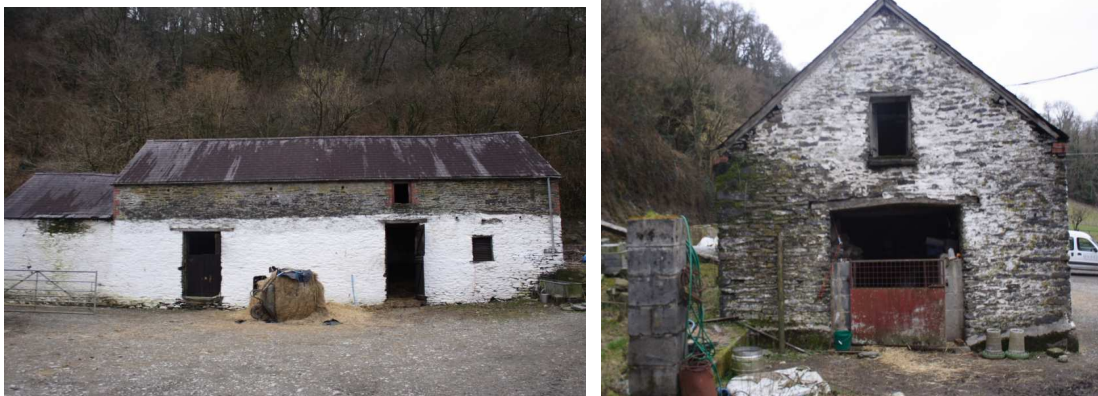
*(Left) northeast facing façade of the cartshed, threshing-barn and stable (Right).  
Entrance to the cart shed*

The cart shed still stands to its original height and has a single square bay with a wooden lintel within the southeast gable wall, and a loft window above. The external masonry is whitewashed on two of the three sides. The interior was inaccessible during the call-out as the building is currently being used as a kennels.

- The front elevation, to the original height, and cart shed entrance were painted with whitewash, providing weatherproofing for the stonework. This has now deteriorated and a new coating would be advisable.

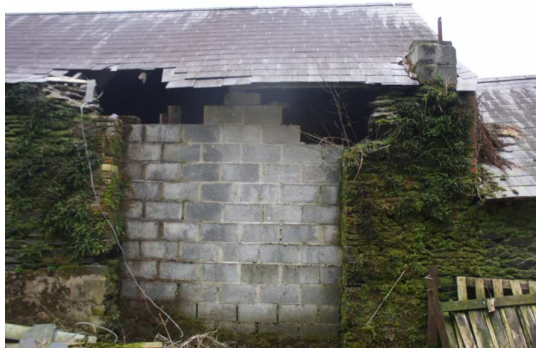
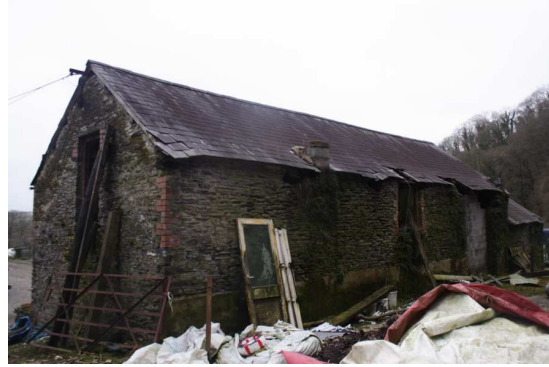
There is a doorway in the rear, internal door of the cart shed that leads to the threshing barn. The barn can also be accessed through the original doorway in the façade and a high-double entrance in the rear wall, now filled in with breezeblocks. Holes in the external rear wall show where an extension to the building once stood and it is possible that it housed a horse-engine, which would have provided power for belt-driven threshing and winnowing machines. The barn has a stone floor and is open to the roof timbers. There is access to loft space to north and south, above the cart shed and stable.

*(Left) threshing-barn entrance and (right) rear of the threshing-barn and stable*

There are several roof timbers and slates that require restoration or replacement. There is extensive vegetation growing on the building, particularly on the rear wall, and there is some masonry damage apparent on the northwest corner and around the breeze-blocked entrance to the threshing-barn.

- Cut back vegetation on the walls, leaving the roots in situ. Spot treat to prevent re-growth.

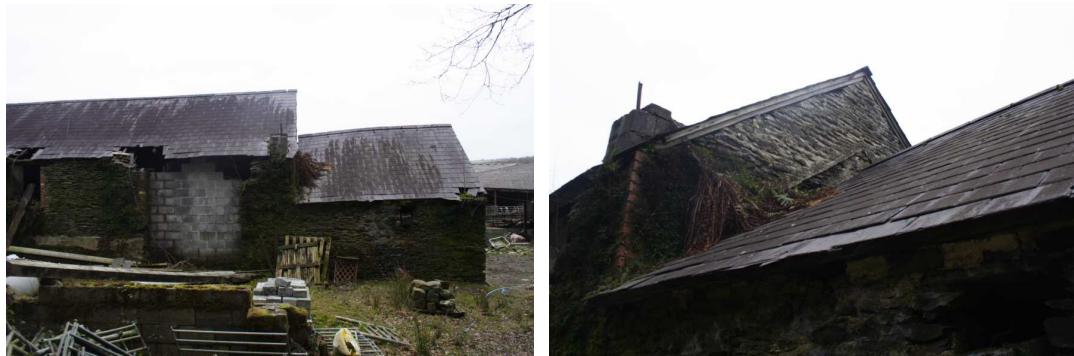
The most pressing need for repair appears to be the roof, particularly that of the cart shed where the pitch of the roof has splayed and dropped. This is likely to put extra, outward pressure onto the sidewalls, with the potential danger of collapse. Any repairs to unstable sections of walling should be carried out after taking advice from a builder, surveyor or structural engineer who has specialist knowledge of historic buildings.

*The cart shed roof (looking northeast and north)*

- Repair or replace missing or displaced roof slates.
- Repair of walls should aim to match the original appearance as closely as possible, using similar materials and methods of construction.
- Match the type of stone used originally and the method of laying. Fallen stone may be salvageable, although additional local rubble stone brought to rough courses is appropriate.
- Consolidate areas of loose masonry using a traditional lime mortar mix, trying to follow the original mix and appearance as far as possible.

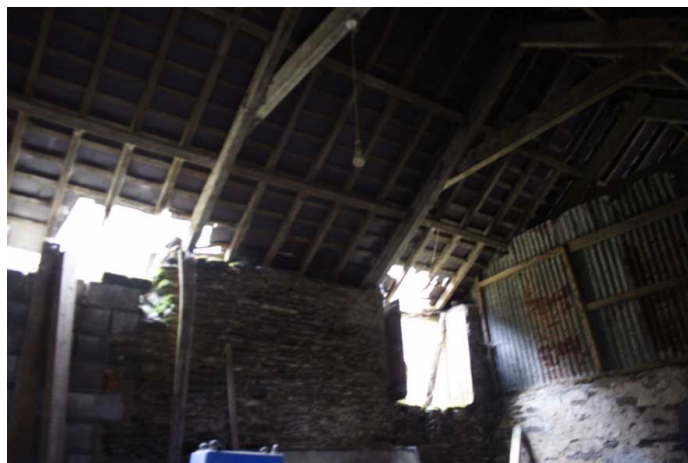
*Roof timbers within the threshing-barn*

- Repair is always preferable to replacement, keeping as much of the original fabric of the building in place as possible. Replacement is only to be carried out where it is absolutely necessary.
- Replacing roof timbers: As a general rule, replacement features should be modelled on similar surviving examples. Where these do not exist the

emphasis should be on matching details appropriate for the locality and the age of the building.
