Glanyrynys W/12/3458

Tir Gofal Farm Visit Historic Environment Report

REPORT NO. 2003/95
PROJECT RECORD NO. 47346

Glanyrnys
Tir Gofal Farm Visit Historic Environment Report

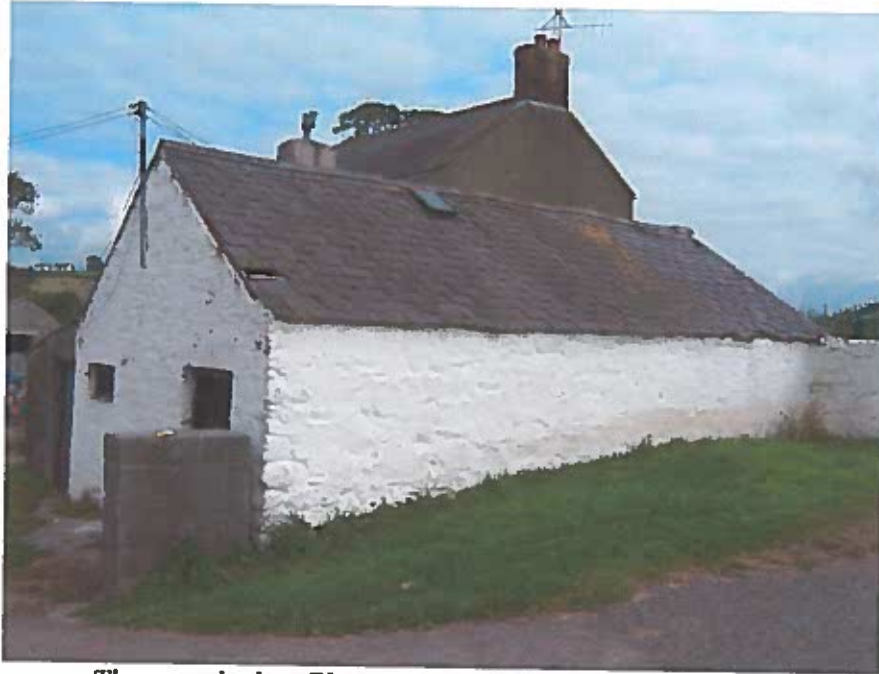
The cow shed at Glanyrynys with the farmhouse behind.

The cow shed is a low one-storey building, originally the west gable end had two doorways, one of which has now been partially blocked. An additional small window is situated in the east gable. The roof is constructed with simple A-frame trusses and iron staple fixings. The roof is slated, and in common with the other buildings in the farmstead is slated in the 'to brat' style. The roof line is dropping in places, which gives the roof a slightly wavy line, although the structural timbers inside appear to be in sound condition.

This building is currently in use and has been divided up by concrete partitions to provide cattle pens. The building appears structurally intact, however slates have slipped and some batons have become rotten from the resulting water ingress.

It is recommended that the roof slates are replaced and the roof repaired in order to bring this building back into a completely weatherproof state. The west gable end is currently a problem area, in that the roof covering does not fully extend over the wall top and will inevitably cause problems with the structural integrity of the building.

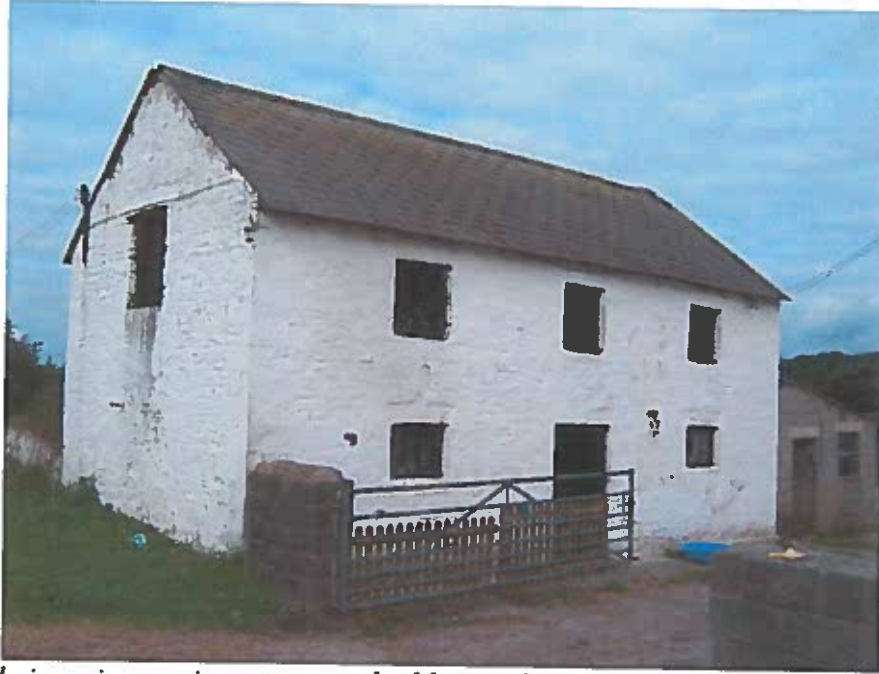
The stable is an impressive two storey building with fine stone arches over the openings.

The roof is in a reasonably good condition as it was re-slatted approximately five years ago by the previous owner. However some slates have slipped and repairs are required to maintain the building in a waterproof condition.

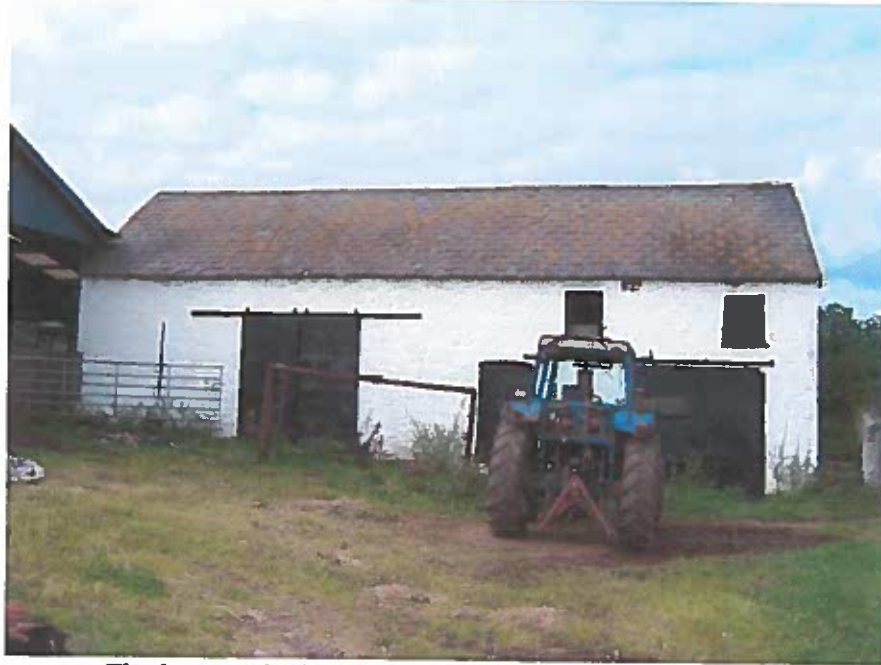
The barn with characteristic large opposing doorways.

The roof structure is still intact although slates are slipping and the roof is beginning to look quite ragged, suggesting that the slate fixings are failing. The farmer is keen to re-slate this building entirely and to replace batons where necessary. He has also expressed interest in putting felt under the slates. This is not a desirable introduction in the restoration of an old farm building and is thought to interfere with ventilation which may cause problems in the future.

There is also a leaking gutter, attached to the large corrugated iron barn to the rear, which is directing water against the west elevation. This should be repaired in order to protect the stonework of the barn from water damage. The external steps to the granary are becoming overgrown with saplings which are becoming established within the masonry. This should be cut off at ground level and the roots spot treated to prevent regrowth. Any further saplings which are growing close to the walls should also be cut back.

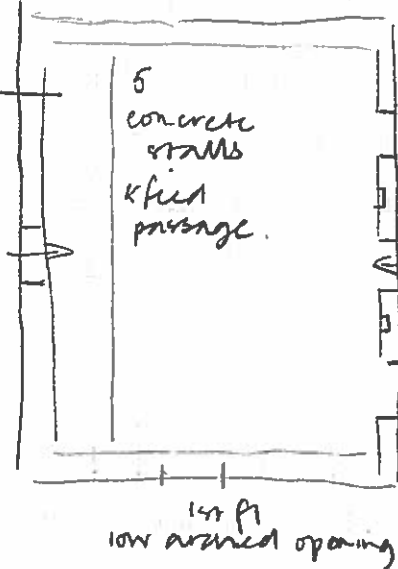
Re-roofed c. 5yrs ago.
some slipped slates.
repairs proposed.
1st floor removed joist holes visible

cement
render
internal
up to 1.5.

3 openings with
shutters in 1st floor.

half hinged door

brick
arch
opening.

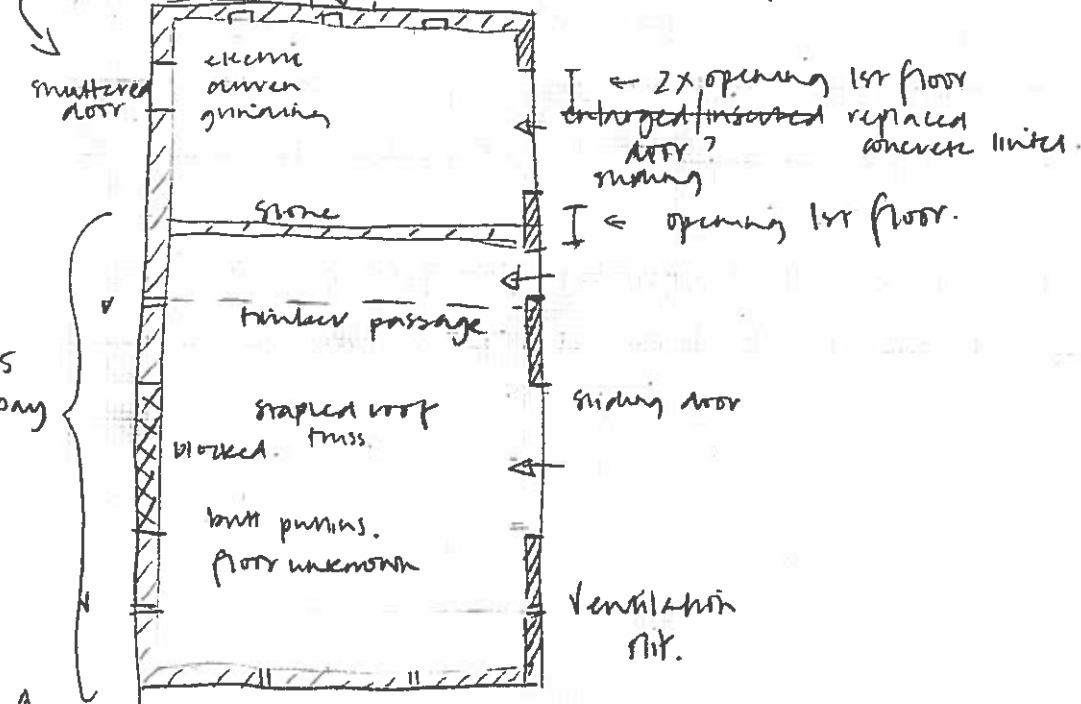
1 storey.

some slates
slipping & roof
line dropping
in places.

not maintained
external steps.

c.i. Barn & lean-to at rear
gutter of lean-to broken - should
repair, currently water may
down ext. wall.
