Blaen Halen W/12/3499

Tir Gofal Farm Visit Historic Environment Report

Report No. 2003/90

REPORT NO. 2003/90
PROJECT RECORD NO. 47348

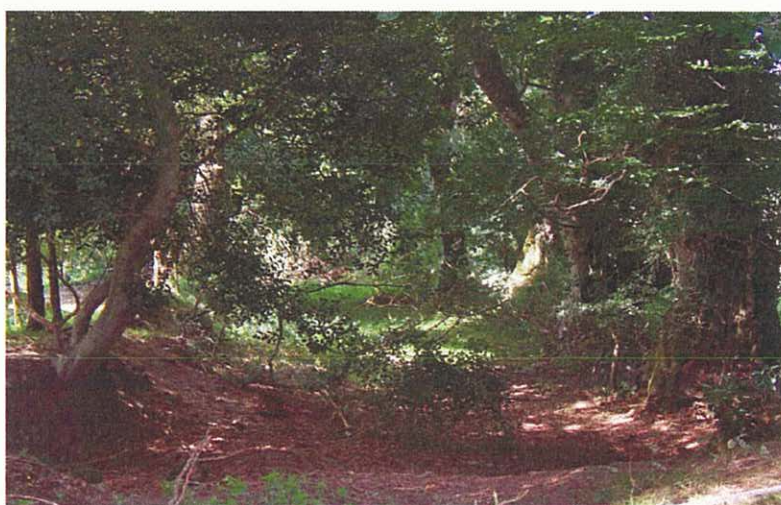
The initial 100 metre section of this trackway, which lies within the holding of Blaen-Halen is now overgrown, although remains visible as a pronounced hollow way, approximately eight metres wide defined by high stone faced earth banks on either side. Mature hedgerow trees have become established on the banks giving the accidental appearance of a wooded avenue. No specific threats were identified from the current management regime.

Plate 1- looking west down trackway PRN 48655

The trackway should be retained as a visible historic landscape feature. Traditional field boundaries should be retained and managed in a sustainable manner.

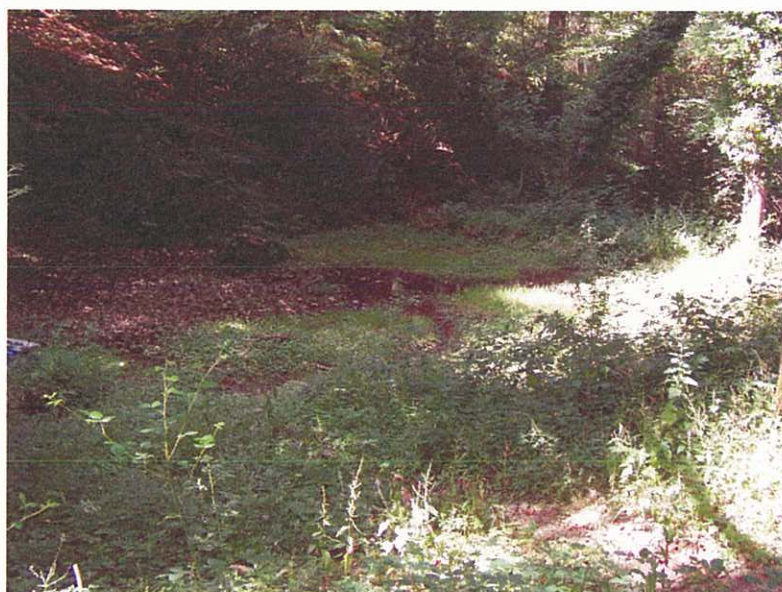
It is silted up now and visible only as an area of marshy ground. The banks can still be discerned, however.

Plate 2- well PRN 48656 is now silted up and visible as an area of marshy ground today.

The landowner has expressed an interesting in restoring the pond. This is to be welcomed, as it would enhance its appearance as a historic landscape feature, and ensure its survival in the long term.

If restoration is to be pursued, care should be taken not to damage the original banks, dam wall and pond lining. Ideally machinery should enter the pond from the south east, where there is a reduced risk of damaging the banks. In order that it doesn't impact on the appearance of the site, spoil should be deposited away from the pond, or in the valley to the north of the dam wall.

The 1888 25 inch to a mile Ordnance Survey map provides an accurate depiction of the original pond outline, which could be used to guide the restoration, and ensure that it is in keeping with its original historic appearance.

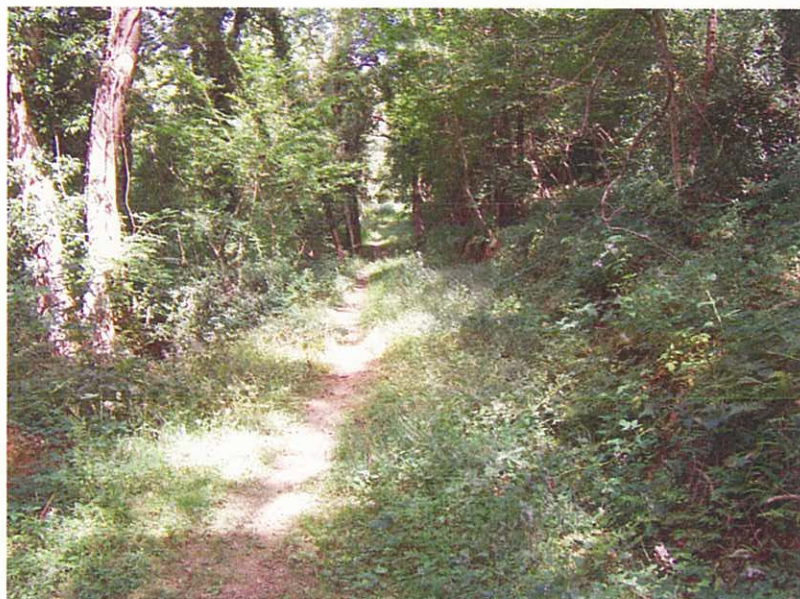
The trackway currently lies in rough pasture and woodland. No specific threats were identified from the current management regime.

Plate 3- looking north along trackway PRN 48657.

The trackway should be retained as a visible historic landscape feature.

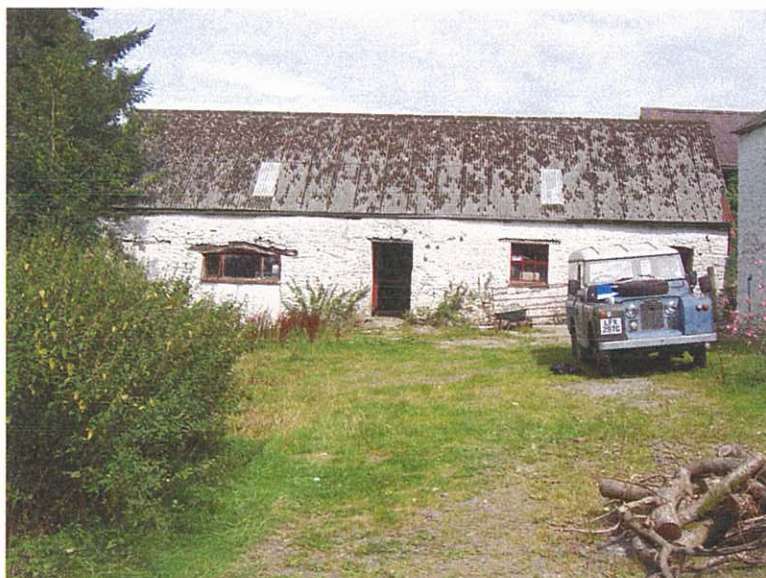
It is currently in a poor and unstable condition. An area of perhaps five metres in the centre of the north wall has been knocked down and rebuilt out of breeze blocks. The western end of the building is in a dangerous condition and is becoming increasingly unstable. Several large structural cracks, some travelling the full height of the walls, are visible in the western end of the building. This is largely due to the west gable end and the north lateral wall separating and gradually becoming displaced outwards. Heavy vegetation growth at the northwest corner of the building is adding weight to an already weakened structure.

Plate 4- southern elevation of combination farm building PRN 48663.

The landowner has expressed an interest in restoring the building. It makes an important contribution to the group value of the farmstead, and it would be a great loss if it were allowed to deteriorate further. The building is currently in an unstable condition. The splayed out walls will need to be rebuilt or stabilised, and a general programme of masonry consolidation and re-pointing undertaken if it is to be brought back into a stable condition. Ideally, the building should be brought back into active agricultural use following restoration.

A preliminary archaeological record was made during the call out visit. This comprised notes, an annotated sketch plan and some digital photos. It is recommended that further recording should be made before and after any restoration works in order to enhance the existing record of the structure. Some guidelines on the general photographic survey of buildings are attached.

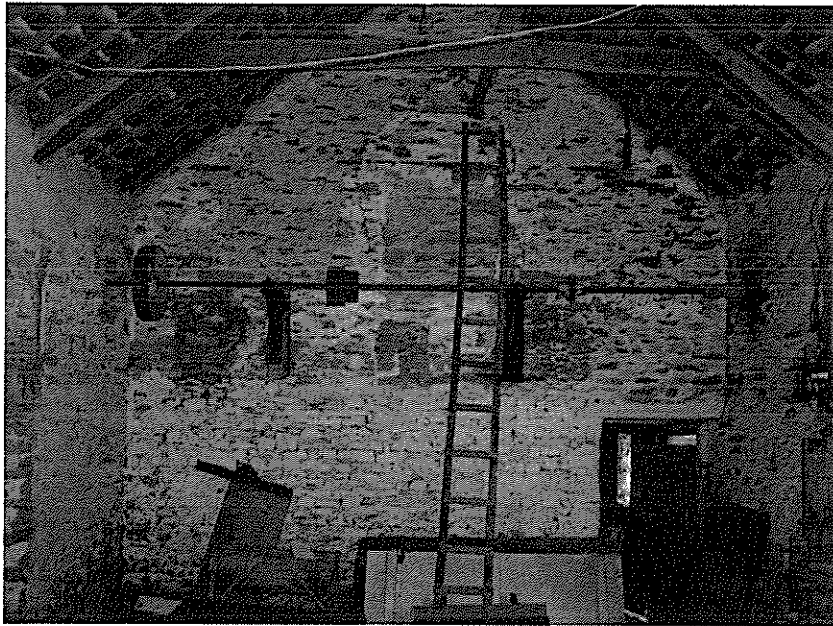
Of particular interest is the drive shaft and fly wheels, which are mounted high on the south partition wall. An additional drive shaft mount is visible lower down in the west lateral wall. The 1888 25 inch to 1 mile Ordnance Survey map shows a small square building (PRN 48665) attached on the west side of the barn at this point. This may have been an engine house, which would have housed machinery for belt driven threshing or winnowing machines situated inside the threshing barn. A large crack is visible in the north gable end where the west wall is leaning outwards. This is also risking destabilisation of the roof trusses, which are supported by the wall. Part of the north gable end has since been replaced with sheet metal.

Plate 5- interior of combination farm building; farmhouse PRN 48664, looking north.

The building, which is an important element of the historic farmstead, requires action if it is to be maintained in the long-term. Structural instability at its north end is a particular concern. Specialist building conservation advice will need to be sought before works are carried out to stabilise this part of the building. A list of specialists in building conservation is provided below. Masonry consolidation is necessary in the east lateral wall of the cow shed, where stone has become detached at the base of the wall. This should be followed up by a more general programme of re-pointing and masonry consolidation. Materials used should be compatible with those of its original construction.

A preliminary archaeological record was made during the call out visit. This comprised notes, an annotated sketch plan and some digital photos. It is recommended that further recording should be made before and after any restoration works in order to enhance the existing record of the structure. Some guidelines on the general photographic survey of buildings are attached.

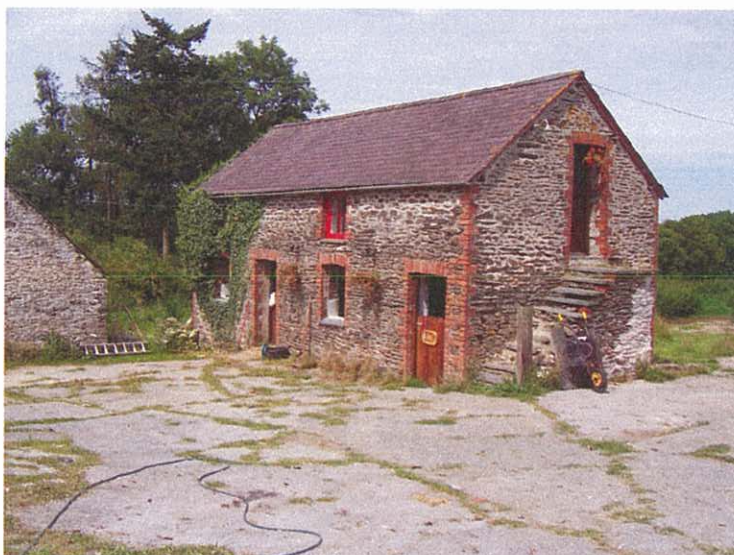
This lofted stable building lies a few metres to the northeast of the farmyard at Blaen Halen, and is a later addition to the farmstead, built during the early years of the twentieth century. It follows an east-west alignment and measures approximately 12 by 6 metres. It is of uncoursed stone rubble construction, with brick corner quoins and window and door dressings, and a pitched slate roof. The lower level is accessed by two doorways of standard width in the south lateral wall. A rectangular window opening is situated to the west of each doorway. The building is divided internally into two bays of roughly equal size. None of the original historic internal arrangements survive, however. The loft is accessed by a set of external stone steps at the east gable end, and would originally have served as a granary. Windows in the south lateral wall are situated above those in the lower storey. The building is currently in a reasonable condition, although ivy growth around the southwest corner is threatening to damage masonry bonds and weaken the roof structure. Some of the slate granary steps are becoming loose and unstable. It continues to be used as a pigsty and a stable.

Plate 5- looking northwest towards combination farm building PRN 48666.

The vegetation growth around the southwest corner should be cut off at the roots, spot treated to prevent re-growth, allowed to die and then removed. This should be followed up by a programme of masonry consolidation and roof repair where necessary. Material used should be compatible with those of its original construction. Ideally the granary steps should also be repaired.
