LLANWENDA CHURCH, LLANWENDA, PEMBROKESHIRE

THE RECORDING OF ARCHAEOLOGICAL FEATURES AT THE CHURCH

Report No.
2003/17

Report Prepared for:
WYN JONES ARCHITECTS

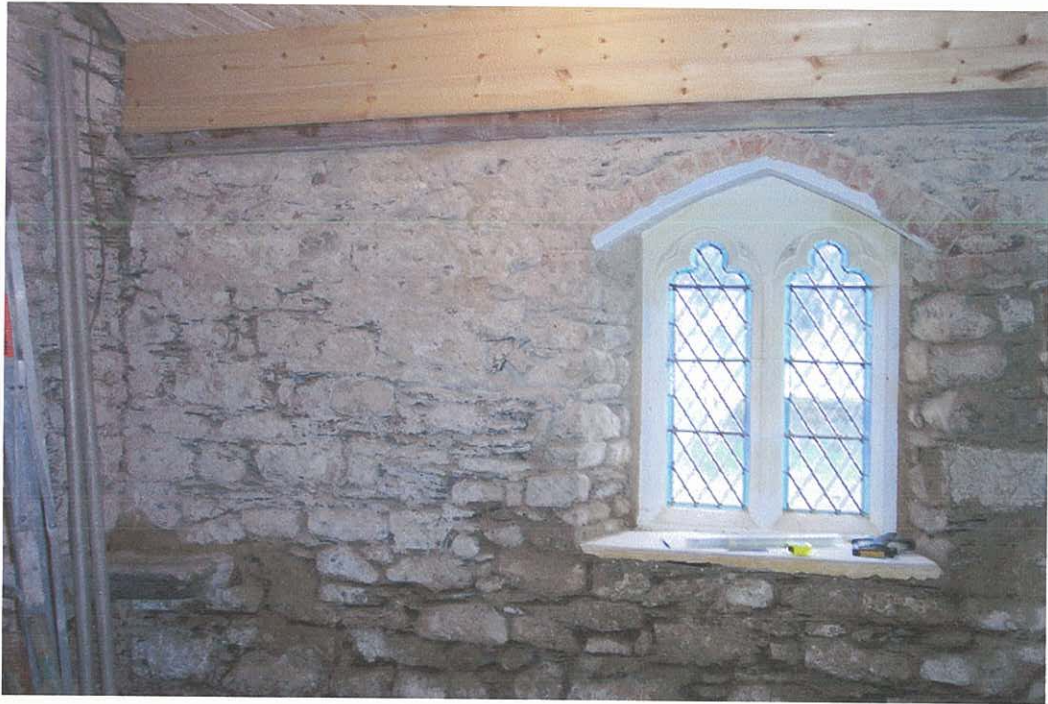
The original wall surface consisted of a thin layer of lime plaster applied to the lime mortared stonework, with numerous layers of limewash. Some patches of surviving limewash showed traces of painted lettering in gothic script. The patches of surviving wall plaster are in a fragile condition and will require conservation. It is hoped that these remnants of the original interior decoration of the church can be consolidated and displayed. Unfortunately insufficient amounts of the writing have survived to enable it to be read. During the recording it was noted that a few more traces of the writing are likely to exist beneath later layers of limewash. Careful removal of the later limewash during consolidation is likely to reveal a few more fragments of the painted script, but owing to the fragmented survival of the earlier wall surface overall, it is unlikely that these would add greatly to the understanding of the writing that is visible at present.

Photo 1: The east end of the south aisle wall showing the area of surviving painted plaster at the top of the wall, to the left of the window.

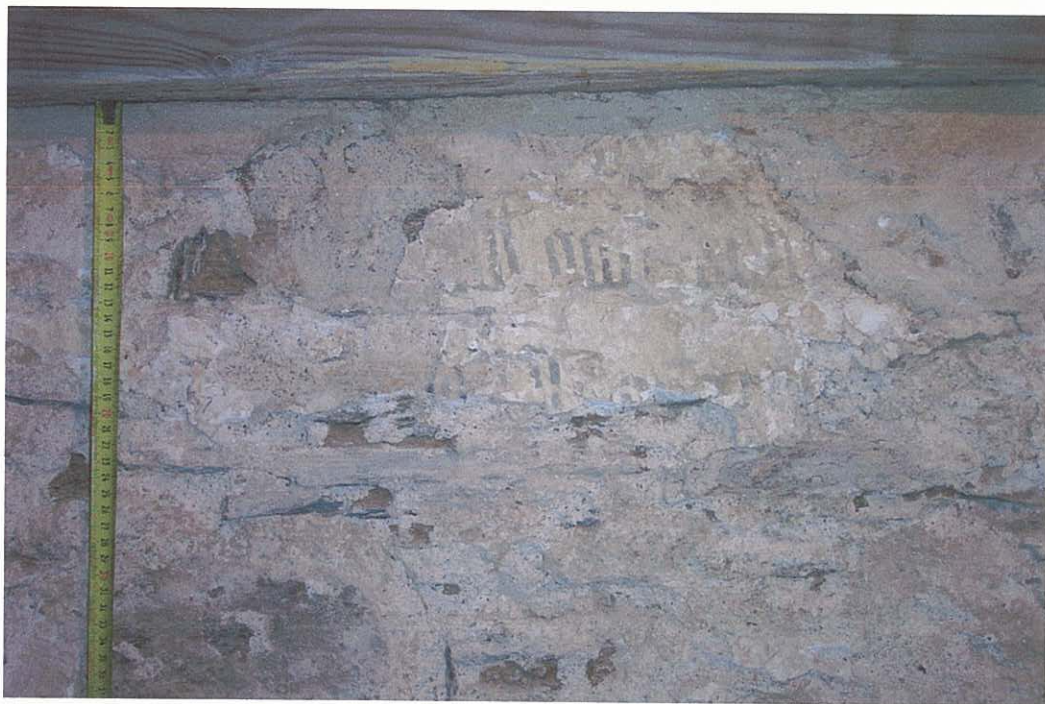
Photo 2: Detail of the largest fragment of painted wall plaster (see figure 1).

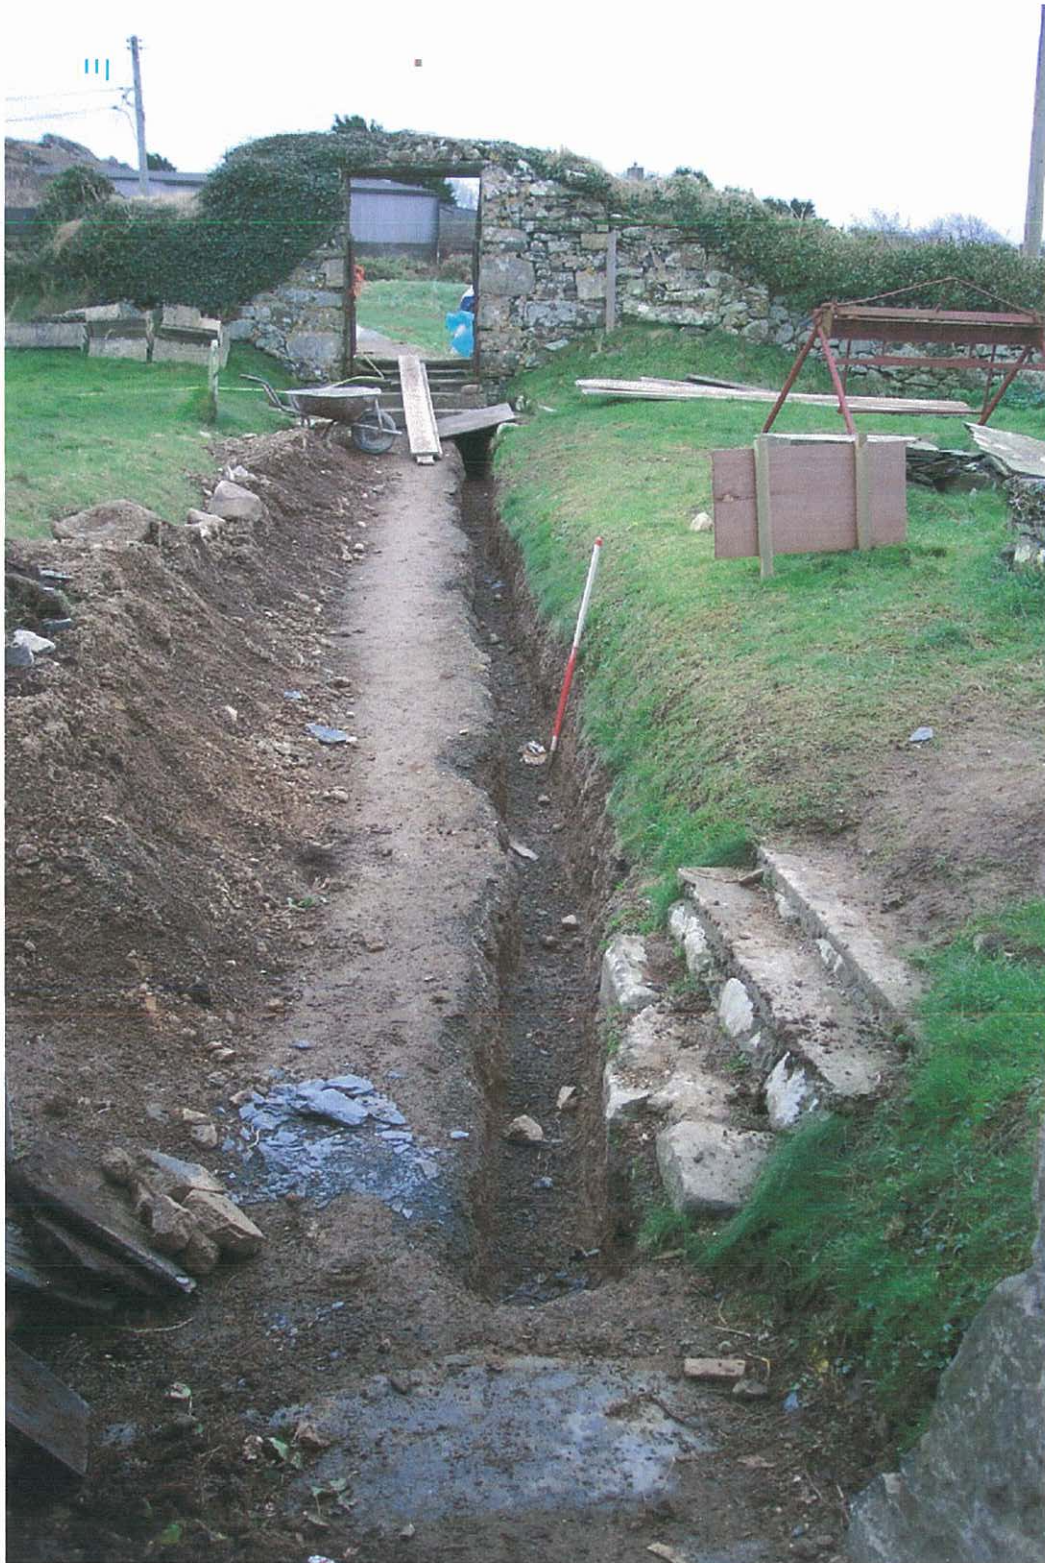
Photo 3: Cable trench looking south.

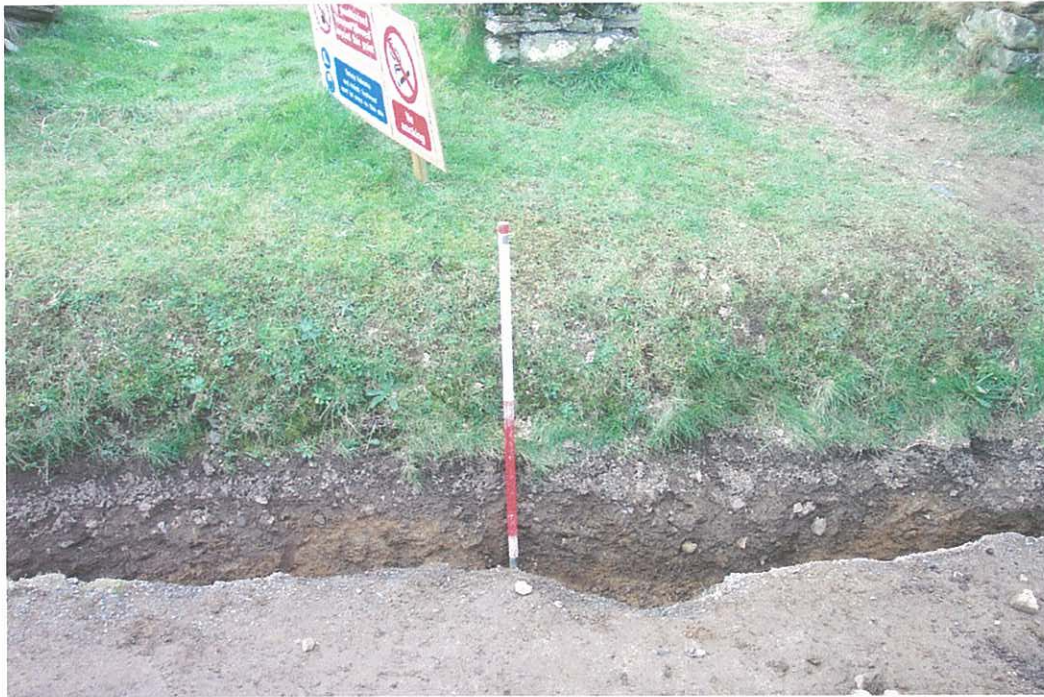
Although human skeletal remains had been encountered during the excavation of the trench, the contractors stated that they appeared to be redeposited rather than articulated. Examination of the trench indicated that the northern half of the trench was cut through disturbed top and subsoil into apparently natural silty clay, while the southern half was entirely within the top and subsoil. The east facing trench side was examined and several cuts (probably intercutting graves) were visible in the northern half of the section where cut into the natural clay. The base of the trench was below the level of the cuts in the northern half. In the southern half of the trench no natural clay was visible and any grave cuts were hard to discern. Some fragments of human bone were however visible in the section. It was not possible to ascertain whether the bones visible in the trench edge were *in situ* or not, although an apparently *in situ* human skull was visible in the east section of the trench. Figures 5 and 6 sketch plans and sections of the trench indicating the nature of the stratigraphy and the locations in which bones and cuts were observed.

The section appears to indicate that the church itself is built upon an area of raised natural clay 'platform'. This is probably a natural feature, but could be an artificial feature constructed from re-deposited clay. If so, this event cannot at present be dated.

Photo 4: Part of the trench edge (northern half) showing probable grave cuts into natural clay.

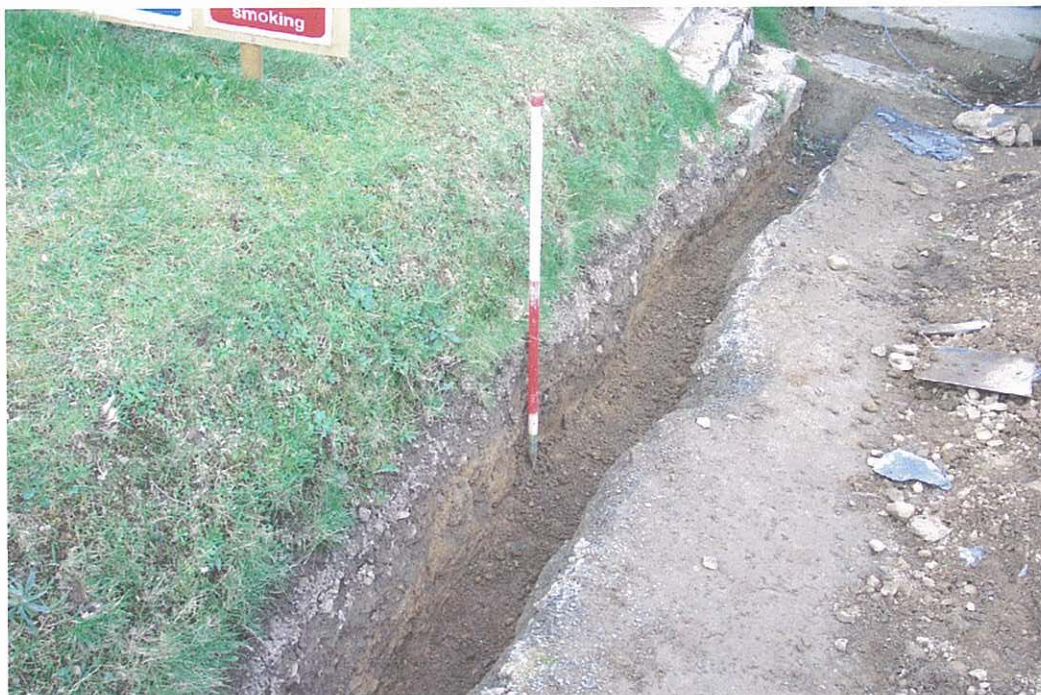
Photo 5: Northern half of cable trench.
