**Tir Gofal Farm Visit Historic Environment Report
Call Out**

Report No. 2003/114

REPORT NO. 2003/114
PROJECT RECORD NO. 47837

Pantiorlech
Tir Gofal Farm Visit Historic Environment Report
Call Out

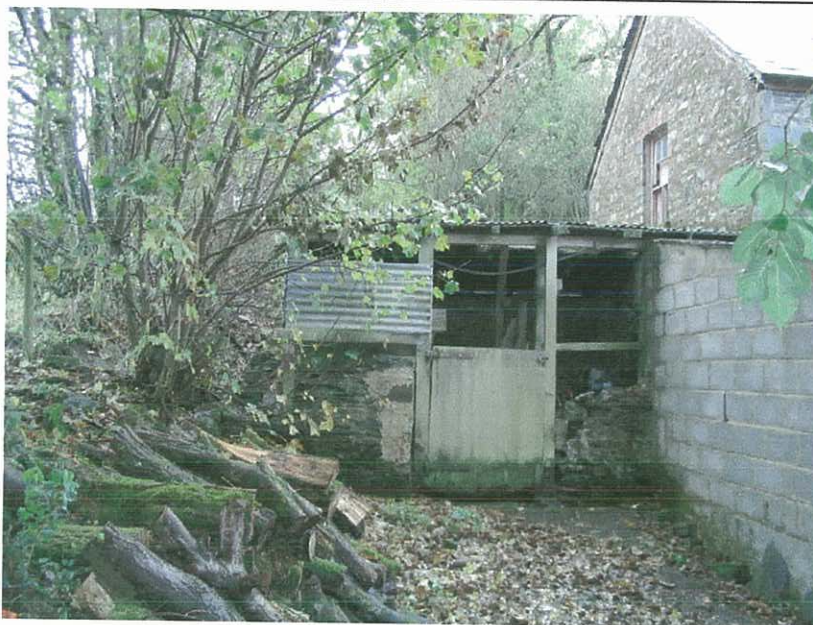
At the east end of the ground floor are the remains of a pigsty. This was originally a 'lean-to' style sty, with a sloping roof. Previous owners had partly built up the walls with breeze-block and corrugated iron, in order to convert the pigsty into a stable. However, the original line of the building can still be seen, and much of the stonework is in a fair condition. The pigsty is in use as a woodshed, no internal features are visible.

Plate 1 *The pigsty against the east gable of the barn. The wooden door and corrugated metal walling were added when the pigsty was made into a stable. The breeze-block on the right of the picture is part of the modern car-port and shed, added against the north elevation of the building.*

Ideally, the pigsty should also be restored to its original size, and the temporary corrugated iron walling taken down. However, the low, sloping roof-line may make the pigsty less useful at its original size, and it would be detrimental for it to be restored only to fall out of use again. If it is decided that it is of more use as a single storey shed (as it effectively is at present) then the walls

should be built up to height in stone, again using materials which match the original construction of the building. It should be ensured that any new works do not obscure the earlier line of the pigsty roof – this should remain visible as it is at present.

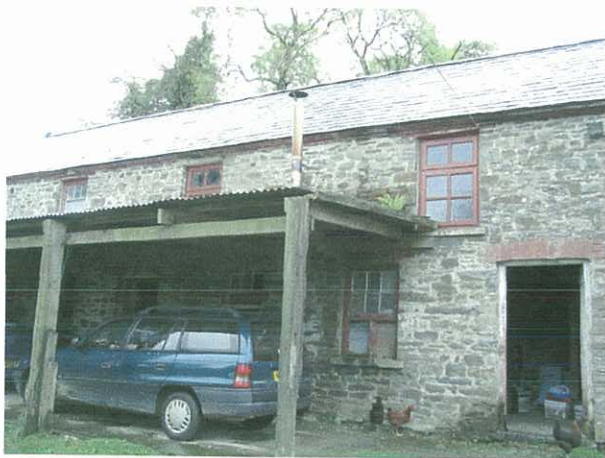
Plate 2 (left) *The centre of the north elevation of the building – the cowshed area.*

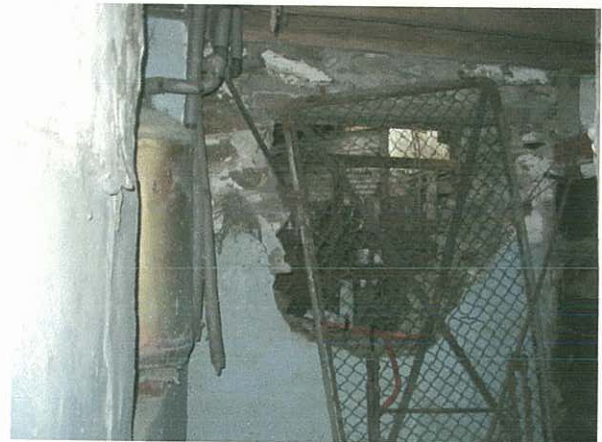
The cowshed has undergone a number of alterations. A recess in the north wall houses a copper boiler (the flue can be seen on the north elevation of the building) which the landowner says dates from the 1950s, when the building was used as a milking parlour. A loose-box has been constructed within the cowshed, at its west end, but this has had no real impact on the structure of the building. More serious are two holes which were knocked into the walls to serve as stable doors – one in the west internal wall and one in the north elevation, enlarging what had been a window into a doorway. These have not been properly finished, and are still rough edged with the core of the walls exposed.

Plate 3 (right) *Interior of the cowshed. The copper boiler on the left is from the barn's use as a milking parlour, whilst the hole in the rear wall was created during the barn's use as a stable.*

Generally, the ground floor is in fair to good condition. However, there are a few works which should ideally be carried out. Most notable is the need to fill in and re-build the areas of wall which were knocked through to provide stable doors. This should be done with care, using stone and mortar which matches as closely as possible the original construction of the building. In the north elevation, where a window was removed to create a doorway, either the window should be replaced (using one which matches the other ground floor windows) or, if it is necessary to retain this access, the opening should be appropriately finished and a wooden door inserted. It is important that the stonework is finished properly, otherwise water can penetrate to the cores of the walls.

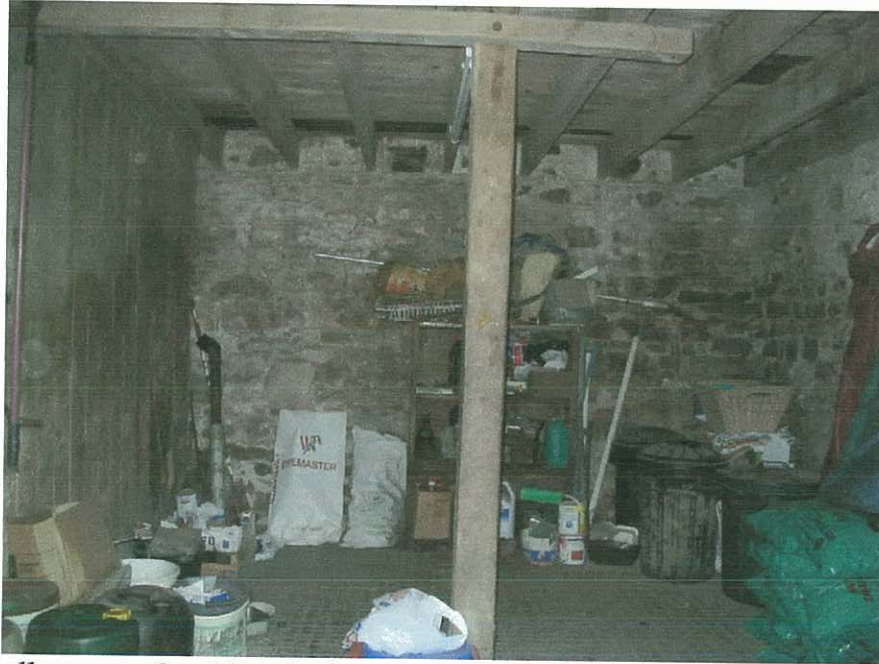
At the eastern end of the building is the stable. This is perhaps the best preserved of the building sections, retaining its original floor, the wooden partition wall to the tack-room and a wooden upright post which probably marks the position of the partition between two stalls. The size of the stalls, as well as their incorporation into a multi-purpose building suggests that this stable was intended for heavy horses – working horses, rather than riding horses, which were normally housed in a separate stable building. The stable floor is of small, square blue tiles, with ridges

Plate 4 *The well preserved stables which would have housed two working horses. Although the partition between the stalls is now gone, the upright wooden post marks its position. The wooden wall to the left of the picture forms the side of the feed/tack-room. Note the original stable floor.*

Future use of the building should ensure that surviving original features (notably the stable floor and dividing post, the trapdoor in the cowshed and the wooden partition walls of the tack-room) are retained. In the long term, the re-instatement of the internal staircase is an option which could be considered.

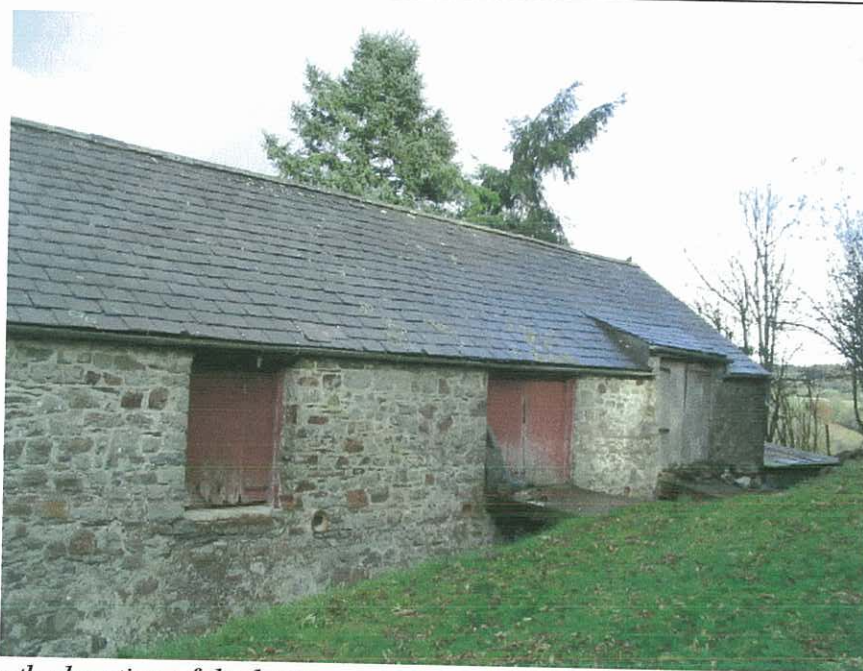
Plate 5 *The south elevation of the barn.*

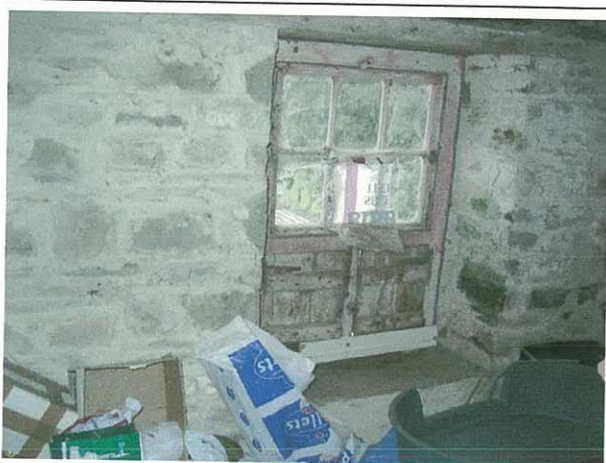
The north elevation of the upper storey contains four windows, with a further window in each gable end. The two windows at the west end of the building, and the one in the west gable end, have been recently replaced with modern wooden windows in the same openings. However, the windows in the east part of the building are original, and are interesting features which provide clues to the building's original function. Each window contains six panes of glass in its top two-thirds. The bottom third consists of two wooden shutters. These would have provided controllable ventilation for stored crops, but they also probably relate to the use of the barn as one side of a foldyard. The north elevation of the barn looks onto a fairly small, flattened piece of

Plate 6 (left) Detail of the windows, showing six panes of glass above two wooden shutters.

The windows in the south face and east gable are perhaps the only real cause for concern at the moment. The surviving original windows should ideally be repaired, rather than replaced. If repair is not possible, then the remaining windows should be replaced with windows made to the pattern of the original, including the six panes and the wooden shutters. The shutters are indications of the buildings agricultural purpose and should be retained as visible evidence of the barn's use as a hayloft.

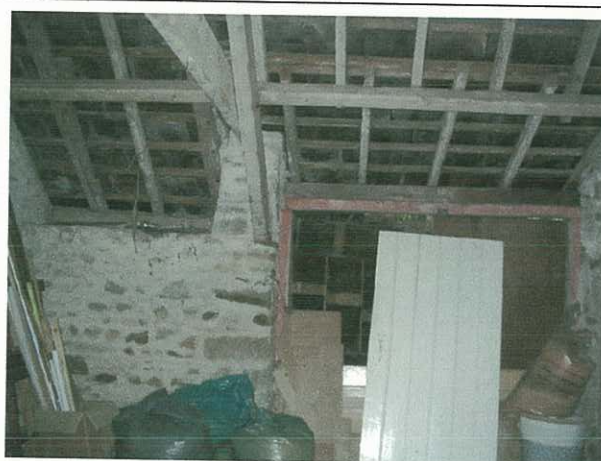
The interior of the first floor is in good condition, the majority of it being in use as a workshop. The area which housed the threshing floor is used for storage. The slate roof is supported on a wooden A-frame which rests on wooden pads set onto the stone walls. The structure appears to be sound.

Plate 7 (right) Interior view of the double doors onto the threshing floor. Note the A-frame of the roof, which is resting on a wooden pad on the stone wall left of the doors.

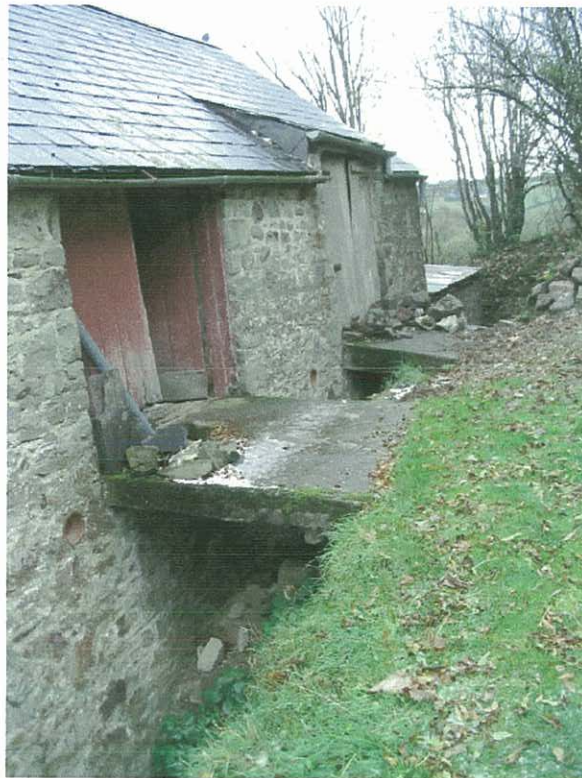
The south side of the building is partially terraced into the hillslope, but there is a gap between the building and the earth bank through which, the landowner says, cattle used to be able to pass. The earth bank was retained by a stone wall, parts of which still survive. In other areas the stonewalling has been lost, and the bank has slumped forwards, narrowing the gap between the building and the bank. About halfway along the length of the building the bank has slumped a long way forward, sufficiently that the earth is actually leaning against the stonework.

Plate 8 *The south elevation of the barn, showing the gap between the building and the earth bank. Underneath the ramp in the foreground, the bank has slumped and earth is resting against the barn wall. The stone in that area comes from the largely collapsed retaining wall.*

The second area of concern is the earth bank to the south of the barn. The stone retaining wall is largely gone, and the bank is badly slumped in places. As a result, earth is leaning against the exterior walls, which will encourage dampness within the barn. The original line of the bank can still be seen and, ideally, the bank should be cut back to that level and a new retaining wall put in place. One option would be to over-cut the bank and construct the retaining wall as a free-standing stone wall. The earth could then be piled back in behind the wall. This would make the structure more stable, since the wall would be capable of weight-bearing and resisting the 'push' from the earth behind it. The other option would be to cut the bank back and construct the retaining wall *in situ*, as a stone facing to the bank. However, this may not have the same strength as a free-standing wall, and may still be liable to slumping.

If no restoration work is carried out in this area, it is critical that the 'channel' around the barn continues to be maintained and kept clear, as it is at present.
