Tir Gofal Farm Visit Historic Environment Report

# REPORT NO. 2003/117 PROJECT RECORD NO. 47858

November 2003

# Pwllauduon Tir Gofal Farm Visit Historic Environment Report

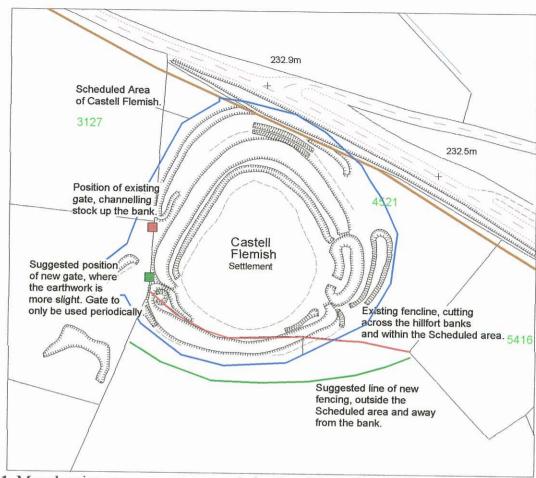
Plate 1. Map showing management proposals for Castell Flemish hillfort.

On the south side, a fenceline runs across the hillfort. Previous reports comment that there are also areas of erosion along the fenceline, where sheep were getting through or under the fence. This is still true, although the situation seems to have improved since the last Cadw report in 1999.

The fencing which runs along the southern bank of the hillfort should be moved further south, entirely off the hillfort and outside the Scheduled Area (see plate 1). To avoid causing further ground distubance, works on the fence should only take place when the ground is dry. The existing fence posts should not be dug out (this would require Scheduled Monument Consent) but should be cut off at ground level.

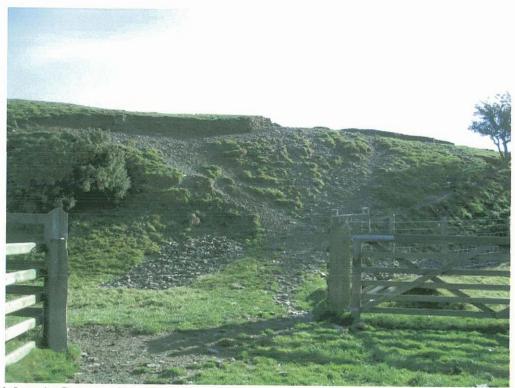
There is also a severe erosion problem on both the north and south sides of the entrance on the southeast of the hillfort. The erosion here is slightly different, consisting of a series of ledges running up the bank. Much of the vegetation cover between the erosion ledges has also been lost. This erosion is caused by two factors — stock and rabbit burrowing. Another cause of isolated pockets of erosion is the formation of sheep scrapes behind (upslope of) isolated semi-mature trees growing in the banks.

Plate 2 (above). Gateway into the hillfort, showing erosion caused on the bank.

On the west side of the site, the gate in the fence just outside the site is a problem since it is channelling stock straight up the banks. This gate should be closed, and stock not permitted to pass through this way. An alternative access point was proposed on the day of the visit, further south along the fenceline (see plate 1). The banks here are much lower, and the gate would lead into a gap through the banks, removing the need for the stock to climb them. In addition, the gate will only be used periodically to allow stock to be put onto the site and later taken off it – the grazing will be controlled, rather than animals having free access to the field.

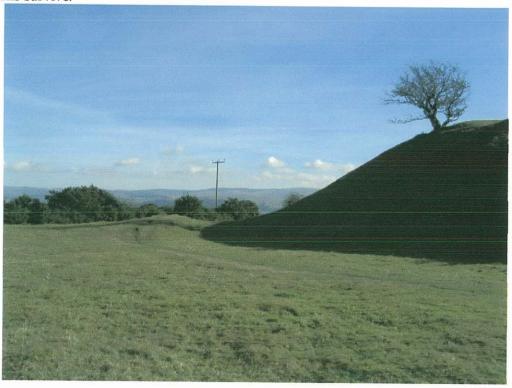
The main bank is generally well preserved, and is up to 3.5m above the base of the ditch, and 2m above the internal ground surface. A simple entrance in the southeast is probably the original entrance, but there are other (probably modern) gaps in the bank, including one in the southwest. The majority of the hillfort is very open, with little scrub growth on the banks. There are a number of small patches of gorse, and a few small trees and bushes have become established on the north and east sides of the site. A few sheep scrapes are becoming established underneath some of the young gorse bushes.

Plate 3 (below). The exterior of a well-preserved section of bank, showing the height to which the earthworks survive.

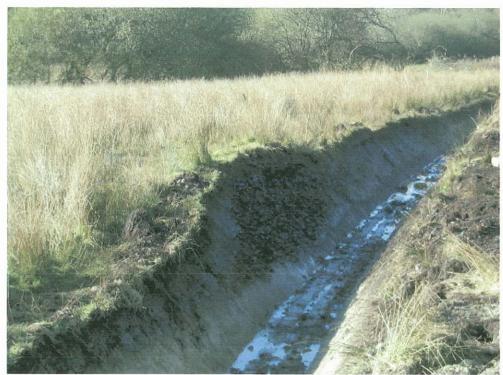
A clearly visible burnt mound revealed by ditch cleaning. The ditch cuts through the middle of the mound, with the profile of the site showing clearly in both the north and south ditch sections. The burnt mound comprises small stones (mostly less than 7cm) and charcoal. Many of the stones show signs of burning or are heat shattered.

The site is currently in a stable condition, but its exposure in the ditch sections makes it more vulnerable to erosion. The landowner is proposing to divide the field which contains the mound. The north of the field is drier, and will tolerate a higher stocking rate than the more boggy southern part of the field, which is to be grazed at a very low stock density. It should be ensured that this site, and the adjacent probable burnt mound (PRN 49195) are included in the southern section of the field, and are grazed at a very low density.

Plate 4. The north-facing section of the burnt mound (PRN 49194) which was found during ditch cleaning.

Fencing should be put in place at least 5m from the edge of the site, and no further ground intrusive activities should be carried out in this area. In the long term, it is likely that vegetation will colonise the ditch sides, covering the sections of the burnt mound. It should be ensured that brambles, gorse and other scrub are prevented from getting a foothold on the site, since their invasive roots will significantly damage the remaining archaeology. An even grass covering, maintained by a regime of very light grazing, will offer the best protection to this important site. In the short term, the mound should be archaeologically recorded, as should the adjacent mound (PRN 49195). Ideally, the exposed ditch sections should also be systematically examined to see if any other features have been revealed. Due to the exceptional potential for the survival of environmental evidence it is also recommended that a programme of sampling is undertaken.

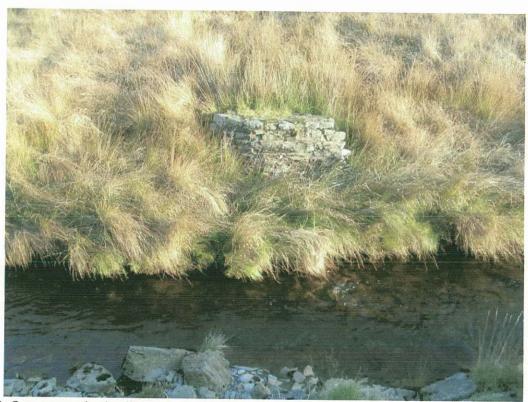
The remains of one stone pier represent the site of a footbridge marked on the 1891 and 1905 Ordnance Survey maps. The pier is rubble stone built, and bonded with lime mortar. It appears to be in a stable condition. No further traces of the footbridge remain.

Plate 5. One stone pier is all that remains of a footbridge (PRN 49694) which was marked on the 1891 and 1905 Ordnance Survey maps.

The site should not be disturbed, and the remaining stonework should be left in place.

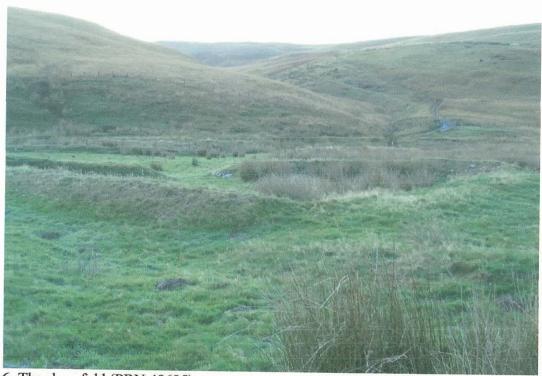
A roughly square sheepfold which survives as a series of turf-covered stone banks with an entrance in the northwest side. The banks are around 0.7m high and appear to be in a good, stable condition. Both the sheepfold, and the small field within which it lies, are seen on 19<sup>th</sup> century maps. The site is currently under pasture and used for grazing.

Plate 6. The sheepfold (PRN 49695).

The site is in good condition, and should be maintained in its current condition under a regime of light grazing.
