Penlan Farm W/11/4051

Tir Gofal Farm Visit Historic Environment Report Call Out

REPORT NO. 2004/19
PROJECT RECORD NO. 47882

Penlan
Tir Gofal Farm Visit Historic Environment Report
Call Out

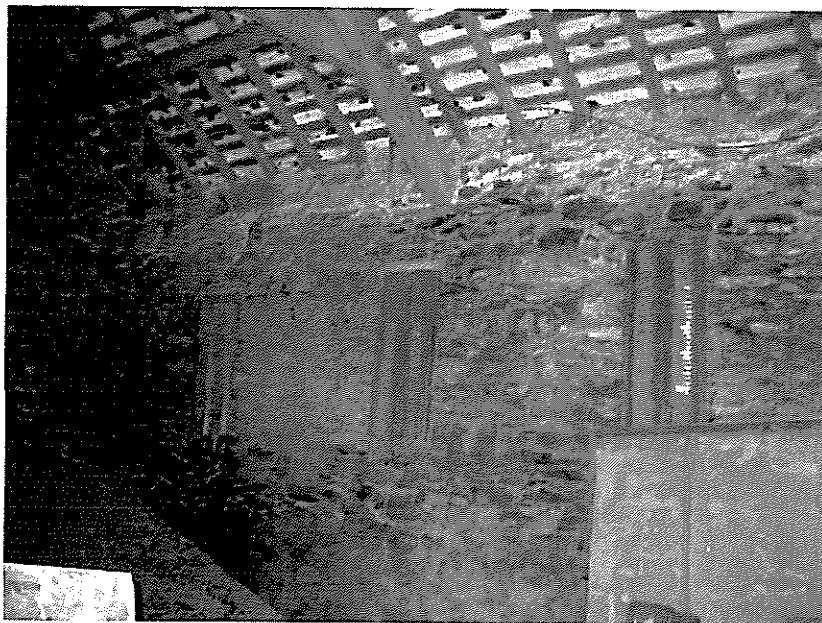
Plate 2 *Detail of the roof inside the barn. The principal rafter rests on a wooden pad and transfers the load of the roof through the walls. The collar is fastened into place with metal bolts. The metal shutters cover the ventilation slits.*

The barn generally is in good condition, and the roof timbers appear to be sound. There are a few areas of the roof where slates are either missing or have slipped out of place. The barn is in use as a feed-store, so it is imperative that the roof remains watertight.

The landowner proposes to re-roof the building through the Tir Gofal scheme.

Re-roofing of the barn is to be welcomed, as it will enable the building to remain in use and therefore will help to ensure its long-term future.

Since the roof is in a fair condition at present it should be possible to re-use a substantial amount of the existing slate. This will help to keep costs down, but it will also ensure that the appearance of the building is maintained. New slates should be sourced to match the existing ones as closely as possible.

The roof timbers appeared to be sound and should be left in place if at all possible. If any do need replacing, the construction methods used in the rest of the roof should be copied in the new timbers.

The building does not currently have any guttering, and it should not be introduced during the re-roofing works. The lack of guttering is not causing any problems at present, and provided that a sufficient roof overhang is maintained, it should not cause any problems in the future.

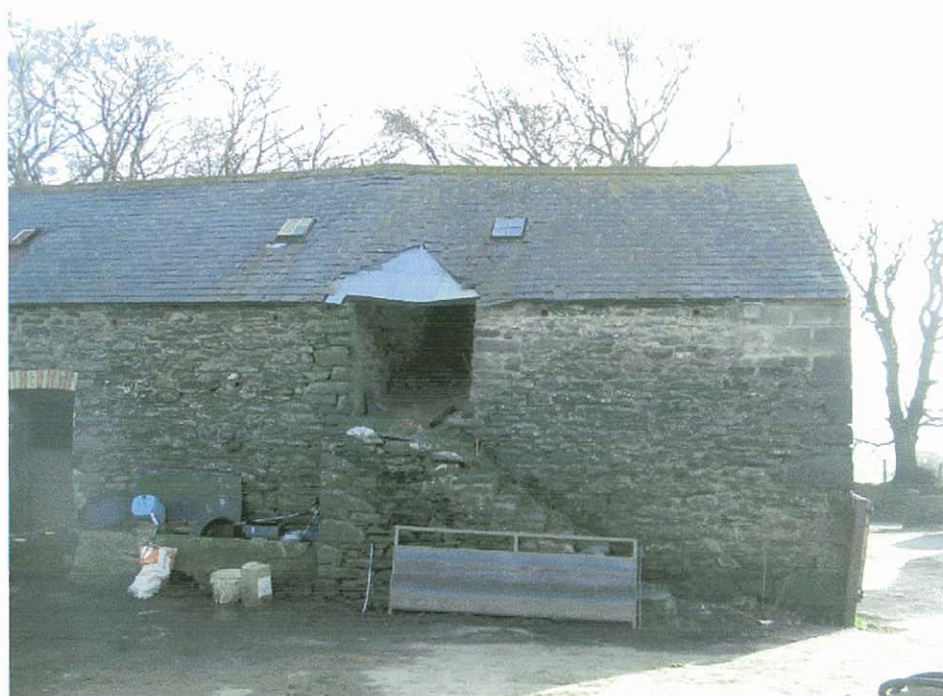
Plate 3 *The south end of the combination farm building. The metal sheeting marks the shape of a dormer head, now lost.*

The building is generally in good condition, and is in use for storage and animal housing. However patches of the roof are in poor condition, especially on the east side where a number of slates are missing. Some of the timbers in the granary, where the dormer was, also seem to be rotten.

Roofing works on this building are also to be welcomed. The roof is currently in fair condition, but work is needed at the south end to ensure that the building remains watertight. As with the barn, as much of the roof slate as possible should be re-used. At the south end, where the dormer head has been lost, some of the timbers are clearly rotten. Ideally, when the timbers are replaced, a new dormer would be constructed, matching the one at the north end of the building. If this is not possible, then the metal sheeting over the 'scar' should be removed, and should be replaced with new timbers and slates.

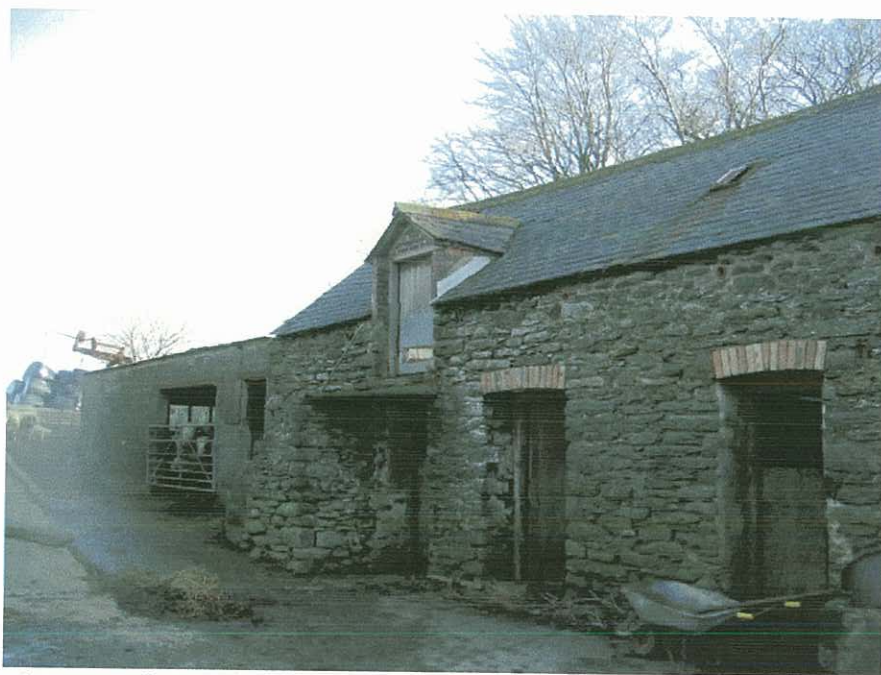
Plate 4 *The staircase at the north end of the building. Note the slate-slab landing with a doorway underneath it, and the red brick dormer entrance into the hayloft.*
