# **Llwynfedw W/11/4056**

## **Tir Gofal Farm Visit Historic Environment Report Call Out**

Report No. 2004/20

Llwynfedw  
Tir Gofal Farm Visit Historic Environment Report  
Call Out

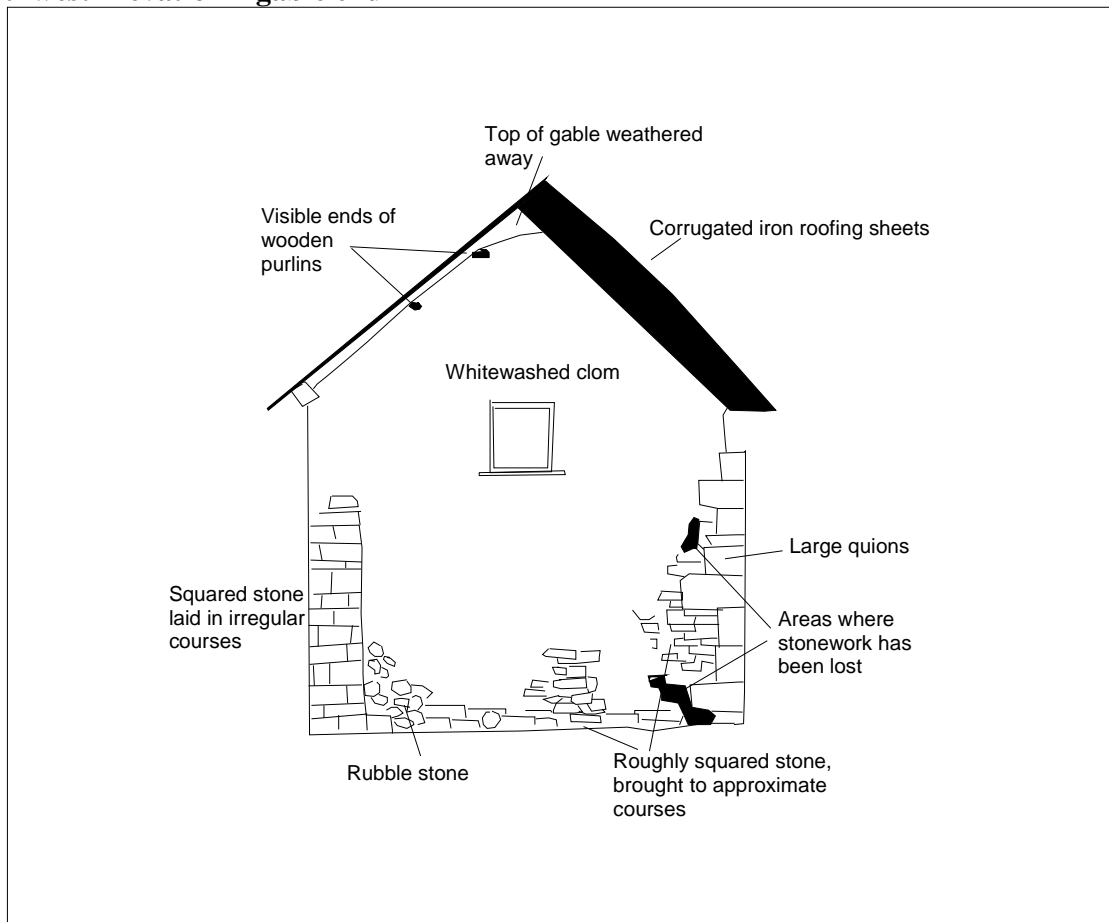
*Rough sketch of the northwest gable highlighting main features. Not to scale.*

This gable shows the different materials and techniques which have been used in the building. The sketch shows where different types of stonework are clearly visible under the whitewash, and highlights how variable the height of the stone support in this gable is. The area of rubble stone particularly stands out, and may be a later repair to the wall.

This gable is generally in fair condition. There are two places where some stonework has been lost, and part of the top of the wall has weathered away.

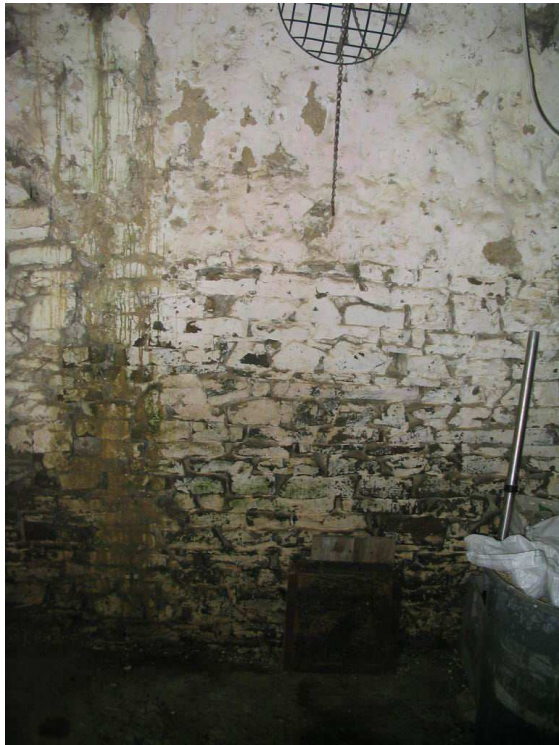
*Above left: Interior of the northeast elevation, showing the regular stonework supporting the clom.*

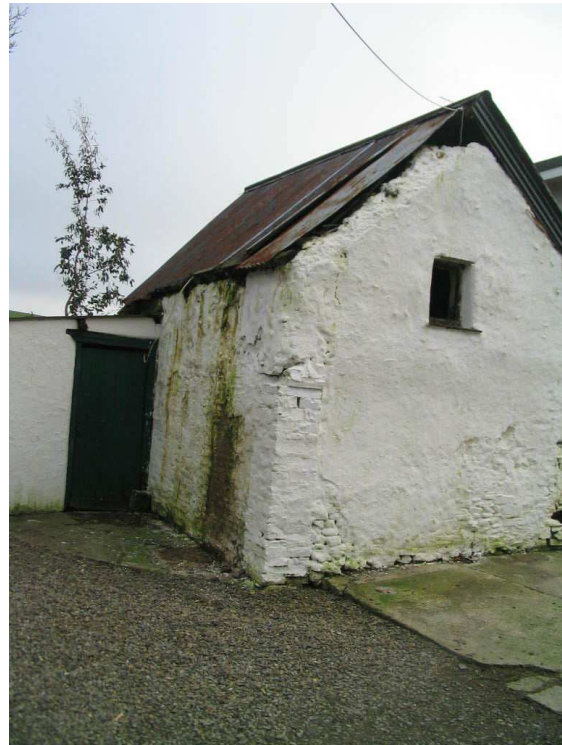
This wall is in good condition. A modern lean-to style shed is against part of it. The only area of concern is at the north end, where water has been running down the wall face. It has brought off some of the whitewash and will soon start to erode the clom if the problem is not addressed.

*Above right: Exterior of the building showing the northwest gable butting against the regular stonework of the northeast elevation. Note the staining where water is running down the face of the wall.*

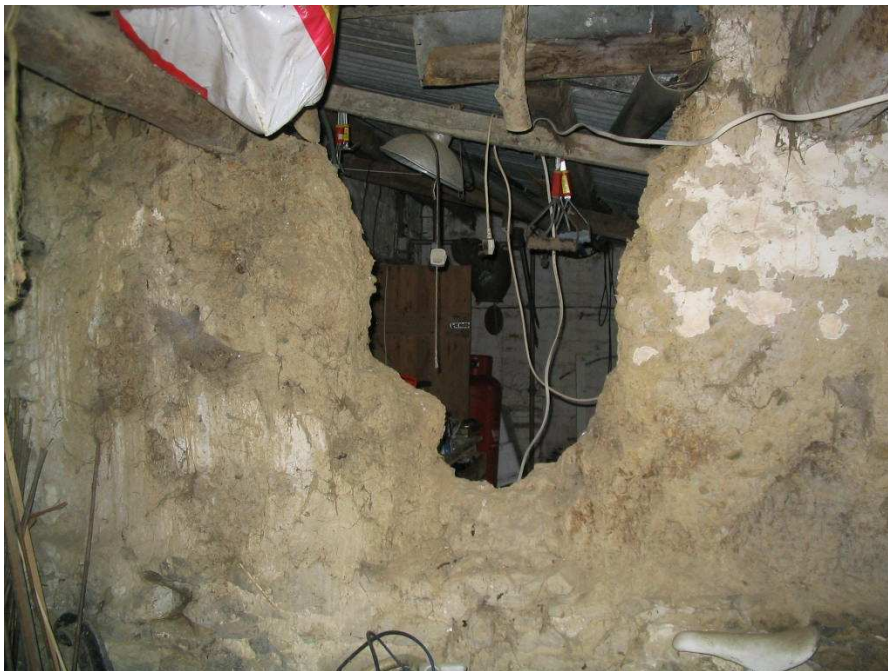
At the north end of this wall is the only doorway into the building. This is edged with large, squared quoins and has a wooden lintel over it – the lintel rests directly onto the stones and has clom built up above it. The structure of this wall is similar to that of the northwest gable, with roughly squared stone blocks forming a low plinth. However, about halfway along the length of the wall is a substantial gap in the clom, almost down to the stonework. This has been formed by water run-off from an insufficient roof overhang, which has penetrated the wall core and eroded the earth structure.

*Part of the clom in the southwest elevation has been worn away by water run-off. This view is from the interior of the building, looking through the wall into the modern shed next to it.*

The repair of the clom walling should also be undertaken with care. The large gap in the southwest wall should be patched with a clom mixture – further advice may be available from the Society for the Protection of Ancient Buildings technical advice line (see appendix for details). Other, smaller gaps in the walls should also be infilled. Once the walls are sound, then consideration should be given to their finishing and protection from the elements. Externally, limewash is the most appropriate. Traces of limewash also survive on the inside, and suggest that this finishing should be applied internally too.

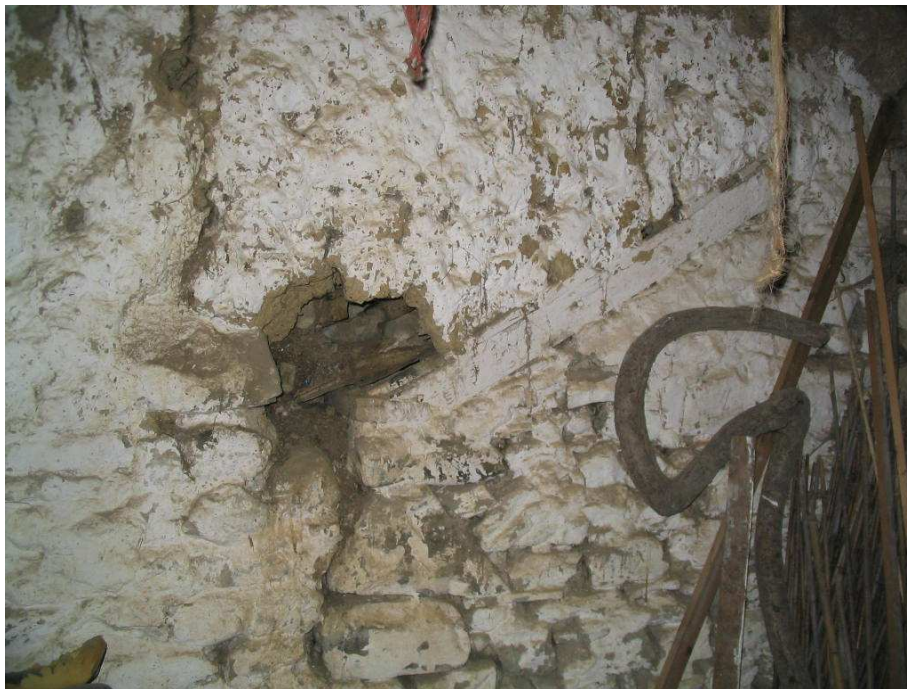
An additional feature was noted on the inside of the southeast gable. A piece of wood, similar to a lintel, has been incorporated into the wall – it runs at an angle, almost as though it were the line of a lean-to shed.

A small gap in the clom next to the wood has been partially infilled with rubble.

*Sloping piece of wood, almost like the line of a lean-to addition, incorporated into the southeast gable wall.*

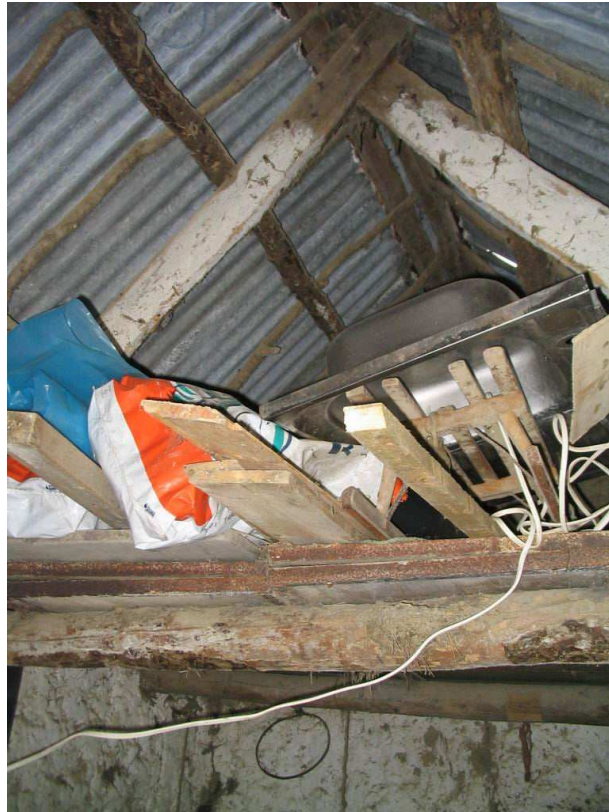
*View of the loft inside the building. The timber supporting the loft is visible in the foreground. Note also the rough form of the purlins and the distance between rafters. These imply that the building was not slated but thatched.*

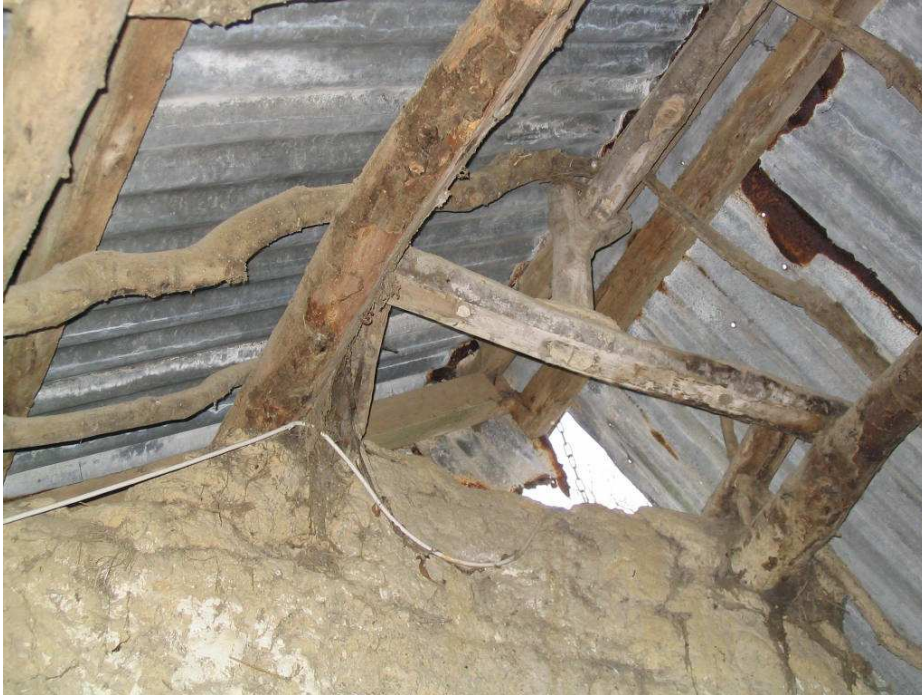
The purlins are formed of whole branches with bark left on, and are bedded into the tops of the walls. The rafters are small, complete branches, set far apart from each other. At the north end, the ridge is supported by a form of improvised king-pin. The roof structure appears to be sound.

*Improvised 'king-pin' supporting the ridge of the roof. This is constructed of a naturally forked branch slotted into a rough tie beam.*

The roof timbers appear to be sound, and are of considerable interest. They should be disturbed as little as possible during any works on the building. Where necessary, they should be repaired and retained but if replacement is unavoidable, the replacement should be in the same style. If the roof is replaced with corrugated iron, it should be ensured that the overhang on the roof is large enough to prevent any water from running down the exterior of the walls. It is beyond the scope of this report to give detailed advice on thatching, but a list of contacts has been provided in the appendix, and more advice may be available from them.

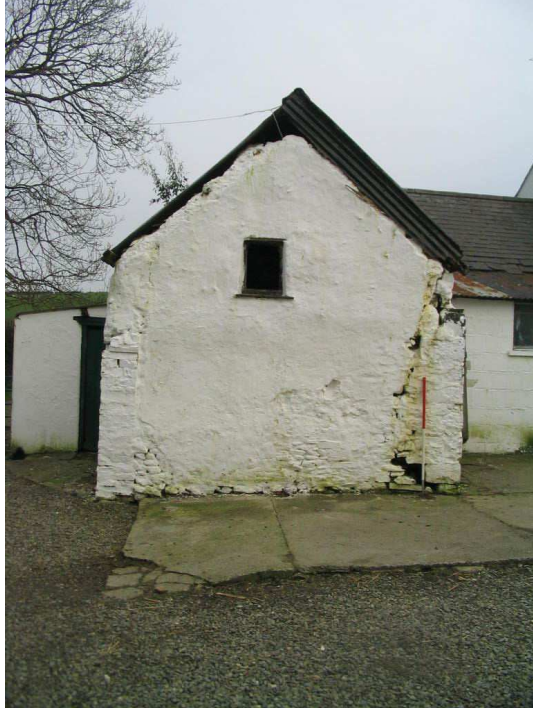
*Northwest gable (above)  
Southeast gable (below) showing  
above the modern roofs.*

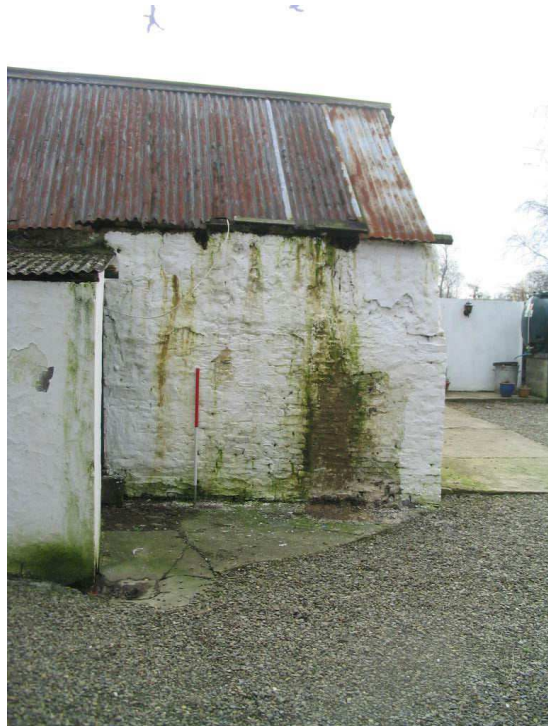
*Northeast elevation (above)  
Southwest elevation (below)*

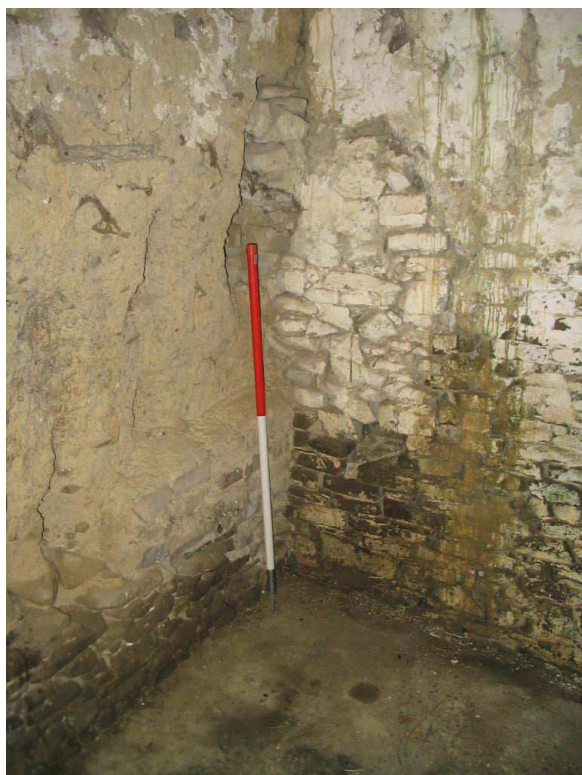
*Above left: Joint between the northeast wall (right of picture) and northwest gable (left of picture).*

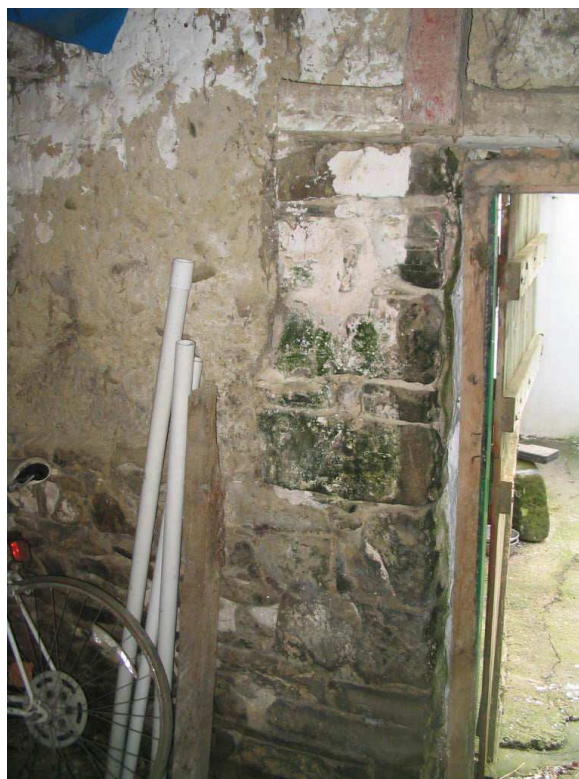
*Above right: The large quoins around the door in the southwest wall.*

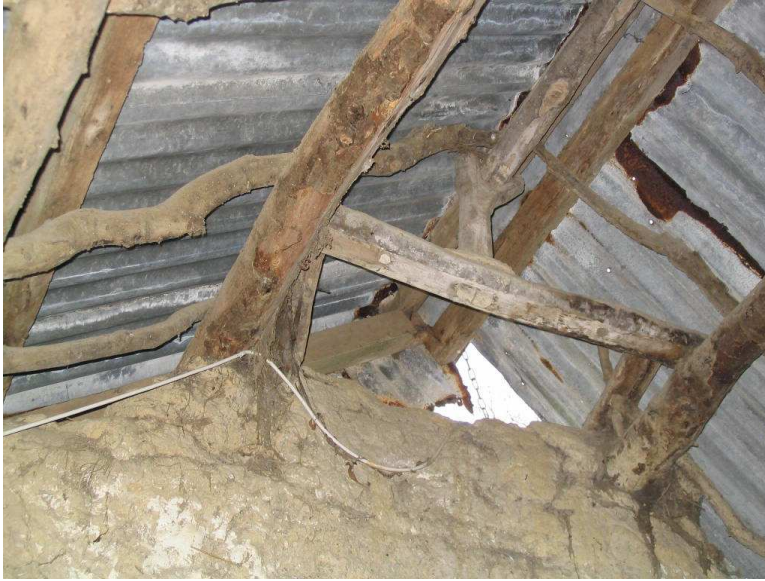
*Below: Roof structure showing purlins made of whole branches set into the top of the wall. The rafters are spaced wide apart, originally to support thatch rather than slates.*
