# **Lower Lodge Farm W/12/3871**

## **Tir Gofal Farm Visit Historic Environment Report**

Report No. 2003/128

REPORT NO. 2003/128  
PROJECT RECORD NO. 48442

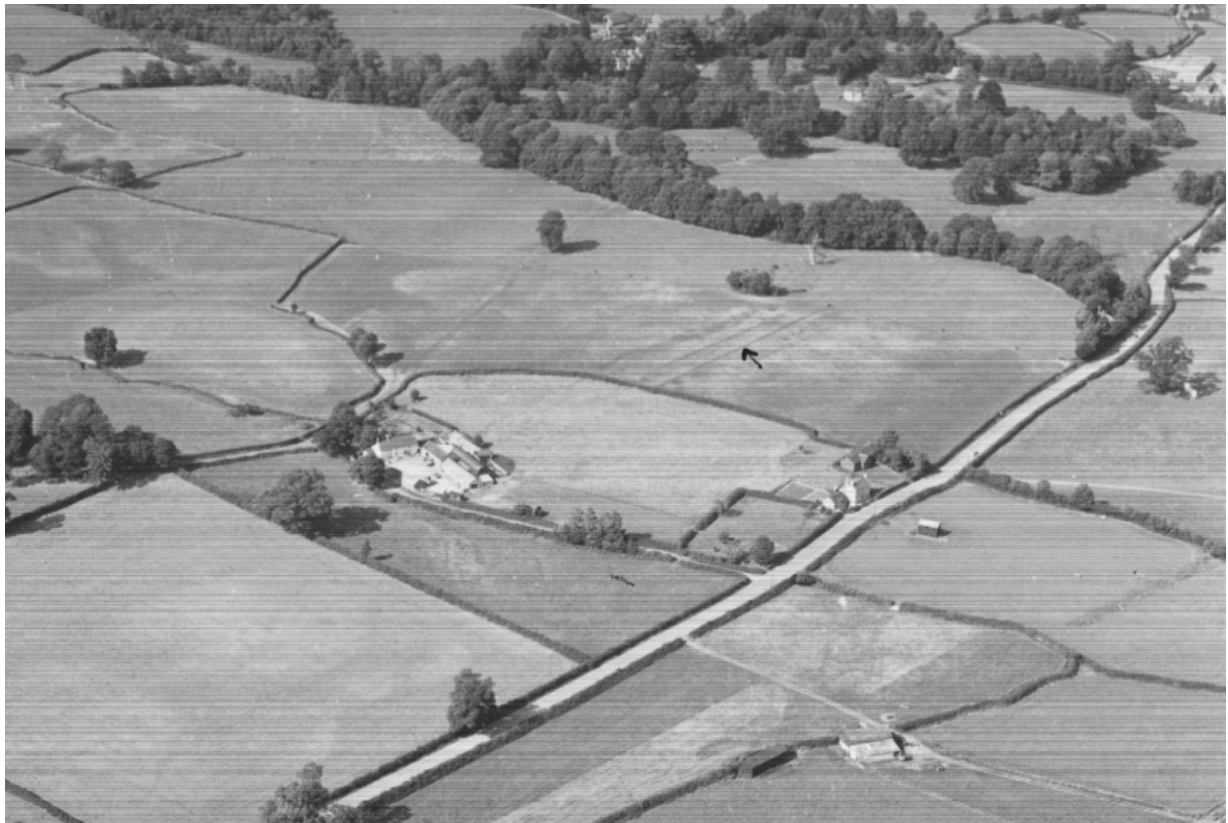
**Plate 1** *The ditches either side of the Roman road (arrowed) picked up as cropmarks in the fields next to Down Farm.*

There is potential for the survival of buried archaeology associated with the Roman road. No ground intrusive activities should take place within 10m of the area marked on the attached map, and tree-planting should be avoided within the area shown.

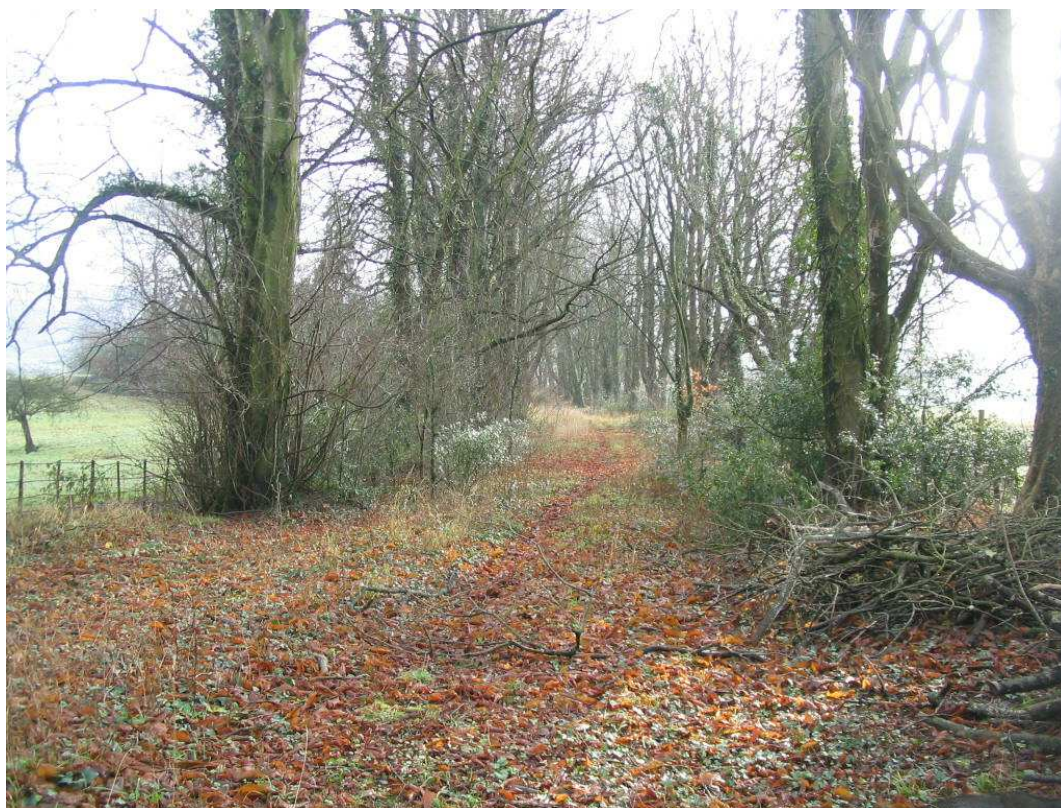
On the west side, the driveway is flanked by iron palings which are generally in good condition.

**Plate 2** *The driveway along the western edge of Glanbrydan Park. Gaps between the mature trees have become partially infilled with saplings and young tree growth.*

The driveway should be maintained in an open and passable condition. The iron palings should be preserved, as should the trees which line the drive. In order to maintain the character of the drive, it is recommended that some of the younger trees and saplings (which have sprung up between the mature specimens) should be removed. This would help to restore a more even spacing, in keeping with what is seen on the early Ordnance Survey maps.

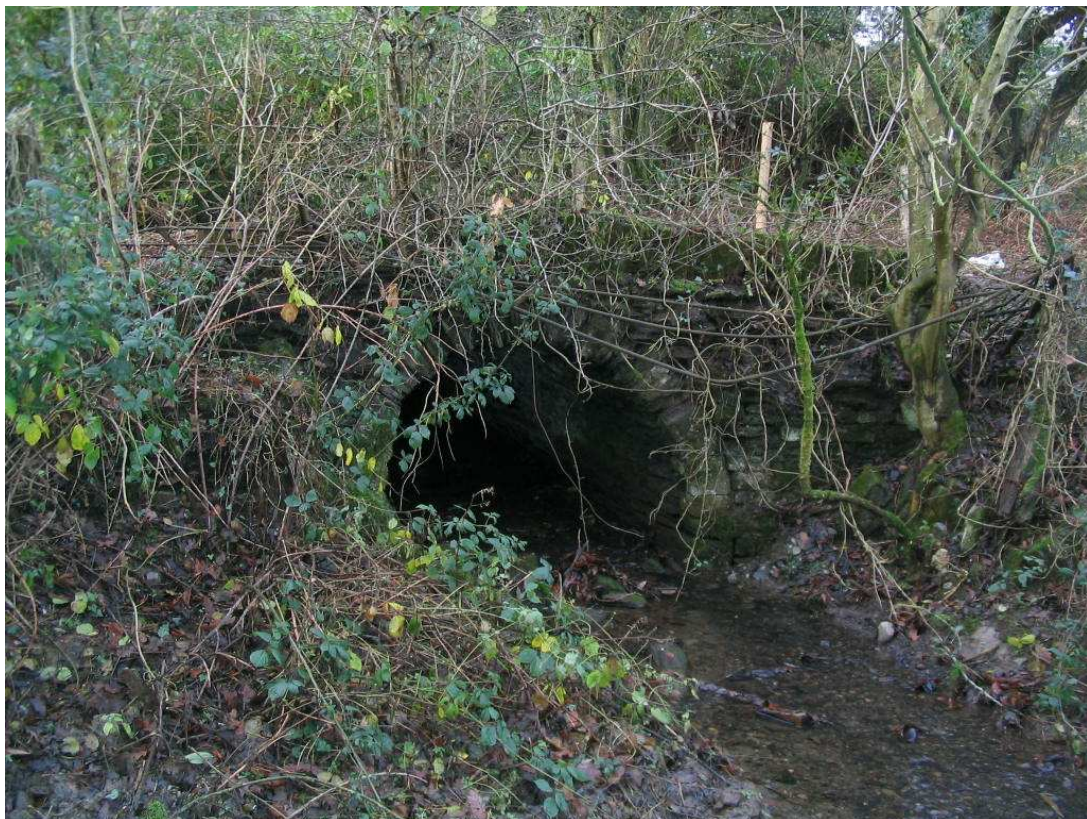
**Plate 3** Bridge on Glanbrydan Park estate. The parapet is brick and was probably added after the original construction of the bridge.

The bridge is in a good stable condition. Maintain as existing.

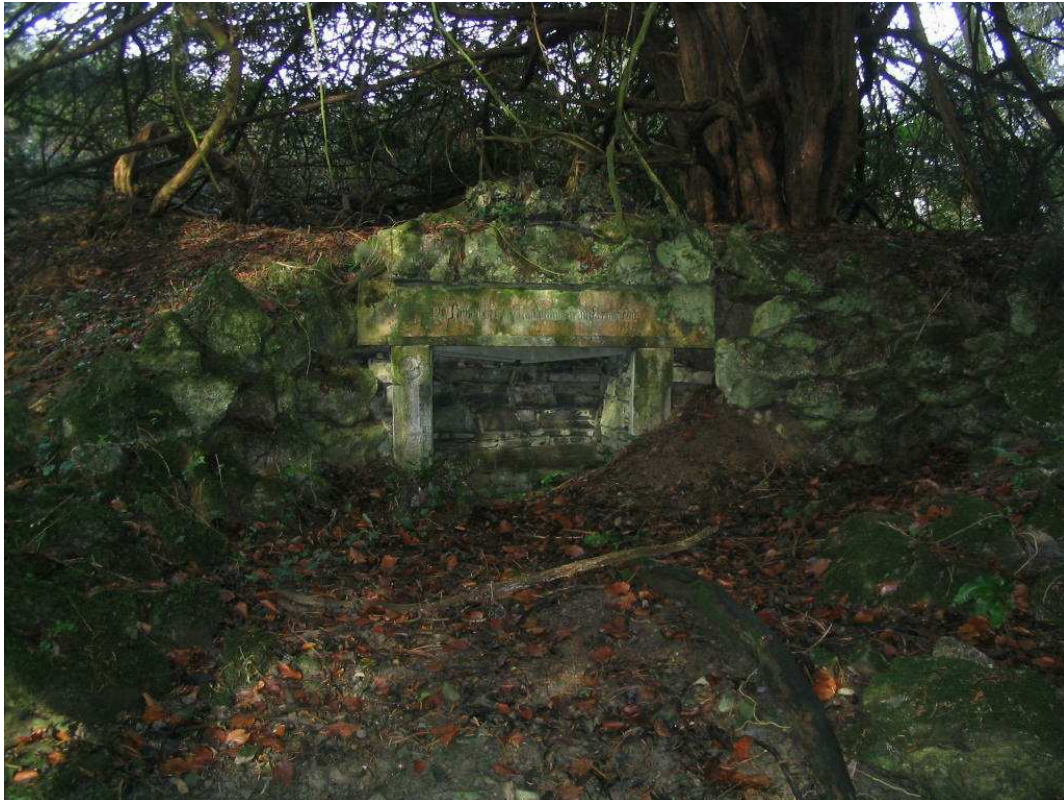
The faced stone of the well forms a strong contrast with the small grotto into which it is set – the grotto has been built in a rustic style, with walls of uncoursed stone rubble. An alcove next to the well probably held a seat. The grotto is approached from the east via a path which is lightly terraced into the stream bank, and picked out by small retaining walls on either side, built of the same rustic style stonework as the grotto. Where the stream has undercut parts of the path, some of the stonework is now gone.

The site is in a stable condition, but access is becoming difficult due to the density of the woodland and vegetation surrounding it.

**Plate 4 (above)** *Grotto containing a well, set amongst a series of woodland walks laid out around 1900.*

It should be ensured that vegetation is not allowed to colonise the grotto itself. Occasional checks should be made of trees which overhang the site, and any loose branches should be removed, since they would cause considerable damage if they fell. Ideally, the path (which led from the bridge (PRN 49712) just west of Lower Lodge Farm (PRN 49714) down to the grotto) should be cleared, and should be maintained in an open state.

It should be ensured that any clearance, or other woodland management, does not cause damage to the stonework of the site or the path.

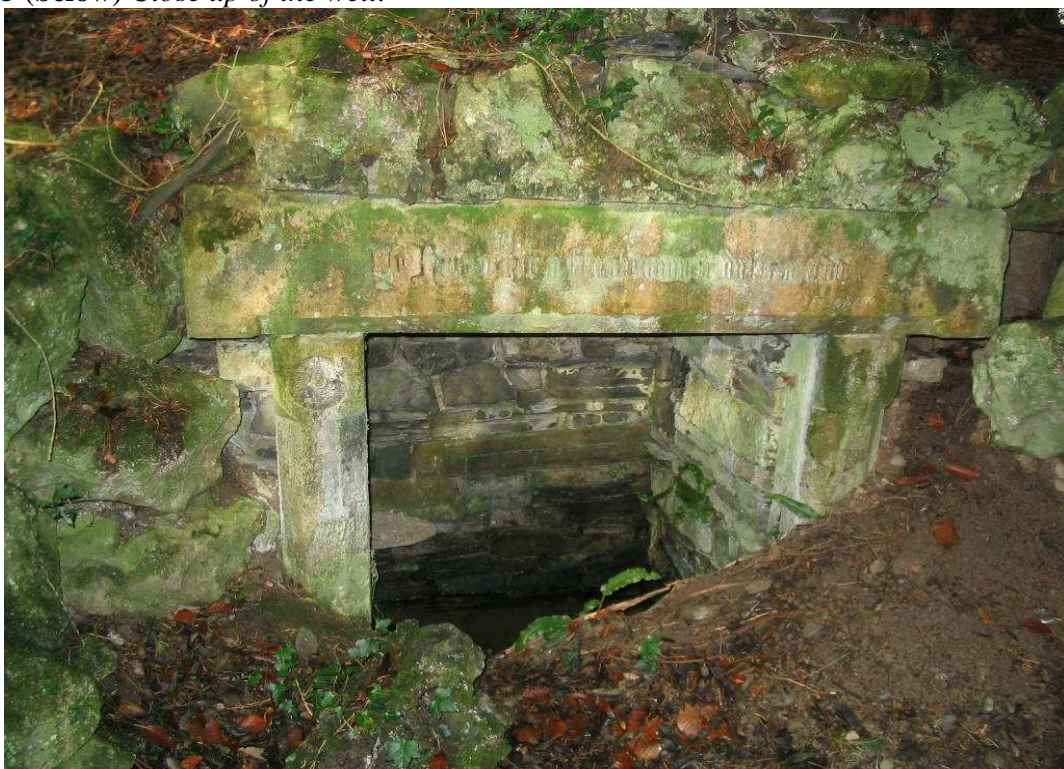
**Plate 5 (below)** *Close up of the well.*

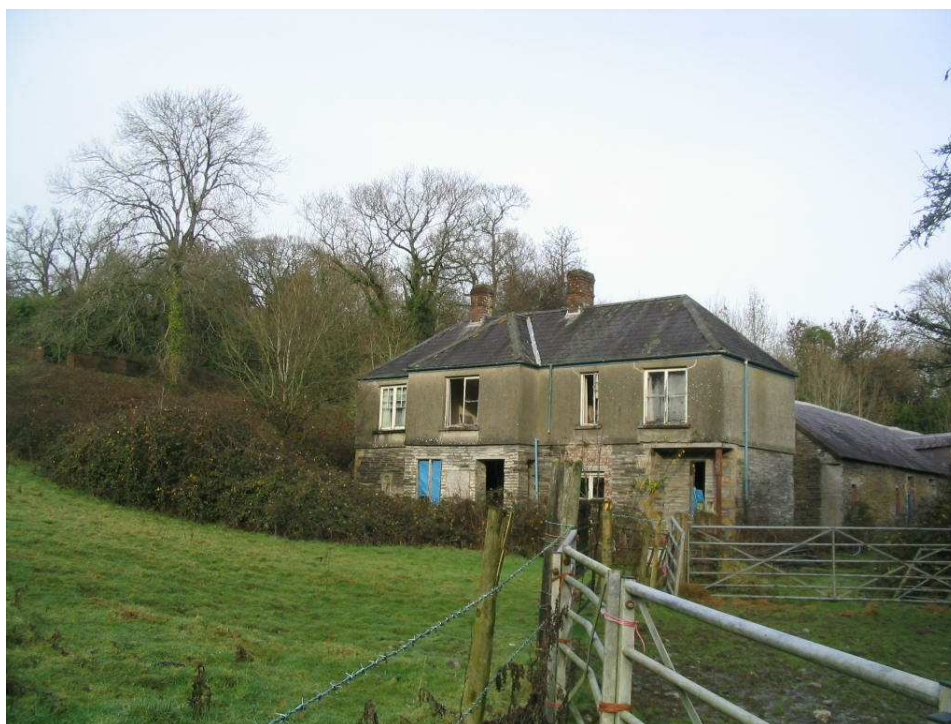
The house is in a stable condition, but is unused. There is now no glass in the windows, but the roof appears watertight, and there are no other obvious problems.

**Plate 6** Lower Lodge Farmhouse. The upper storey has a datestone of 1830.

The best way to ensure the long-term preservation of this building would be to bring it back into use, and this would be the ideal management. In the interim, the building should be maintained in a stable condition, using materials and techniques which match the original construction.

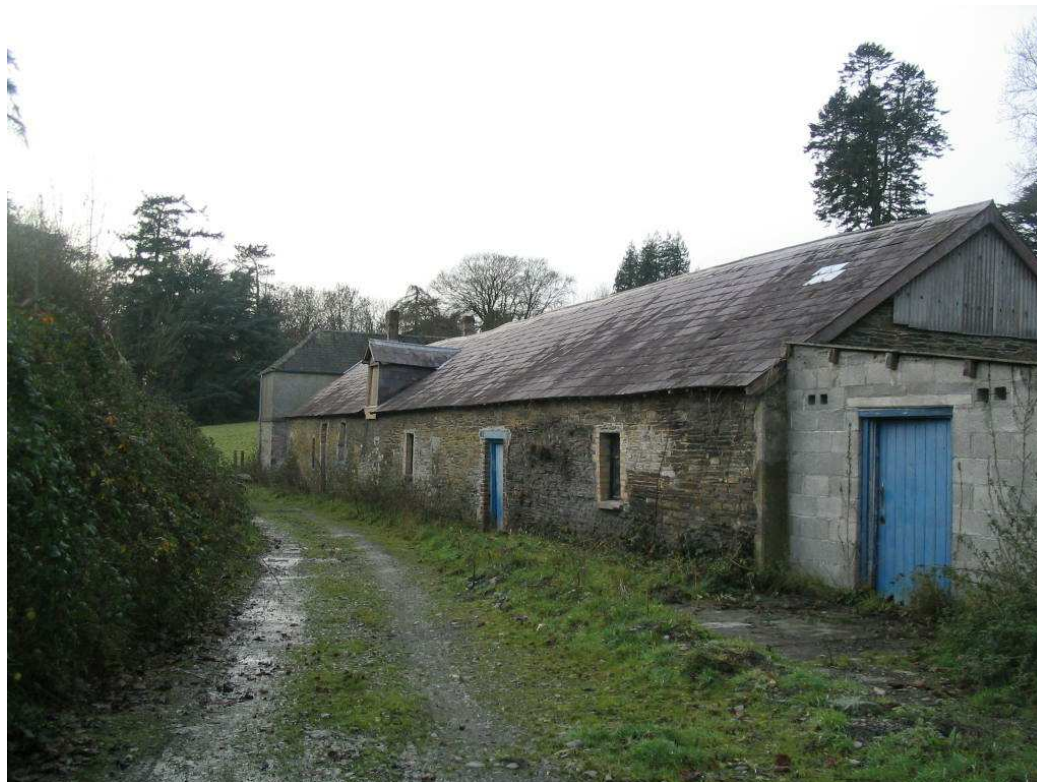
The building is currently in good condition, and the roof appears sound. Part of the building is used for storage whilst other parts are unused.

**Plate 7** *The cowshed at Lower Lodge Farm.*

The best way to ensure the long-term preservation of this building would be to bring it back into use, and this would be the ideal management. In the interim, the building should be maintained in a stable condition, using materials and techniques which match the original construction.

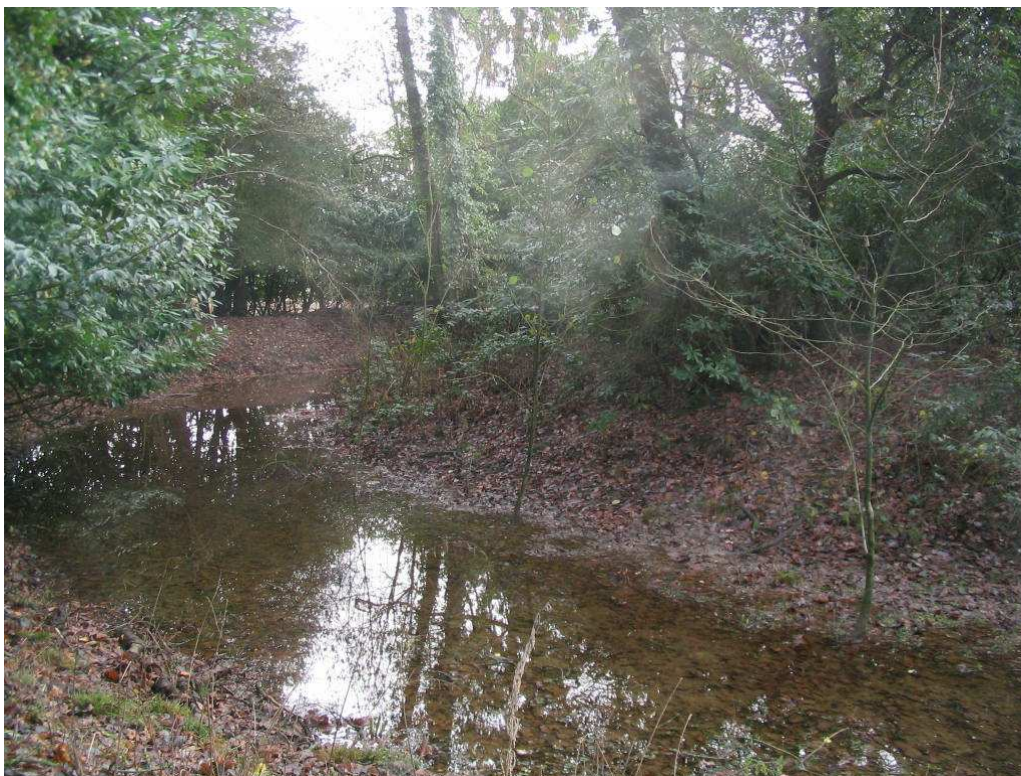
**Plate 8 (above)** *The island at the south end of the boating lake.*

The woodland around the edge of the lake should be managed to ensure that it remains within the original compartment and does not spread out into the park. The undergrowth may also need to be controlled in order to ensure that the wood does not become impenetrable, and that access to the lake remains possible.

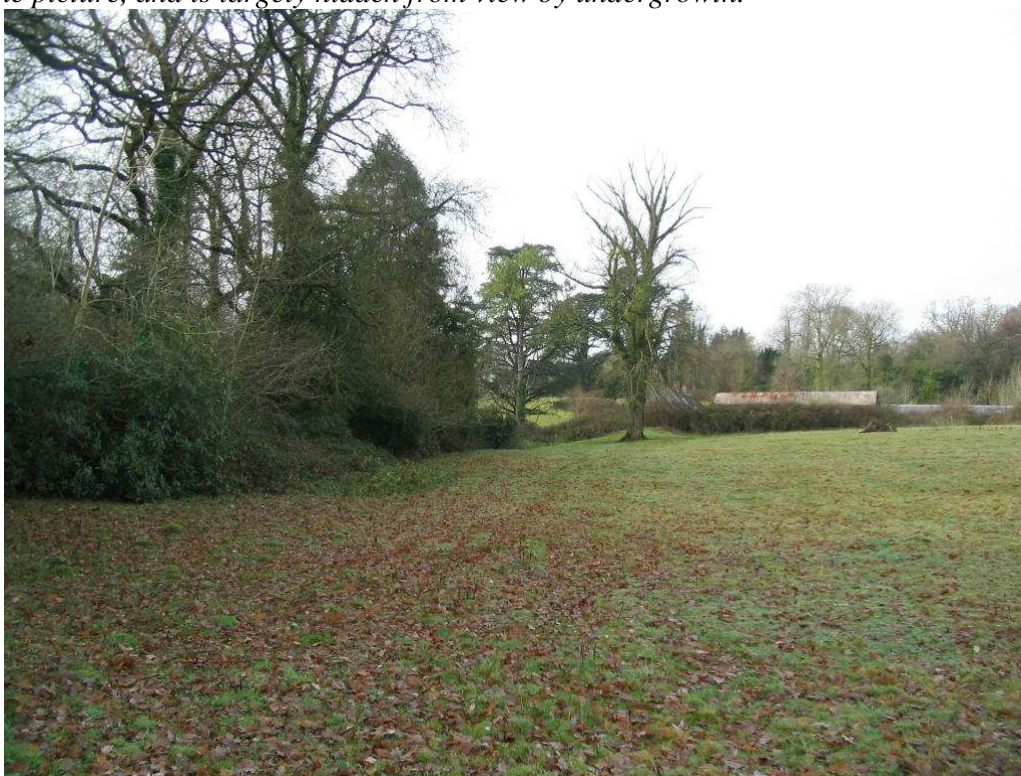
**Plate 9 (below)** *Parkland south of Glanbrydan Park house. The boating lake is in the trees on the left of the picture, and is largely hidden from view by undergrowth.*

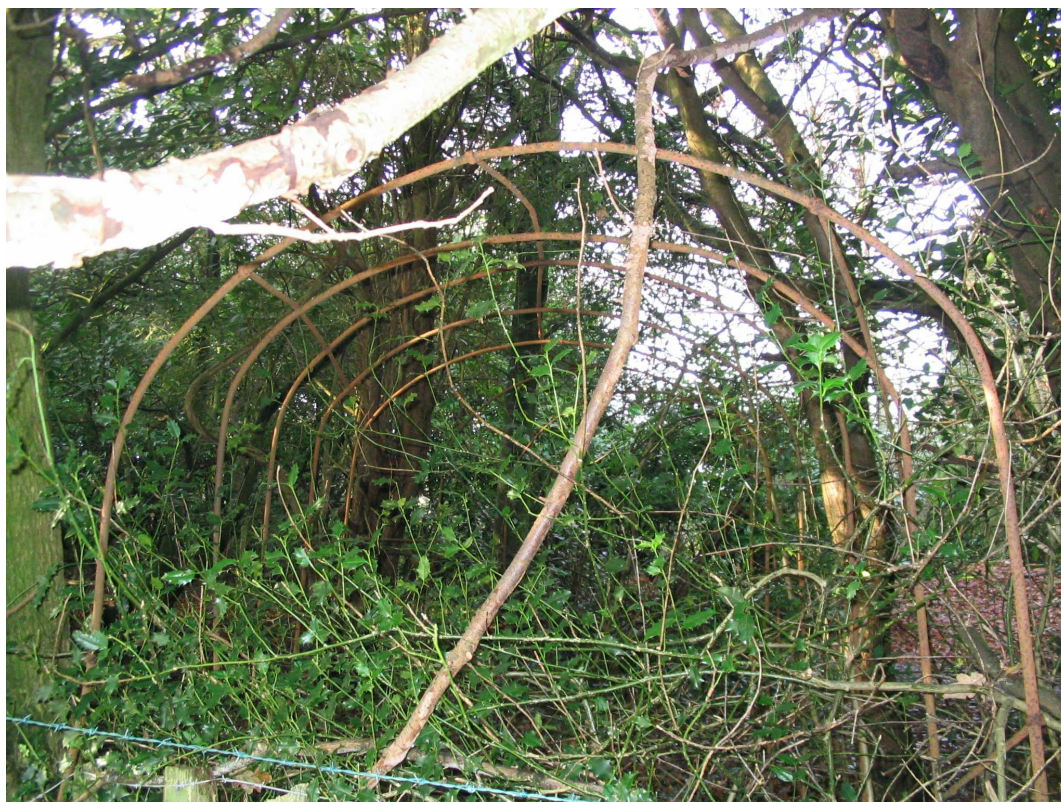
**Plate 10** *Metal supports for climbing plants which would have formed a covered walkway leading to the rose garden.*

These metal arches are valuable evidence for the layout of the gardens, and should be retained. It should be ensured that no damage is caused to this feature during management of the woodland around the house. Ideally, some of the paths through the wood would be re-opened, and the pergola could be brought back into use.

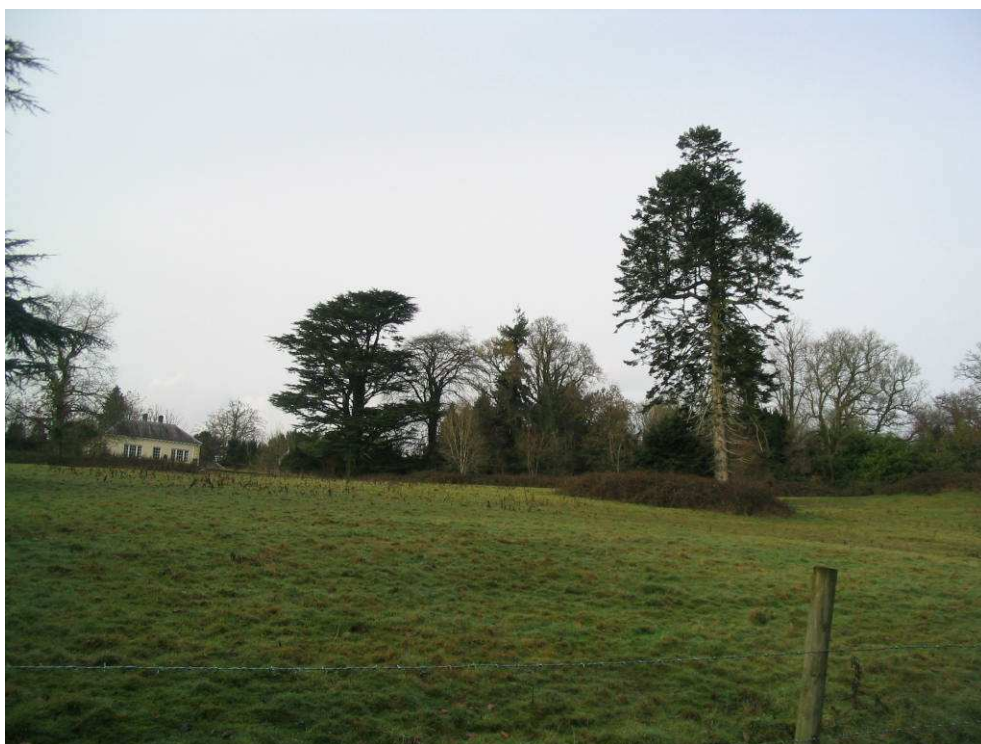
**Plate 11 (above)** *View across the parkland near the house, showing a number of mature specimen trees.*

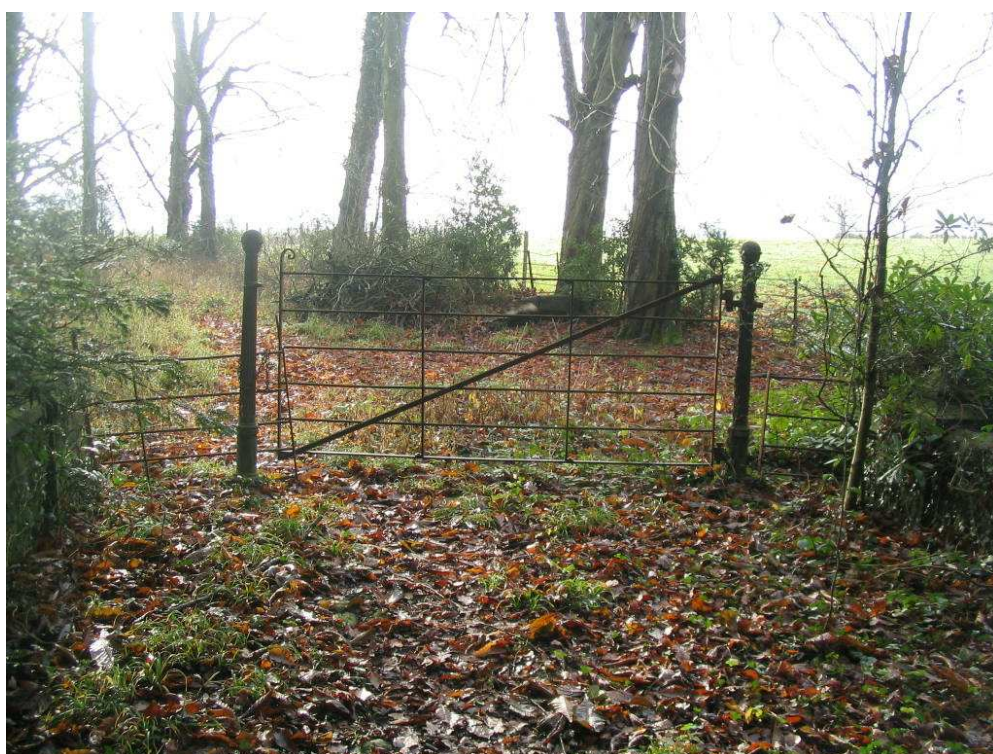
states of repair – some are in good condition, others have been pushed over by cattle. Of most concern is the wooded area around the house. This is now very overgrown, and although many of the paths are still visible they are not passable, so they are not used. The dense vegetation obscures features within the woodland –notably the pergolas and the dance hall.

**Plate 12 (below)** *Surviving iron palings and gates give a distinctive character to the grounds surrounding Glanbrydan Park house.*

The wholesale repair or replacement of the iron palings is not possible within Tir Gofal.
