Heolddu W/12/3876

Tir Gofal Farm Visit Historic Environment Report Call Out

Report No. 2003/112

15th October 2003

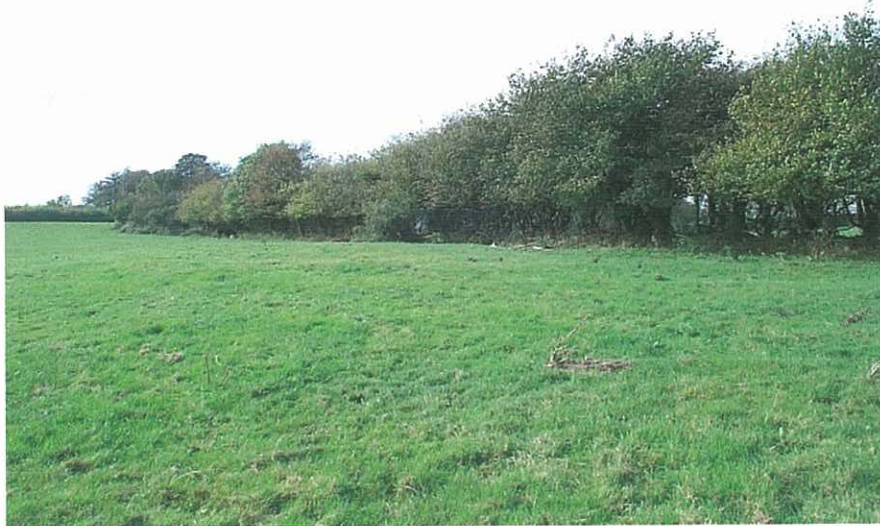
The ring cairn is visible as a roughly circular earthwork bank, although the break of slope is so gentle it is difficult to pinpoint the outer extent of the feature. The ring cairn is no longer hollow in the centre but appears to have been filled at some point resulting in a raised platform. A hedgeline of hawthorn and hazel overlies the monument, which is more visible on the eastern side of the hedge. The hedge sits upon a small earth and stone bank, and has not been laid for several years; many of the hedgerow trees are grown out forming large dense stools. Apparently the hedge has not been stock proof for some time and supplementary wire netting has been attached to the larger hedgerow trees.

Prn 11984 - the ring cairn is visible as a low turf covered bank

It has been proposed through the Tir Gofal scheme to restore the hedgeline to a stockproof boundary, this will allow greater flexibility in the management of the farm. In order to achieve this the hedge will be laid and will involve the introduction of two new lines of fence posts to either side of the hedge. As the site is a Scheduled Ancient Monument Cadw were consulted on the proposals. It was concluded that the restoration of the boundary would not have a significant negative impact on the monument, but would be a positive step in the improved management of the site and its environs. In carrying out the fencing efforts should be made to reduce the number of fence posts which are introduced onto the site, and straining posts should not be placed within the scheduled area. The fence posts should be driven rather than dug into position. The laying of the hedge should not include the introduction of standard trees within the scheduled area, as these will encourage stock to congregate on the monument to find shelter and may cause pockets of erosion or poaching.

As this work will involve ground intrusive activities into the scheduled area, scheduled monument consent will be required from Cadw. Please contact Kate Roberts for a consent form
<mailto:Kathryn.Roberts@Wales.GSI.Gov.UK>

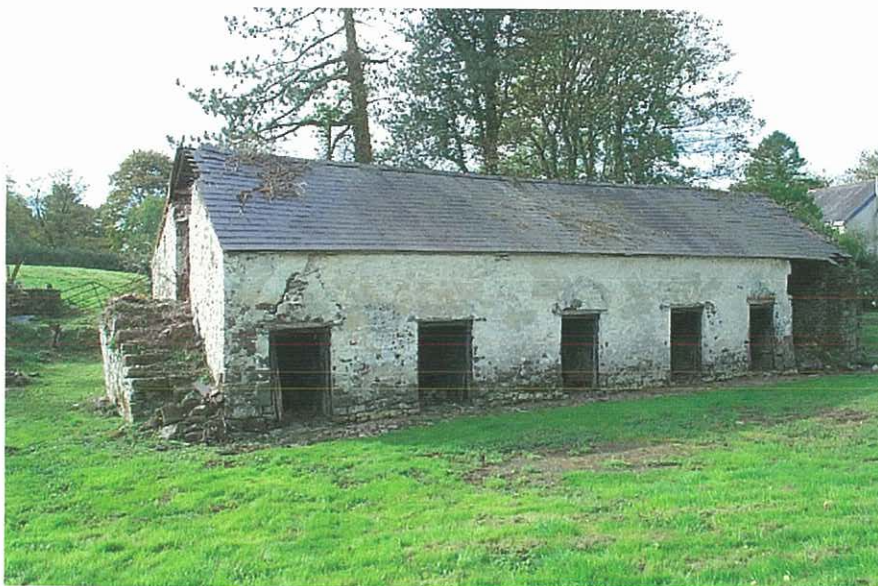
The condition of the building is mixed. When the current owners took over the farm, in the early part of 2002, the cow shed was very overgrown with ivy, and substantial trees had grown up in close proximity to the building. The current owners have removed all of this vegetation, and it is clear that the extensive ivy growth and years of neglect have left this building in a poor state of preservation. The corrugated iron roof is largely intact although in places this has corroded and holes are appearing in the sheeting. The slates are largely in a reasonable condition except where the ivy had evidently grown beneath the slates and dislodged them at either end of the building.

The masonry is also in a mixed condition, the lateral walls appear largely stable. However, there are several areas of concern. In a number places the masonry has collapsed. The outer skin of masonry above the gable end doorway has fallen away and also above the surviving doorway in the southeast facing wall. Perhaps the most extensive collapse includes the cart shed extension at the northwest end of the building. Here a large part of the southeast facing wall has completely collapsed, taking with it a section of the gable end. The ty bach at this end also lacks a roof.

The cow shed is a rare example of a once common Carmarthenshire building

With the vegetation removed it is necessary to consolidate this building urgently. The priority is to make the building watertight and stable. It is hoped that through Tir Gofal the roof covering can be entirely repaired and reslated. This would be a very worthwhile undertaking. It is also of utmost urgency to repair the areas of masonry collapse, as the structural stability of the walls is in jeopardy as long as the wall core is exposed.

Although this building is not currently listed in its own right, it does fall within the curtilage of other listed structures and therefore should be treated as a listed building. It would be advisable therefore, to keep the local authority conservation officer informed of any works to the building. As with any restoration projects involving listed buildings the works should be based on an ethos of repair rather than replacement, in order to retain as much of the historic fabric as possible and where necessary to replace materials on a like for like basis.

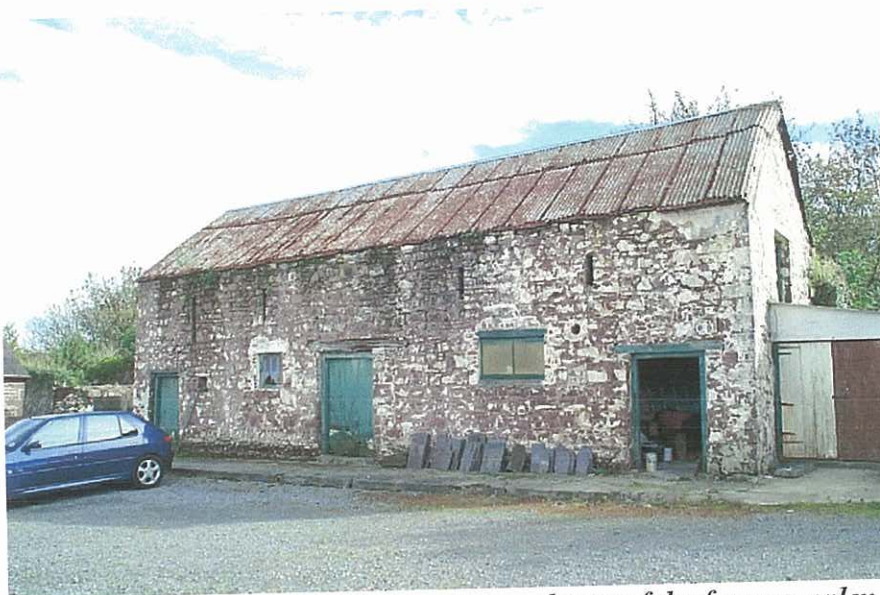
The condition of the building is poor, the corrugated iron roof is severely corroded, and has become quite perforated. In addition the roof does not extend adequately at eaves level and rainwater is evidently pouring down the wall face, particularly on the front (northwest) elevation which bulges outwards to some extent. The owners have discussed this problem with people who have known the farmstead for a long time and apparently this bulge in the front wall is of some antiquity and does not appear to have increased to any great extent in the recent past. However there is a danger, with rainwater no longer being sufficiently deflected from the wall tops and wall surface, that the bonding mortar will become eroded and that the wall will lose its structural stability. In addition an inscribed datestone in the centre of this elevation, just below the eaves, is becoming quite eroded and the inscription is gradually being lost. The interior of the roof was not fully looked into since the safety of the floor is questionable, however it was observed that one of the collars to a truss was broken.

Prm 26415 – the listed stable is an integral part of the farm complex

This listed building is in dire need of attention to the roof. It is of great concern that the roof no longer appears to be adequately watertight. The ingress of water will undoubtedly affect the stability of this structure in the long term. Indeed, although the bulge in the front wall is of some antiquity, water percolating through the fabric of the wall could cause the vital bonding in the wall to fail.

Ideally the roof covering should be replaced in slate with a sufficient overhang at the eaves to deflect rainwater away from the wall face. If the reroofing of the building in slate is too costly to achieve quickly, it maybe appropriate to replace the roof with corrugated sheeting which would at least afford protection to the building in the short term and would be light enough to carry out without major structural works to the roof structure. Any works to the building should be carried out in full consultation with the local authority conservation officer.
