Maes Cottage W/12/3905

Tir Gofal Farm Visit Historic Environment Report Call Out

Report No. 2003/122

Maes Cottage
Tir Gofal Farm Visit Historic Environment Report
Call Out

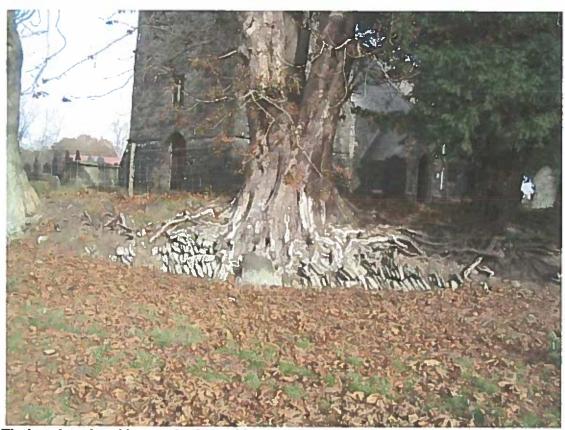
The boundary shared between land owned by Maes Cottage and St. Peters Churchyard, Llanybydder.

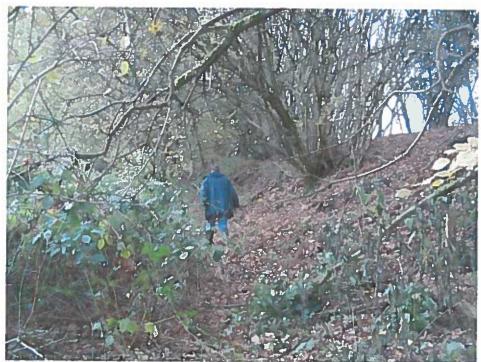
A well-preserved section of the railway embankment runs for around 320m (350yds) along the western edge of this land holding. The shape is still very clear, showing its flattened top and smooth, steep sides. This section of embankment is highest at its north end, where it stands to a height of some 5 - 6m (18 - 20ft). The surface of the embankment is still covered with the stone ballast which was laid around the tracks and sleepers. Original railway post and wire fences run along either side of the embankment.

The site is generally in good condition, though some scrub is growing up in places and a number of semi-mature trees are growing along the top and sides of the embankment. At the north end is a very small conifer plantation which marks the land boundary – beyond this, the embankment has been flattened and survives only as a parch mark in an improved field. Scrub is also partially blocking the ditch and has obscured the culvert.

Plate 1 (above) The railway embankment, part of the dismantled Manchester-Milford line. Plate 2 (below) A small, stone-built culvert passing under the embankment, now very blocked with silt and leaves.

Some scrub clearance will need to be carried out on this site. Vegetation should be cut at ground level and removed, and care should be taken that the ballast which covers the ground surface is not removed during these works. Trees growing on the sides of the embankment are a concern, since their roots will eventually cause damage to the structure. They are also more vulnerable to wind-throw, since the depth of soil on the sides of the embankment is very shallow. Ideally, most of the young trees growing on the sides should be cut at ground level and removed. The ones growing on the flattened top are more stable, but care should be taken that the top of the site is not allowed to become overgrown and, consequently, impassable. Any trees which look unstable, or which are growing in thick clumps should also be removed and trees which are left in place should be managed to prevent them from becoming unstable. Coppicing may be one appropriate method of woodland management.

Re-growth of vegetation is likely to be comparatively slow, because of the stone ballast on the ground, but clearance may need to be periodically carried out in the future. If the site shows signs of turfing over, then light grazing may prove a practical way to achieve this in the long term. Future maintenance should aim to keep the site in a stable and visible state.

The survival of the original railway fencing contributes to the significance of this site, and it is important that this is not lost. The majority of the fence posts are now rotten, but the design of the fencing is clear – simple post and wire, with the wires becoming closer set towards the base of the fence. The fencing should be replaced on a 'like for like' basis, using the surviving stretches as a pattern.

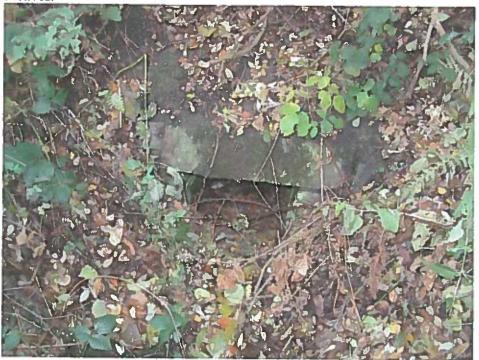
A pronounced ditch runs along the east side of the embankment, then turns sharply and drains into a small, stone-built culvert which runs under the railway embankment. A simple, small footbridge formed of one concrete slab crosses the channel which leads into the culvert. The ditch does not appear to carry on to the south beyond the culvert so must have been put in place to only drain a few exceptionally wet fields.

The landowner is also proposing to create a pond, and to clear and re-use the ditch east of the embankment, as well as the culvert which it drains into. The restoration of these features would be very welcome, especially since they would be re-used for their original purposes. Clearance of the culvert should be carried out carefully by hand. The depth of the drain is not known at this point, and there is also a possibility that there is a stone lining to the channel leading into the culvert. Any such lining should not be damaged or removed. The channel should be kept within its original cut and care should be taken that only modern silt and rubbish are removed from it – its depth should not be increased.

As far as is practical, the ditch should also be cleared by hand, again taking care that any lining is not disturbed or damaged. The line of the ditch is very clear, and it should not be expanded beyond its original outline or depth — only modern silt should be removed. Ideally, a photographic record should be made of the site during and after clearance, (including more detailed photographs of the culvert and any ditch or channel linings) and a copy of the photographs deposited with Cambria Archaeology.

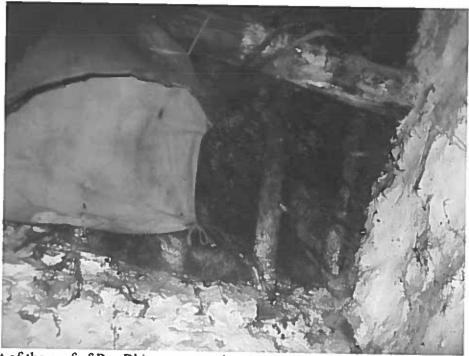
Map evidence suggests that Pen Rhiw cottage was constructed sometime between 1840 and 1886. The cottage is a simple stone-built two-room dwelling with a loft and a fireplace in each gable. It is now roofed with corrugated metal, but some thatch is preserved under this, and from inside it appears that the thatch rests on closely-set branches rather than on rafters. The remains of a piece of cloth are still pegged onto the underside of the roof – this was probably put in place to stop parts of the underthatch from drying out and falling into the room. Thatching in this way is typical of cottages constructed in the 19th century by, and for, labourers – it did not require a professional thatcher, and was therefore cheaper and easier to maintain (Wiliam, E:1993:p.21). Another interesting survival is the chimney hood at the north end of the house. Although the fireplace has been replaced with what is probably a bread oven, the chimney hood still survives. It appears to be constructed of wattle and daub, covered in layers of limewash. Again, this was a typical feature of rural labourer's cottages, but is one which very rarely survives.

Plate 3. Part of the roof of Pen Rhiw cottage: close set poles taking the place of the rafters with an underthatch woven into them. The cloth would be in place to prevent parts of the thatch from falling into the room.

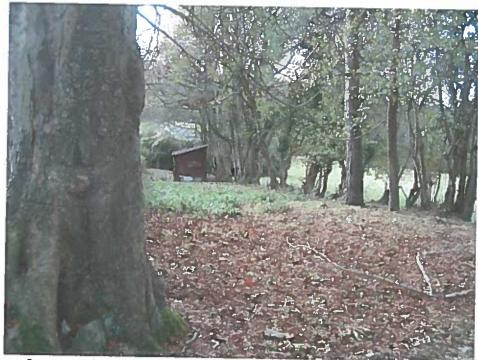
The cottage is in a stable condition, and a line of mature trees marks out the garden. The landowner has expressed an interest in re-instating this boundary.

Plate 4. Line of trees marking the edge of the garden associated with Pen Rhiw cottage.

There are no works proposed which affect the building directly, but the garden is an important part of the setting for this typical 19th century cottage. The landowner has expressed an interest in restoring the boundary around the garden, and this would be welcomed. It was probably originally a laid hedge, and ideally this would be re-instated, although some of the mature trees may be retained as standards, and incorporated into the hedge.

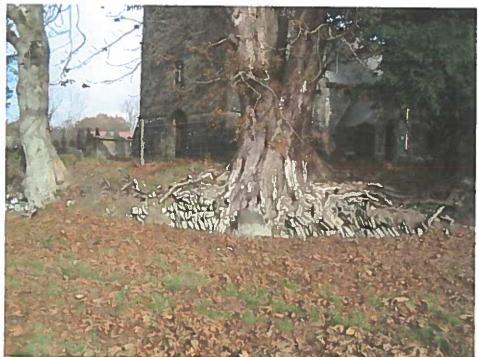
The boundary which survives today is a raised earth bank, topped with mature trees and partially supported by a stone facing on the bank. This is formed of small to medium sized stones which are pressed into the earth bank rather than being a self-supporting wall.

The boundary is in various states of repair – in places, the stonework is almost entirely gone but towards the east, sections of it stand nearly intact. Tree-roots are the major cause of damage to the wall – they are dividing the stonework and pushing individual stones out of the bank. The boundary is no longer stockproof, and gaps between the trees are infilled with wire netting, on both the churchyard side and the field side of the boundary.

Plate 5. The boundary shared with St Peters Church, Llanybydder. Tree roots are pushing the stone facing off the bank, and there is little earth left that the stones can be set back into.

There is comparatively little that can be done to restore this boundary now that the trees are so mature. In places, the outside of the bank now has no earth for stones to be set into, but consists solely of tree-roots, and the stone facing in these areas cannot be restored. In other parts the stonework would benefit from the replacement of fallen stones, and if this were carried out on a regular basis it would certainly slow the rate of decay.

In order to make the boundary stockproof, the most practical solution is to put a new fence in place outside the bank. The appearance of the bank would then be maintained, since it would prevent the necessity for small patches of 'infill' fencing between the trees around the churchyard. These could be taken down once the new fence is in place.

It is important that the strip of land between any new fence and the bank is not allowed to become overgrown. It may need occasionally to be cleared of scrub or undergrowth.
