# Underhill Farm W/12/3934

# Tir Gofal Farm Visit Historic Environment Report

Report No. 2004/15

## REPORT NO. 2004/15 PROJECT RECORD NO. 48461

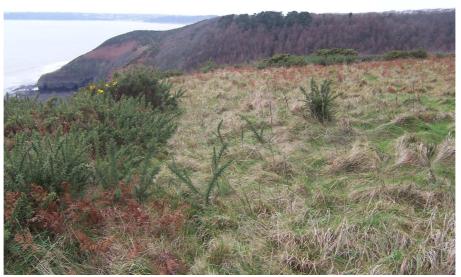
The monument is essentially in stable state but is gradually becoming obscured by vegetation. Aerial photographs show that the northern slopes below the hillfort have long been covered in thorn and bramble, but that elsewhere the monument was covered in a rough grass sward, maintained by low numbers of grazing animals. In recent years however, the bramble and gorse have gradually encroached around the slopes in all directions and this has effectively prevented animals from accessing the interior of the monument which is now becoming engulfed by gorse, bramble and thorn.

Prn 3665 – the interior of the Top Castle Hillfort looking west. Although the interior is largely still grass cover, gorse, bracken and thorn are gradually encroaching.

Gorse and bramble which are encroaching into the interior of the hillfort should be cut back by hand at ground level. Where possible the flanks to the south and west should be cleared of scrub although this would be best tackled in small sections.

Once animals are free to graze the open areas of the hillfort regular monitoring needs to be carried out to ensure that no parts of the monument are suffering from erosion, particularly on the earthwork defences which are especially vulnerable to wear.

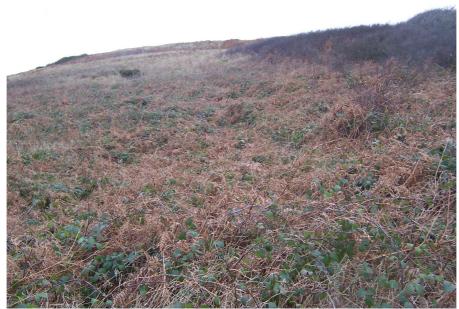
Prn 3665 – the way up to Top Castle Hillfort from the south is difficult due to dense bramble cover, making it awkward for grazing animals to gain access to the hillfort interior.

In order to enable animals to reach the summit of the Top Castle to graze, paths through the overgrown slopes to the south will need to be kept clear and free of obstructing vegetation.

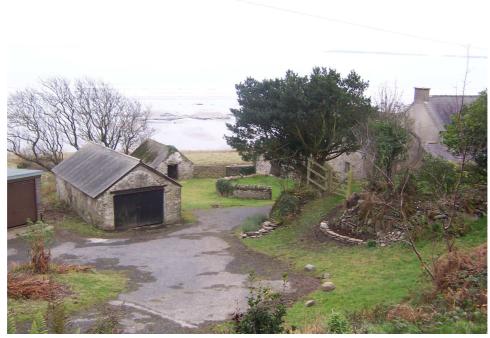
Prn 21687 – Underhill Farmstead enjoys extensive views over Carmarthen Bay

The farmstead retains much of its historic integrity, and the buildings and structures within the complex are largely unchanged. Any modifications to the farmstead should ideally be carried out sympathetic to the historic core, using traditional materials and techniques where possible.

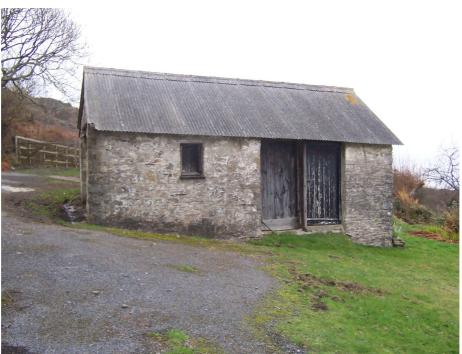
The building is in a sound condition, and appears to have been repointed. The eastern wall demonstrates some bulging in the masonry, but this does not appear to be an ongoing problem and the wall appears to be stable. The roof is supported by an A-frame truss, jointed with metal pins and covered with corrugated asbestos.

Prn 48711 – this farm building at Underhill has been converted into a garage, however it retains much of its historic character

This building appears to be in a stable and watertight condition at present. Ideally any further maintenance works should be carried out using traditional materials and techniques.

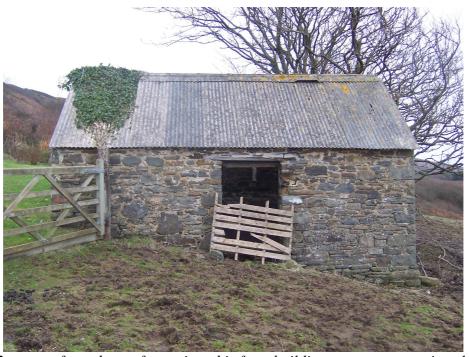
The building still has its original pointing visible, which is finished to be flush with the wall face. It is also a distinctive rosey colour. There is also evidence of white limewash coating the exterior.

The building appears to be in reasonably stable condition at present, although there are some localised areas of concern including the loss of the jamb stones in the western doorway and also some ivy growing over the roof at the northern end.

Prn 48712 – apart from the roof covering, this farm building appears to survive almost in its original form, with a stone flag floor internally.

Although this building is currently in a relatively stable state it could benefit from some repair works in order to secure it for the long term. Of primary importance is the removal of ivy from the northern end of the roof. Also the stones which have fallen from the western doorway should be reinstated.

Any repointing works should be carried out using mortar of a similar composition and hue to the existing lime mortar. There is also some possibility of the restoration of one of the buildings following the review after 5 years of the scheme. If possible this building should be given precedence over farm building Prn 48711, as this retains more of its historic integrity. Should the roof be subject for restoration, careful consideration should be given to the choice of materials used. As mentioned above it is possible that this building was originally thatched, and following the removal of this material it was very likely replaced with corrugated iron. Further advice should be sought prior to works to the roof being undertaken in order to discuss the suitability of materials. Before any restoration works are carried out a photographic record should be made of the building, with specific attention to those areas which will be affected, ideally these should be backed up by further photographs taken during, and on completion of the works. Guidelines are provided appended to this report, but if any further advice is required please contact Cambria Archaeology.

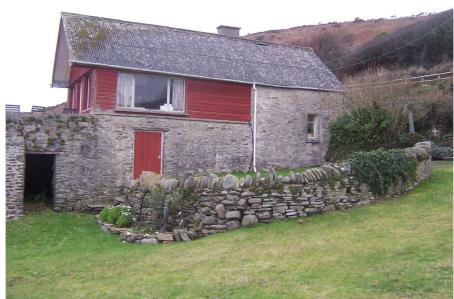
This feature is clearly identifiable on the  $1^{st}$  and  $2^{nd}$  edition Ordnance Survey maps and survives in good condition.

Prn 48713 – the low stone wall in the foreground appears to mark out a levelled area where a horse engine would have operated.

This historic element of the farmyard should continue to be maintained in stable and visible condition.

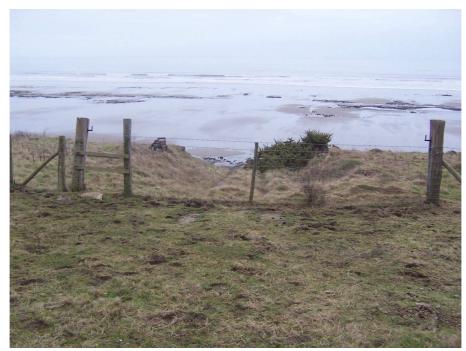
Immediately to the south of the farmyard at Underhill are the remains of a concrete slipway descending down onto the beach. On the eastern side is a mechanical winch for the purposes of hoisting boats. The land is eroding quite rapidly onto the beach which is 4 or 5 metres below and consequently the slipway is disintegrating.

Prn 48714 – the slipway below Underhill is gradually crumbling onto the beach below. To the left is a metal winch for hauling boats up the slipway.

This feature is gradually succumbing to natural erosion by the sea. No management recommendations apply.

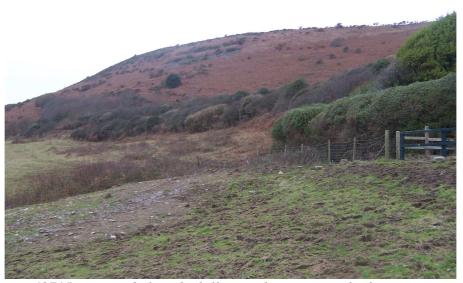
Although this quarry was not visited it is visible from the coastal path and the beach below as a prominent scar in the hillside.

Prn 48715 – a scar below the hilltop is the remains of a former quarry identified on the 1891 Ordnance Survey map

This quarry should be maintained as a visible landscape feature.
