Ystradwalter W/12/3943

Tir Gofal Farm Visit Historic Environment Report

Report No. 2003/110

Ystradwalter
Tir Gofal Farm Visit Historic Environment Report

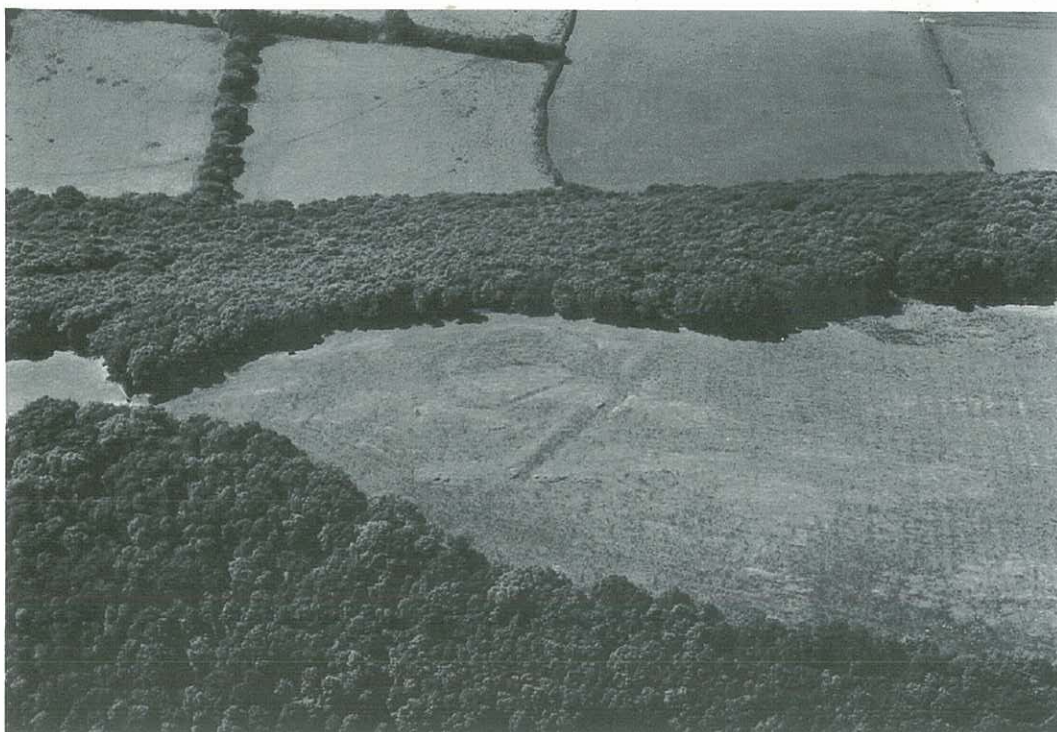
AP Oblique/DAT/James,T/1989/AP89-120.32/SN7835

A small promontory fort seen clearly on aerial photographs. The photographs show a large, gently curved ditch cutting off the promontory to the south. Within this area of land is a circular or oval inner enclosure, which appears to be linked to the outer defences by a short length of ditch at the north end.

The site is currently under pasture and seems to be in a very stable condition. There is no scrub or gorse encroachment and it is very visible.

Plate 1 (above) *Aerial photography has revealed the shape of this small promontory fort. The northern, outer ditch is still a clear earthwork (see plate 2). The inner, circular enclosure is harder to make out on the ground.*

The site should be maintained in its current condition. No ground-intrusive activities should take place in or near the hillfort and the current regime of light grazing should be continued.

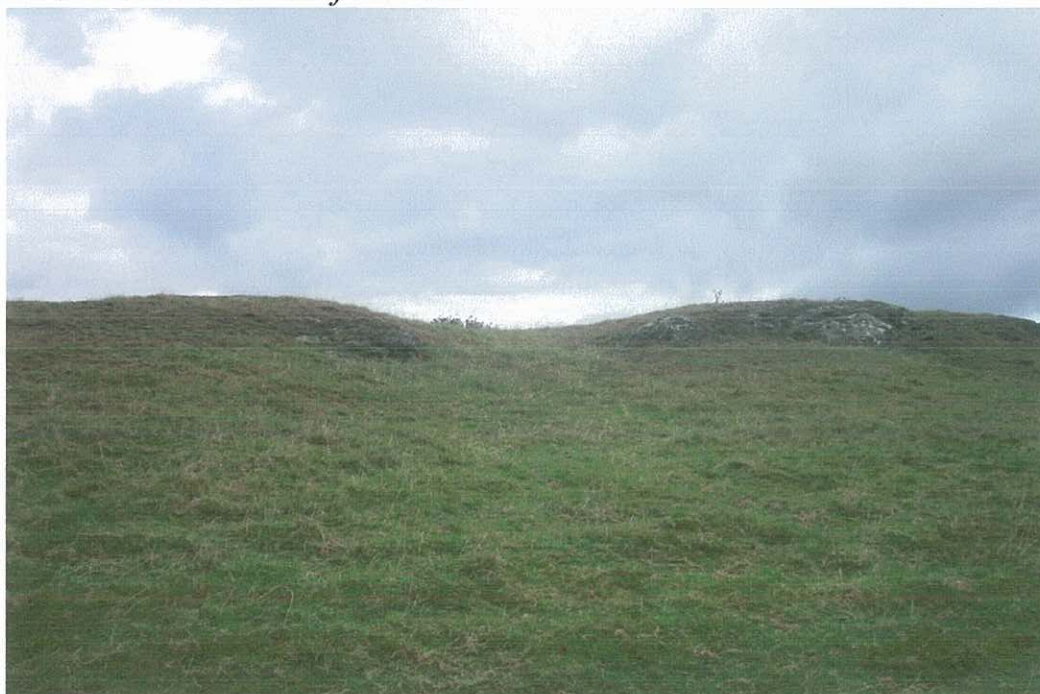
The site is much less clear from the ground. Although there are earthwork remains, the natural topography is very undulating and the earthworks are very denuded so it can be hard to distinguish between them. However, the outer ditch is clear and is especially well preserved at its southeast end where it can be seen to be rock-cut and around 2.75m wide. The line of this ditch remains as a visible earthwork as it curves around, defining the northern edge of the site. There is a clear bank on the inner (southern) side and traces of an outer bank at the east end of the ditch.

Plate 2 (below) *View of the east end of the outer ditch. This is the best preserved section and shows the rock-cut construction of the ditch.*

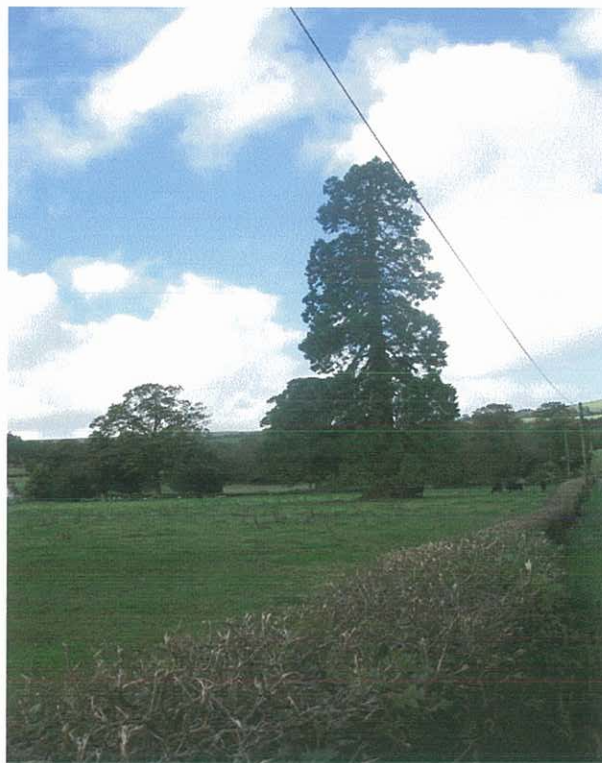
The parkland still has a very open aspect and is used for pasture. A number of trees remain, scattered across the park, and the diversity of tree species represented probably reflects the deliberate planting of specimen trees. Several of the more mature trees are probably original elements of the parkland.

Plate 3 *Pen y Bont park includes a number of very mature trees. Some may be original plantings.*

The park should be maintained under pasture as far as possible, and no new field boundaries should be put in place. The landowner has indicated that they may carry out some tree-planting under the Tir Gofal scheme – this is to be welcomed, but future planting should follow the layout of trees seen on historic maps. Copies of the relevant maps will be included with the report.

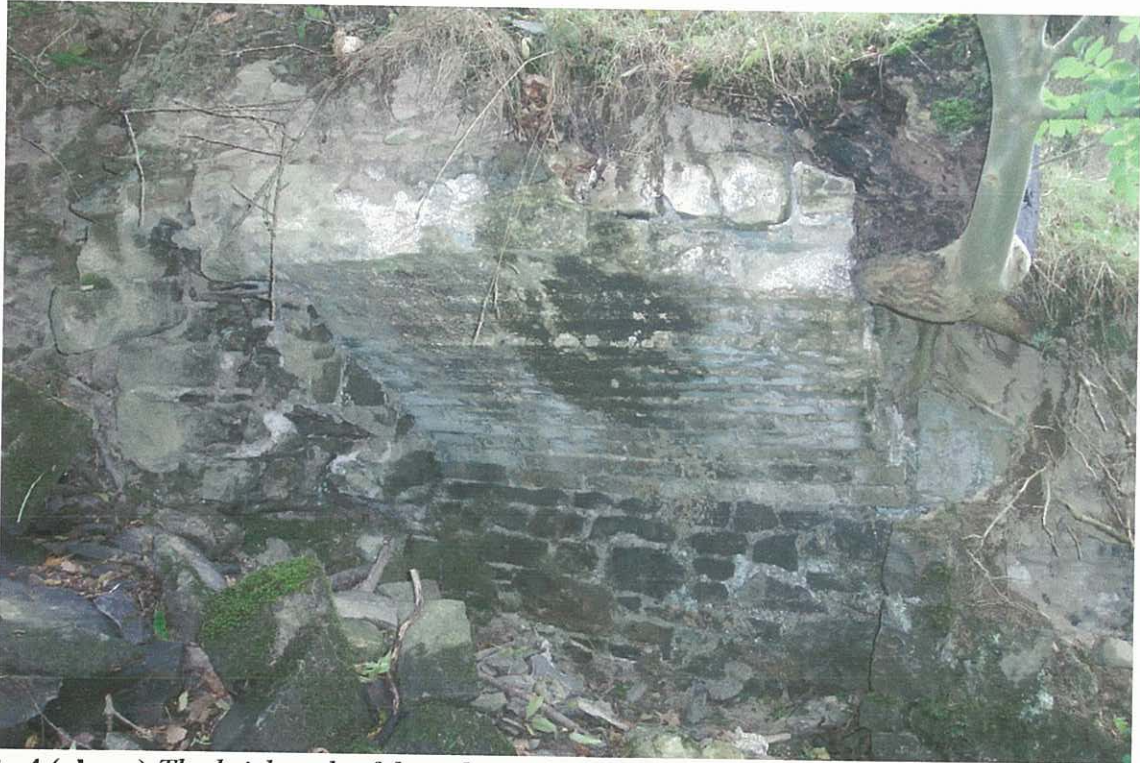
Although the structure and shape of the pond is still visible, it is very overgrown. Mature and semi-mature trees are growing within the silt of the pond, and the stone revetment wall is partly tumbled in several places. It is also overgrown, with vegetation obscuring and destabilising the stonework. The channel through the wall is still clearly visible, but no trace of the sluice mechanism survives. The brick-built culvert is in a poor state, with only the southern half surviving. A large tree-stump is on top of the masonry. Its roots have partially penetrated the structure, and new growth from the stump is threatening the brickwork.

Plate 4 (above) *The brick arch of the culvert which leads away from the pond (PRN 49180). New shoots from an old tree-stump are leaning heavily on the masonry.*

In the short term, the most immediate concerns relate to vegetation growth which is threatening both the dam wall and the brickwork of the culvert. Saplings and scrub which are growing along the dam wall should be cut back at ground level, and larger roots treated to prevent re-growth. Larger, mature trees should be managed to ensure that they do not fall and damage the stonework. Any branches that are rubbing on the stonework should be removed.

The growth from the tree-stump on the culvert should be cut back and the stump treated to prevent further re-growth. Any restoration works will require that the culvert is consolidated, and this should be carried out using materials which are faithful to the original construction.

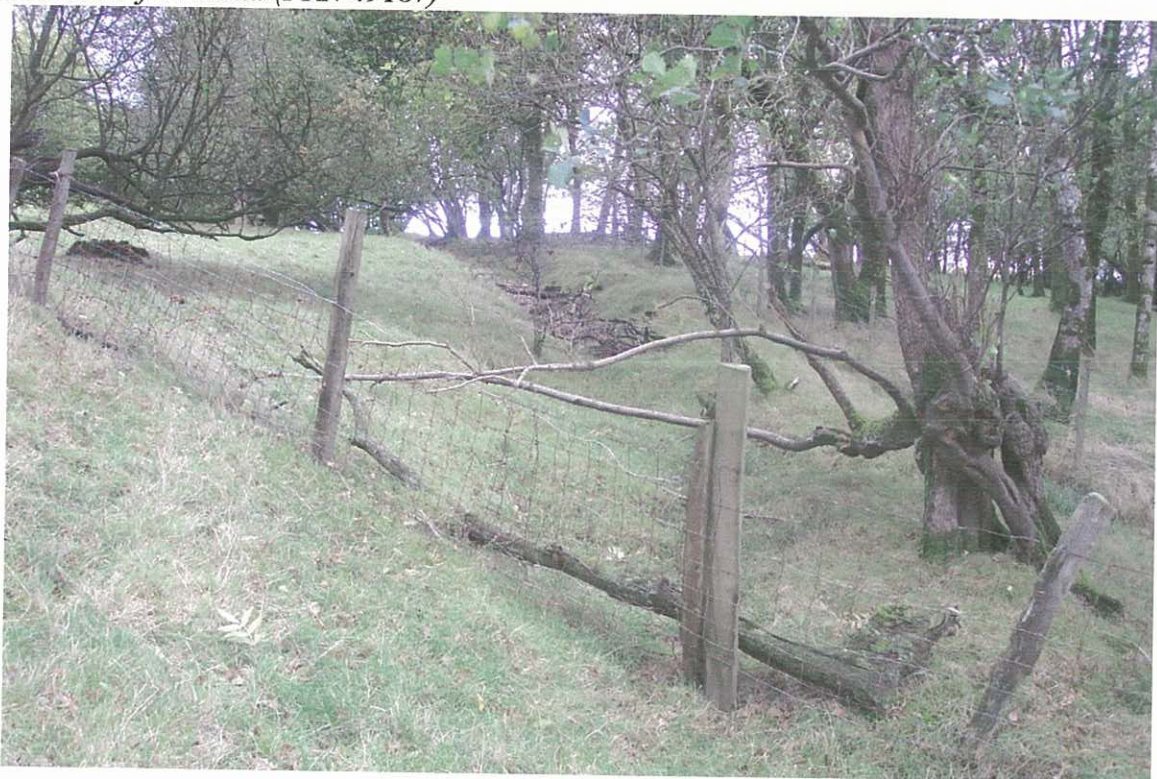
Plate 5 (below) *The line of the leat (PRN 49181) leading west away from the pond, towards Ystradwalter farmstead (PRN 49187)*

The leat is visible as a cut in the hillside, running at quite a steep gradient. It runs parallel to the stream but the gradient is much more controlled: the stream falls sharply at the east end and then rapidly levels out into a narrow, steep-sided valley. The leat runs along the side of the valley at a higher level.

The leat is in a stable condition, running through open woodland. Any disturbance to the leat should be avoided, and future woodland management plans should ensure that no ground intrusive activities are carried out along the line of the leat.

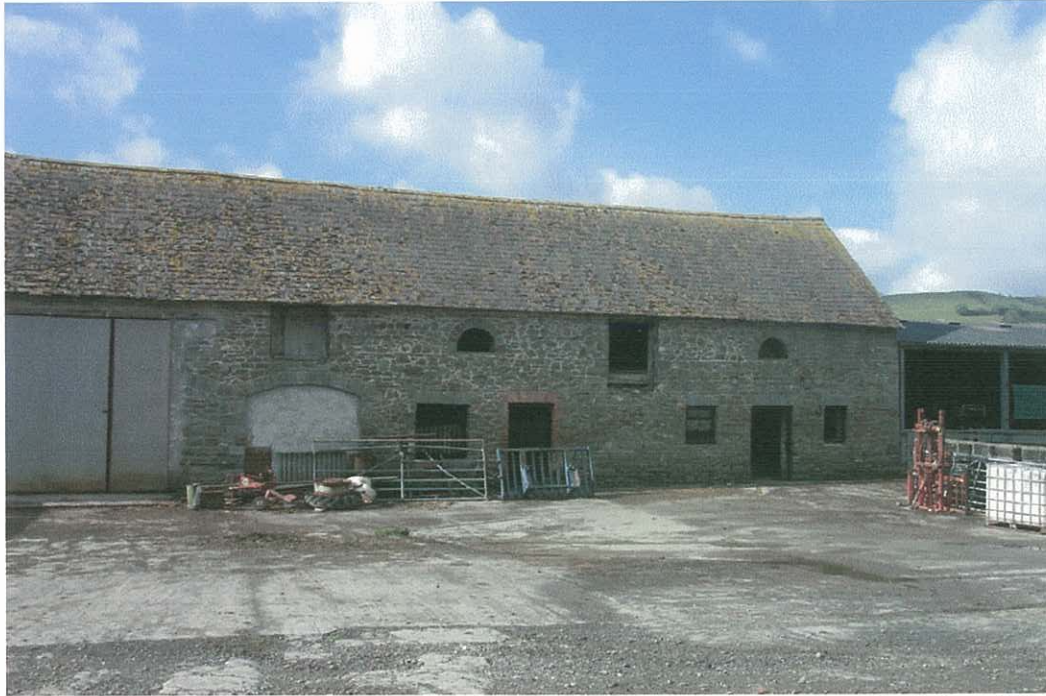
Plate 6 (above) *The north-south range (north end) of the combination farm building, (PRN 49185). This houses stables and a now-blocked cartshed entrance. The modern doors (left of picture) cut through another cartshed entrance.*

In general, this building is in good condition and is in use. However, several of the openings have been blocked with breeze-blocks. Any future maintenance and repair works should use materials and techniques appropriate to the original construction of the building. The east-west part of the building has been largely obscured by modern farm buildings, and some consideration should be given to the siting of any more new buildings in order to prevent the ‘planned’ character and stylistic uniformity of the farmstead from becoming invisible.

The milling machinery is an interesting aspect of the building’s function, and should be left in place. Any future development of this building should ensure that the machinery is protected, and its future assured.

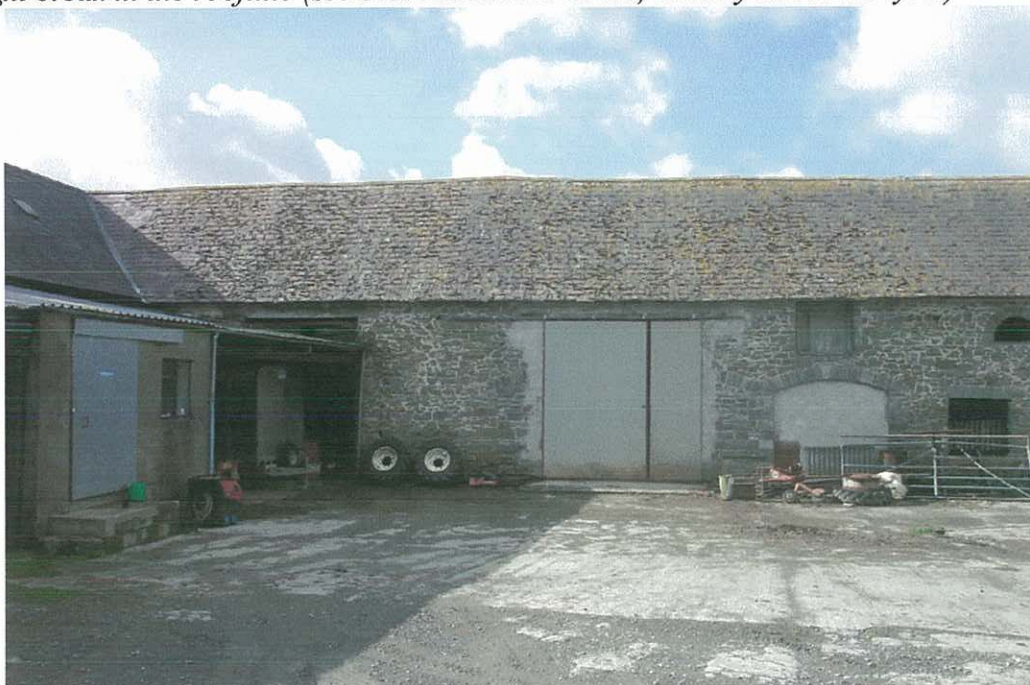
Plate 7 (below) *South end of the same range, showing a number of phases of building. The stables and cartsheds may be the original building, whilst the modern doors are a later insertion. The southernmost end (left of picture) is probably also a later addition, but it is seen on the 1891 Ordnance Survey map. An interior dividing wall marks the original south external wall and there is a slight break in the roofline (see between the two doors, directly above the tyres)*
