Cwmgelli-fach W/12/3986

Tir Gofal Farm Visit Historic Environment Report

Report No. 2004/43

REPORT NO. 2004/43 PROJECT RECORD NO. 48485

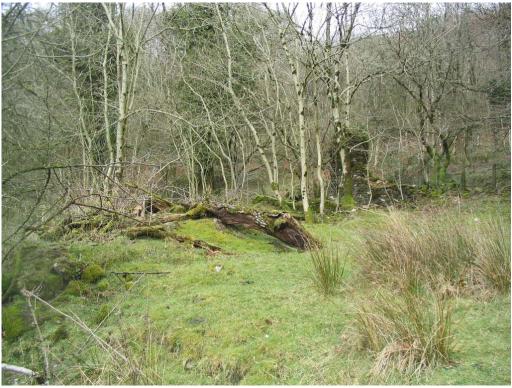
The remains Cwmgelliuchaf farmstead Prn 48768

The ruins of Cwmgelli-uchaf are lightly grazed but also rather overgrown with young saplings which have become established close to, and within, the masonry remains of the building. These saplings will undoubtedly cause the rapid deterioration of the rest of the structure by dislodging stonework and also potentially cause damage by windthrow.

The site of Cwmgelli-uchaf would benefit from the removal of some of the young saplings which pose a threat to the masonry remains of the building. The trees should be cut at ground level and the roots left in place and spot treated with a suitable herbicide to prevent regrowth. Care should be taken when felling and removing trees from the site, to prevent damage to the remaining stone work. **Site Category** B

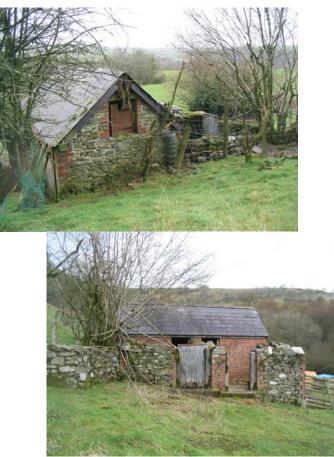
The condition of the pigsties is deteriorating and it is hoped that the building can be restored through the scheme. The slates on the roof are beginning to loosen and some have slipped. The roof timbers appear to be in a reasonable condition. Elsewhere the masonry in the yard wall is becoming loose and the rubble stone capping is unstable. In isolated areas the facing stonework is also failing. The door to the right-hand sty is missing and the yard gates, constructed in corrugated iron are dropping on their hinges.

Prn 48765 – Cwmgelli-fach pigsty, (left) the west facing gable showing the loft hatch, and (right) the south of the pigsty showing the yard walls

The roof should be repaired and slates should be refixed to make the structure watertight.

The yard wall needs to be consolidated. Works should endeavour to replicate the existing style of construction, in particular the use of red brick for the quoins, gate jambs and pier should be retained. The use of quartz in the rubble stone wall capping should also be copied; these elements are characteristic of the building and should be retained.

The gates to the yard and the doors will also need to be restored. Where possible these should be repaired in preference to replacement and any new doors and gates should copy the original design.

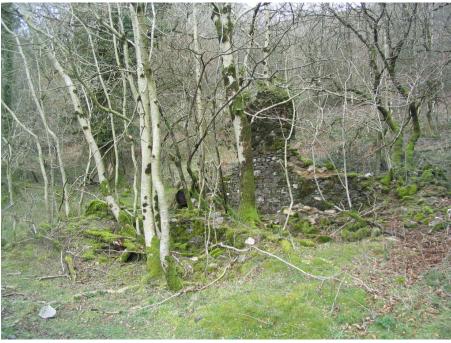
Prn 48768 – the remains of the farmstead at Cwmgelli-uchaf have become colonised by saplings.
