# **ST DAVID'S CHURCH PRENDERGAST, HAVERFORDWEST PEMBROKESHIRE**

## **ARCHEOLOGICAL WATCHING BRIEF**

Report No. 2003/104

ST DAVID'S CHURCH, PRENDERGAST, HAVERFORDWEST  
ARCHAEOLOGICAL WATCHING BRIEF

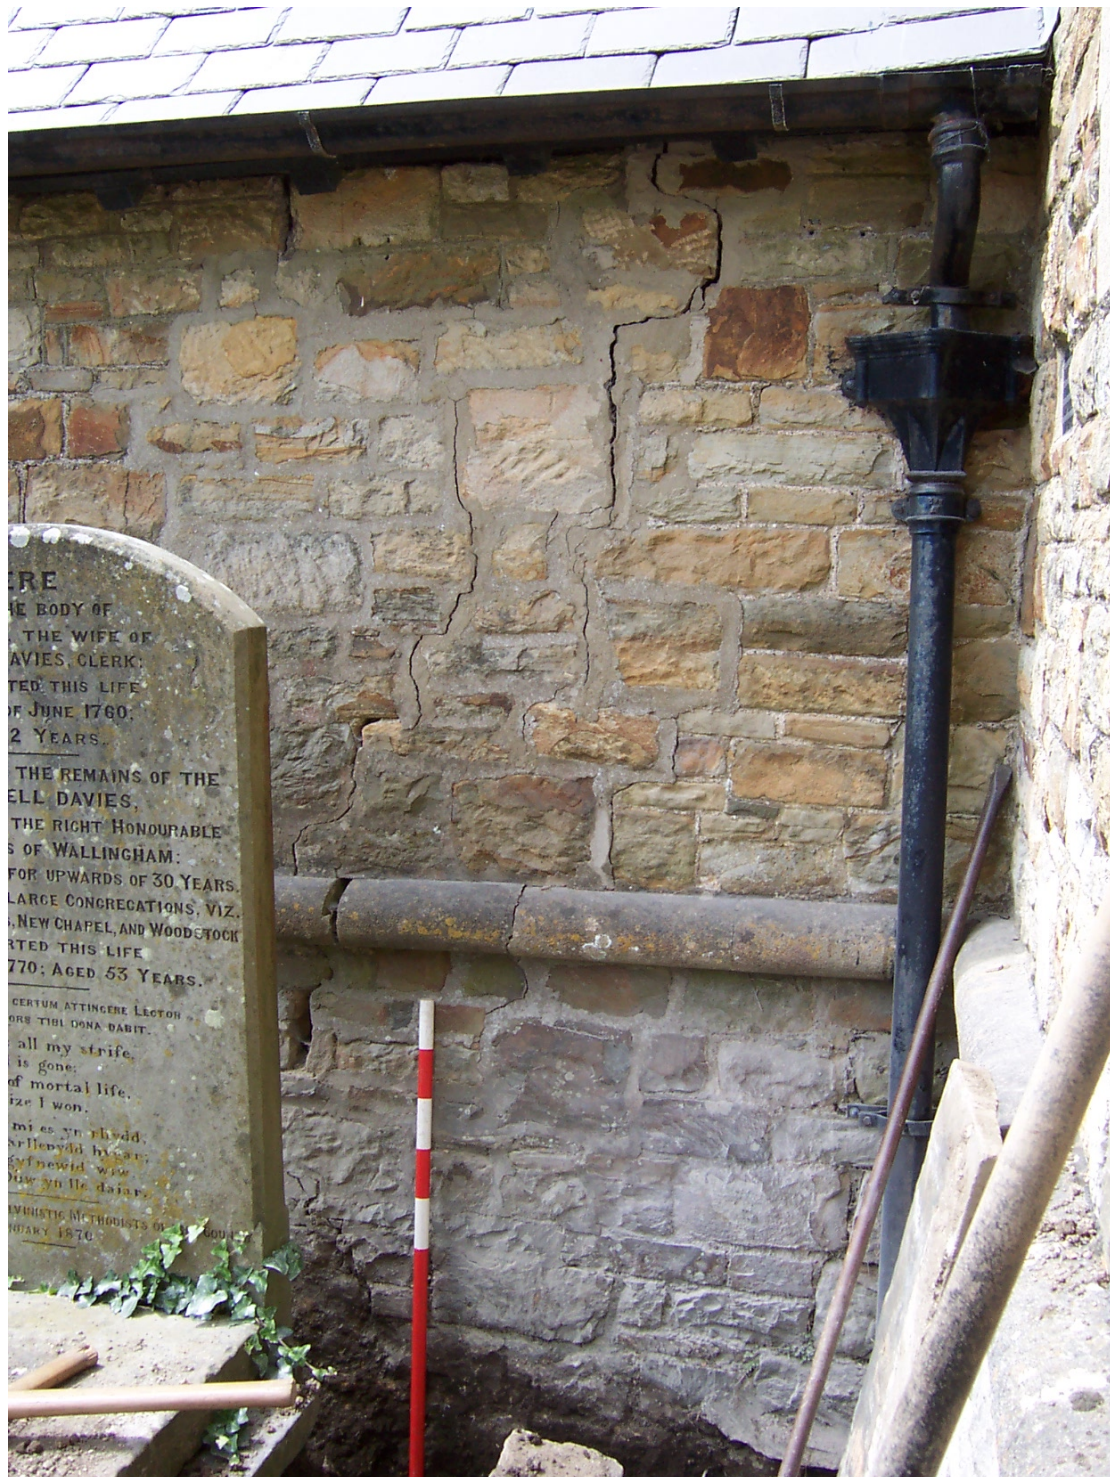
**Photo 1: Subsidence crack on east side of porch. View W. Scale 1m**

211 E side of porch showing subsidence cracks. View W. Scale 1m

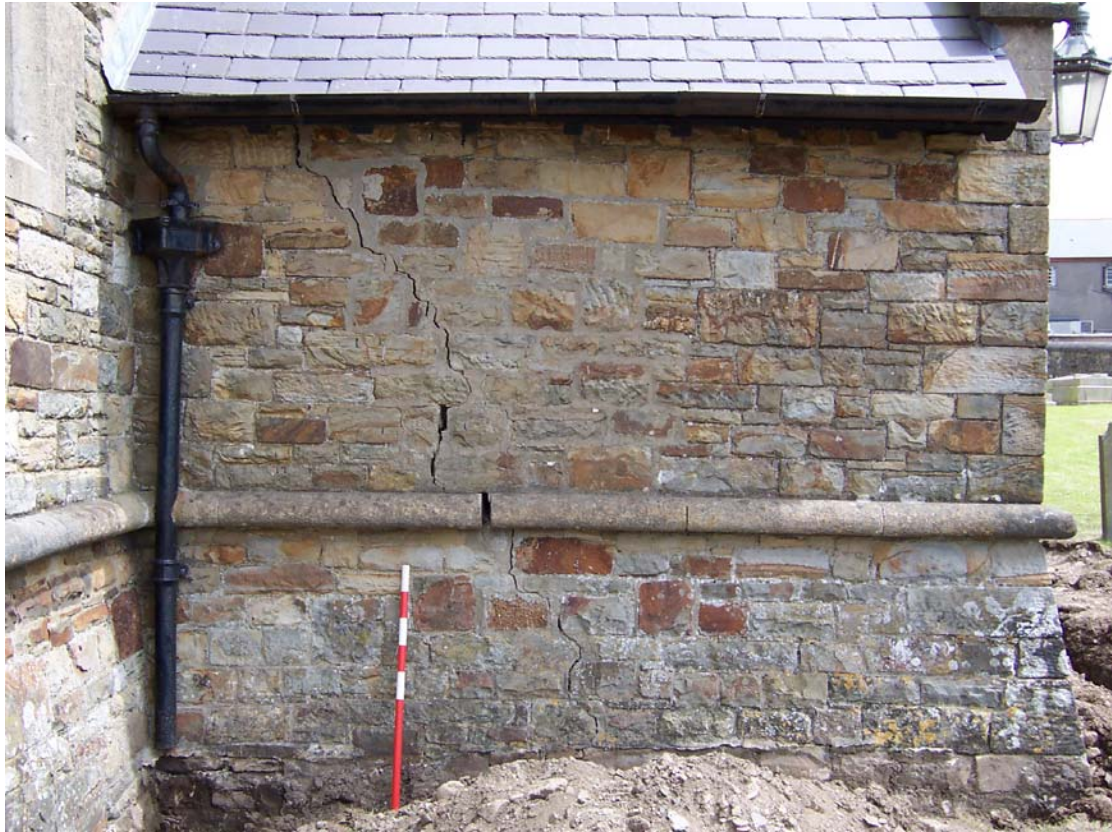
There was no archaeological presence the next day, but Rob Hall of Cadw called in on the site when a 1.5m deep test pit has been machine dug at the front of the porch, apparently all through made up ground. The decision was made to do nothing further with the porch footings and the test pit was backfilled (pers. comm. Frans Nicholas). The porch appears to have splayed footings continuing in line with the splay visible above ground level (Photo 2).

**Photo 2: Subsidence crack on West side of porch. View E. Scale 1m**

212 W side of porch showing subsidence cracks. View E. Scale 1m
